HELICOPTER SECONDARY STRUCTURES  
RELIABILITY AND MAINTAINABILITY  
INVESTIGATION

Kaman Aerospace Corporation

Army Air Mobility Research and Development  
Laboratory

January 1974

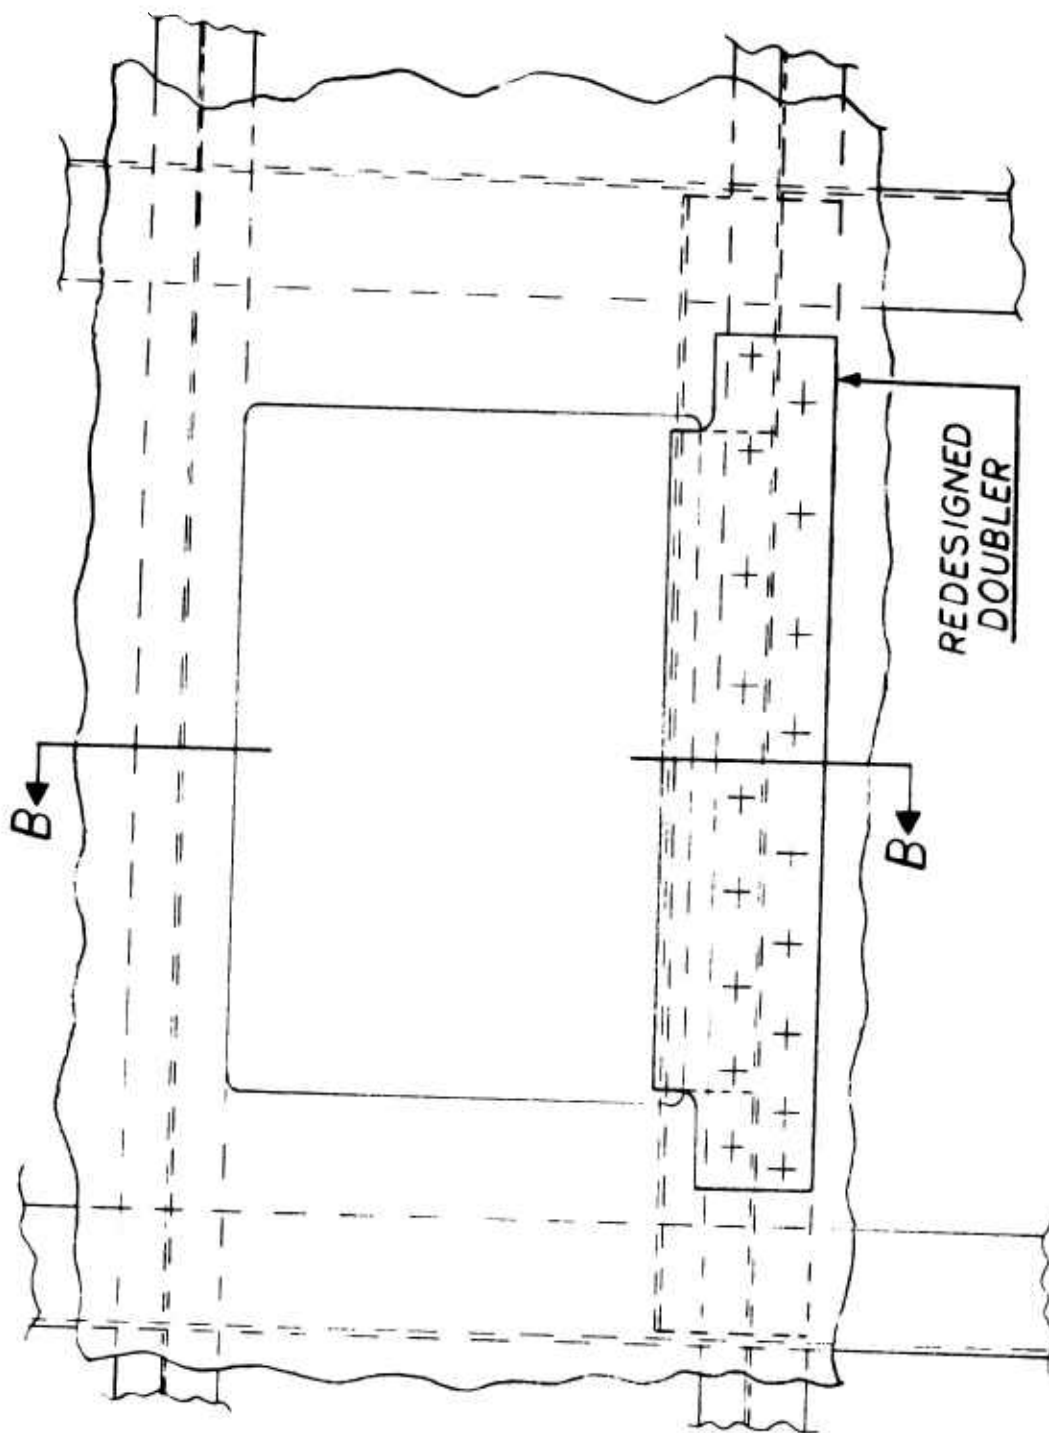
Figure 22. Sketch of Modified Design Box Step.

Accordingly, the step on the right-hand side was modified by the addition of a doubler to the step area. This doubler is external to the fuselage skin and projects forward and aft beyond the cutout in the skin which forms the box step. The doubler also wraps inboard over the top of the step area. These configurations are illustrated in Figures 22 and 23.

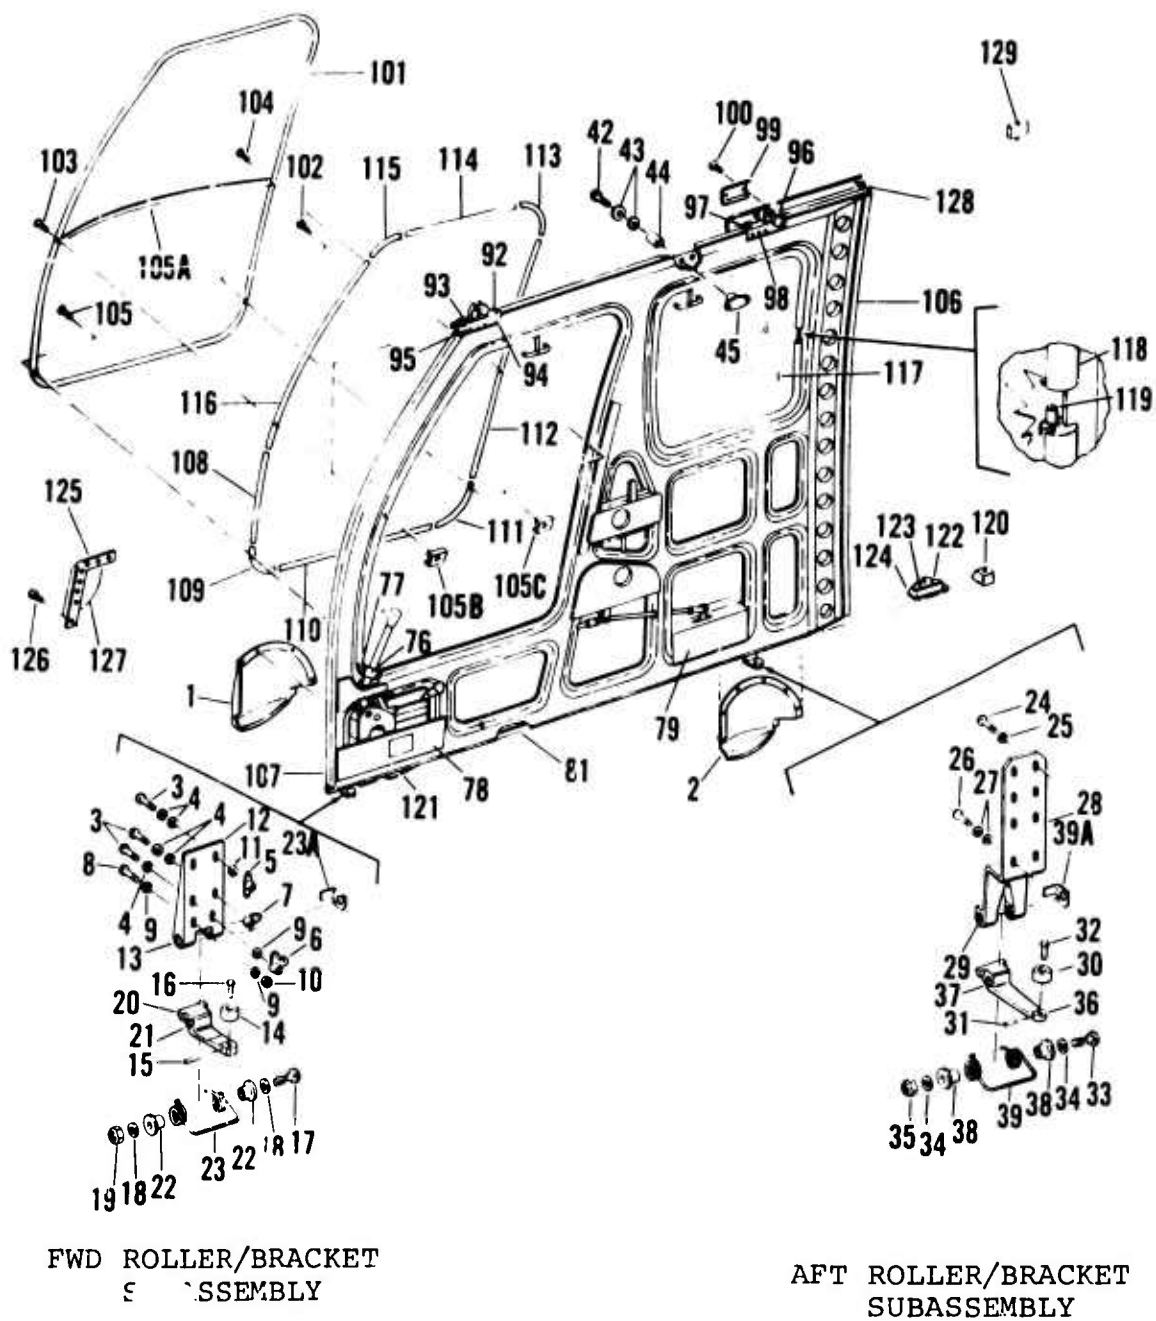
The lower roller assembly level FMEA is presented in Table XII. The most probable functional failure modes for the lower roller assembly are predicted to be excessive roller wear, rollers out of adjustment, and broken rollers.

Figure 31. Parts Breakdown, Lower Roller Assembly.
