HLH/ATC ENGINE SHAFT SUPPORT BEARING  
DEVELOPMENT PROGRAM

Boeing Vertol Company

May 1974

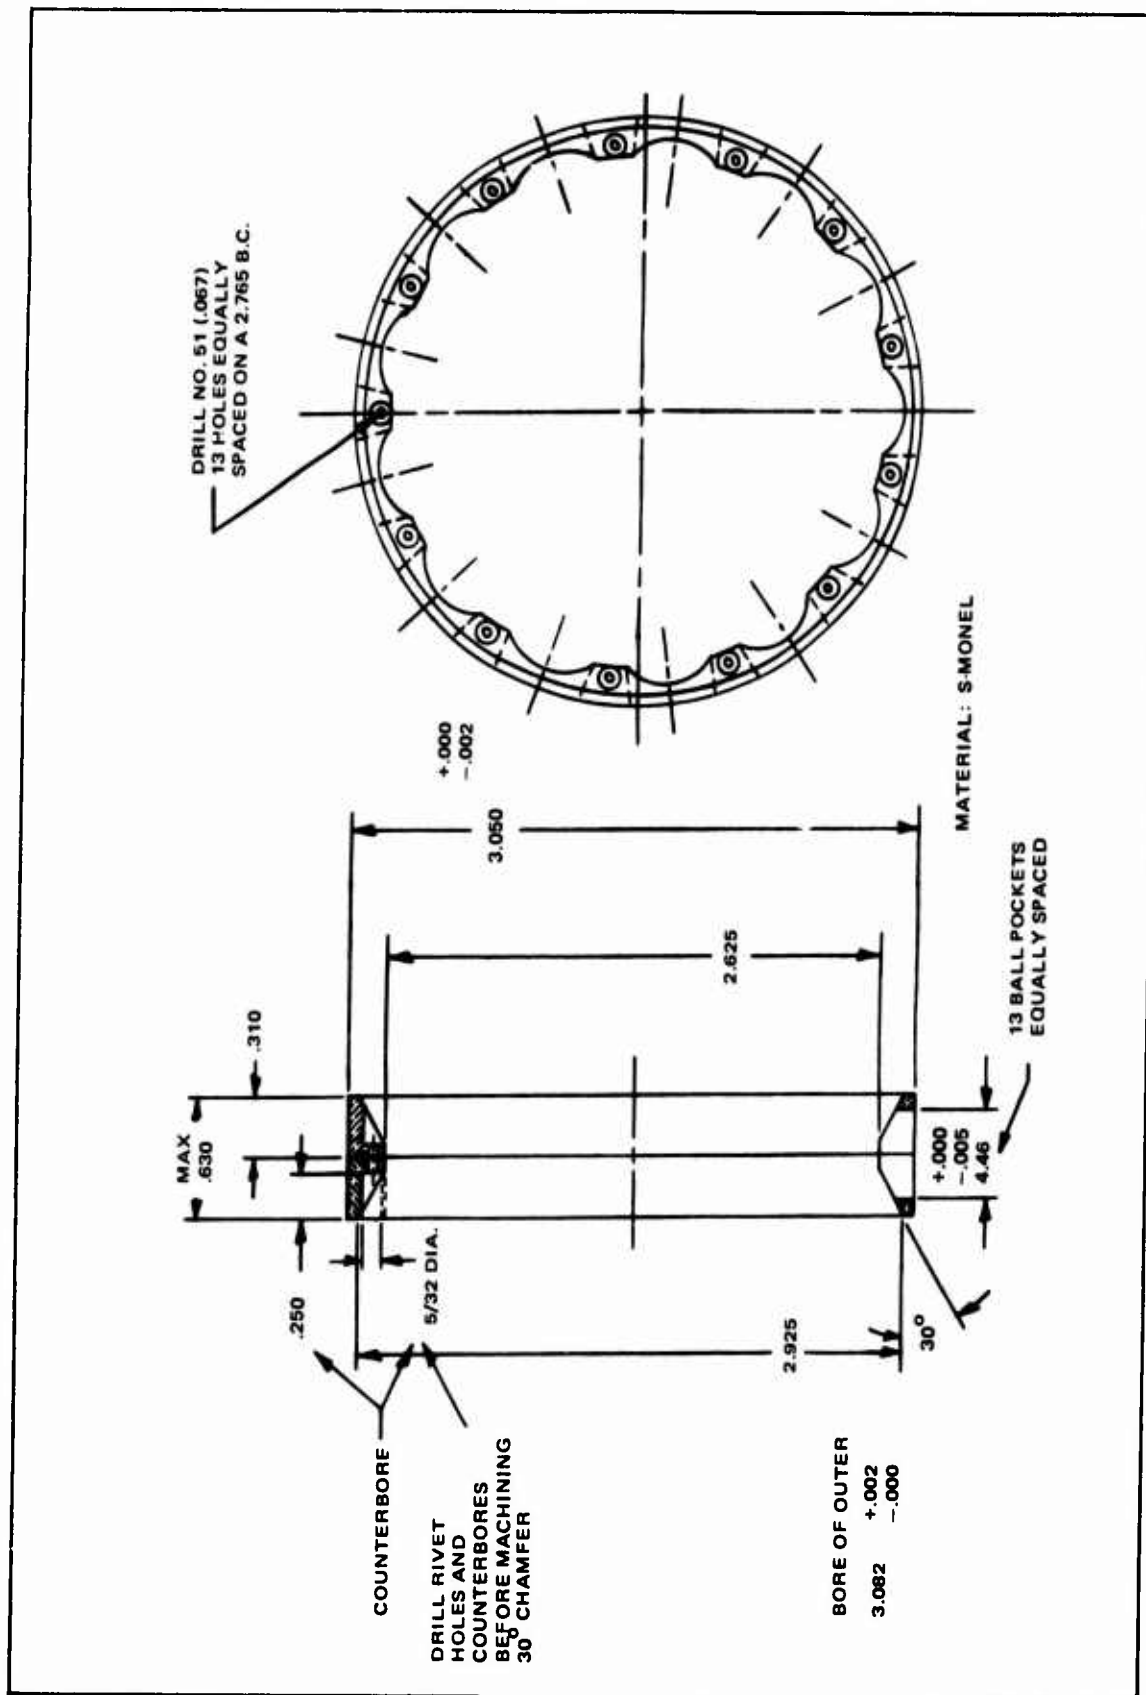
Figure 12. Machined Outer-Land-Riding S-Monel Cage.

An outer land riding S-Monel cage (Figure 12) was designed and fabricated after significant wear was observed in the inner land riding specimens. The rationale involved the action of centrifugal force on an unbalanced cage; an inner land riding cage tends to wear only in one area, with rate of wear increasing as the cage becomes more and more unbalanced. An outer land riding cage tends to wear more evenly about its periphery, although other factors, such as the tendency of an outer land riding cage to trap lubricant in the outer race, mitigate against its universal use.

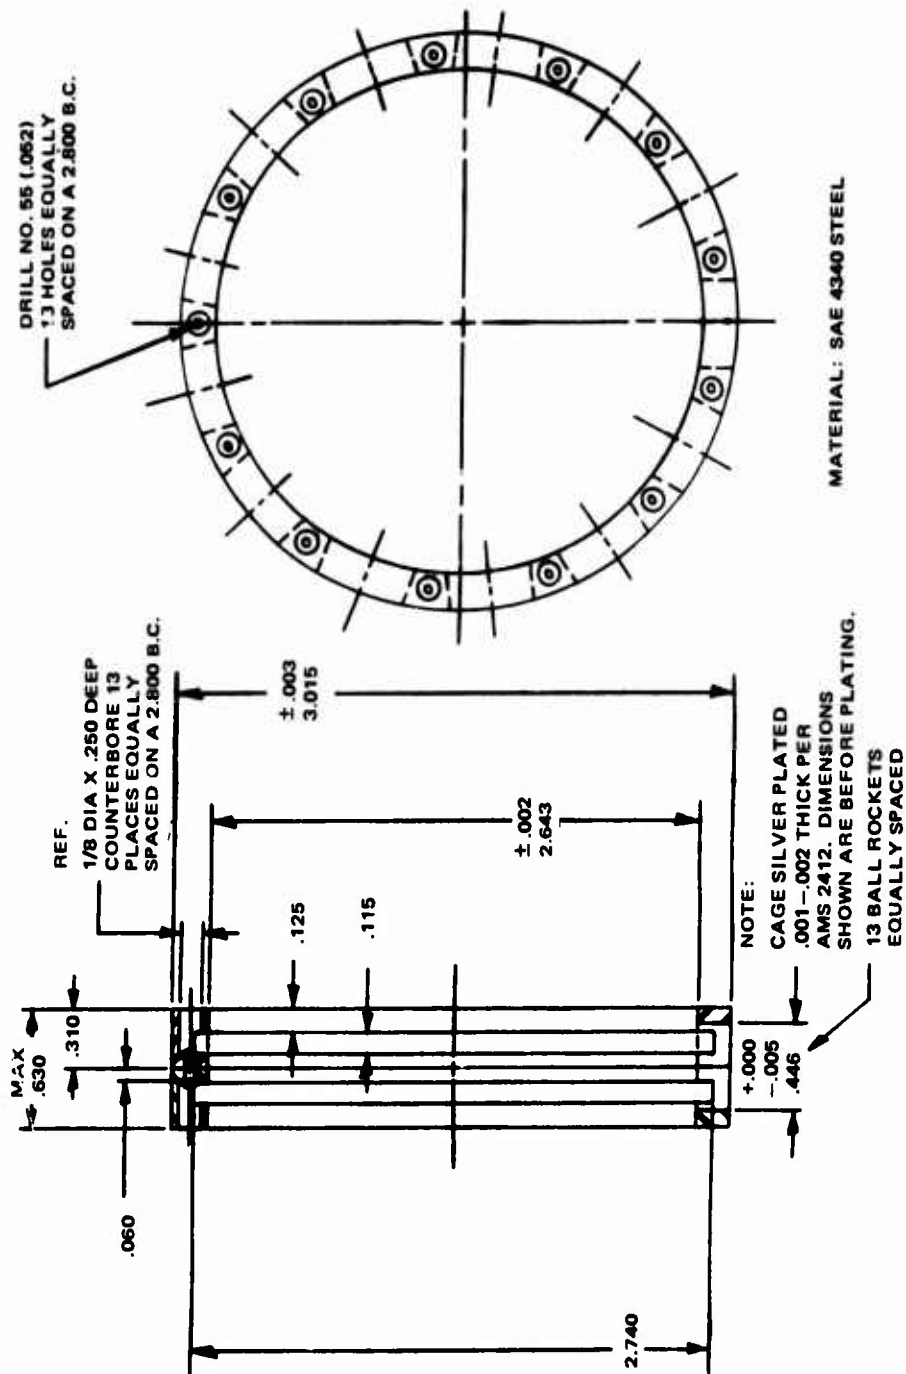
Figure 13. Two-Piece Machined Steel Cage, Silver Plated.

After severe wear, indications of inadequate grease circulation, and fracture of a number of cages occurred during testing, a silver-plated machined steel cage (Figure 13) was designed and fabricated. The rail section and short rivet design were incorporated for high strength; the silver plate provided some marginal lubrication; internal annular grooves provided space for grease circulation around the inner race.

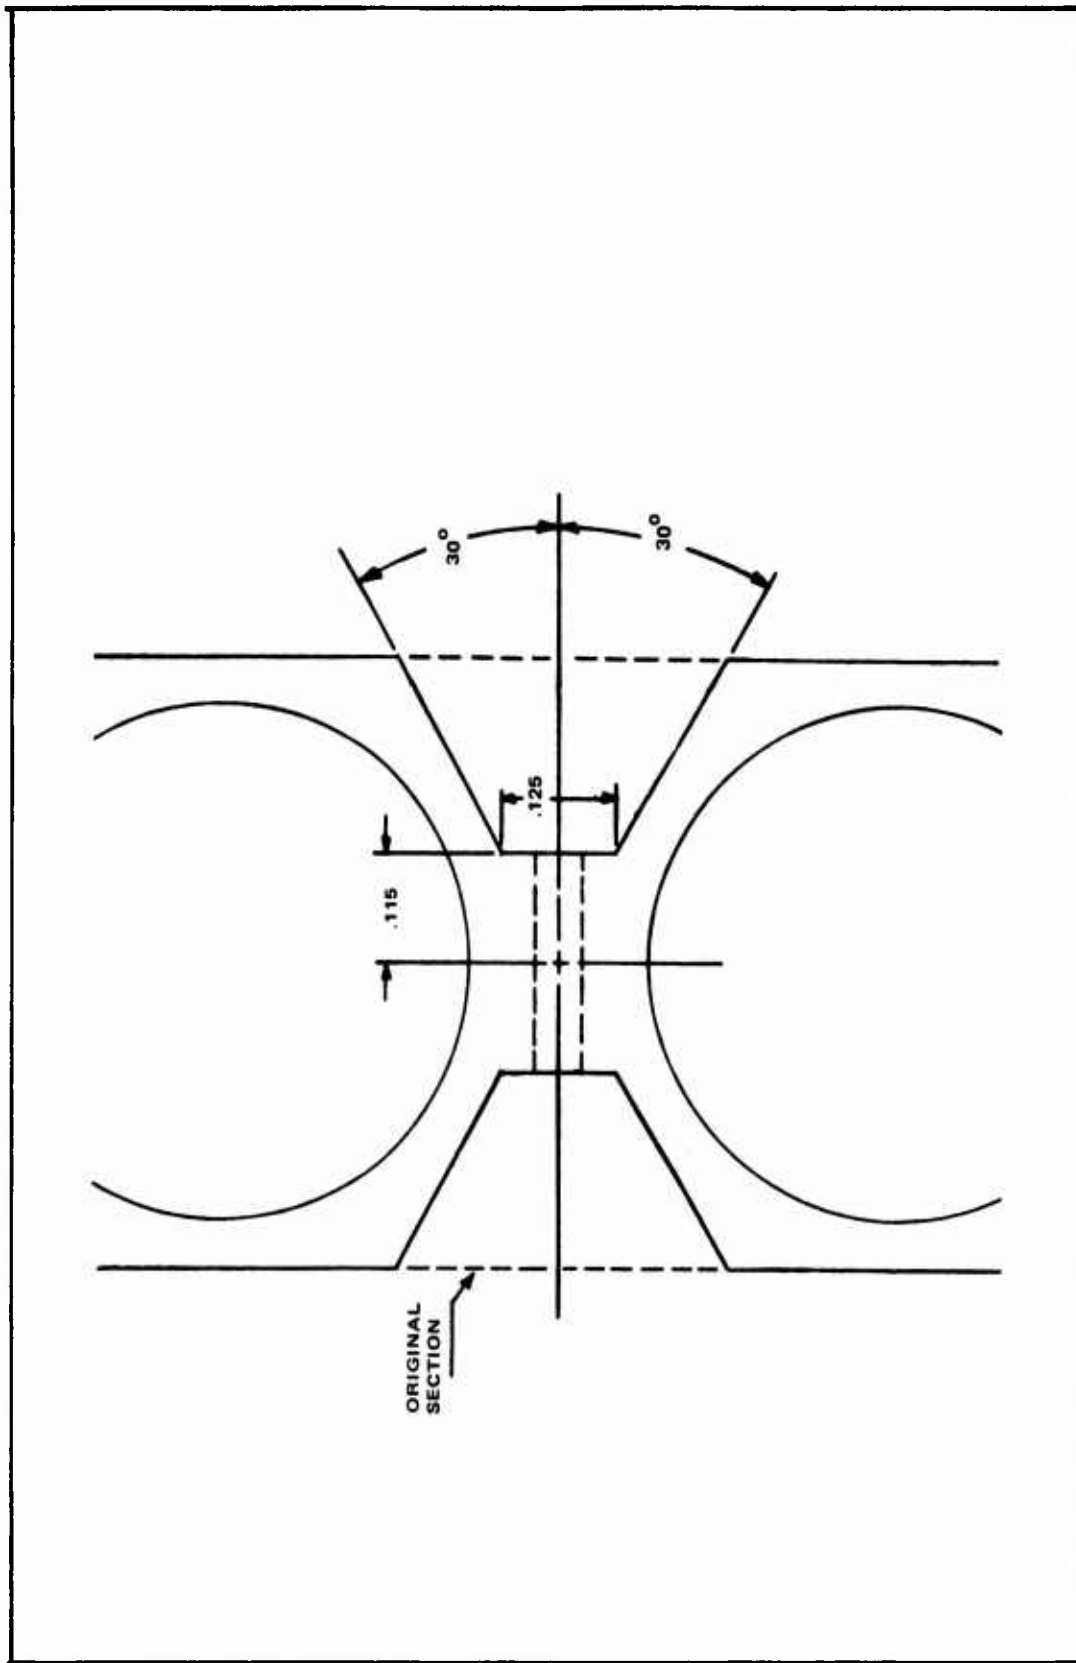
Figure 21. 111-KS Insert Cage Modified.

Testing of the first insert type cages indicated insufficient lubrication. Two of these cages were then reworked as shown in Figure 21 to reduce stock and thereby increase grease fill and internal grease circulation.

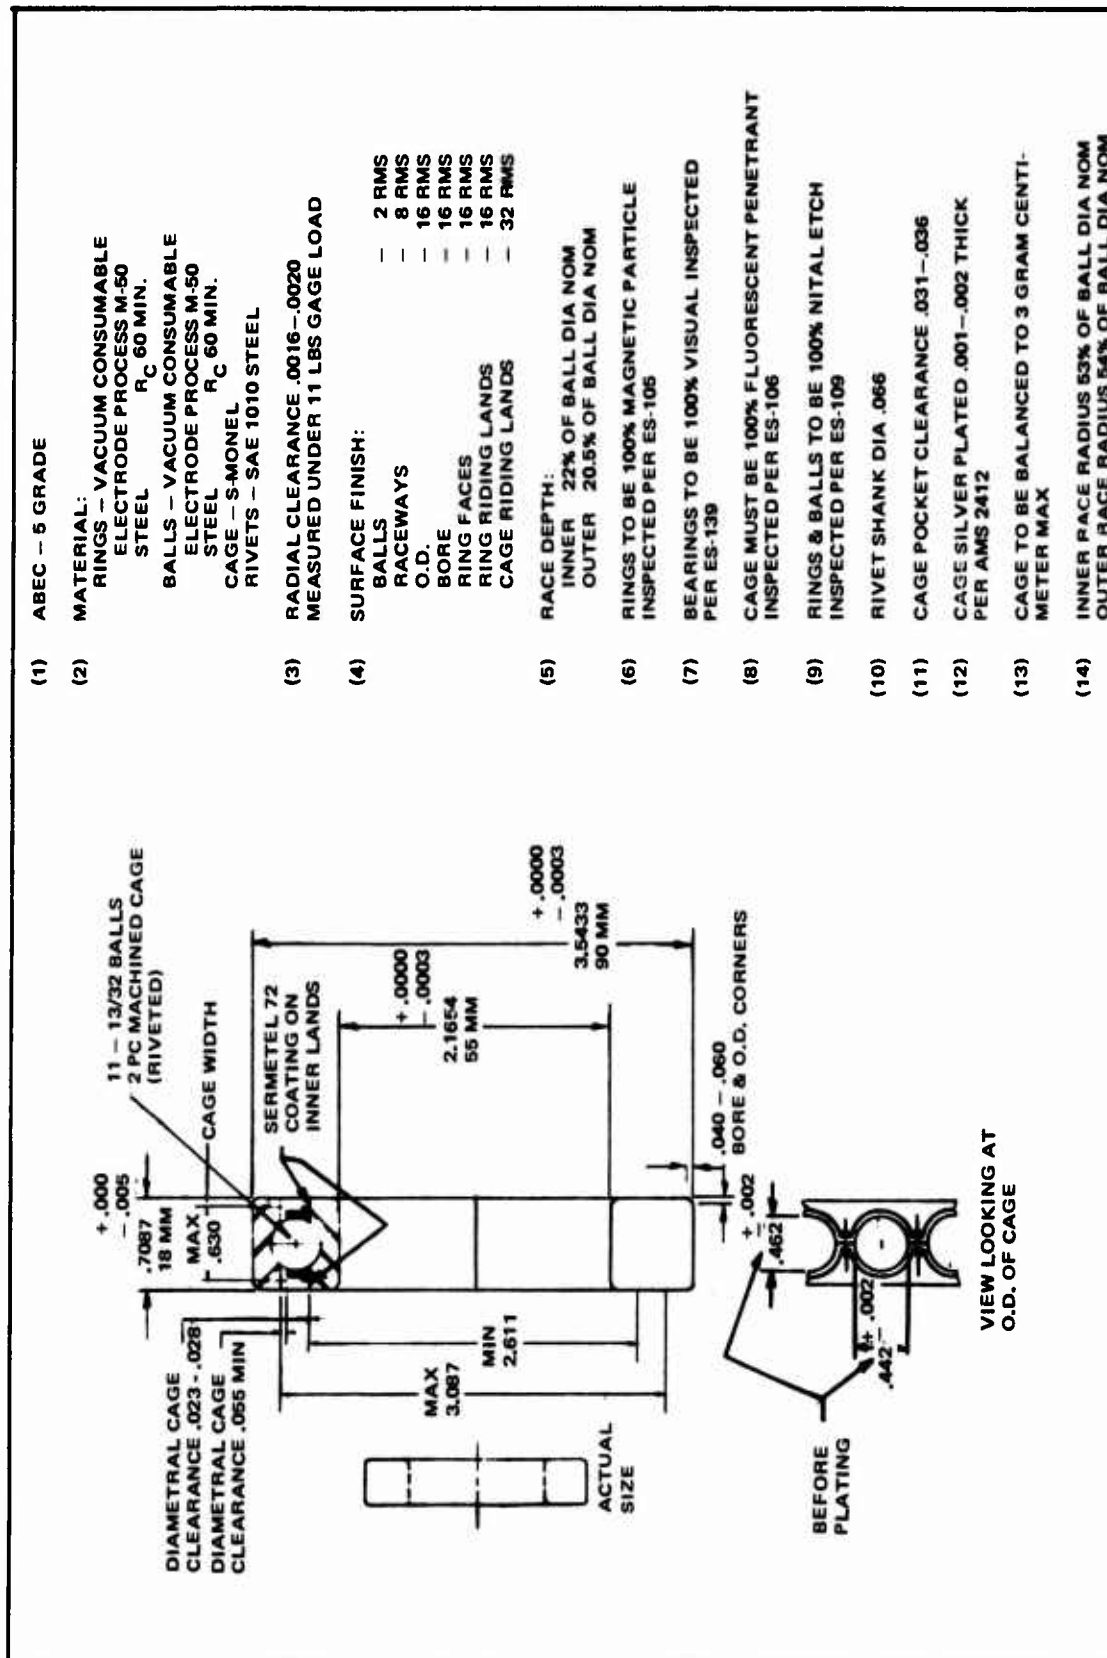
Figure 23. Modified Test Bearing, Sermetel 72.

- Two bearings were fabricated to the configuration shown in Figure 23. The inner race cage riding lands were coated with "Sermetel 72", by Sermetel Division, North Wales, Pennsylvania. The coating was a final attempt to reduce the severe cage land wear experienced during prior testing.
- A major review of all the cage designs tested indicated that the original ball riding, pressed steel cage appeared to operate satisfactorily under the specified test conditions. Therefore, a machined ball riding cage (Figure 24) was designed and fabricated. This final cage design was assembled into the bearing configuration shown in Figure 25.

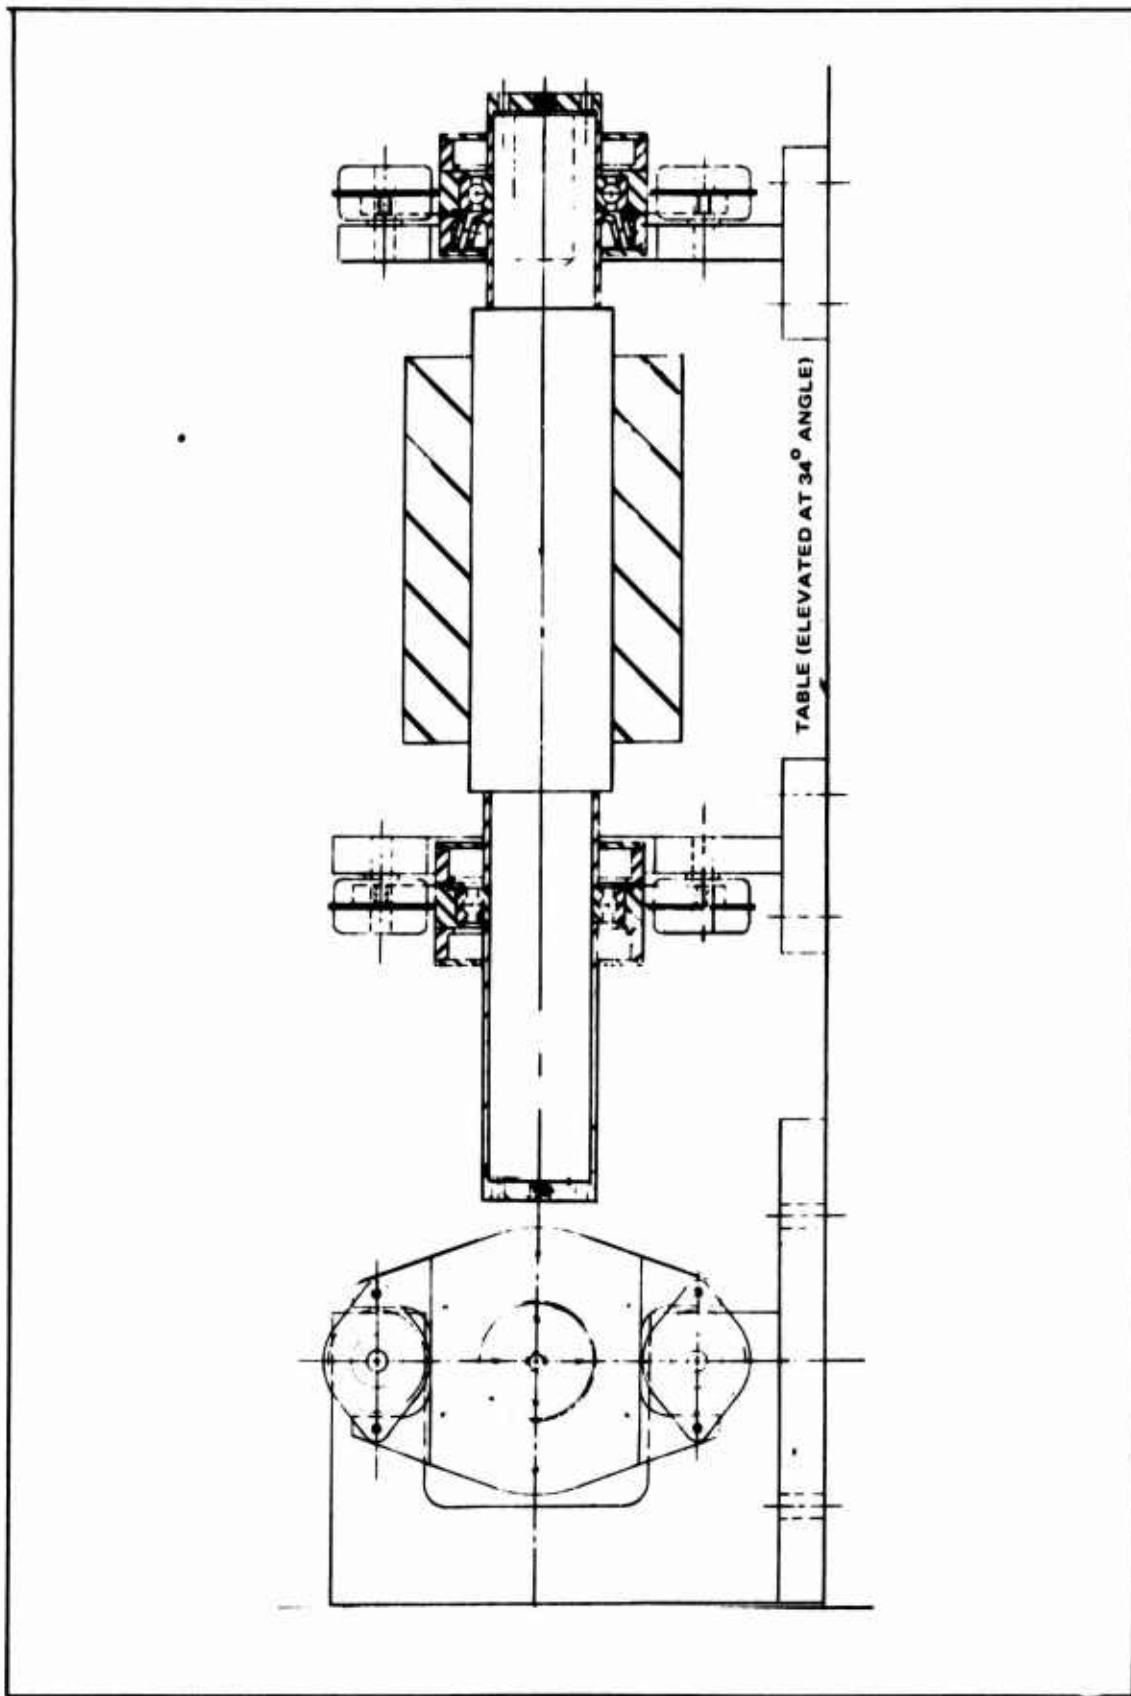
Figure 28. Test Rig, Version 1.

Version 1 of the test rig (Figure 28) shows a view of the test spindle as initially set up; two spindles were fabricated, designated A and B, respectively, in this report. A plain housing was installed on the drive end of the rig, and a grease-circulating device was installed on the outboard end. After the first test on each spindle, the grease circulating devices were changed from the "uphill" side of the outboard housing to the "downhill" side, as shown in Figure 29 (test rig, Version 2). At the same time, labyrinth seals with 0.010-inch diametral clearance were installed on both sides of each housing.

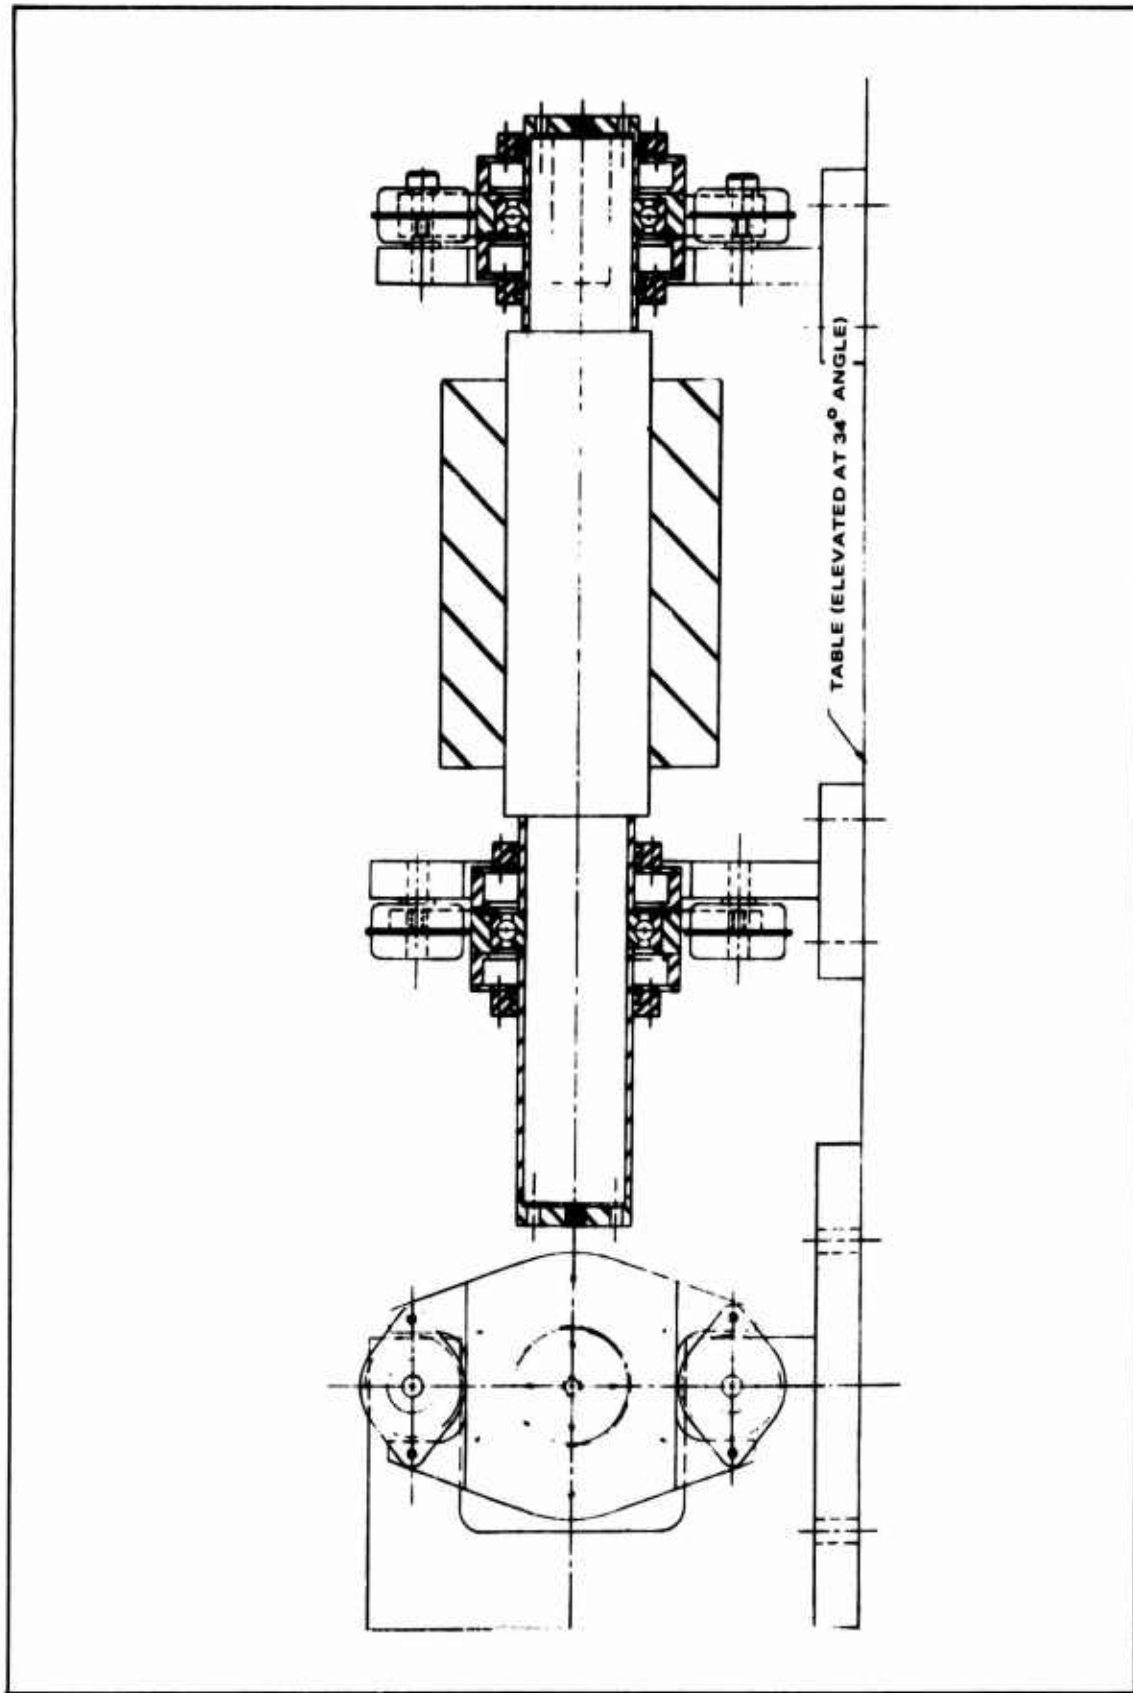
Figure 30. Test Rig, Version 3.

Three tests ran with no grease circulating or flinging device in either housing, as shown in Figure 30 (test rig, Version 3). Final testing was done with washer-type grease flingers on both sides of each test bearing to retard grease migration, as shown in Figure 31 (test rig, Version 4).

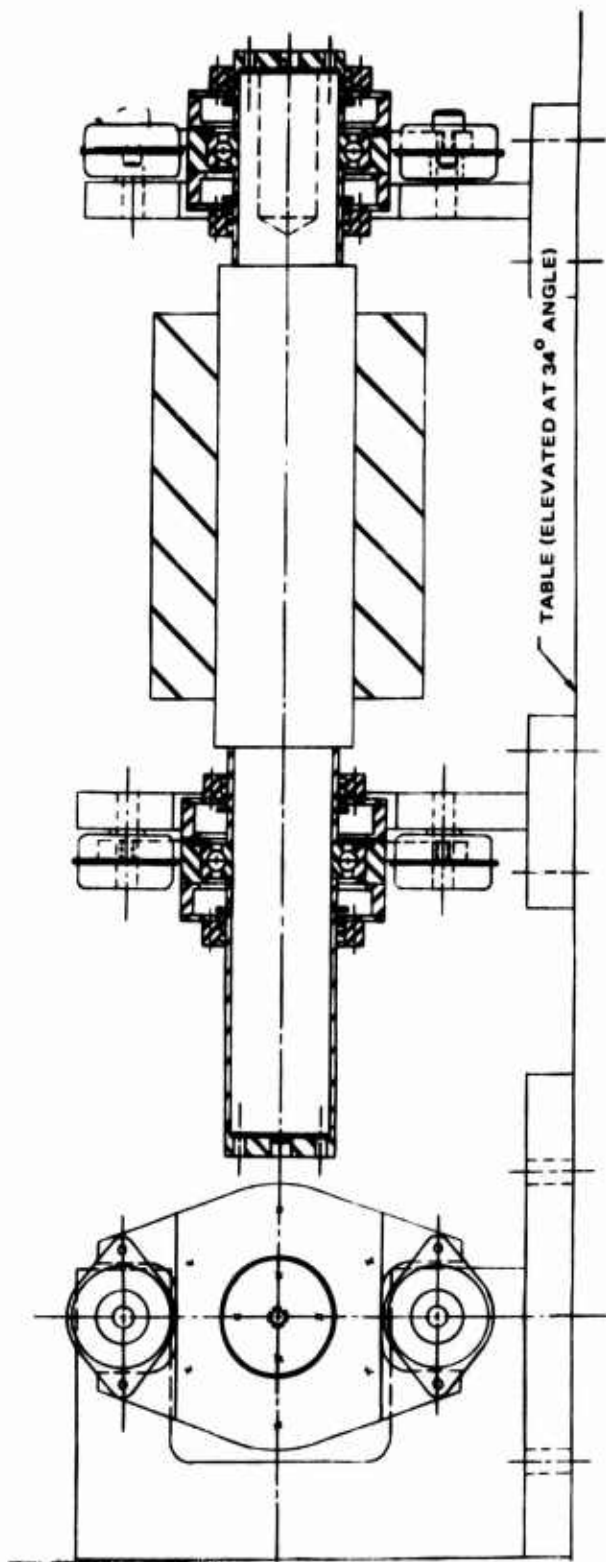
Figure 31. Test Rig, Version 4.

Prior to the final series of tests, Version 4 of the test rig (Figure 31) was again modified to more closely simulate the actual helicopter shaft support housing. The final modifications were as follows:

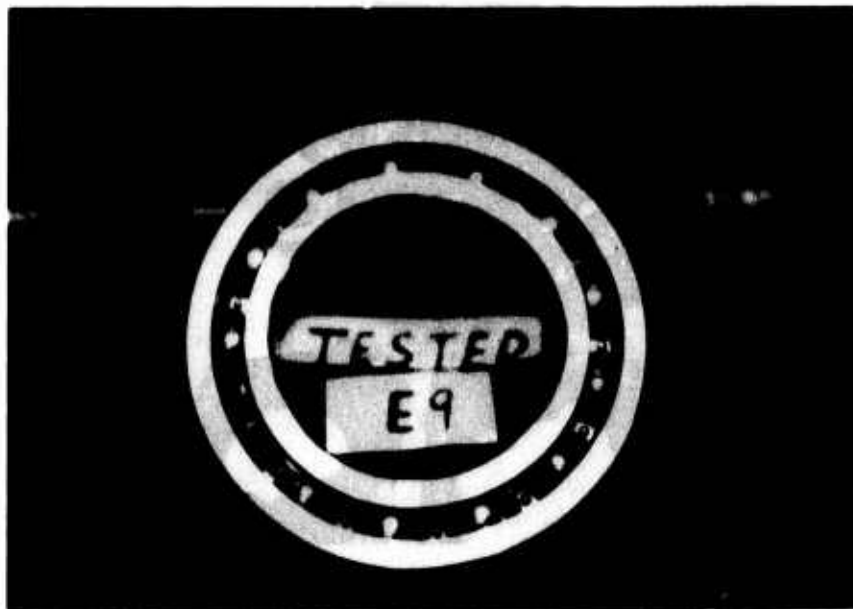
Figure 43. Bearing S/N E2, After Test 1.

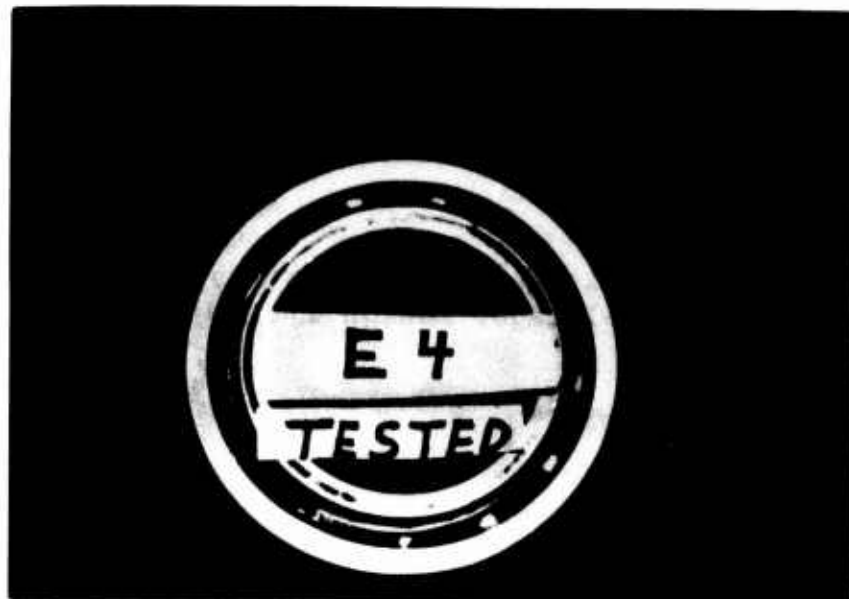
Figure 49. Bearing S/N E4 After Test, Grease Still in Bearing.

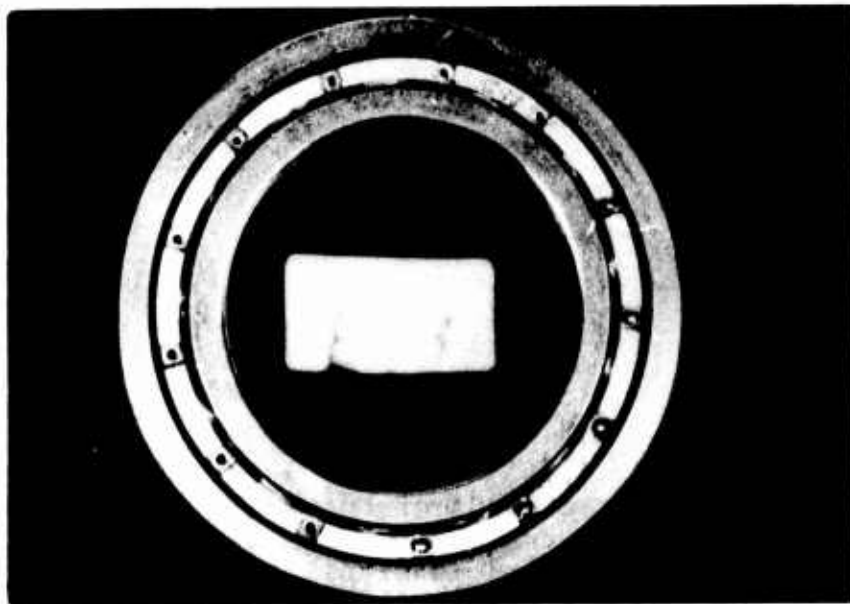
Erratic performance of bearings resulted in several teardowns and inspections, so housing and seal evaluations were impossible. Basically, the bearings had difficulty getting enough grease and were partially starved. Their torque tended to be high or to vary, causing the shaft to change its misalignment, and causing the close-running labyrinth seals to contact the shaft. The test was terminated prematurely, and bearings were inspected. Balls and races were cloudy, indicating surface deterioration. Figures 50 and 51 show one of these bearings before and after test.

**Figure 51. Bearing E13 After Test (Some Rivets Have Been Removed for Disassembly).**

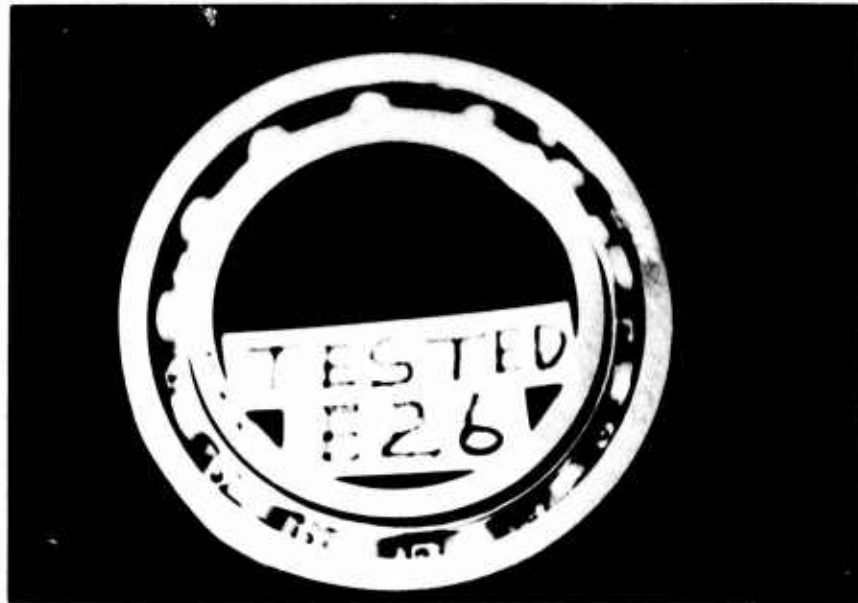
After 300 hours the test was suspended. Both bearings had worn on the bore, with the heaviest wear, approximately 0.035 inch, in the drive-end bearing. The outboard bearing had experienced maximum depth of wear of 0.018 inch. Neither cage had lost rivets. Figures 52, 53, and 54 show a bearing before test and the 2 bearings after test.

Figure 54. Bearing E26 After Test.

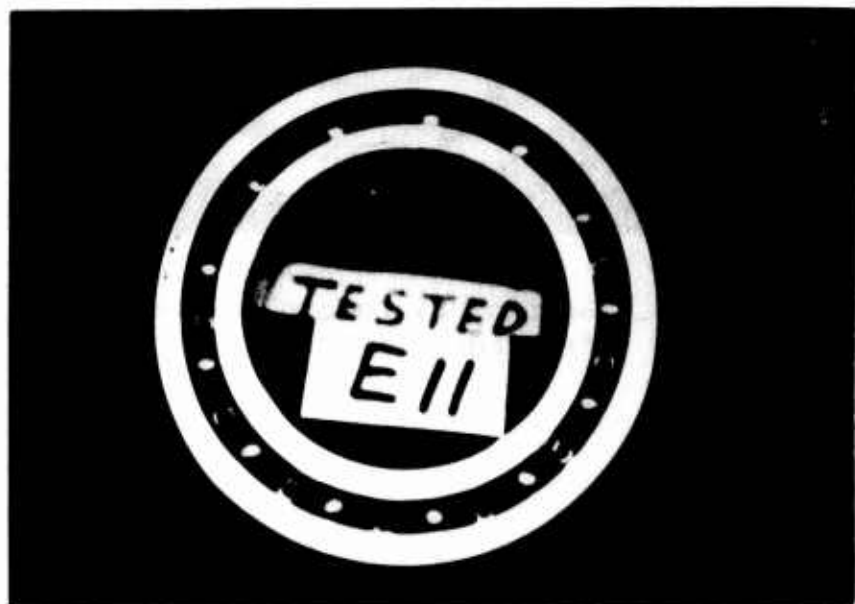
During the last several hours of operation, performance of the drive-end bearing was erratic, and the grease additions to this position were attempts to stabilize it. At 246.2 hours the rig was shut down and disassembled. The cage in the drive-end bearing was found to have lost all rivets and separated. The outboard end bearing was still intact. Figures 55, 56, and 57 show the bearing with Teflon-coated cage before test, and two bearings after test.

Figure 57. Bearing E11 After Test.

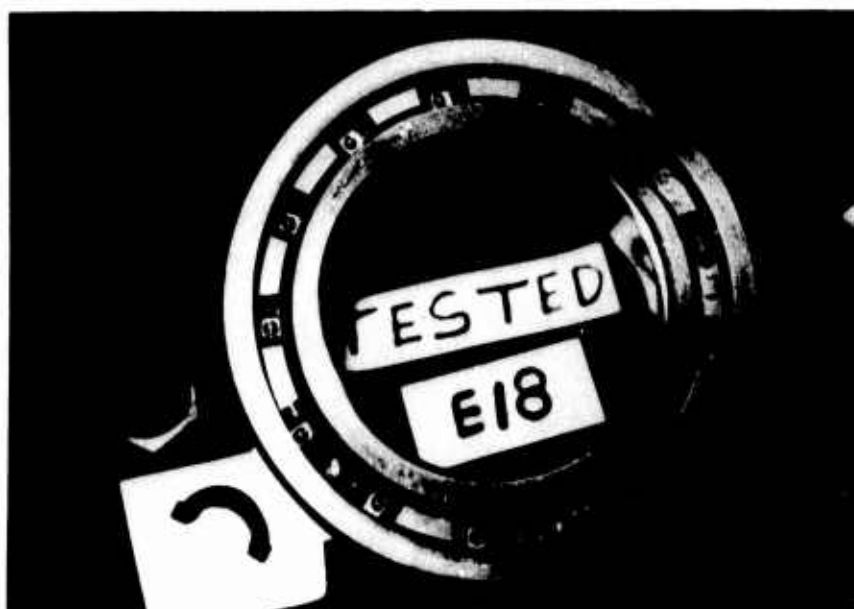
These tests evaluated bearings S/N E18 and E24 with reworked insert type cages (Figure 21) in which stock had been removed to facilitate grease lubrication. Figure 61 shows a bearing before test. All stock was removed from the steel frame. Both tests ended in very short time with broken cages (see Figures 62 and 63).

Figure 62. Bearing E18 After Failure, Test 10.

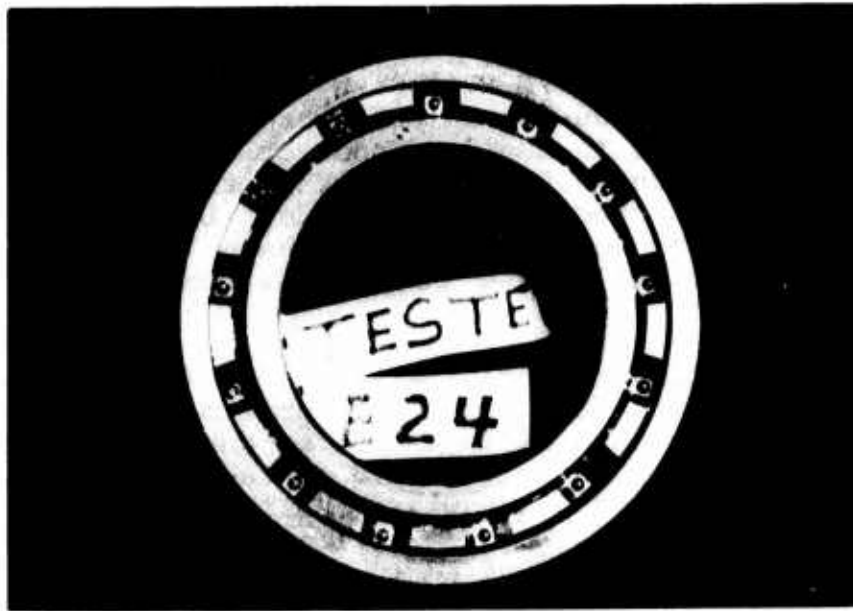
Figure 63. Bearing E24 After Failure, Test 9.

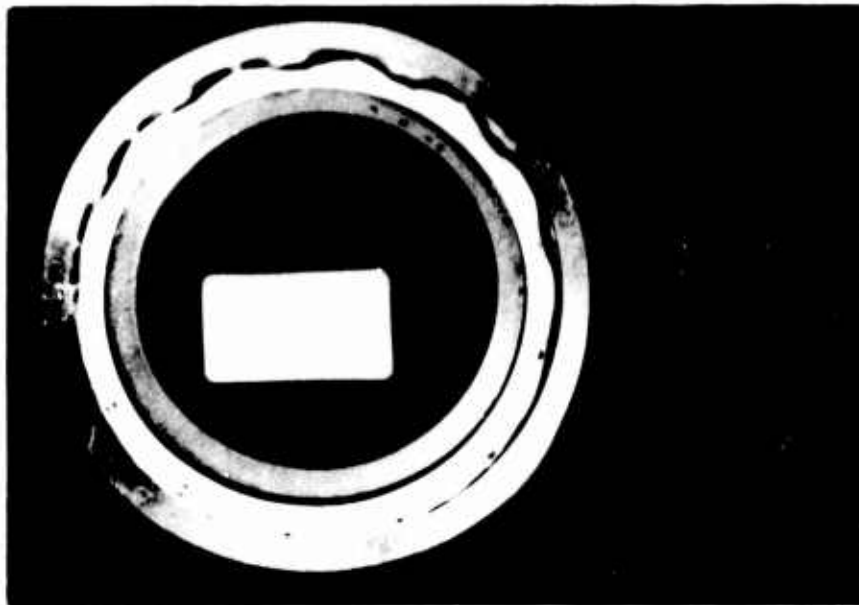
The outboard bearing (S/N E20) with Design 3 cage (Figure 65 before test, Figure 66 after test) wore through the silver and into the base metal in the land contact area to depths of 0.007 inch on one half and 0.015 inch on the other. The O.D. of the cage had not contacted the outer lands. Balls had not worn through the silver on the pockets. There appeared to be a trace of Teflon left on the inner lands, embedded in the surface finish.

Figure 66. Bearing E20 After Test.

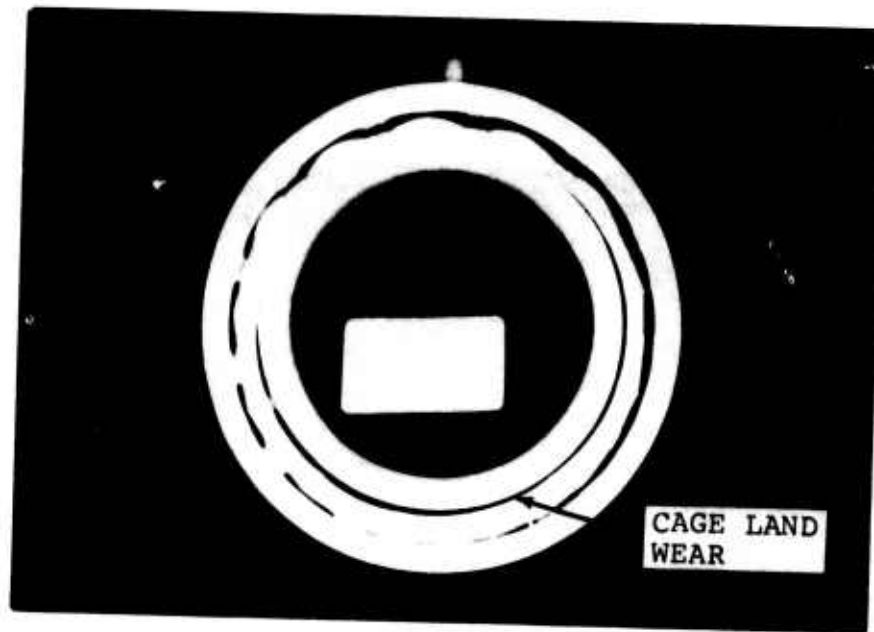
Figure 74. Bearing S/N 32 After Test.

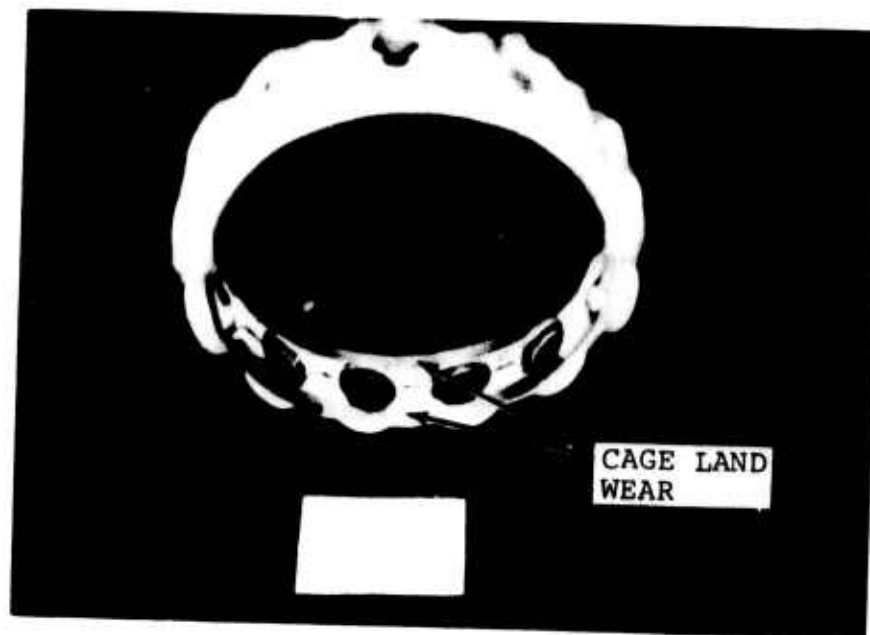
Figure 75. Cage S/N 32 After Test.

were functioning normally. Cage wear was essentially the same on both halves, again indicating an improvement.

Severe cage wear was caused by unbalance. For future testing, cage balance should be checked and held to 3 gm cm maximum.

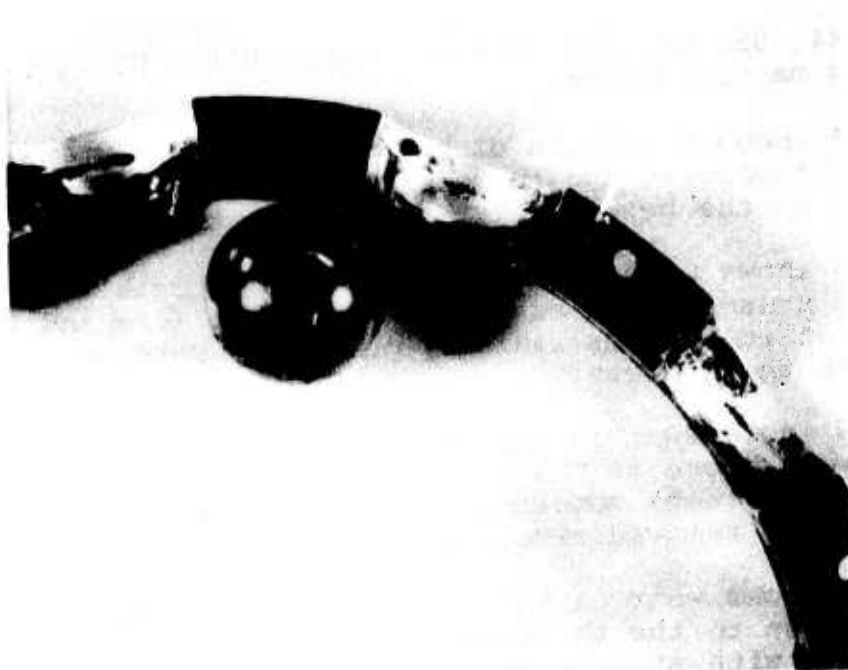
Figure 85. View of Cage Pockets and a Ball, Bearing S/N 6.

Figure 85 shows wear in the ball pockets. This wear is concentrated around the bore of the cage, but fore and aft in each pocket it extends radially outward. Dark grease residue remains in the pockets.
