ELASTIC PITCH BEAM TAIL ROTOR OPERATIONAL  
SUITABILITY INVESTIGATION

Kaman Aerospace Corporation

Army Air Mobility Research and Development  
Laboratory

July 1974

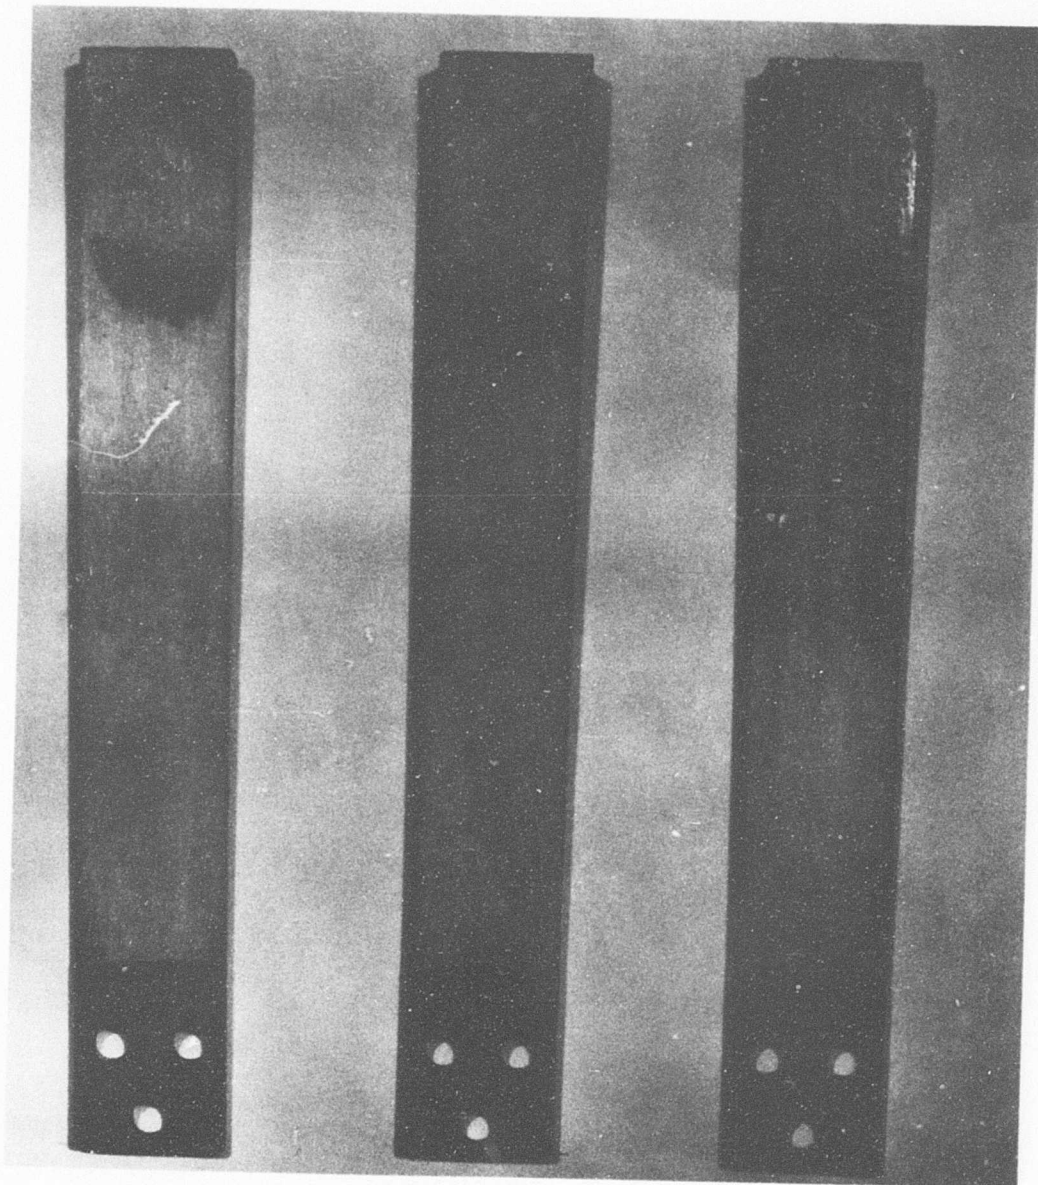
Figure 7. Constant-Deflection Reverse-Bending Fatigue Specimens of Unidirectional S Glass, Type 1002-1014S, Tested at 96,000 psi Maximum Fiber Stress at 200 cpm, No Environment.

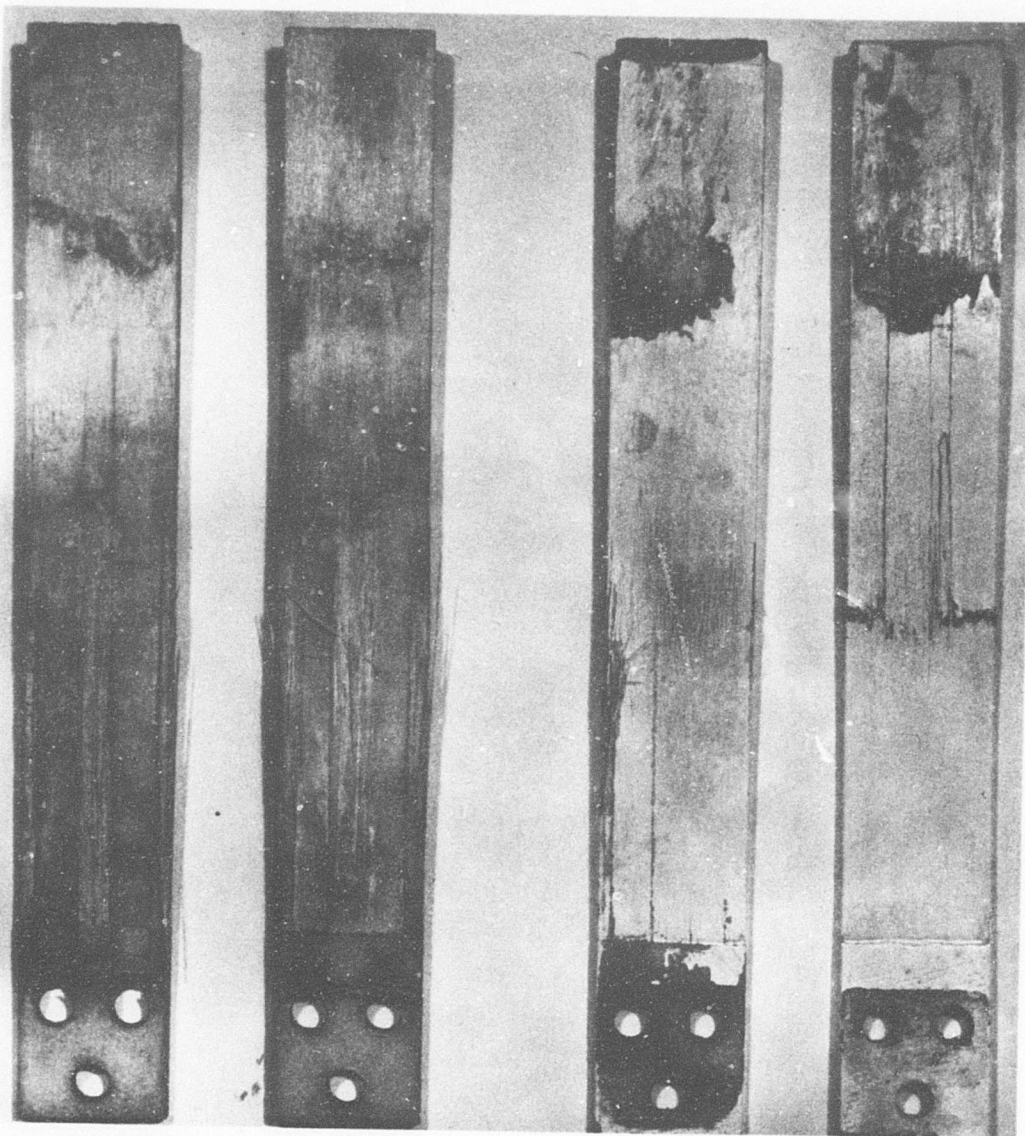
Figure 8. Constant-Deflection Reverse-Bending Fatigue Specimens of Unidirectional S Glass, Type 1002-1014S, Tested at 96,000 psi Maximum Fiber Stress at 200 cpm, Bare and Acrylic Coated Specimens Under Environmental Conditions.

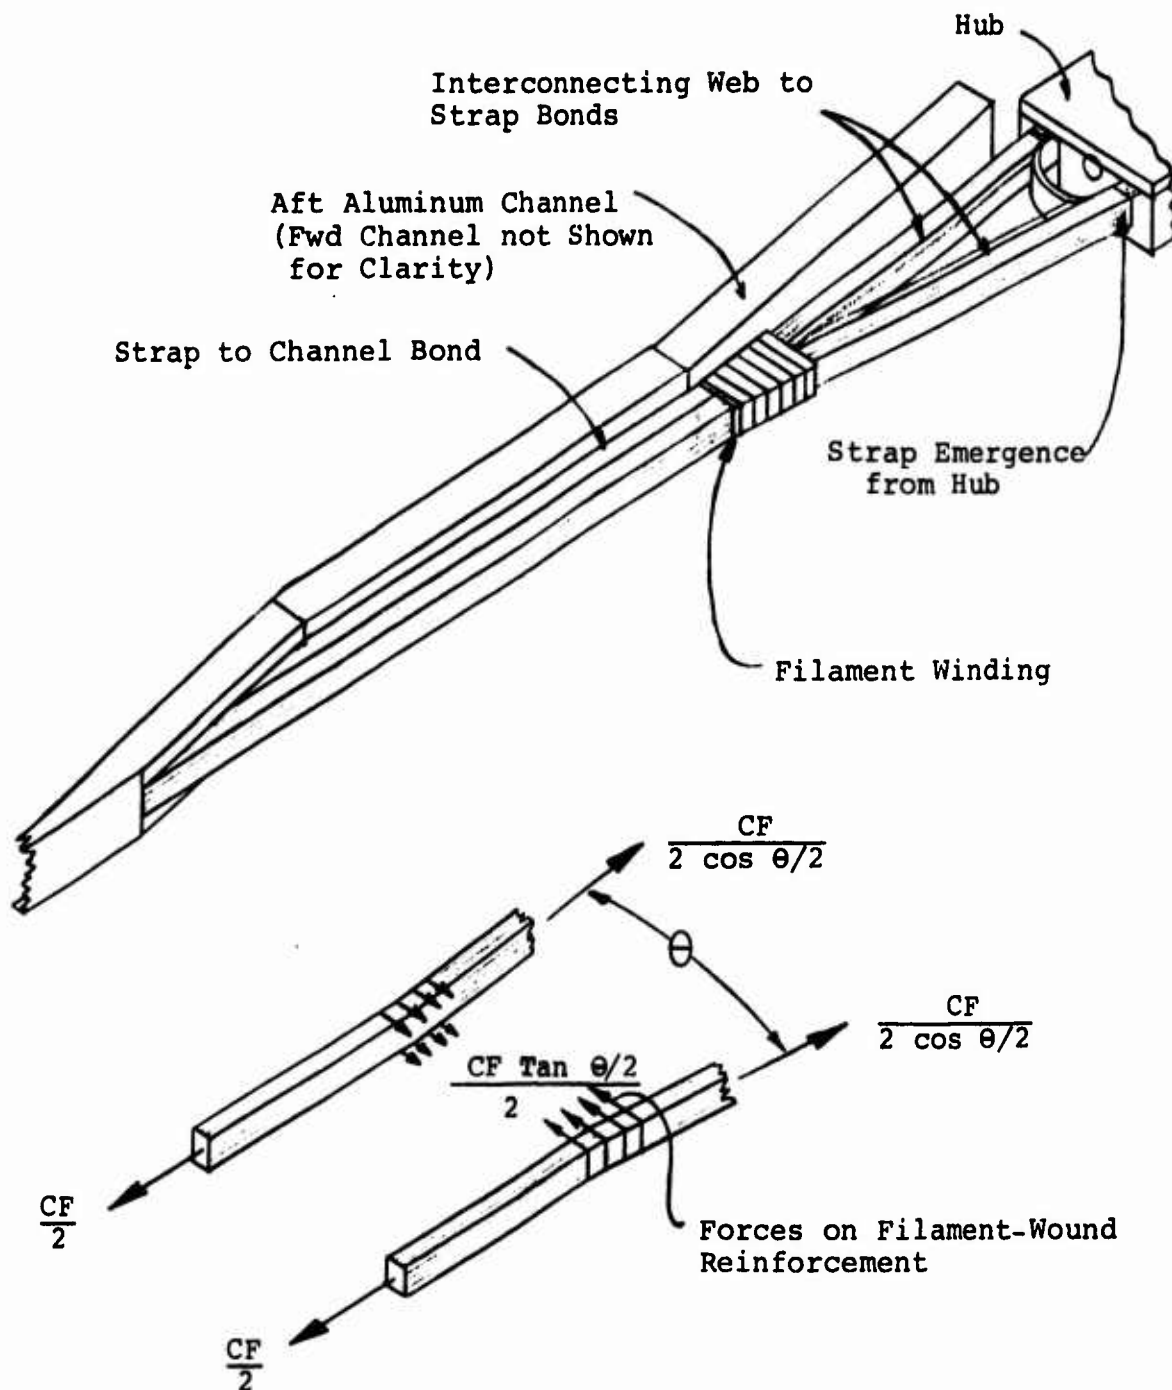
Figure 17. Elastic Pitch Beam Critical Areas.

The critical areas of the unidirectional 1002-1014S glass elastic pitch beam straps that were closely monitored for signs of wear or filament fracture are as illustrated in Figure 17. These critical points are the point of strap emergence from the hub, the interface between the straps and the interconnecting web, the area of the straps directly under the filament winding, and the interface between the straps and the

aluminum channels. The point of strap emergence from the hub is considered to be a prime suspect area for strap failure due to the presence of high vibratory flatwise and edgewise bending stresses, axial stresses due to centrifugal force, torsional shear stresses due to twisting of the straps through the required pitch angles, as well as transverse shear stresses caused by rotor torque and thrust--all of which are conducive to producing high filament stresses, fretting damage at the hub-strap interface, interlaminar shear stresses in the straps, and bond shear stresses between the straps and the elastomer-lined hub interfaces. The straps, along their interfaces with the interconnecting web, are considered to be critical because they are subjected to high shear stresses as well as secondary lateral tensile forces required to maintain the structural continuity between the straps and the web through their bonded juncture, creating interlaminar shear stresses in the outer plies of the strap structure. The area of the straps lying directly beneath the filament winding is also critical because it is subjected to localized lateral shear and bearing forces, tending to cut or fret the filaments of the straps which are in contact with the filament winding. The filament windings are critical themselves because they are subjected to centrifugal induced splitting forces within the laminate caused by a change in strap planform configuration in this localized area. The bonded juncture of the elastic pitch beam strap with the two aluminum channels is also considered to be an area where strap damage might occur. Examination of these critical areas revealed no indication of filament breakage, interlaminar shear failure, or fretting damage associated with the strap design. The conclusion that can be drawn from this evidence is that the strength of the strap and the adequacy of its attachment to the hub and aluminum channels have been clearly demonstrated.

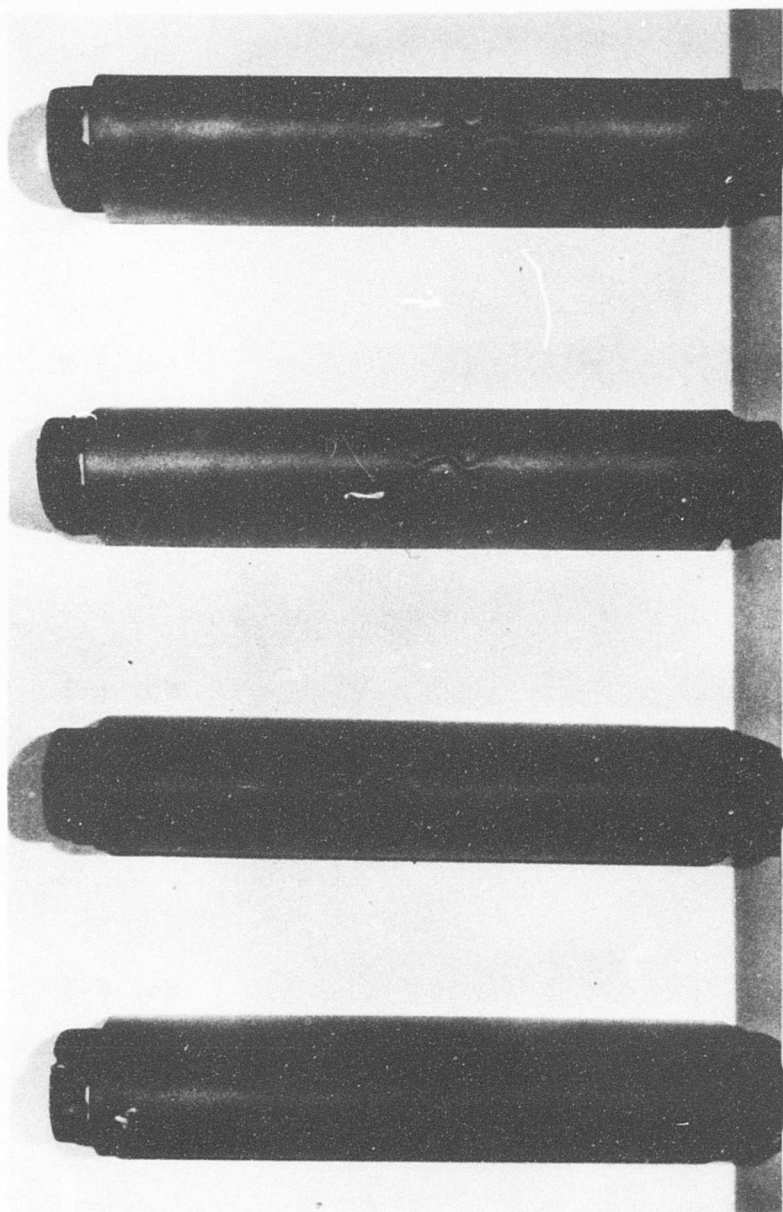
Figure 30. Stellite and Titanium Test Specimens After Sand Erosion.

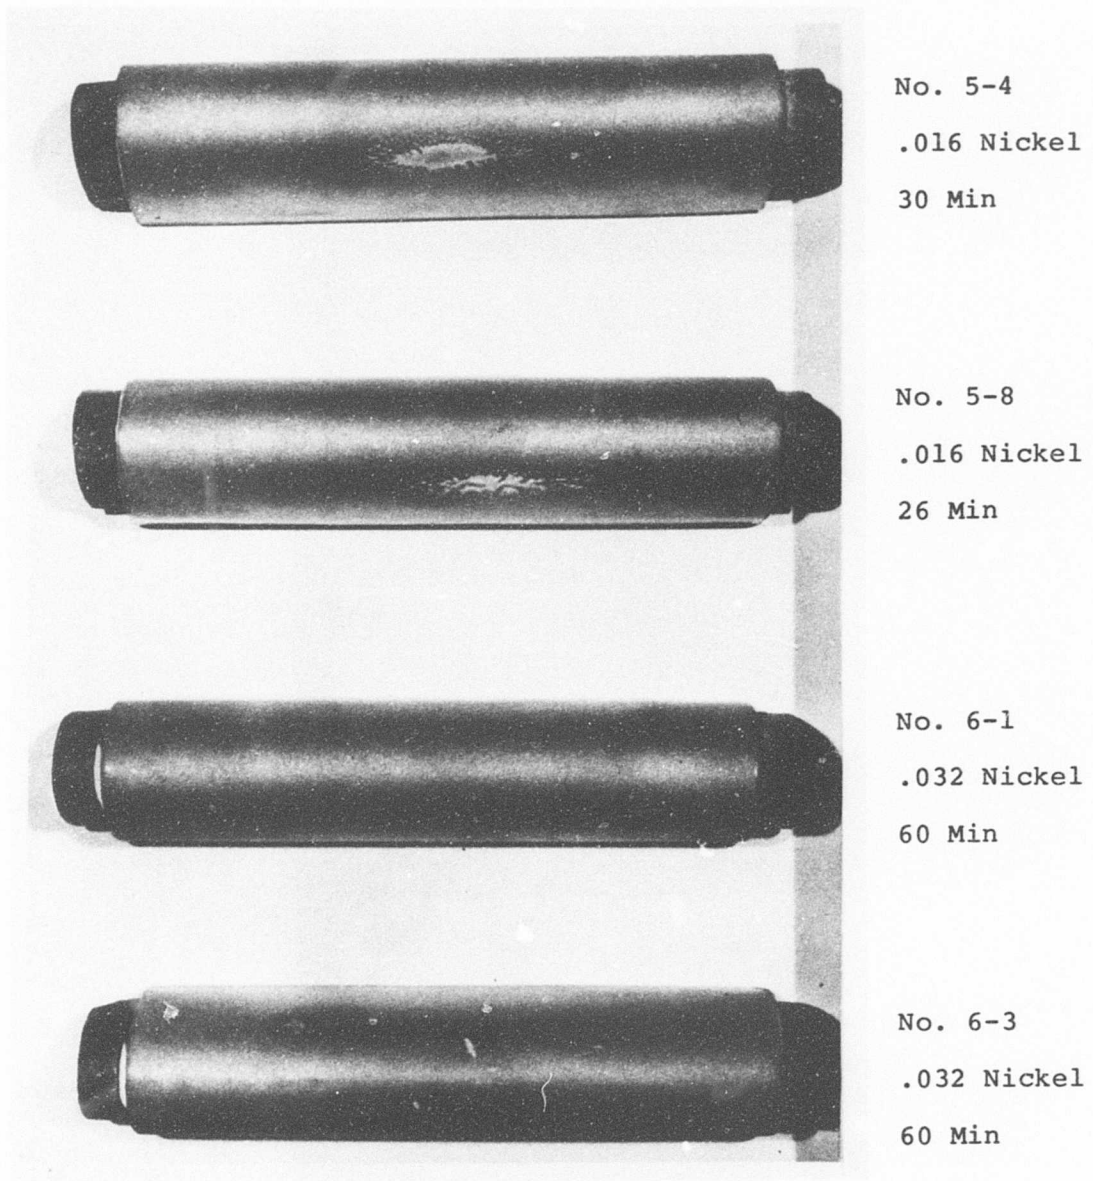
Figure 31. Electroformed Nickel Test Specimens  
After Sand Erosion.

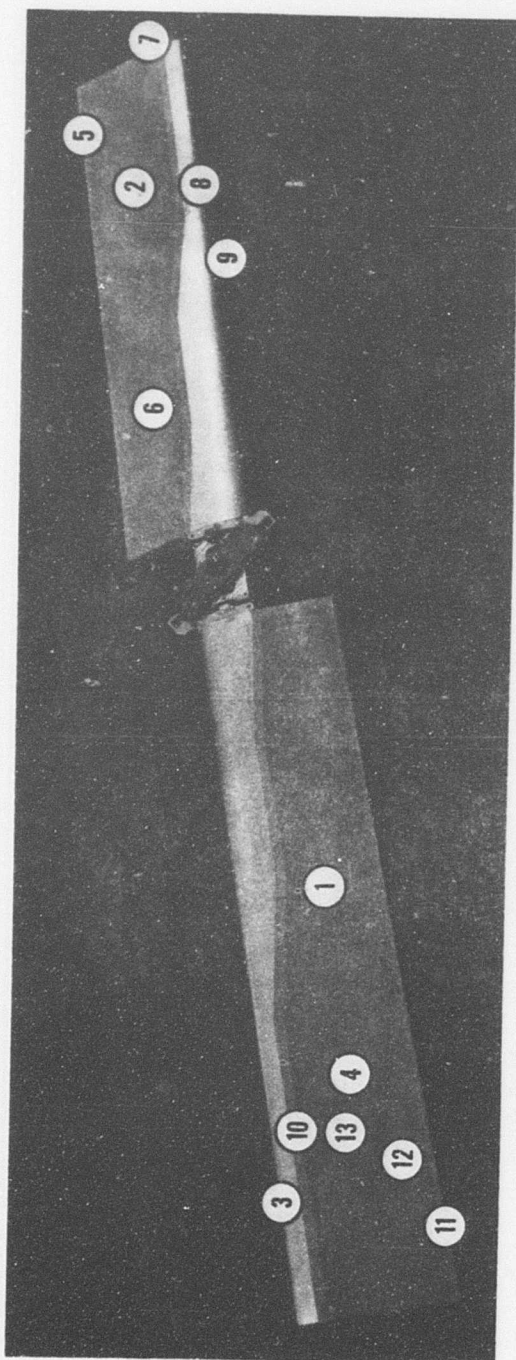
Figure 64. Sequences of Location of Ballistic Firing on Elastic Pitch Beam Tail Rotor Blade and Spar.

The whirl test was concluded at the end of Run 12 after 6 hours 25 minutes of cumulative running time, since damage inflicted by subsequent ballistic firings rendered further whirl testing risky. Additional ballistic damage inflicted on the whirl rotor, spar assembly and outboard blade sections with 7.62 and 12.7mm AP ammunition is shown with comments in Figures 55 through 63. All ballistic firings with 12.7mm AP ammunition were conducted at an impact velocity ranging from 2800 fps to 2875 fps. All ballistic hits imposed on the whirl blade, spar component and outboard blade section are superimposed on Figure 64 and summarized in Table X.
