CRASH INJURY REPORT

U. S. ARMY U-1A
De HAVILLAND OTTER ACCIDENT
Fort Carson, Colorado
16 June 1959

Aviation Crash Injury Research
of the **F**light **S**afety **F**oundation

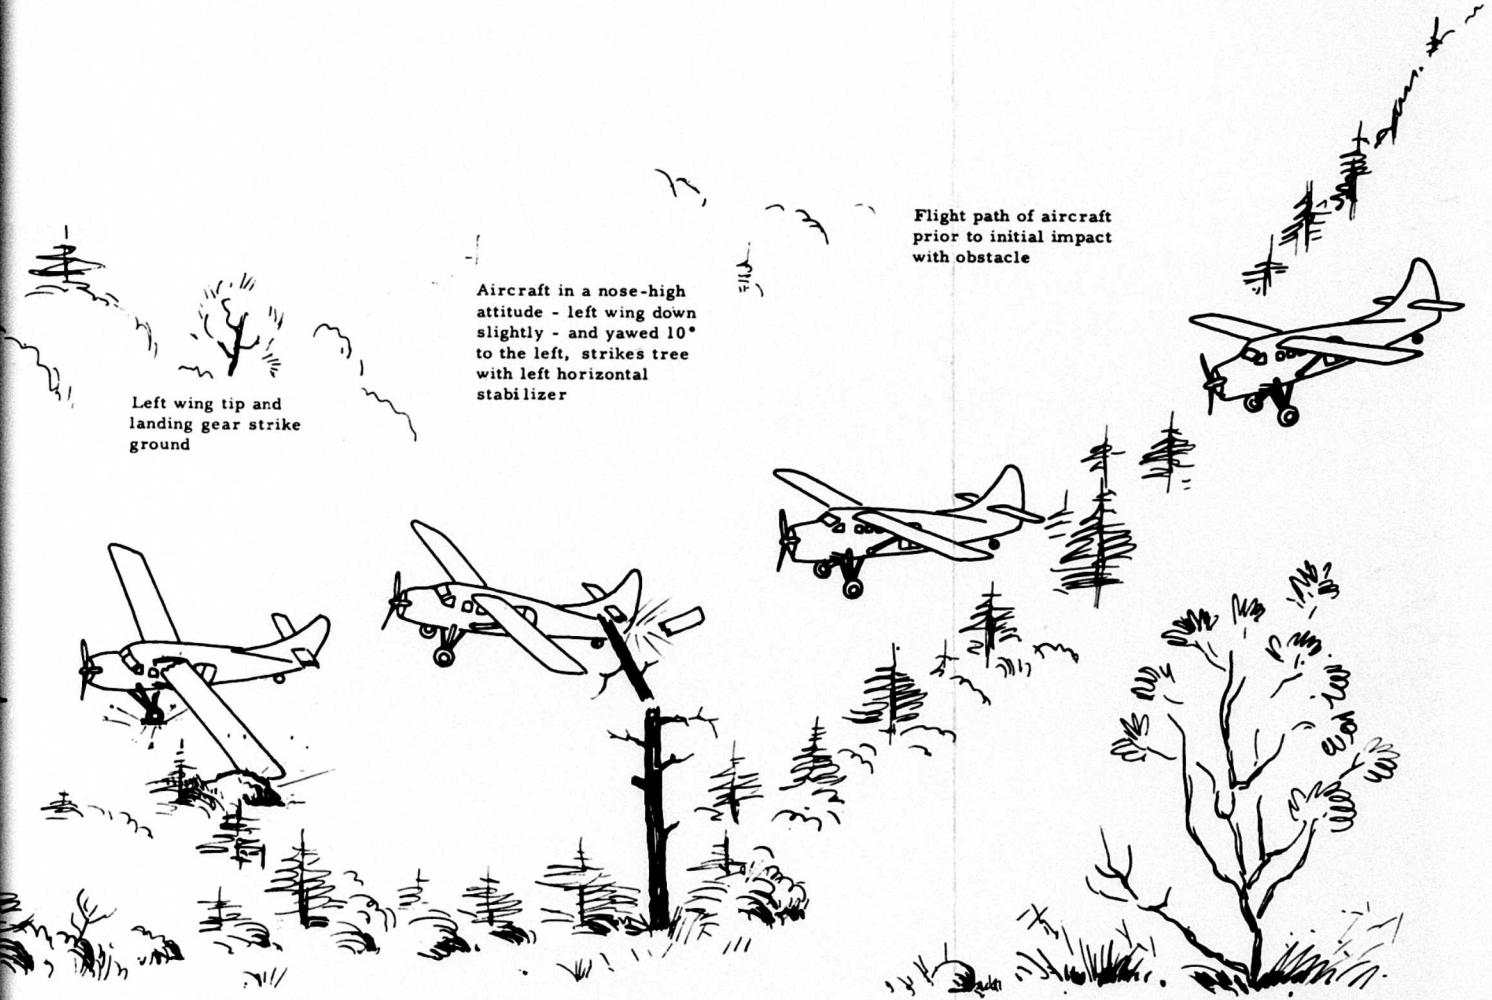
As the aircraft descended into the canyon, the left horizontal stabilizer struck the trunk of a dead tree, shearing off part of the stabilizer and elevator. (See Kinematics Diagram, p. 9, and Fig. 12, p. 21.) At the time of this impact the aircraft was flying at minimum flying speed in a nose-high attitude with the left wing slightly down. The impact caused the aircraft to yaw approximately 10 degrees to the left and to begin rolling to the left while continuing to move forward and downward.

Left wing tip and landing gear strike ground

Aircraft in a nose-high attitude - left wing down slightly - and yawed 10° to the left, strikes tree with left horizontal stabilizer

Flight path of aircraft prior to initial impact with obstacle

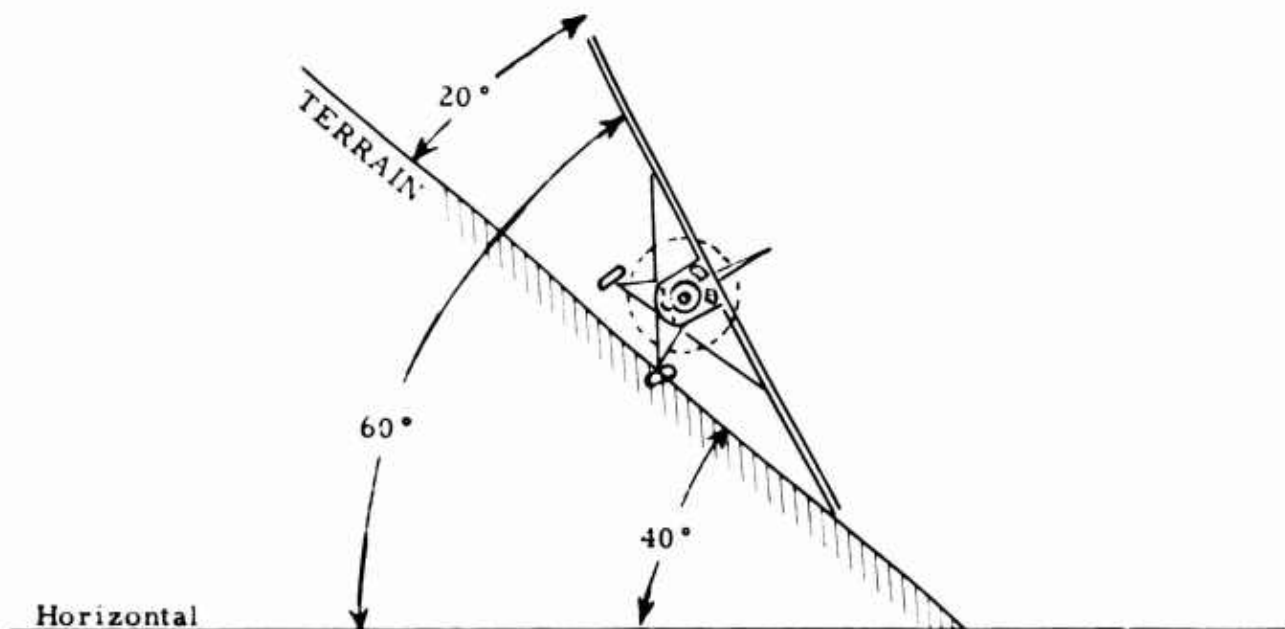
View looking rearward along the flight path, showing the roll attitude of the aircraft in relationship to the horizontal and the terrain at principal impact with the ground.

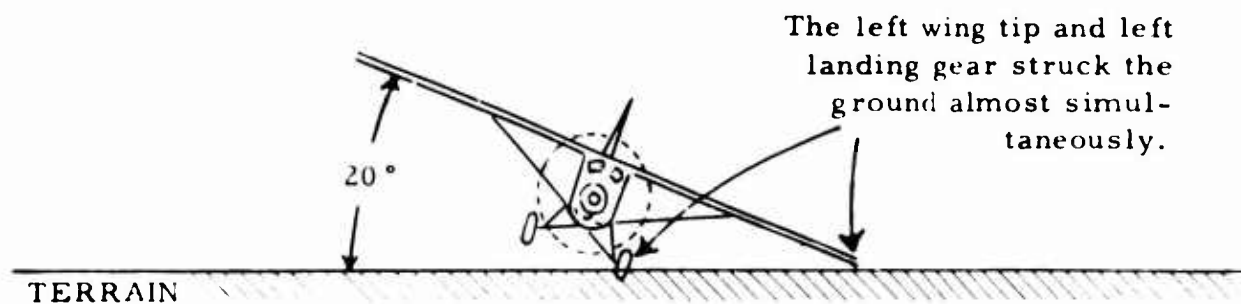
View showing the wing-down attitude of the aircraft in relationship to the terrain at principal impact. (Slope of the terrain has been rotated to the horizontal.)

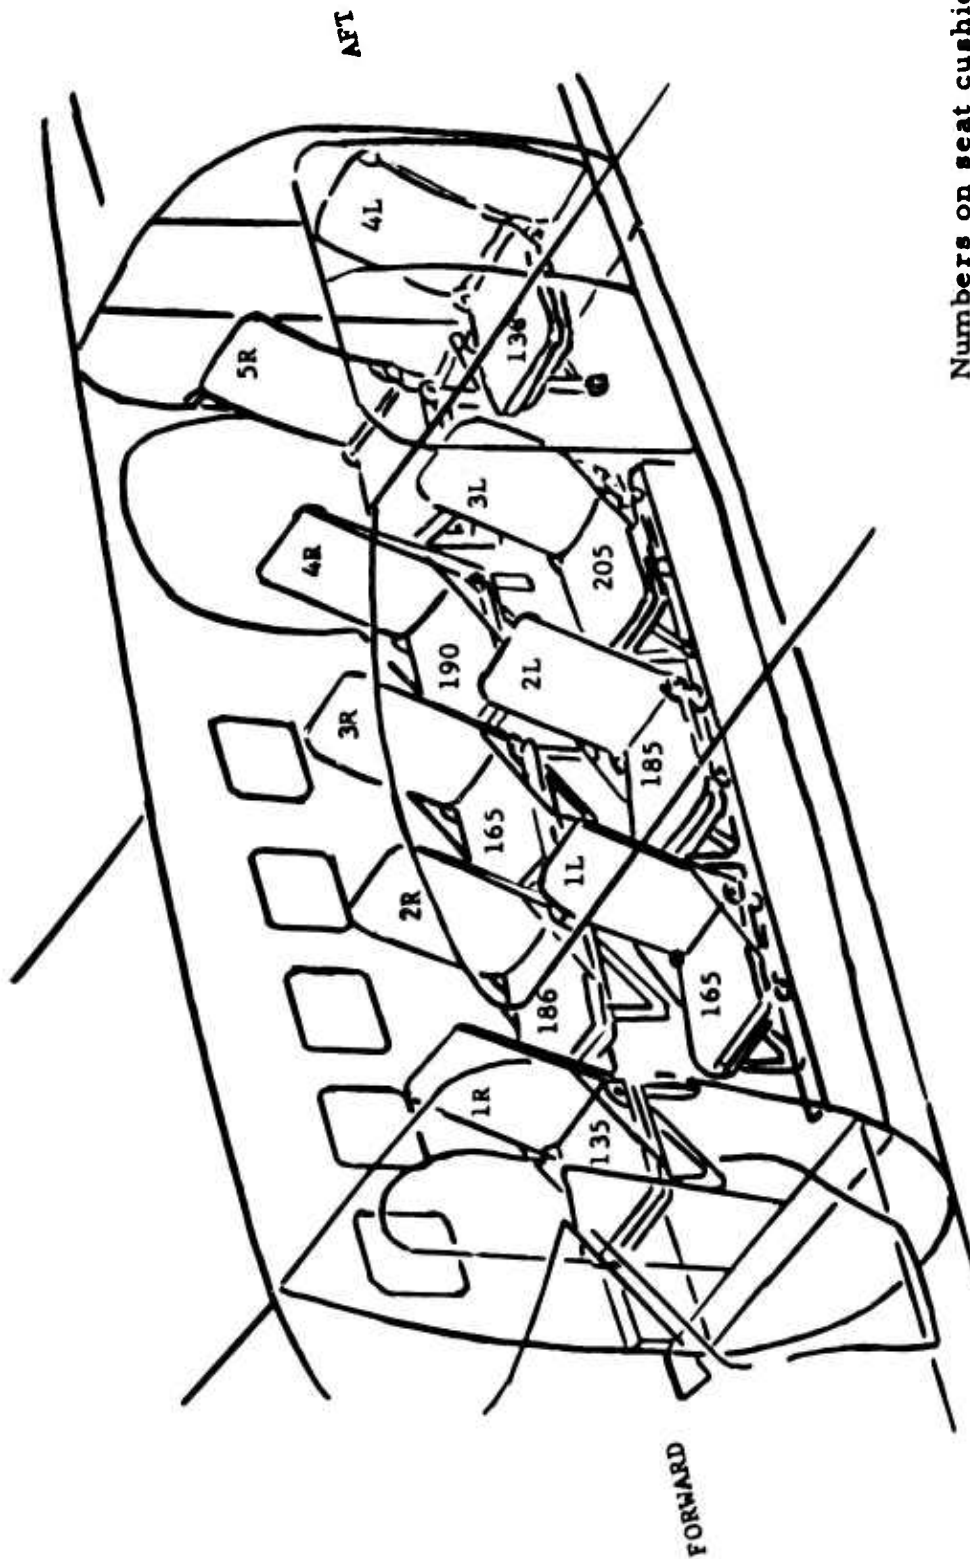
Numbers on seat cushions
are weights of occupants.
5R was unoccupied.

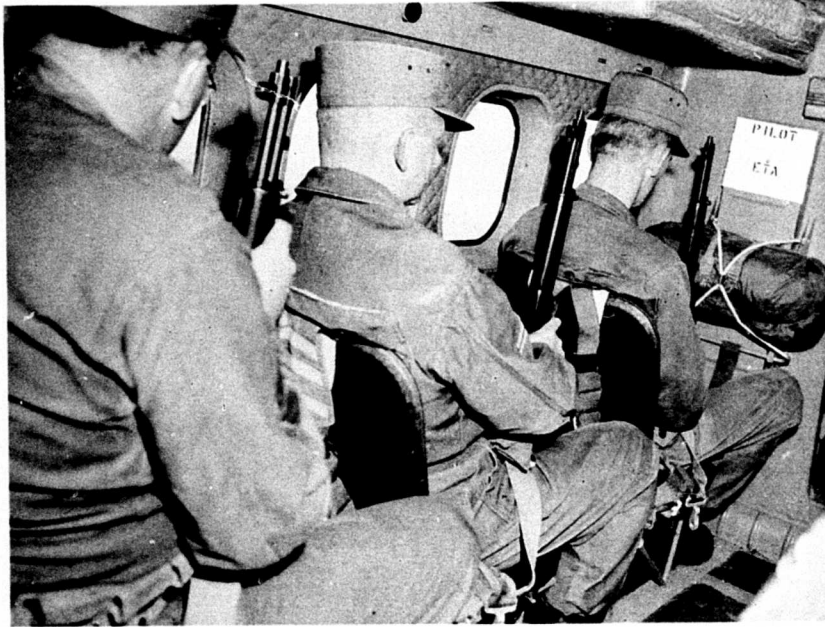
Fig. 15. View of the left-hand cabin area, showing the manner in which combat troops position their weapons during flight. (Passenger occupying the rearmost seat is not shown.)

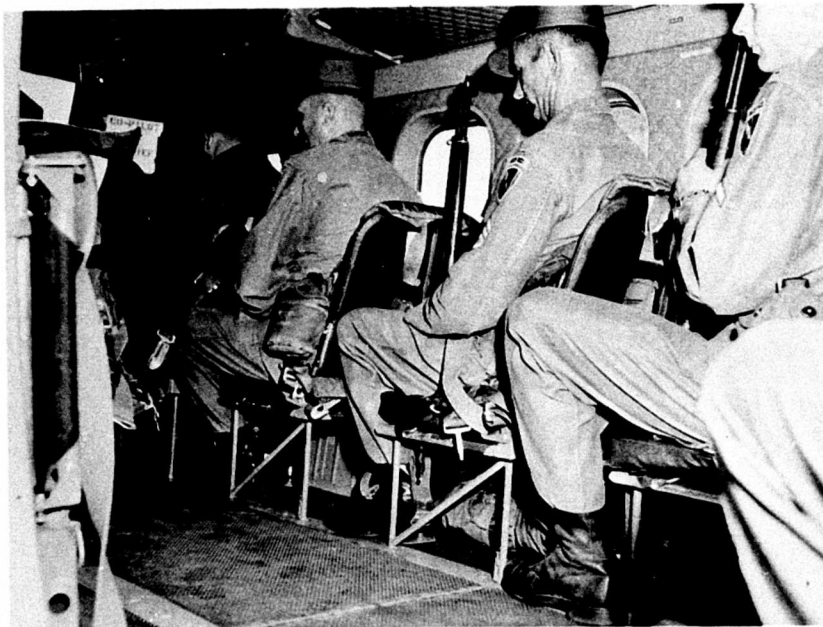
Fig. 16. View of the right-hand cabin area, showing the seating configuration utilized in transporting combat troops. (Note positioning of weapons, with muzzle near face and head.)

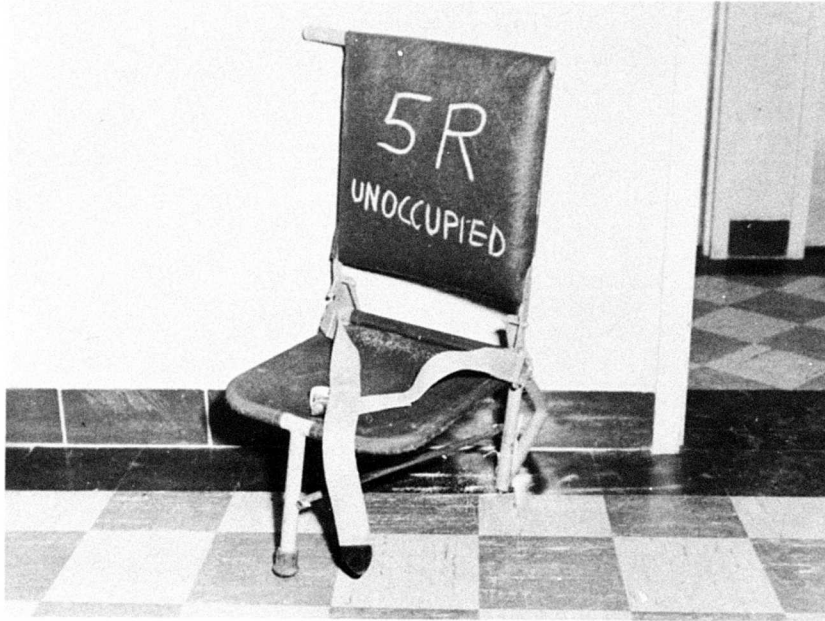
Fig. 53. Seat 5R was unoccupied and folded up against the rear partition.
