**CRASH INJURY INVESTIGATION**

**HU-1A BELL IROQUOIS HELICOPTER ACCIDENT**

**East St. Louis, Illinois**

**21 October 1959**

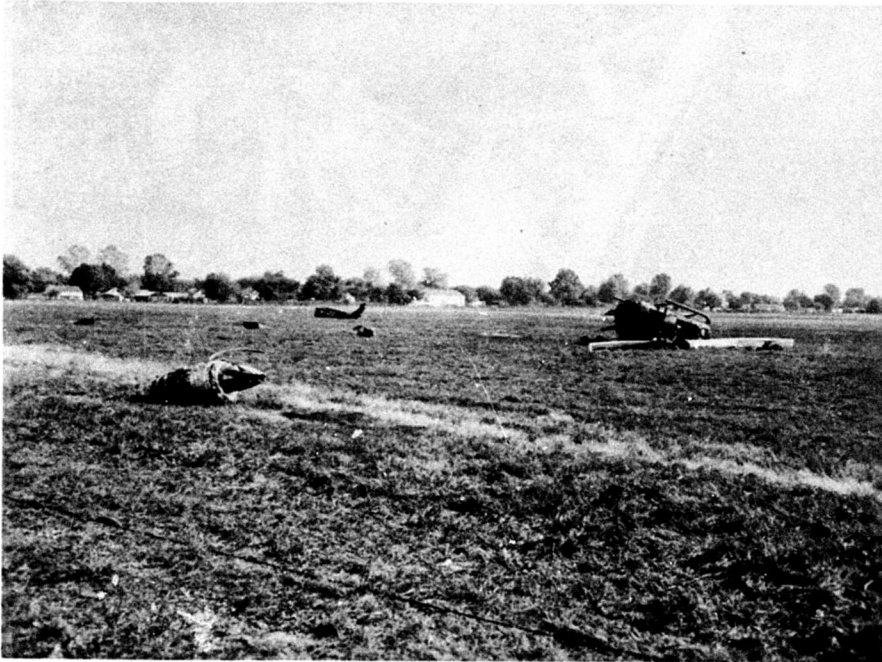
Fig. 14. Ground view of main wreckage area.

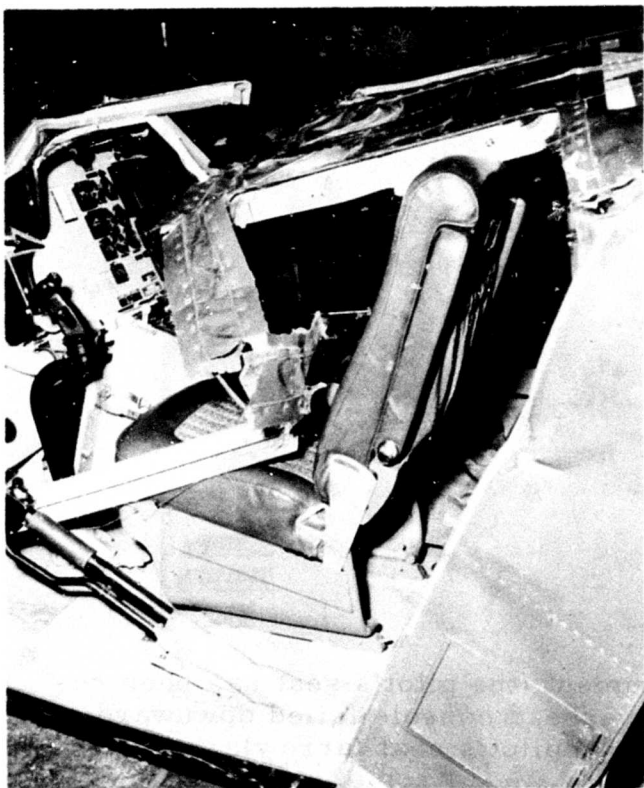
The instrument panel, even though loosened by impact forces and displaced slightly forward, sustained very little damage and remained intact. (See Fig. 22, p. 17; Fig. 31, p. 21).

Fig. 22. Instrument panel broke forward (away from occupants) during crash (arrow).

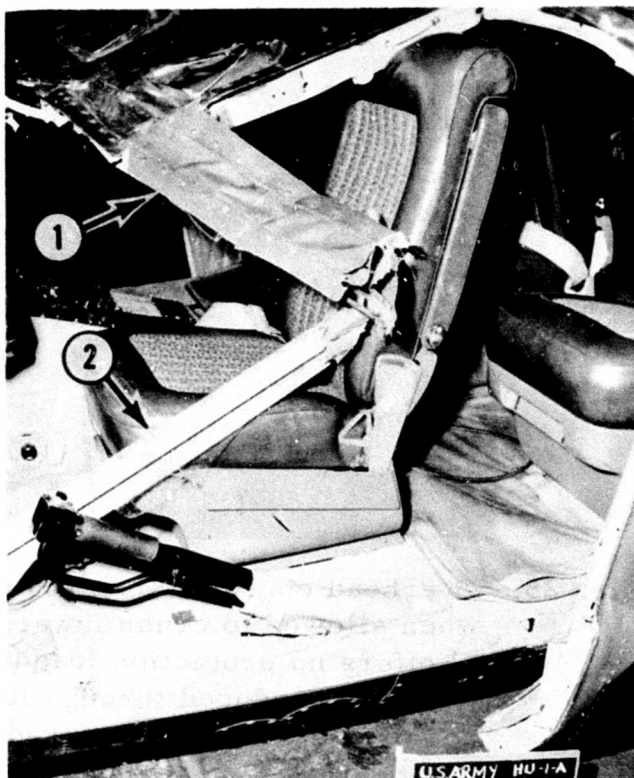
Fig. 23. Copilot's (left) overhead window frame (arrow 1) and left forward door post (arrow 2) were crushed inward.

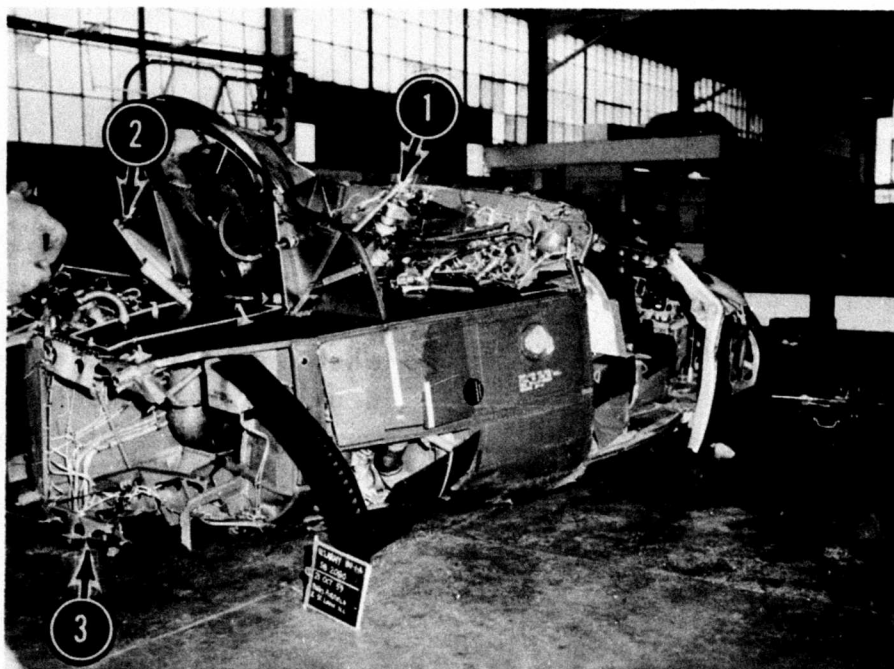
Fig. 41. Aft right fuselage, showing position for rotor mast and transmission (arrow 1), engine area (arrow 2), tail boom attachment (area 3).

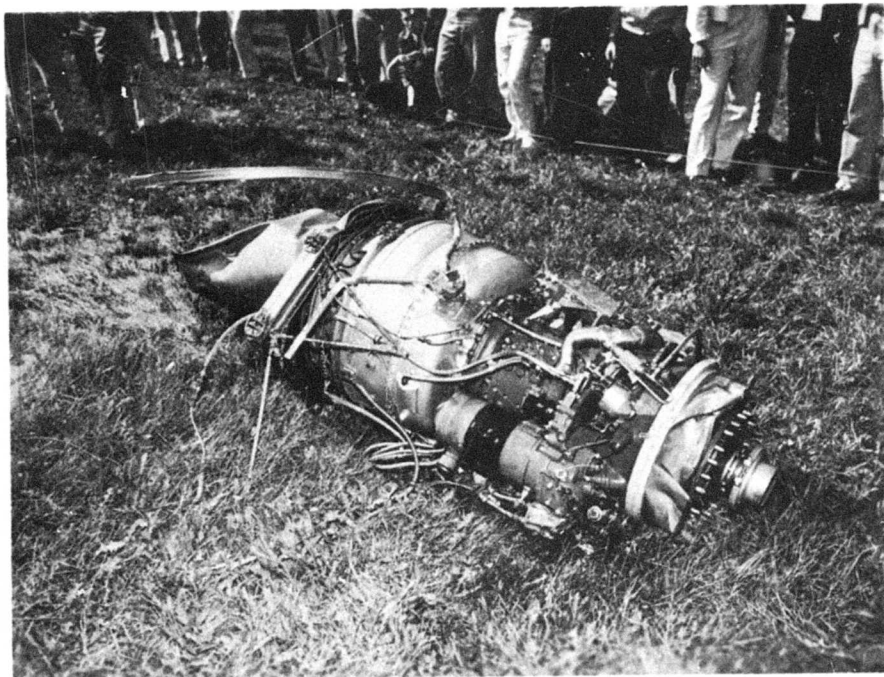
The engine was torn free and damaged in bouncing and rolling. (For close-up view of engine where it came to rest, see Fig. 45, p. 28). The main transmission, mast, and rotor assembly was partially torn free as a unit. Both the transmission and the rotor blades were extensively damaged.

Fig. 45. HU-1A jet engine shown as it came to rest.

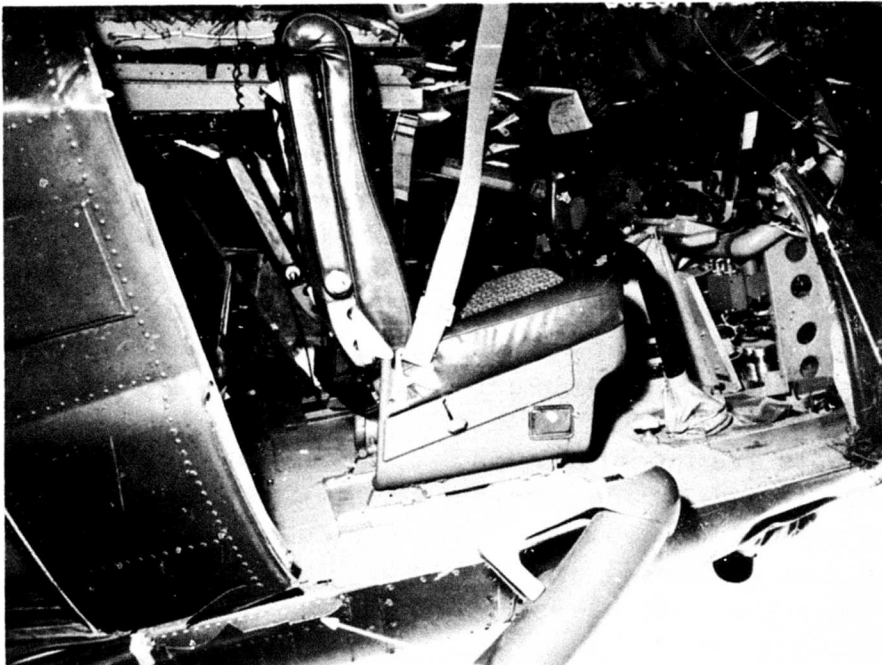
Fig. 51. Close-up of pilot's environment (right side).

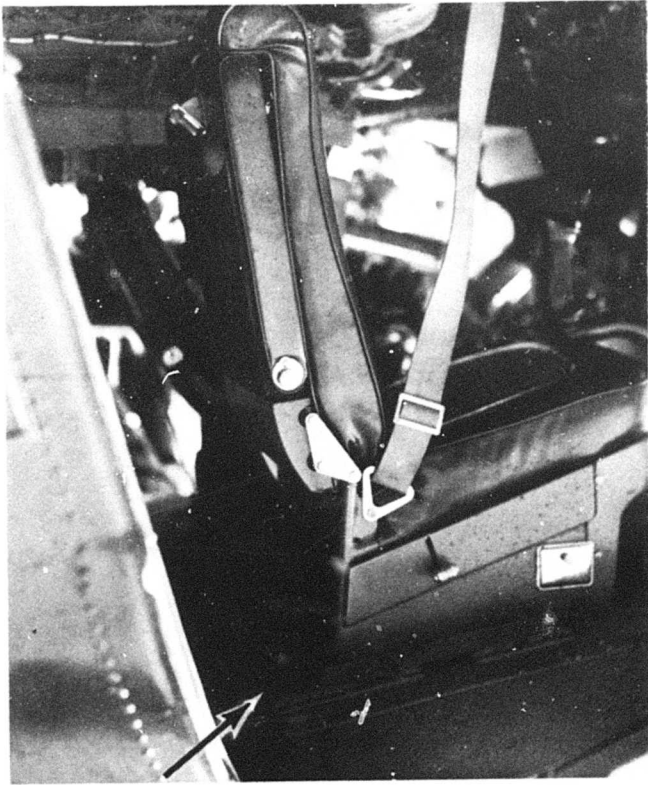
The pilot's and the copilot's seats were individually mounted on large, flat supporting plates with tracks for forward and aft adjustment. (See plates and track fittings in Figs. 56-58, p. 35 ff.). The three individual seats across the center of the cabin were mounted on one large plate. The triple seat across the aft end of the cabin was supported by tubular structure in the usual manner for Army troop seats.

Fig. 56. Pilot's seat is shown installed in the HU-1A. Mounting plate, upon which seat tracks were mounted, was held to aircraft floor with 16 bolts.

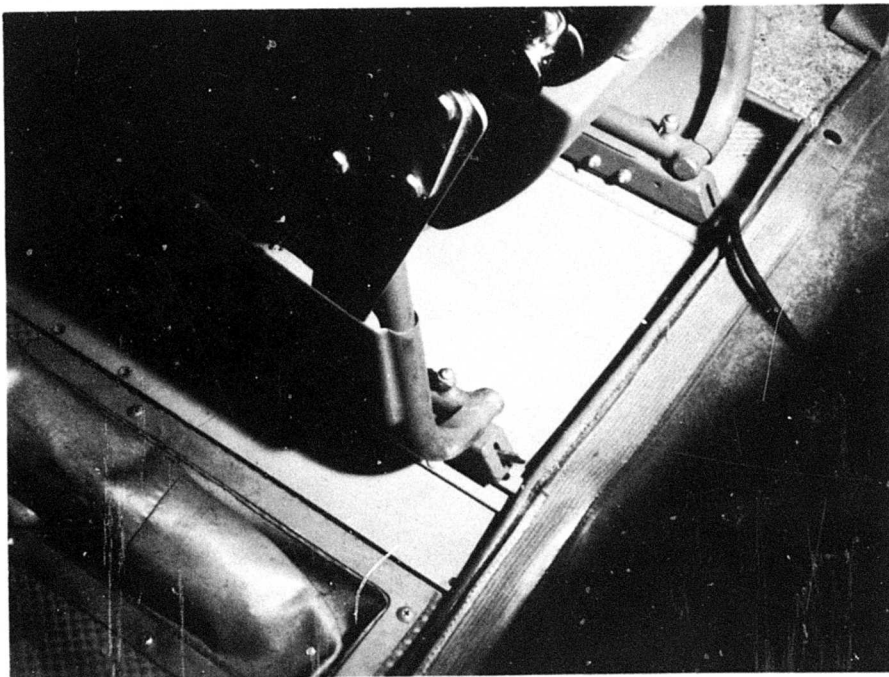
Fig. 57. Seat tracks on mounting plate afford fore/aft adjustment.

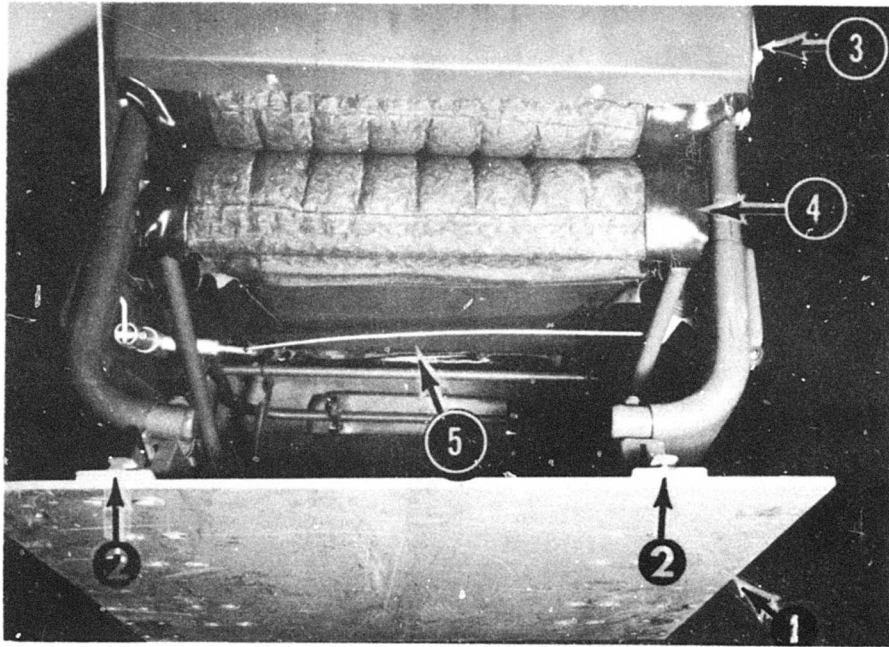
Fig. 58. Seat mounting plate (arrow 1), seat track (arrow 2), seat back (arrow 3), seat cushion (arrow 4), and seat bottom (arrow 5).

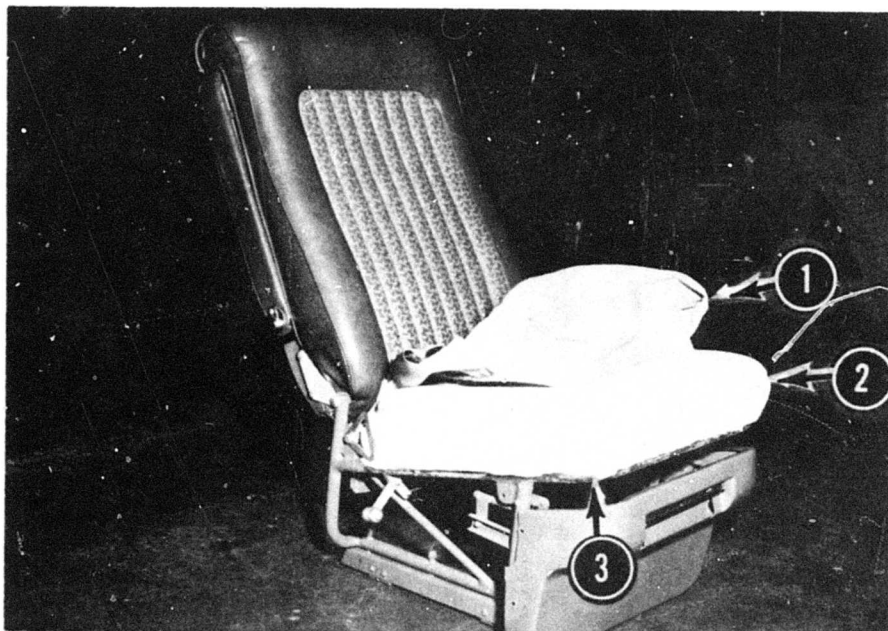
The seats are model TE 432F-2, constructed on a frame of chrome-moly aircraft-grade tubing (SAE 120), and have a cushion of 4-inch polyurathane foamed material. The seat pan is a sheet of nylon, impregnated with neoprene, drawn very tightly over the tubular frame and bonded securely. (See Figs. 59-63, p. 36 ff., showing stripped seats).

Fig. 59. Plastic (leatherette) upholstery (arrow 1) was removed from the seat cushion, revealing a 4-inch thick cushion of foamed polyurathane (arrow 2). This cushion was cemented to the top of the seat pan (arrow 3).

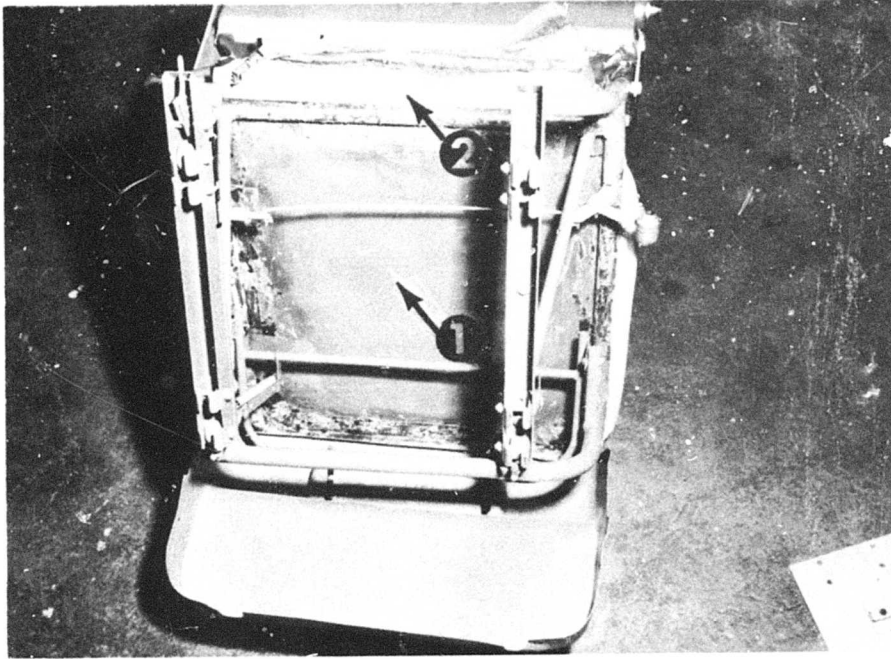
Fig. 60. The bottom of the seat pan (arrow 1) is a sheet of nylon material impregnated with neoprene. This sheeting has been stretched tight over a frame of chrome-moly tubing (SAE 120) and bonded to the tubing (arrow 2).

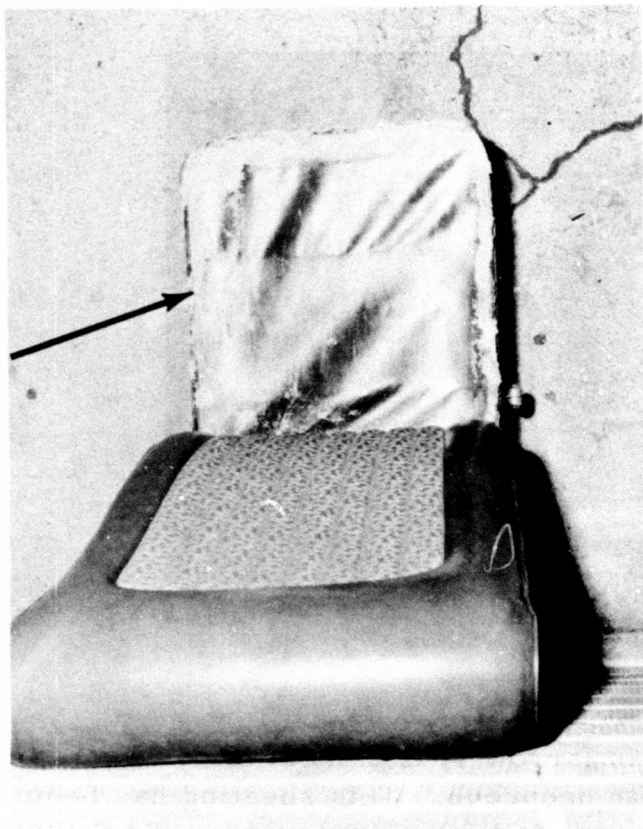
Fig. 62. Top view of seat pan.

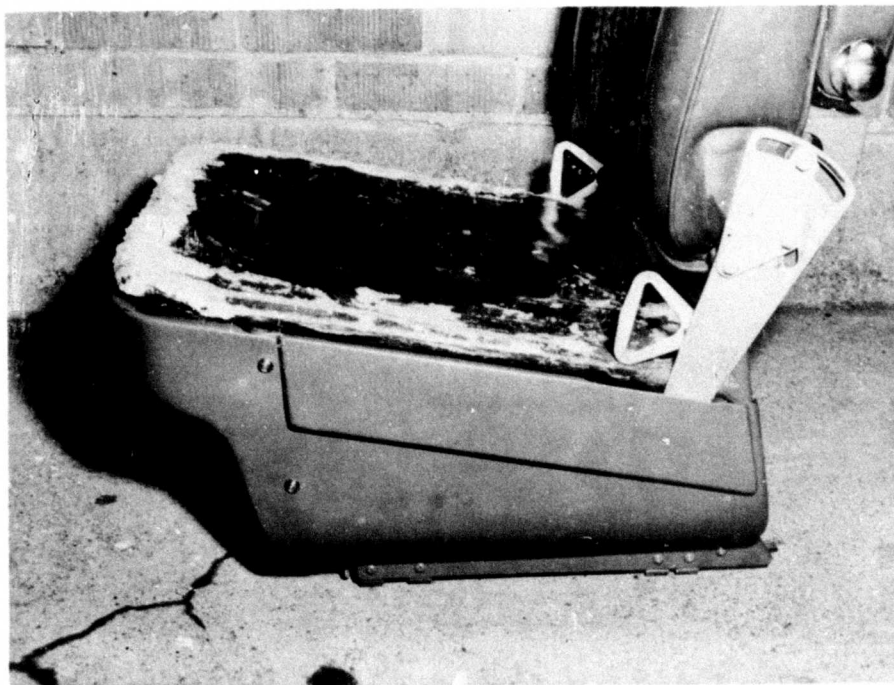
Fig. 63. Side view of seat pan.

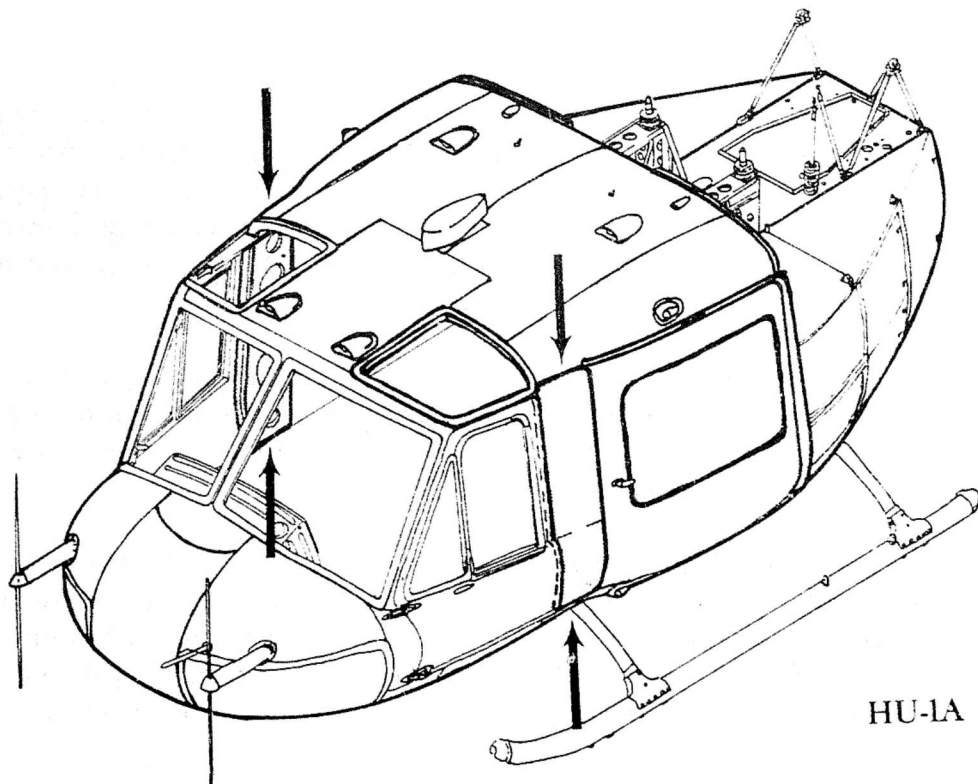
The extreme forward portion of the roof is supported by the front door frames and a center strip of the windshield frame structure. (See structural drawing and photographs of damage in Fig. 17, p. 14; Fig. 67, p. 44). Both forward door frame members and the windshield frame in the center failed completely, and the forward edge of the overhead structure crushed inward 18 to 24 inches.

Fig. 67. Reference drawing to illustrate structure referred to in Figs. 45 and 46.

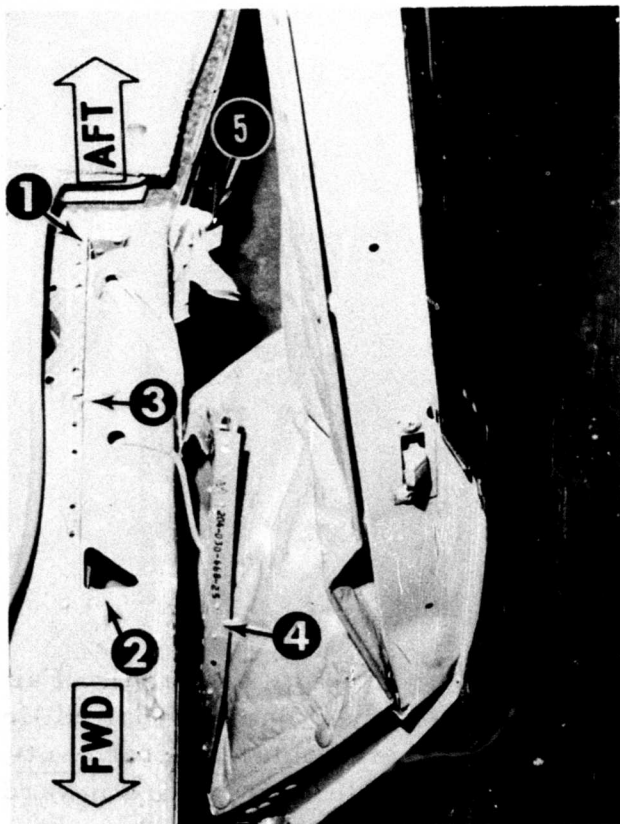
Fig. 71. Structural integrity of the vertical support member (which also serves as door frame for forward and cargo doors) depends on the strength of "L" stringers (arrows 1 and 2) and of the inner skin attachment method (arrows 3 and 4). The outer skin attachment system is pointed out by arrow 5.

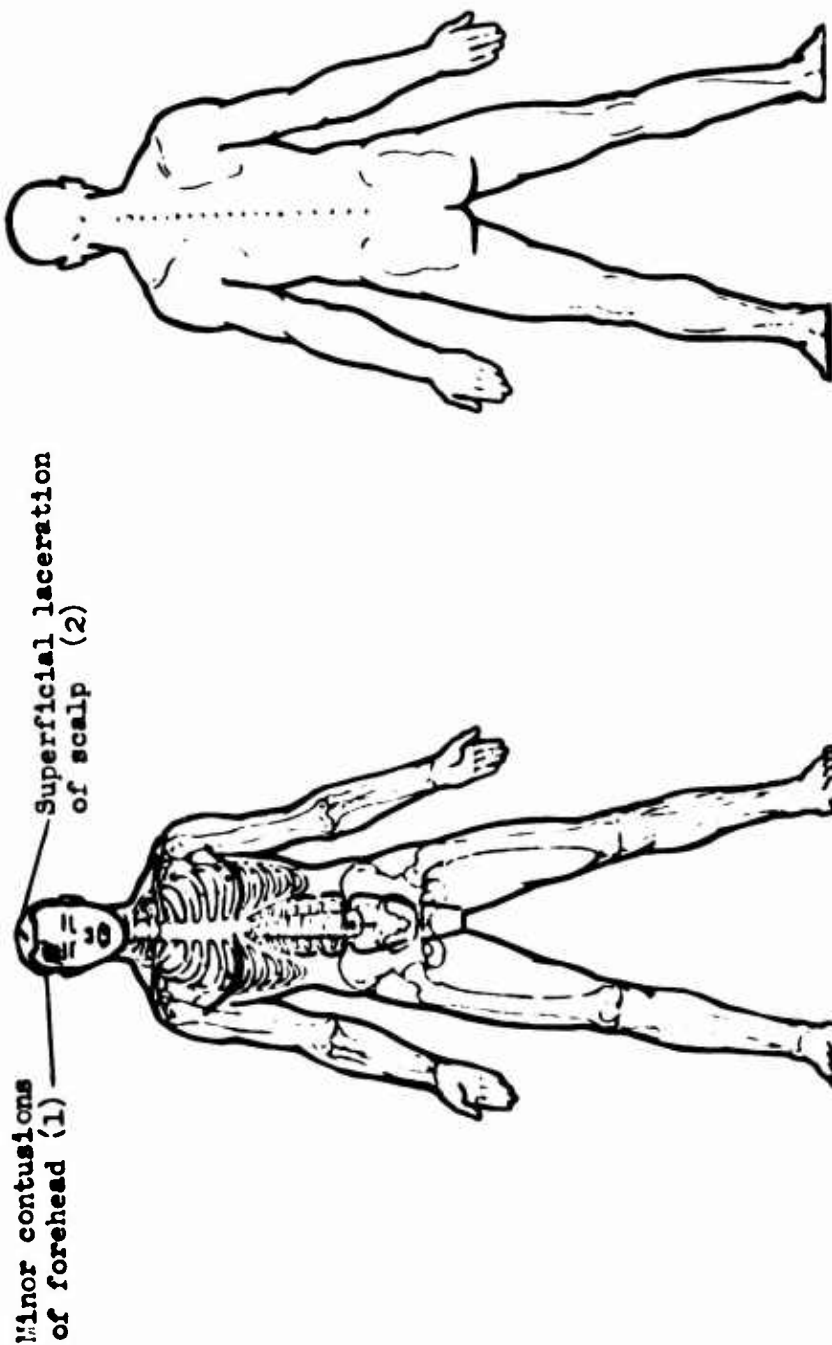
CREW CHIEF - Left Seat

1. Cause undetermined
2. Cause undetermined
