**SUBJECT:** Operational Report - Lessons Learned, Headquarters, 1st  
Battalion, 63d Armor, Period Ending 31 October 1967

DEPARTMENT OF THE ARMY  
 HEADQUARTERS, 1ST BATTALION 63D ARMOR  
 Fort Riley, Kansas 66442

SUBJECT: Operational Report - Lessons Learned RCS CSFOR-65

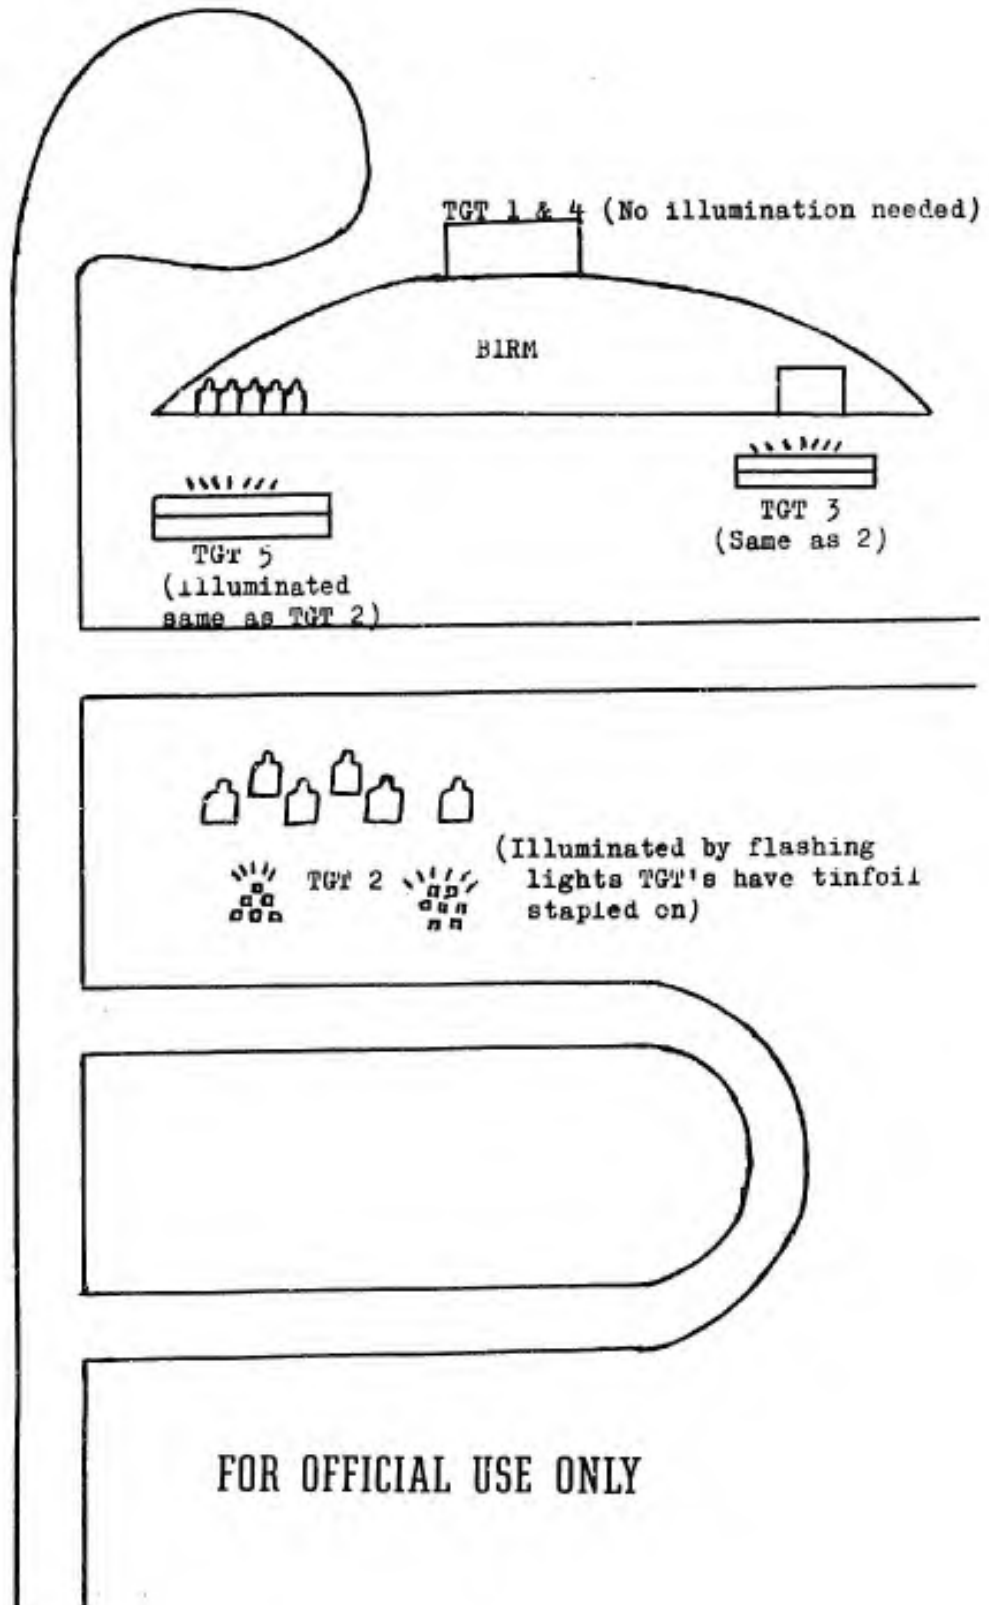
APPENDIX TO ANNEX B  
NUMBER 1

c. Expedient Illumination - This unit made maximum use of the XM 44, gunner's night vision device, and the Starlight Scope to aid in location of targets 2, 3, and 5. The device, "Flashing Warning Light-Amber" commonly found on highways was also used. These lights were placed in front of the targets and protected by rocks and 8" x 8" wooden beams. The reflection of the lights on the targets gave the impression of hostile fire and provided a target deflection means for the passive vision devices. See Appendix 1 to Annex B for schematic layout of targets.
