Technical Note N-986

AIRFIELD PAVEMENT EVALUATION, ROYAL THAI NAVY STATION,  
BAN U-TAPAO AIRFIELD, THAILAND

D. J. Lambiotte and R. B. Brownie

August 1968

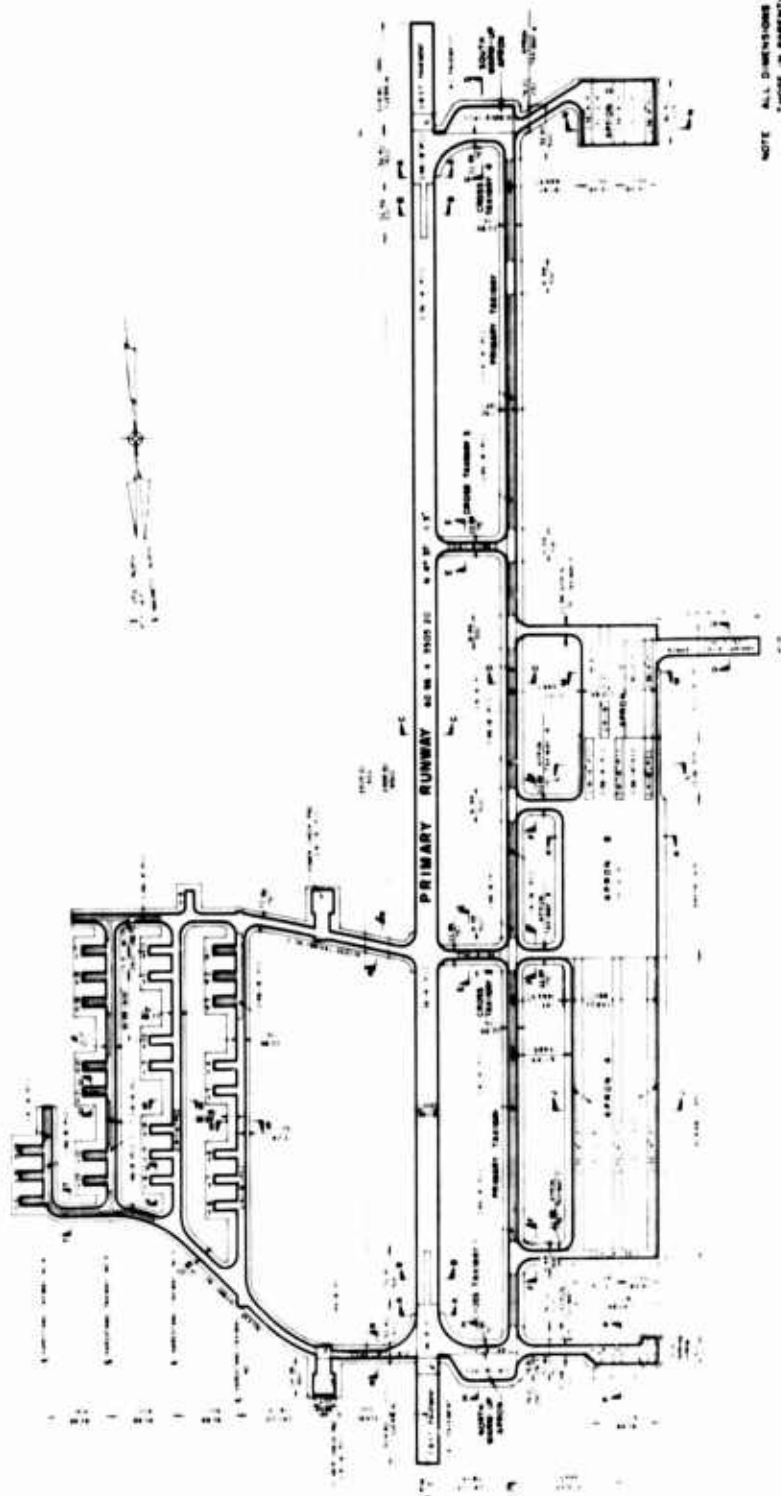
FIGURE 4

Approximately the first 500 feet of this taxiway (adjacent to Access Taxiway 2) showed signs of distress soon after construction and was replaced.(See Figure 4). The replaced section exhibits very high concrete
