HIGH TEMPERATURE ELASTOMERIC INTEGRAL FUEL TANK SEALANT EVALUATIONS

TECHNICAL DOCUMENTARY REPORT NO. ML-TDR-64-207

September 1964

(Prepared under Contract AF33(657)-10962, by The Boeing Company, Airplane Division, Wichita Branch, Wichita, Kansas; Lyle G. Middleton, author)

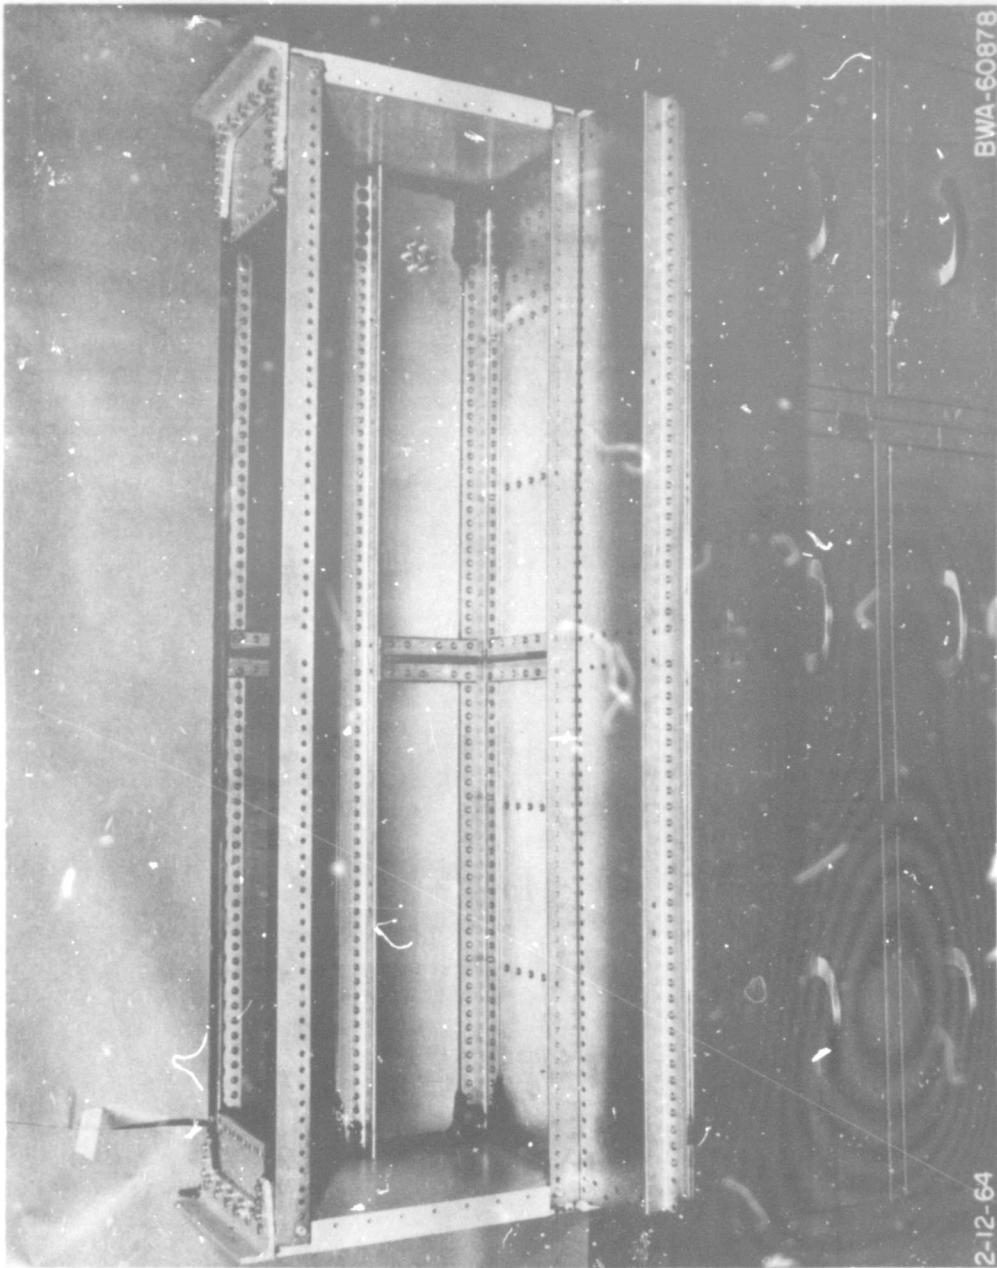
FIGURE 7

NOTE: This tank is completely faying surface sealed with the AFML fluorocarbon sealant. In addition tank ends were fillet sealed with the same sealant.

TEST TANK NO. 3 PARTIALLY ASSEMBLED (LOWER SKIN NOT INSTALLED)

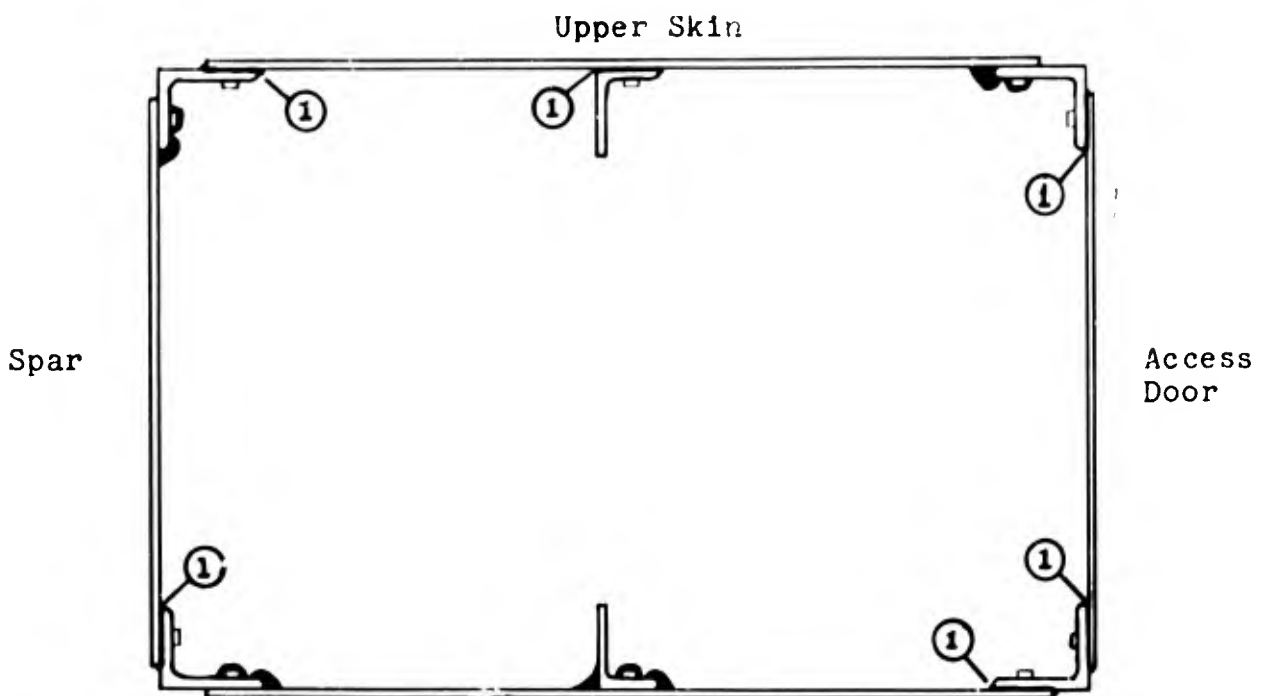
FIGURE 10
TYPICAL CROSS-SECTIONAL VIEW OF TANK NO. 1 (EC-2288)

Faying surface seals were applied during the tank assembly to the areas shown in Figure 10. In addition the spar web stiffeners and the access door stiffeners were faying surface sealed. Sealant was applied to one faying surface using a rubber roller to roll on a continuous coating of sealant. Mating surfaces were joined and all fasteners installed within three hours after thawing the sealant. Faying surface "block-off" seals (approximately 1 inch wide) were applied during tank assembly to the mating surfaces which were not faying surface sealed as shown typically in Figure 17. This was to prevent traveling leaks in areas to be subsequently fillet sealed. The tank access door was also completely faying surface sealed.

- d. Fillet seals were applied during and after the tank was assembled to the areas shown in Figure 10. Fillets were applied by injecting thawed sealant from polyethylene cartridges fitted with nozzles cut to form the desired fillet shape. Fillets on fasteners were formed with a fairing tool. Because of the high flow of EC-2288 due to its low viscosity, it was necessary to build up fillets in two or more applications to obtain the desired fillet size. Final fillet dimensions approximated those shown in Figure 11. However it was observed later that fillet dimensions over the tops of fasteners were less than Figure 11 due to the high flow of EC-2288.
- e. The completely sealed tank was cured 4 hours at 200°F followed by 2 hours at 300°F.
- f. The tank was then pressure tested per Section B.1.d. No leakage was observed.

①—Faying Surface Seals.

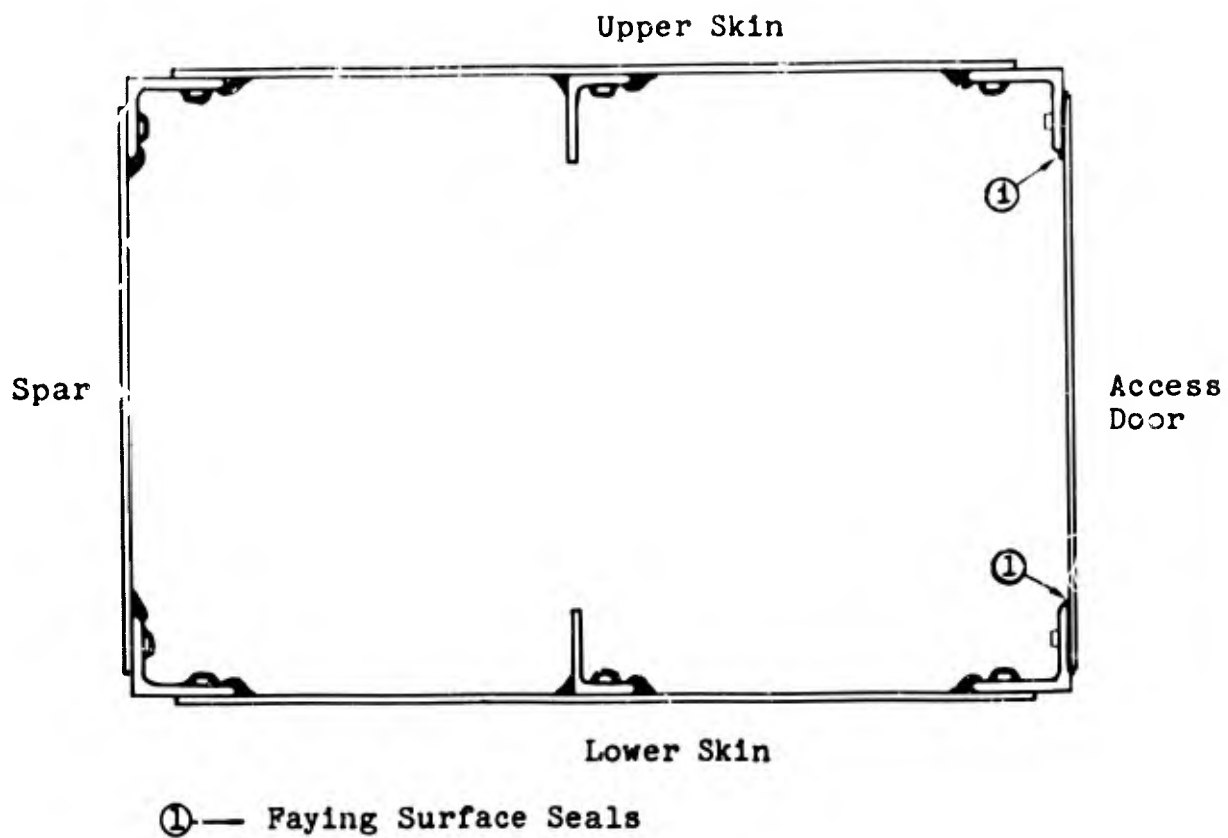
FIGURE 14
TYPICAL CROSS-SECTIONAL VIEW OF FILLET SEALED TANKS
(Numbers 2 and 4)

- a. This tank was completely fillet sealed with the AFML fluorocarbon sealant (Figure 14). The frozen sealant cartridges were thawed to room temperature and fillets were applied using the equipment shown in Figure 16. Fillets were applied in two applications. A small first fillet was applied, followed by the final full bodied fillet using the nozzle shown in Figure 16. Final fillet dimensions were per Figure 11. Fasteners were sealed by running a continuous fillet over a row of fasteners, or by applying a ball of sealant to a fastener head and pressing it against the structure with flared tubing tools (see Figure 16). In a few areas fasteners were brush coated with sealant thinned with MEK, prior to applying the fillets. Final sealant fillet dimensions were per Figure 11.
