NWC TP 4738

# SAFETY TESTS OF EXPLOSIVES TRANSPORT TRUCKS

## NAVAL WEAPONS CENTER

CHINA LAKE, CALIFORNIA \* JULY 1969

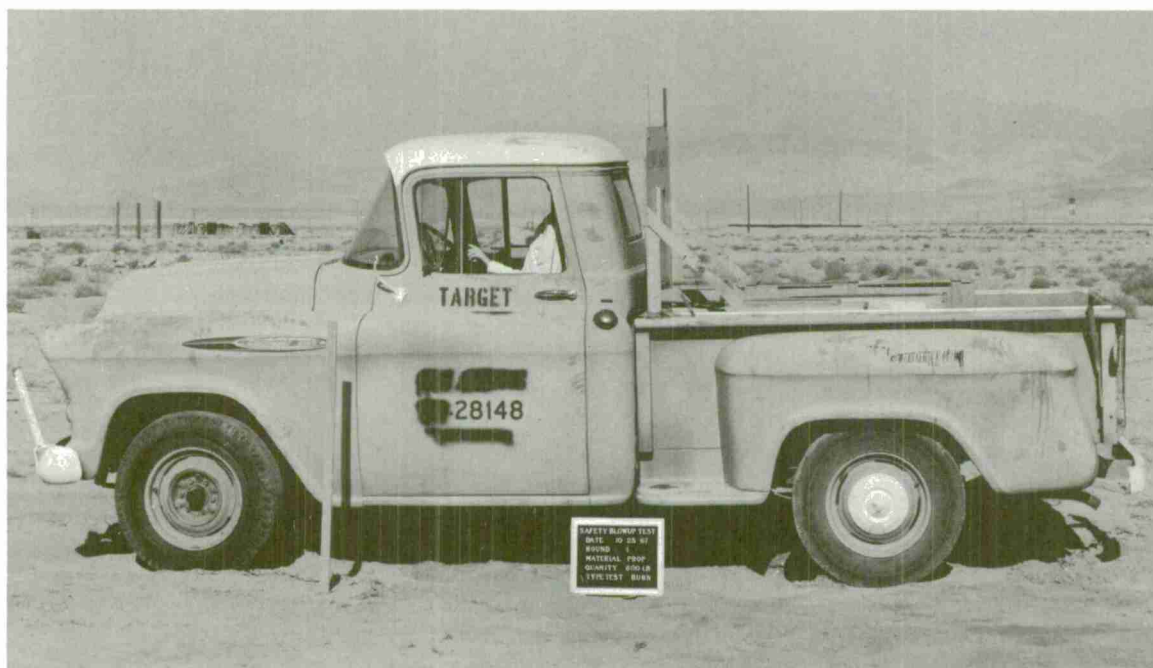
FIG. 1. Typical 1/2-Ton Truck Used in Explosives Safety Tests.

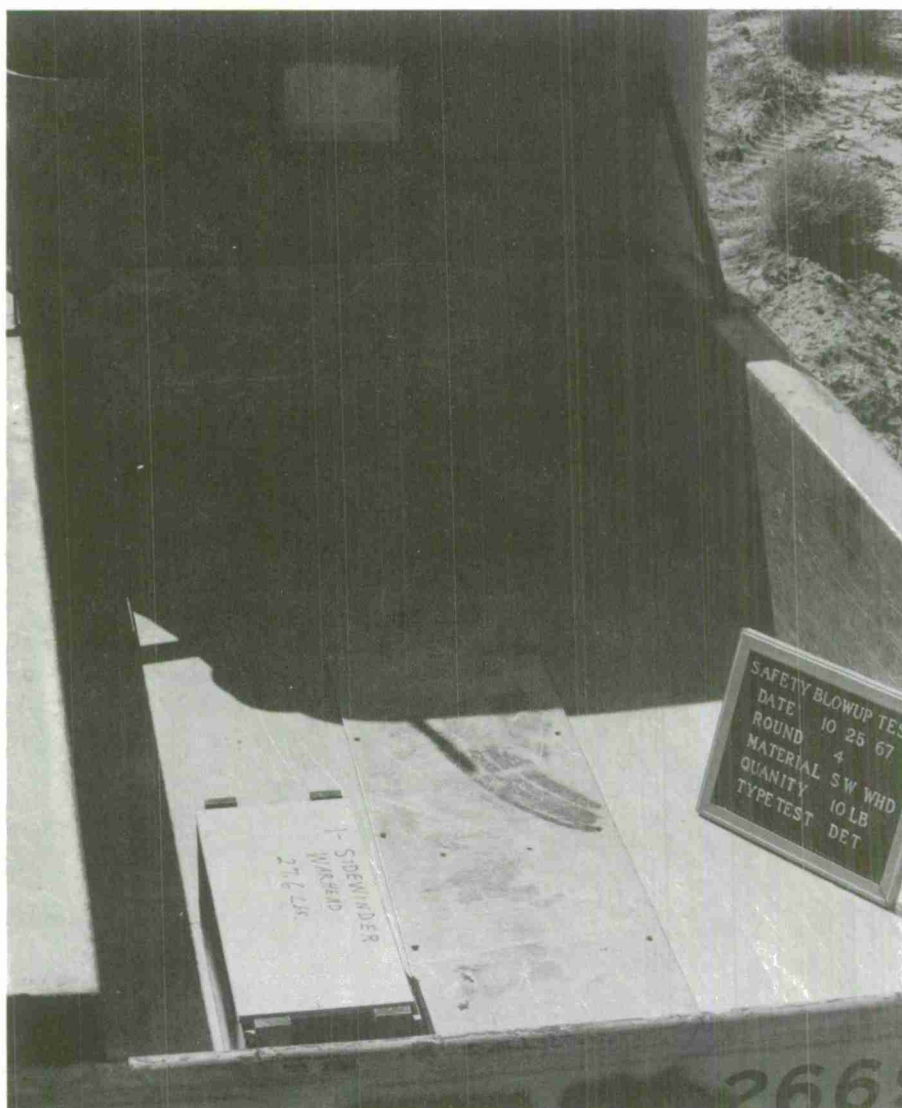
For Test 4, a detonation test, a wooden box containing a Sidewinder high explosives (HE) fragmentation warhead loaded with 10 pounds of Composition C-3 was put in place near the rear of the truck bed (Fig. 13).

FIG. 13. Fragmentation Warhead in Truck for Test 4.
