Technical Note N-1044

PROTECTION OF FLOATING PONTOONS FROM CORROSION -- PART III.  
CONDITION OF TEST FLOATS AFTER THREE YEARS

August 1969

↓  
NAVAL CIVIL ENGINEERING LABORATORY  
Port Hueneme, California 93041

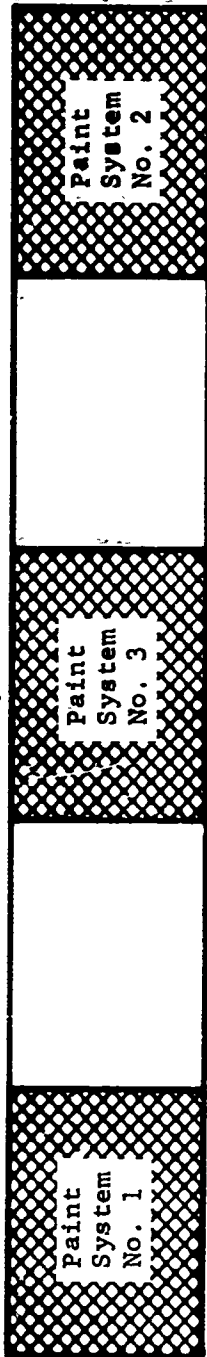
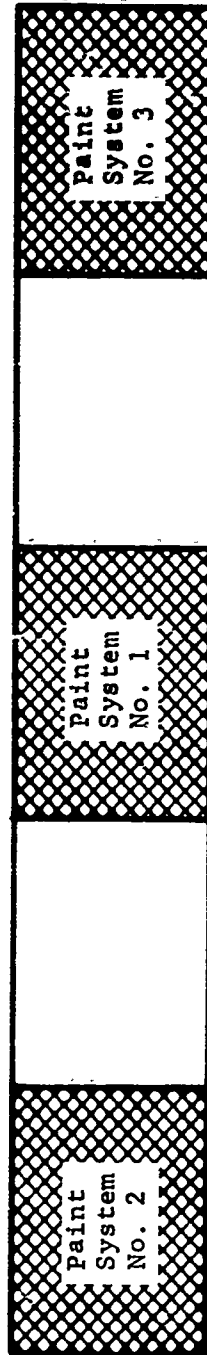
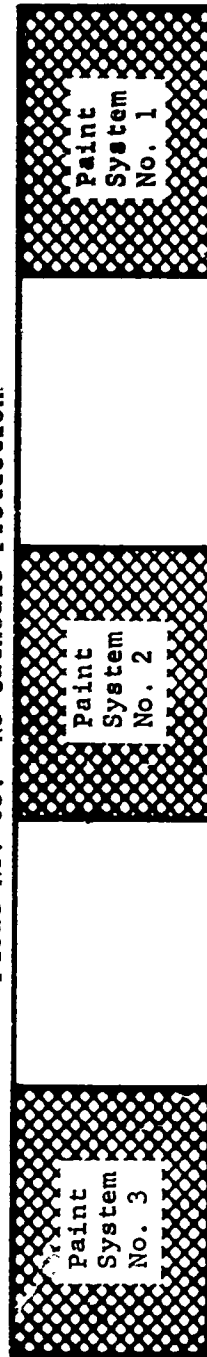
Figure 3. Design of pontoon float test.

Each test float consisted of three pontoons spaced a pontoon length apart and secured together with steel angle-iron bracing. They are commonly called 1 x 5's, because they have a width of one and a length of five pontoons. The test design for the three floats is shown in Figure 3. Each of three paint systems investigated was applied to one of the three pontoons in each test float. The pontoons in each float were arranged randomly as shown in Figure 3, so that each coating system would have the same magnitude of exposure to impact and abrasion damage. The design also permitted a study of the effect of each cathodic protection system on each of the three coating systems.
