PROGRAM TITAN IIIM

STANDARD SPACE LAUNCH VEHICLE
COMPONENT DEVELOPMENT REPORT

FOR THE
TITAN IIIM STAGE I COMBUSTION CHAMBER

9180-941-DR-3

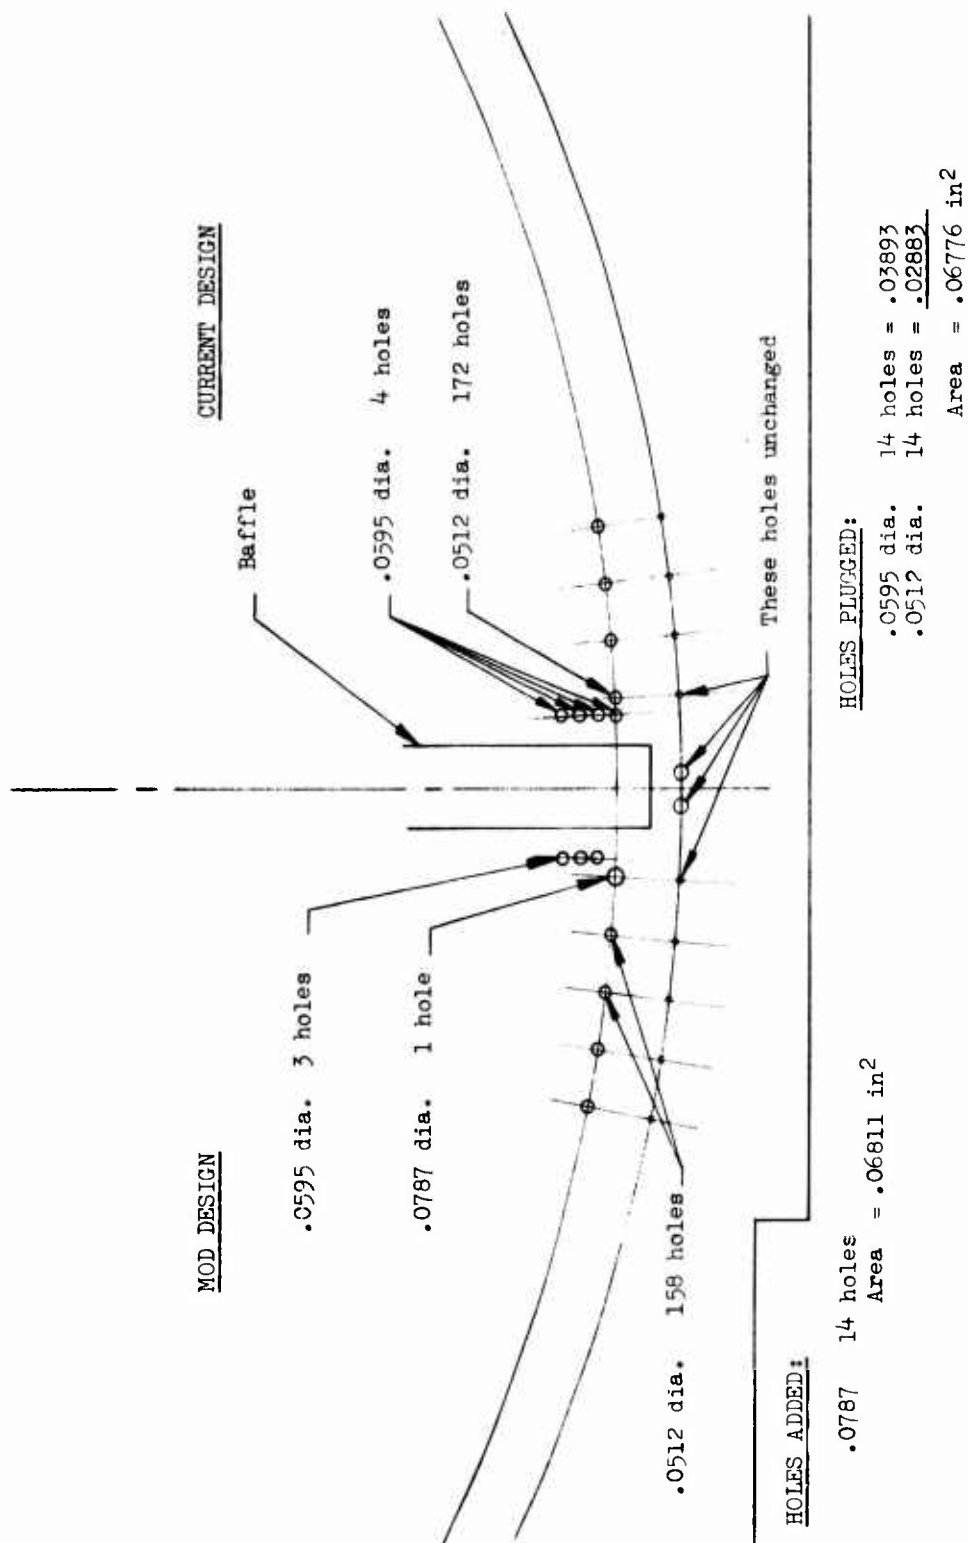
Figure 9 -- Film Cooling Modification

During the development and early verification testing there were instances of heat marking and erosion on the forward flange such as shown in Figure 8. This was attributable to inadequate dispersion of the fuel film cooling from the baffle injector. The film cooling pattern of the injector was modified as shown in Figure 9. Thereafter such minor instances of erosion as occurred were all within acceptable limits as given by the specification.

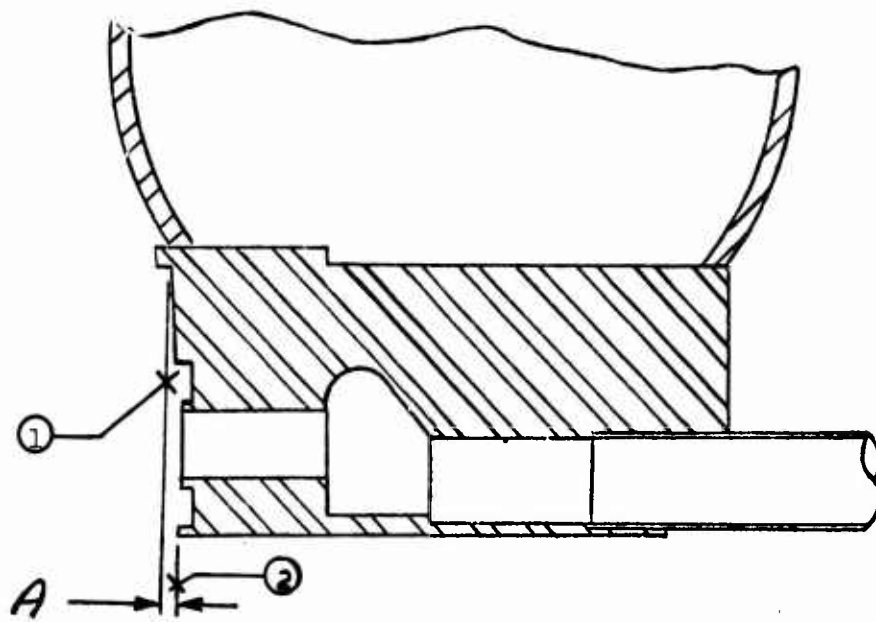
Figure 11 -- Combustion Chamber Flange Distortions

Combustion chamber S/N 012 was subjected to a dimensional inspection after the conclusion of its testing. Combustion chamber S/N 009, which did not have an excessive gap condition, was also inspected for comparative purposes. Both combustion chambers had been subjected to identical test series. The results of these inspections are presented in Figure 11. The baffle numbers refer to the injector baffles and are included to provide circumferential reference points. The mid points between the baffles are also shown. The inspection results illustrate that the flange was distorted similarly in both chambers. It is of interest to note that chamber S/N 009 did not exhibit a gap problem during testing, while chamber S/N 012 did. After this disclosure, a flatness check of injector S/N 661 was made. The mounting flange of the injector was found to be flat within 0.003 in.

The flange of the chamber becomes distorted as a result of testing. Surface No. 1 and Surface No. 2 (from Figure 11) are obtained in a single machining operation. This would produce surface differences (dimension "A") of approximately ± 0.001 in. in an unfired chamber. Combustion chamber S/N 015 was inspected before testing and the "A" dimensions recorded varied from +0.003 to -0.001 inches.

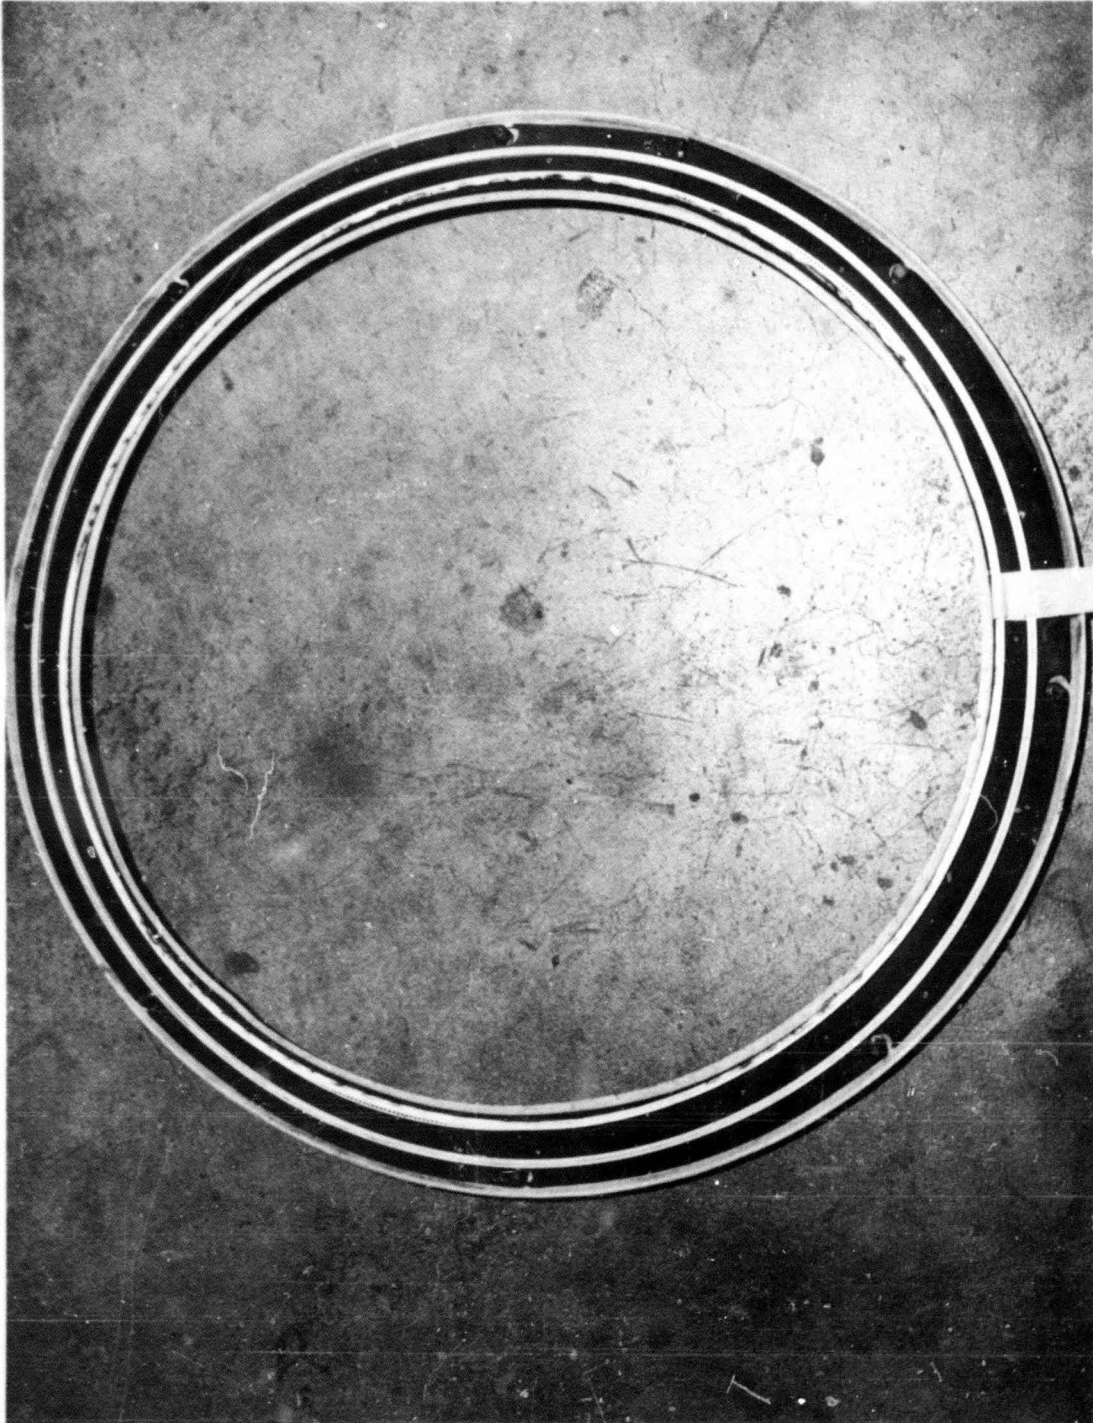
Figure 12 -- Raco Seals

During the TCA verification testing, instances of damage to the inner Raco seal (Figure 12) at the injector to chamber interface occurred. The damage consisted of charring and cracking of the Teflon portion of the seal. The cracks provided a leak path for the fuel directly to the combustion zone rather than through the injector, resulting in inefficient utilization of the propellant. Such a leak path is shown in Figure 13 and a damaged seal in Figure 14.

The Titan IIIM TCA may subject the seal to a more severe environment than other Titan family systems. The injector operates with 10.5% chamber fuel film coolant, as compared to 16.1% with the 87-9 design. Therefore, surface temperatures on the chamber flange are 1500^oF on Titan IIIM, and only 1000^oF on the production flange.

A record of seal damage similar to that of the Titan IIIM was also encountered on the Titan B and C and the Titan II programs, although the thermal environment of those chambers is less severe than the Titan IIIM. Disassembly of a SLAP (Service Life Analysis Program) engine revealed the Raco seal also to be in a condition similar to that of the Titan IIIM seal. The SLAP engine had been subjected to two acceptance tests (20 seconds and 165 seconds) prior to its delivery.

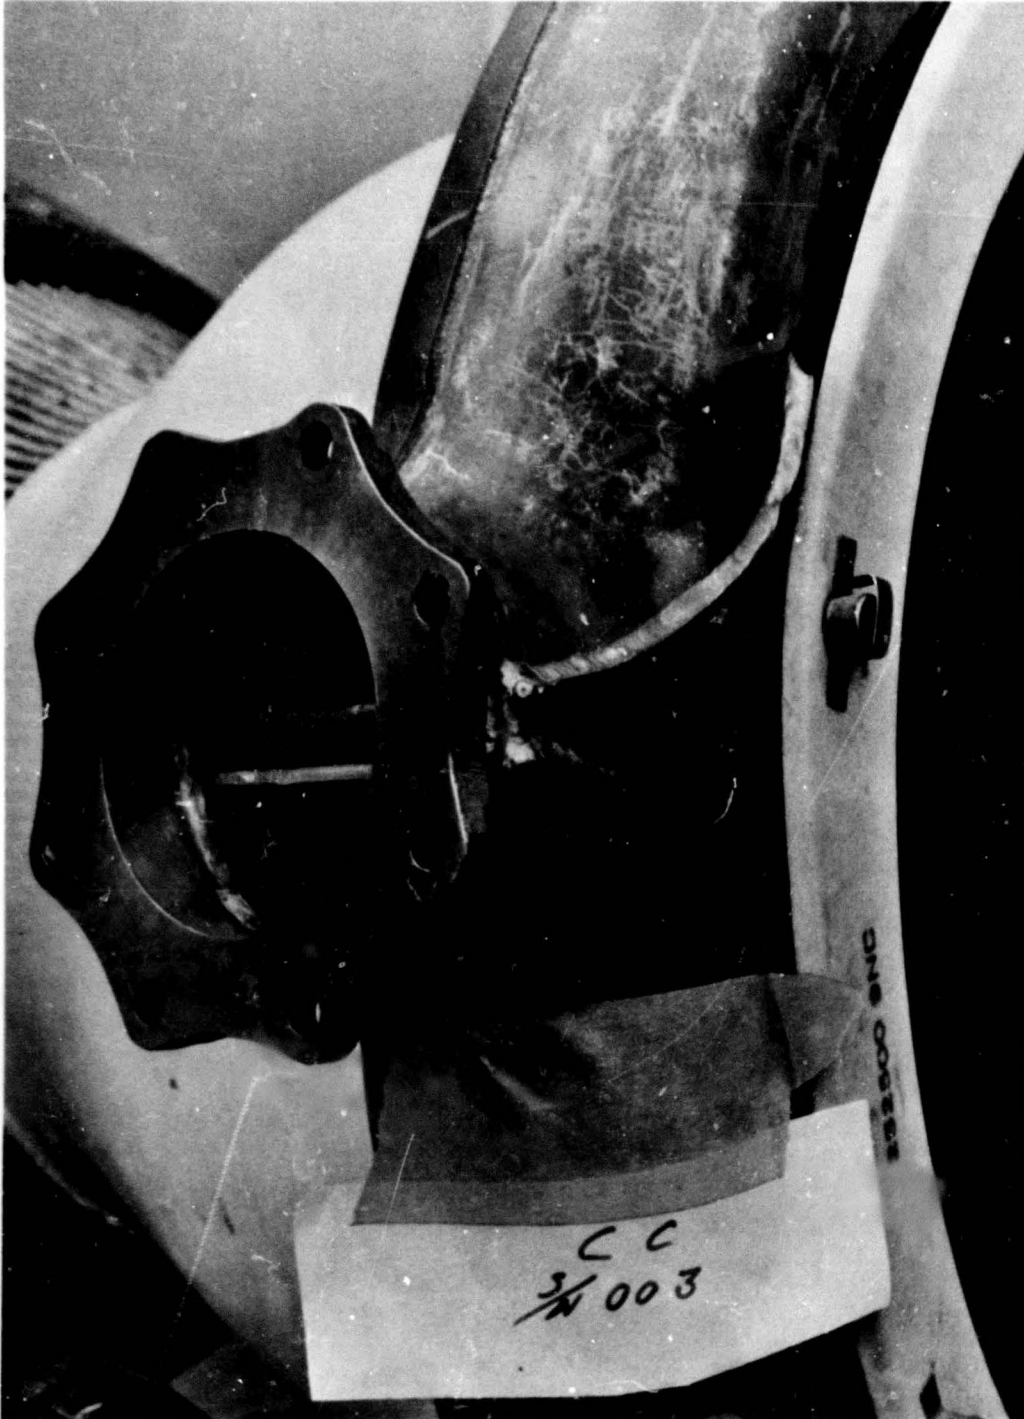
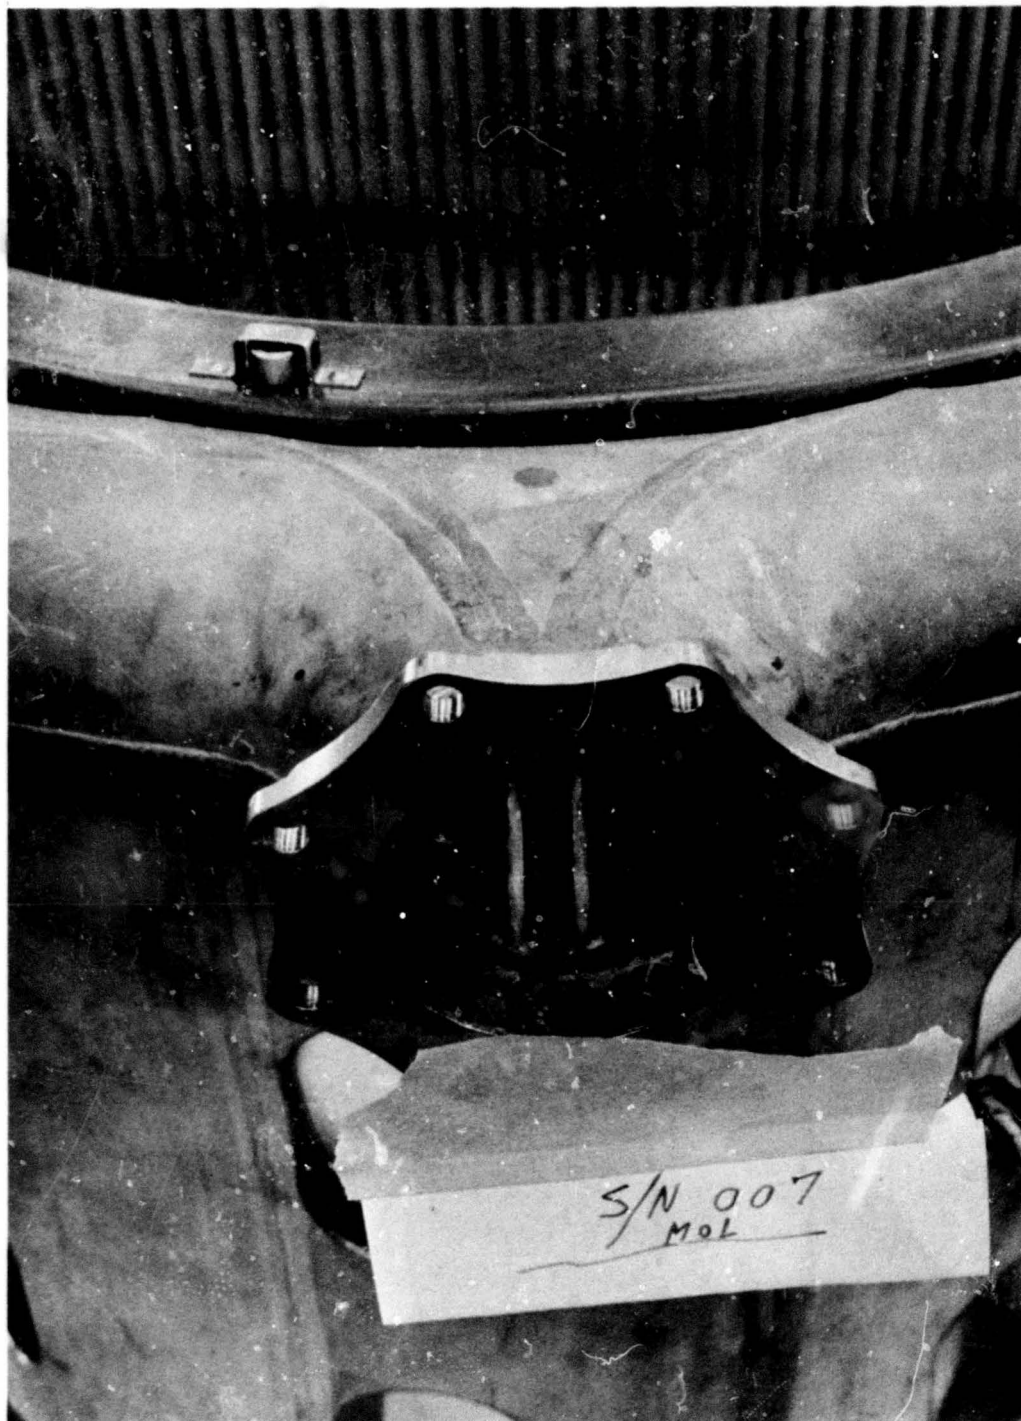
Figure 19 -- Mounting Flange and Torus Changes -- Chamber S/N 003

This problem occurred in the concentricity between the holes and centerbores in the forward flange where the holes were milled prior to welding the closure ring and torus while the counterbores were made after welding. The problem was corrected by performing both operations after welding.

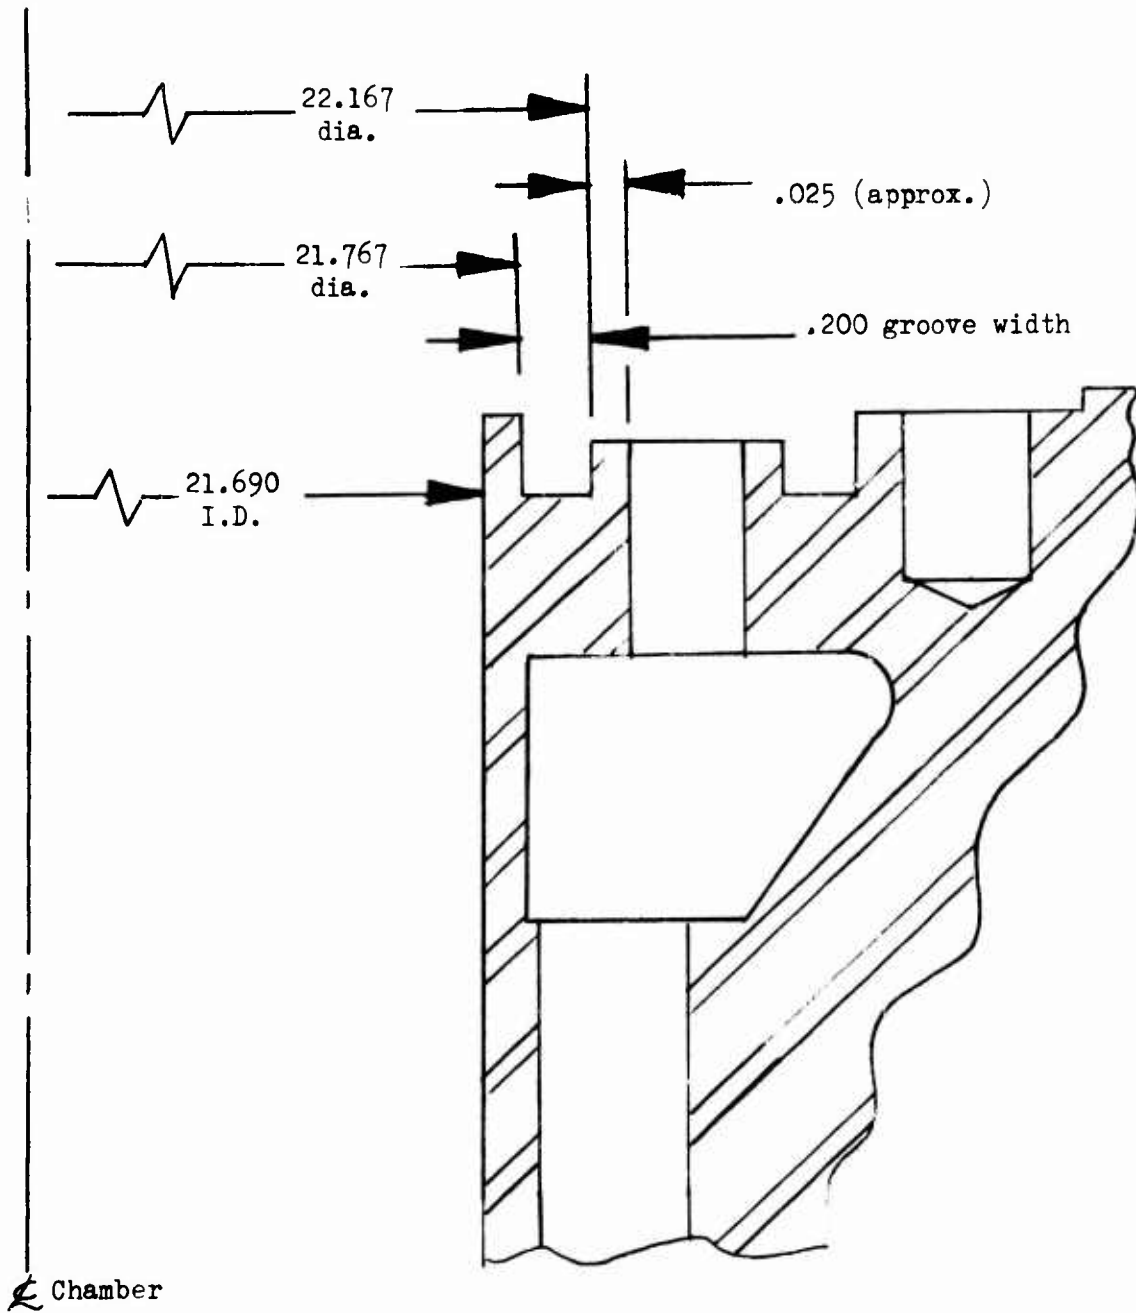
Figure 21 -- Combustion Chamber Flange -- S/N 019

Alternative (2) was therefore selected as the more satisfactory means for correcting the problem in chambers S/N 019 and S/N 020. Drawing No. 701773 (AEIP seal utilized for Titan IIIM at the inner seal) requires a minimum seal groove width of 0.195 while the chamber flange per B/P 1130174 is designed for a minimum groove width of 0.214 in. The chambers were machined as shown on Figure 21. All dimensions are to be to blueprint with the exception of the 22.167 in. dia, which normally is 22.250 ± 0.010 in. dia.

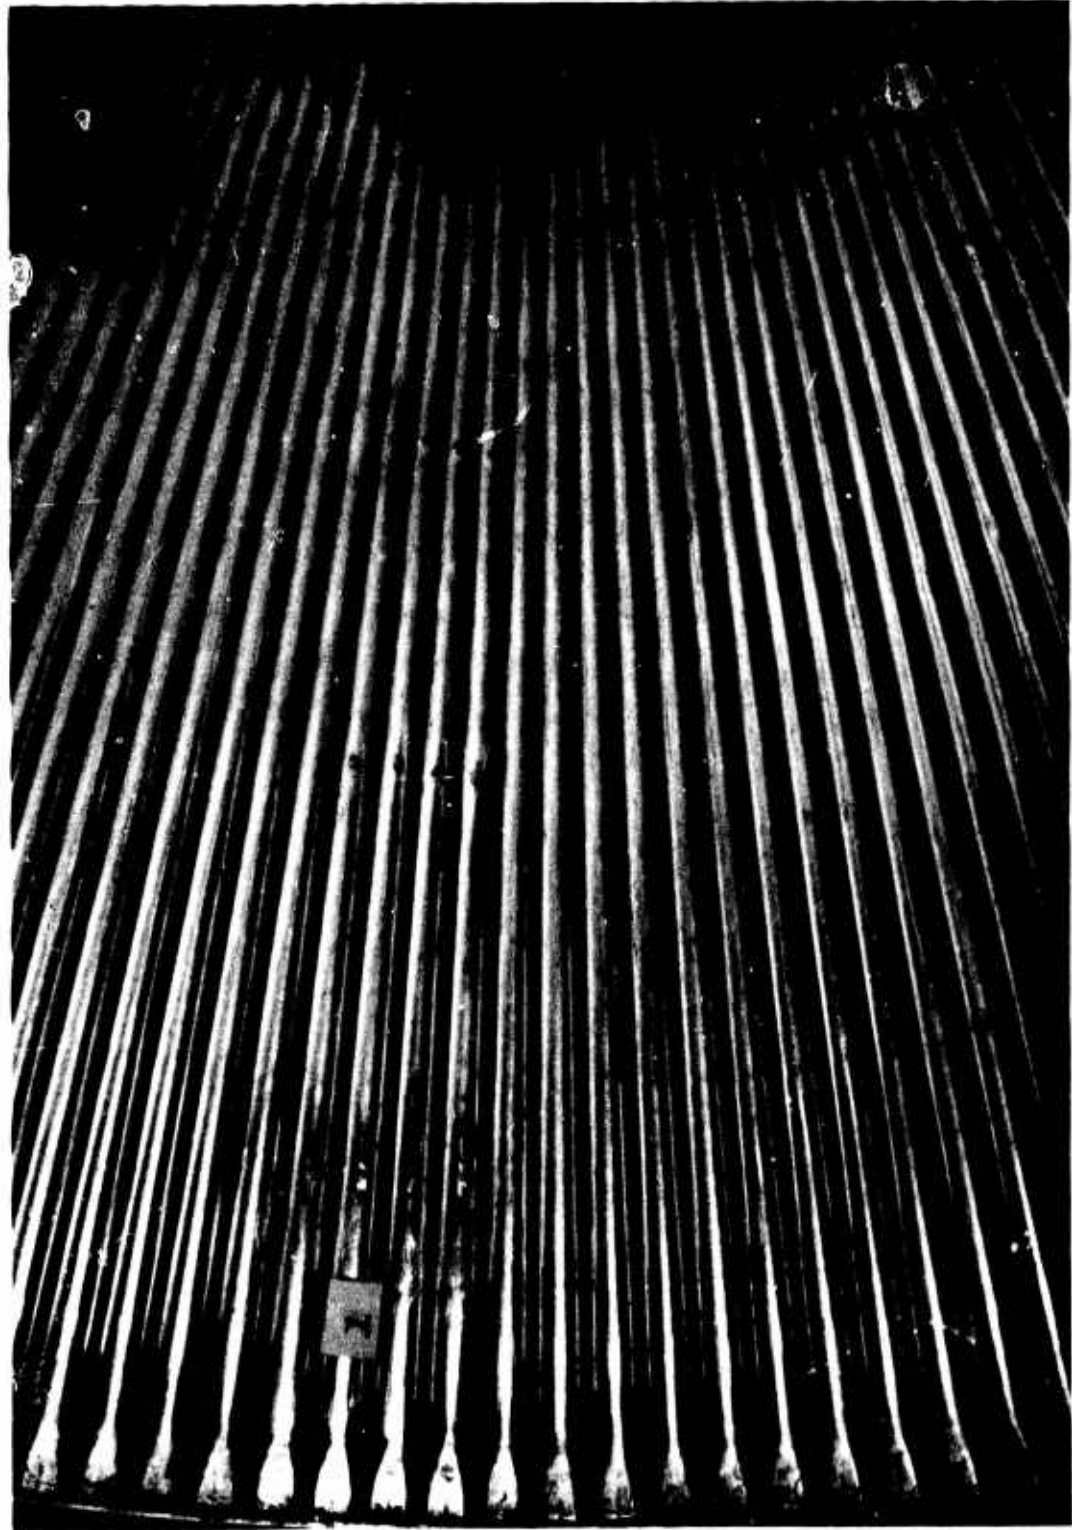
Figure 26 -- Chamber S/N 003 -- Braze Patch Installation

Test 3051-D01-1A-006 was made with the braze chamber S/N 003. Figure 26 shows one section of the braze patches installed. Figure 27 shows the chamber after firing. The results, in general, agreed very well with the predicted values. In the throat the braze indicated a wall temperature between 1570°F and 1670°F ; the predicted was 1510°F .

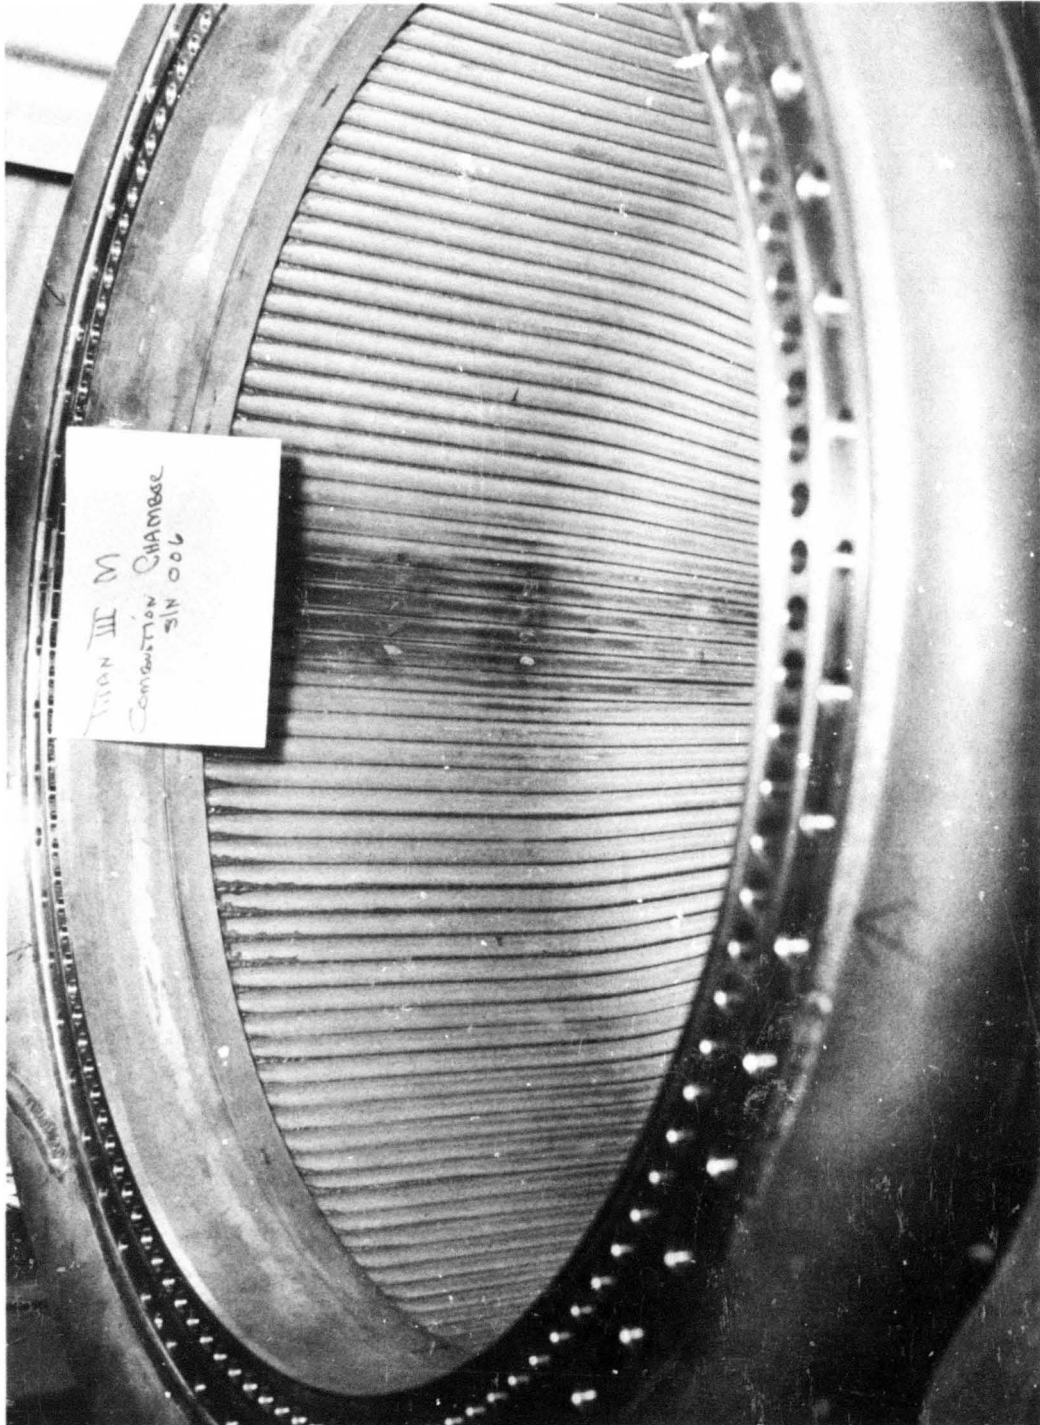
Figure 29 -- Chamber S/N 006 -- Braze Patch Installation

A third Titan IIIM chamber (S/N 006), instrumented with braze patches as shown in Figure 29, was tested on an engine subassembly (Test No. 3051-D01-1A-021) with injector S/N 653, which had 9.4 percent film cooling. The braze patch data indicated that this low film cooling flow resulted in more circumferential temperature variations than the previous two chambers (S/N 003 and 005). The hottest zones were directly under and just adjacent to the baffles where temperatures of 1740°F were noted. The region between baffles was the coolest with the maximum temperature range the same as the previous two chambers, i.e., 1575 to 1670°F . Although the tubes were ebony black above the throat, no heat marked tubes were noted.

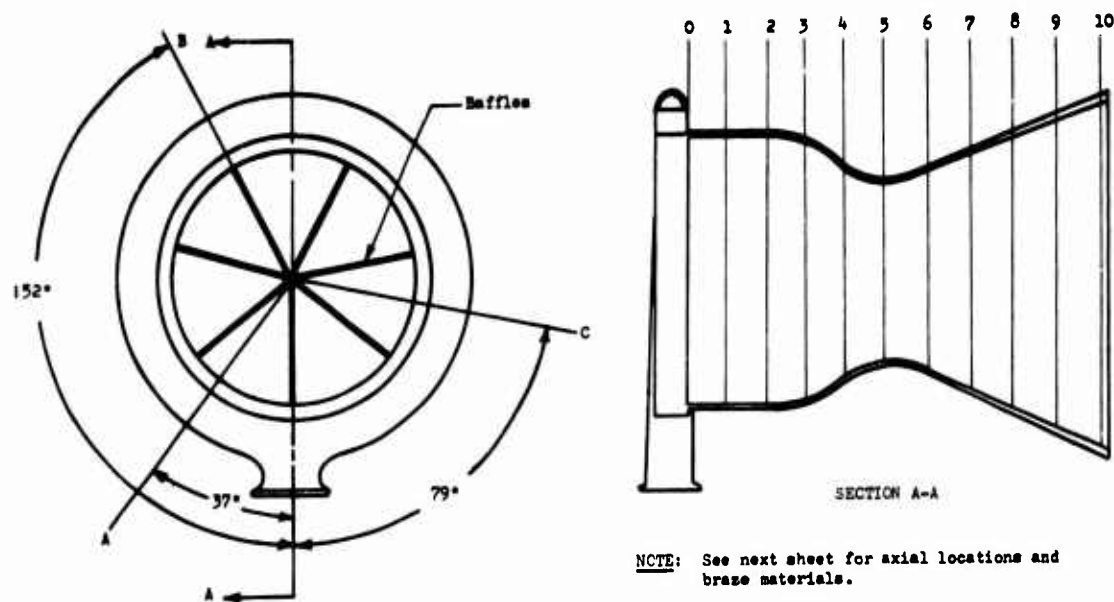
Figure 30 -- Braze Patch Locations

The maximum temperatures noted at the throat were 1740°F . All braze patches located adjacent to the baffle ("A" location in Figure 30) melted from the throat to the injector end, and there were more variations and local streaking in the patch data above the throat than in the previous two chambers. The braze patches used at each location are listed in Table 11.

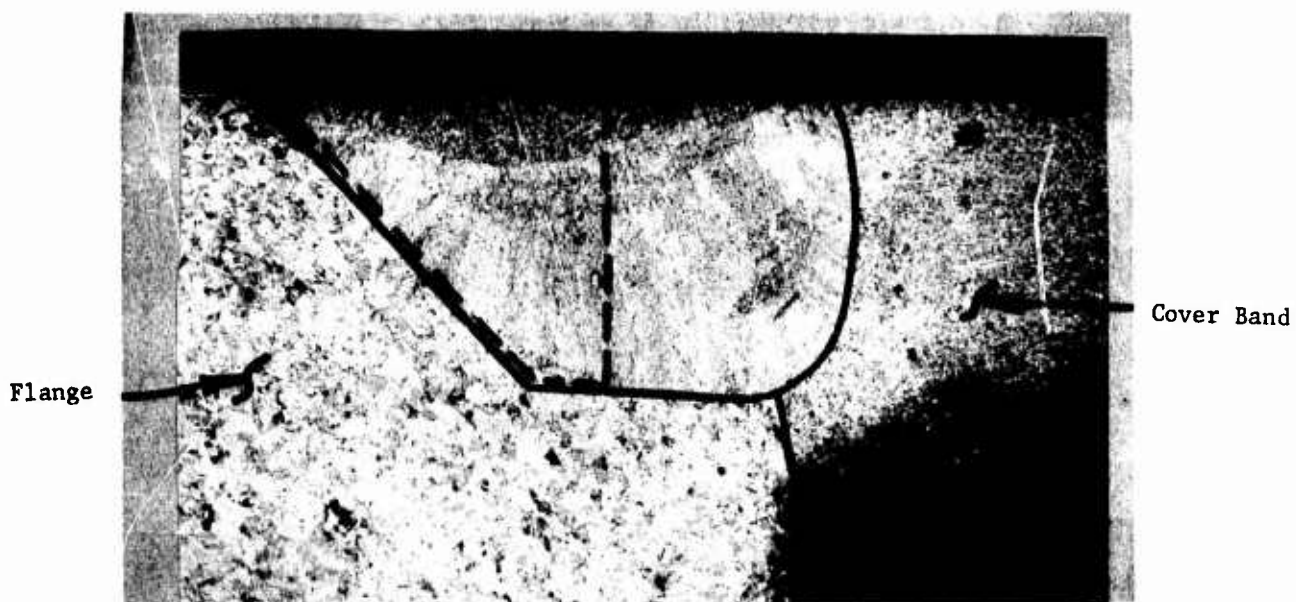
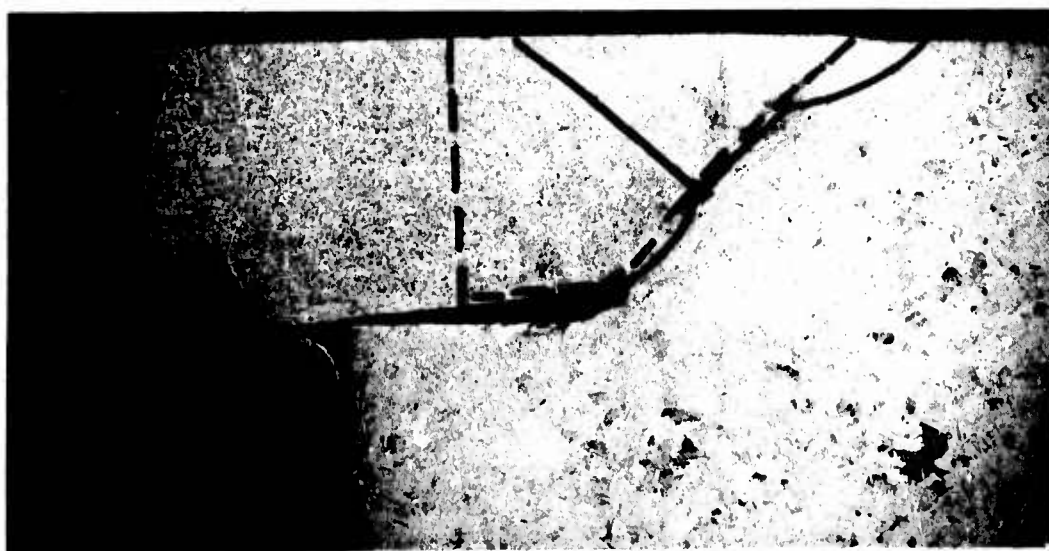
Figure 32 -- Chamber S/N 011 -- Section through Forward Flange

A complete metallographic inspection was made of the cover band area. The crack was attributed to inadequate weld penetration and to improper positioning of the band. These conditions are shown in Figure 32.

NOTE: The solid line outlines the weld nugget. The dotted line represents correct position of cover band.

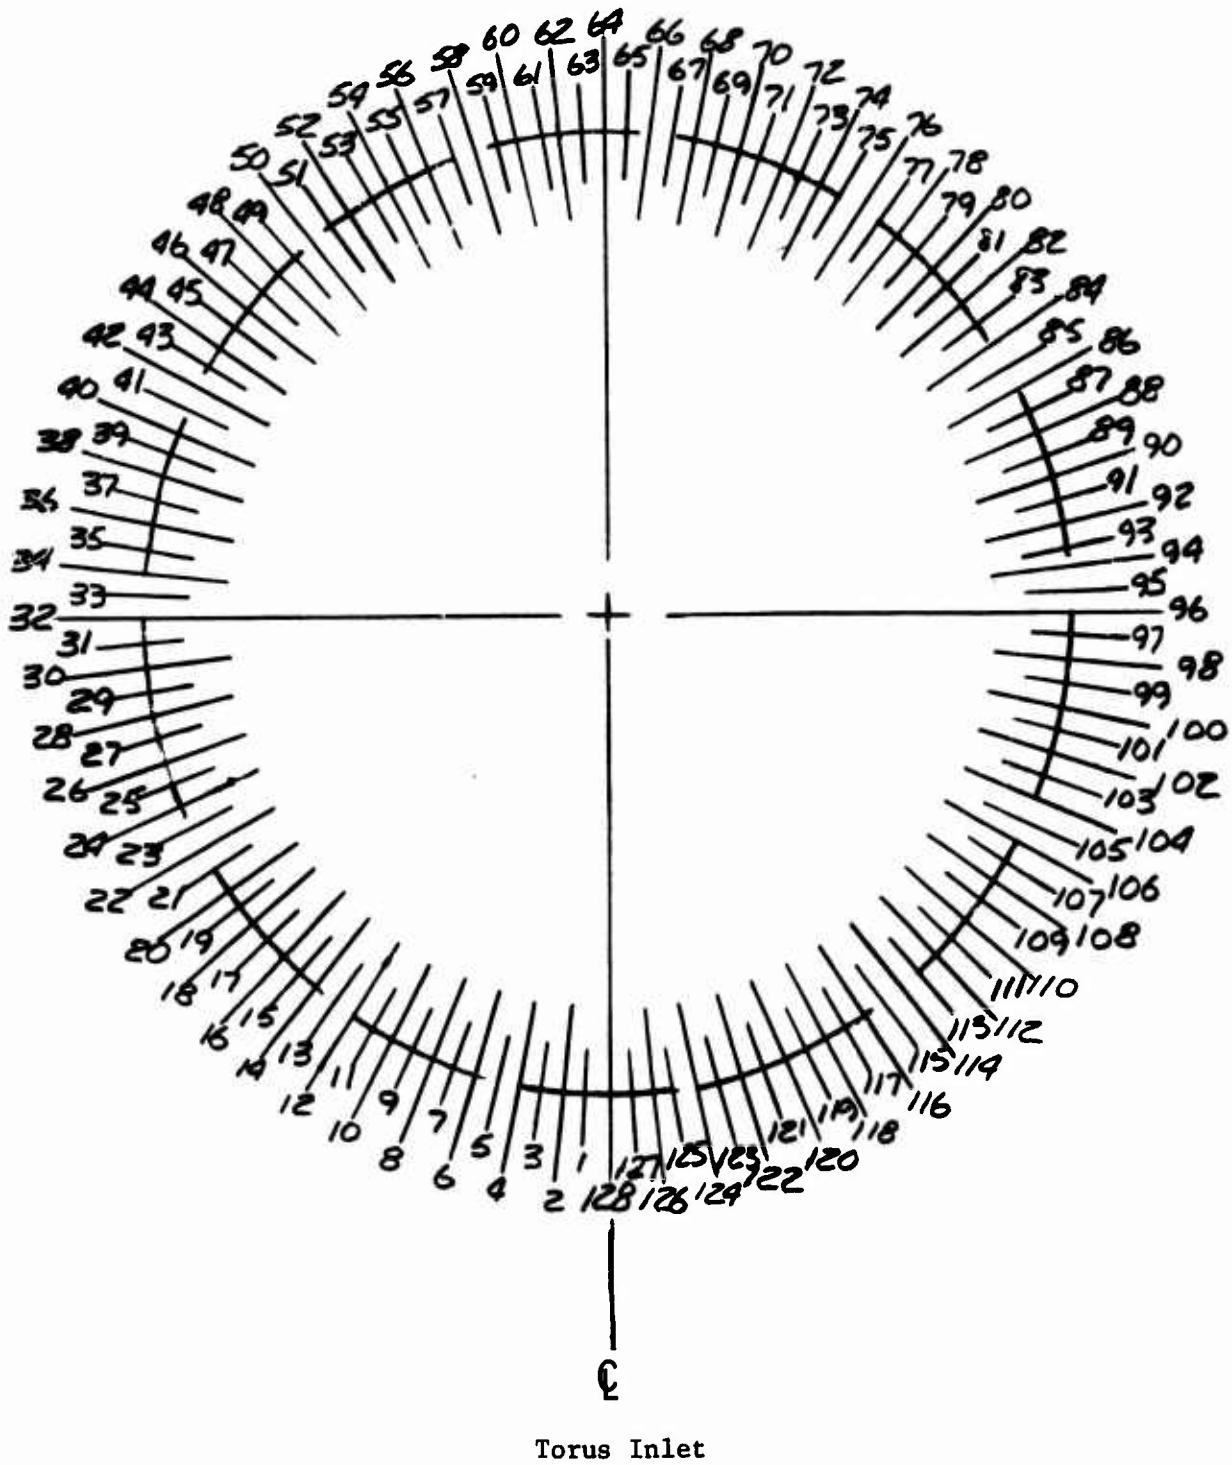
Figure 39 -- Flow Splitter Test -- Tube Locations

Testing was next initiated to determine the distribution in the first-pass ("down") tubes. Testing began with chamber S/N 003, whose aft flange had been removed in order to measure the flow rates before they were equalized in the aft collector ring. The initial results showed a wide dispersion, from 51 percent to 117 percent of nominal. During a test of the torus assembly conducted separately, it was observed that some tubes slots were not flowing. Examination of the test setup disclosed that a 2-in. connection had been made at the torus inlet. This produced a high velocity jet with unequal pressure distribution in the torus. The proper 4-in. connection, corresponding to the engine plumbing, was made in the test setup and testing resumed.

The improper inlet fitting invalidated only the data obtained for the first-pass tubes. During the tests of the second-pass tubes the maldistribution in the first-pass tubes was compensated by the aft manifold, which produced nearly equal pressures at the inlet to the second-pass tubes. The differences in pressure were therefore small with respect to the total pressure drop in the tubes.

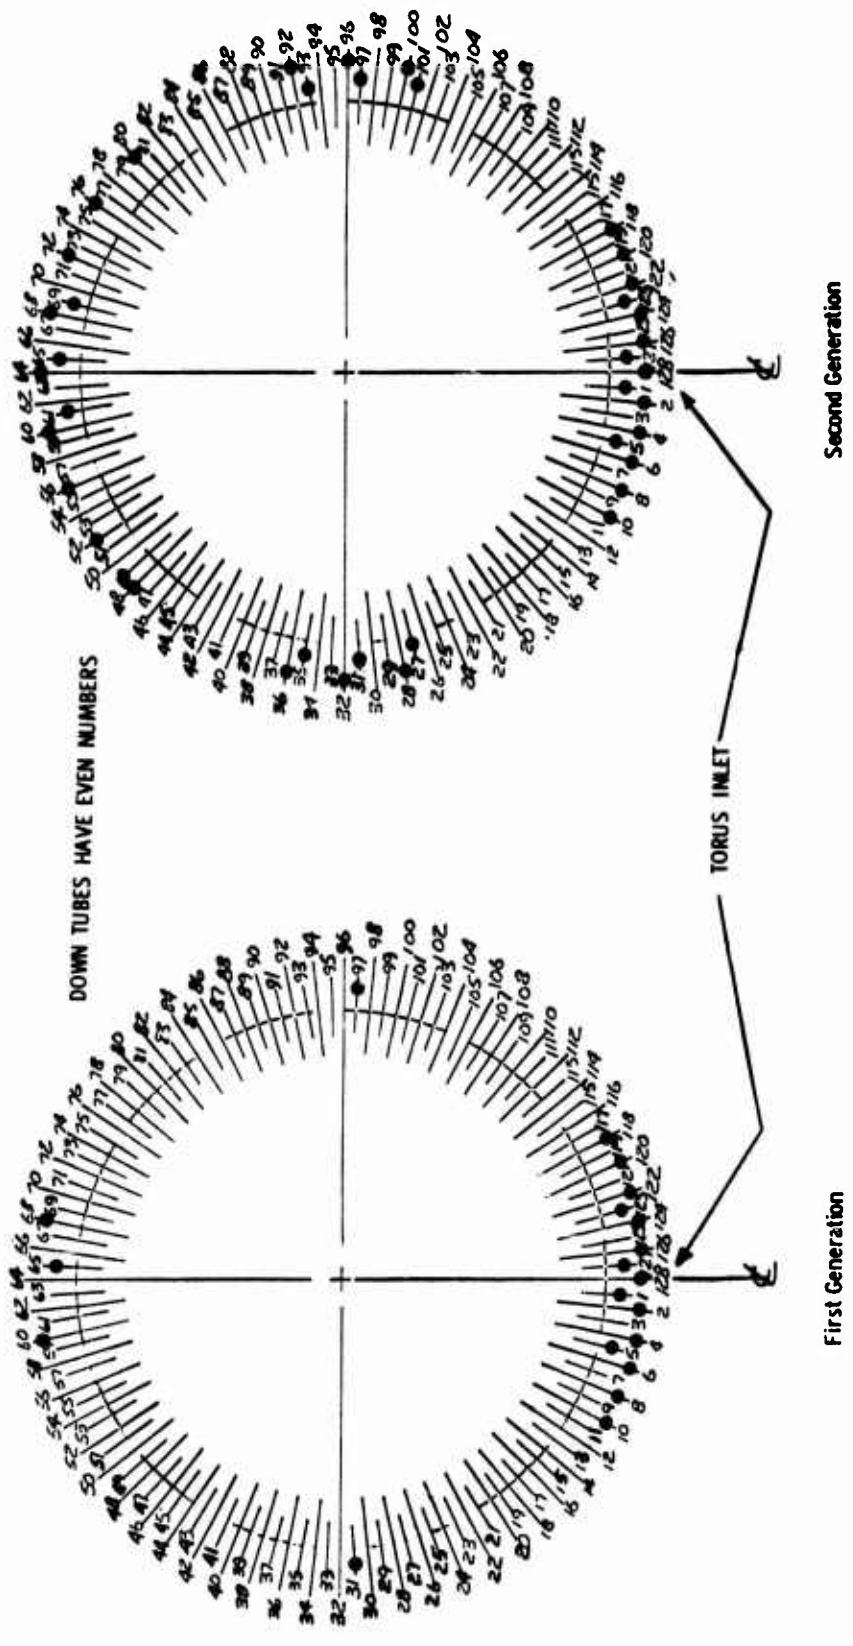
Figure 40. Pressure Tap Locations

(d) The pressure taps were located farther from the torus and the exit manifold ends of the tubes to reduce hydraulic entrance effects. Figure 40 illustrates the location of the tubes.

The most reliable data obtained during the various tests conducted disclosed a flow variation from -8.6% to +4.0% of the nominal weight flow per tube. The R_{BO} of the tube with least flow (-8.6%) was determined to be 0.765 with the engine operating at the worst chamber thermal conditions: $MR = 2.15$, $P_c = 796$ psia, $T_{ci} = 98^\circ F$, chamber film coolant - 10.5%. The actual R_{BO} is therefore within the design limit of 0.82.*

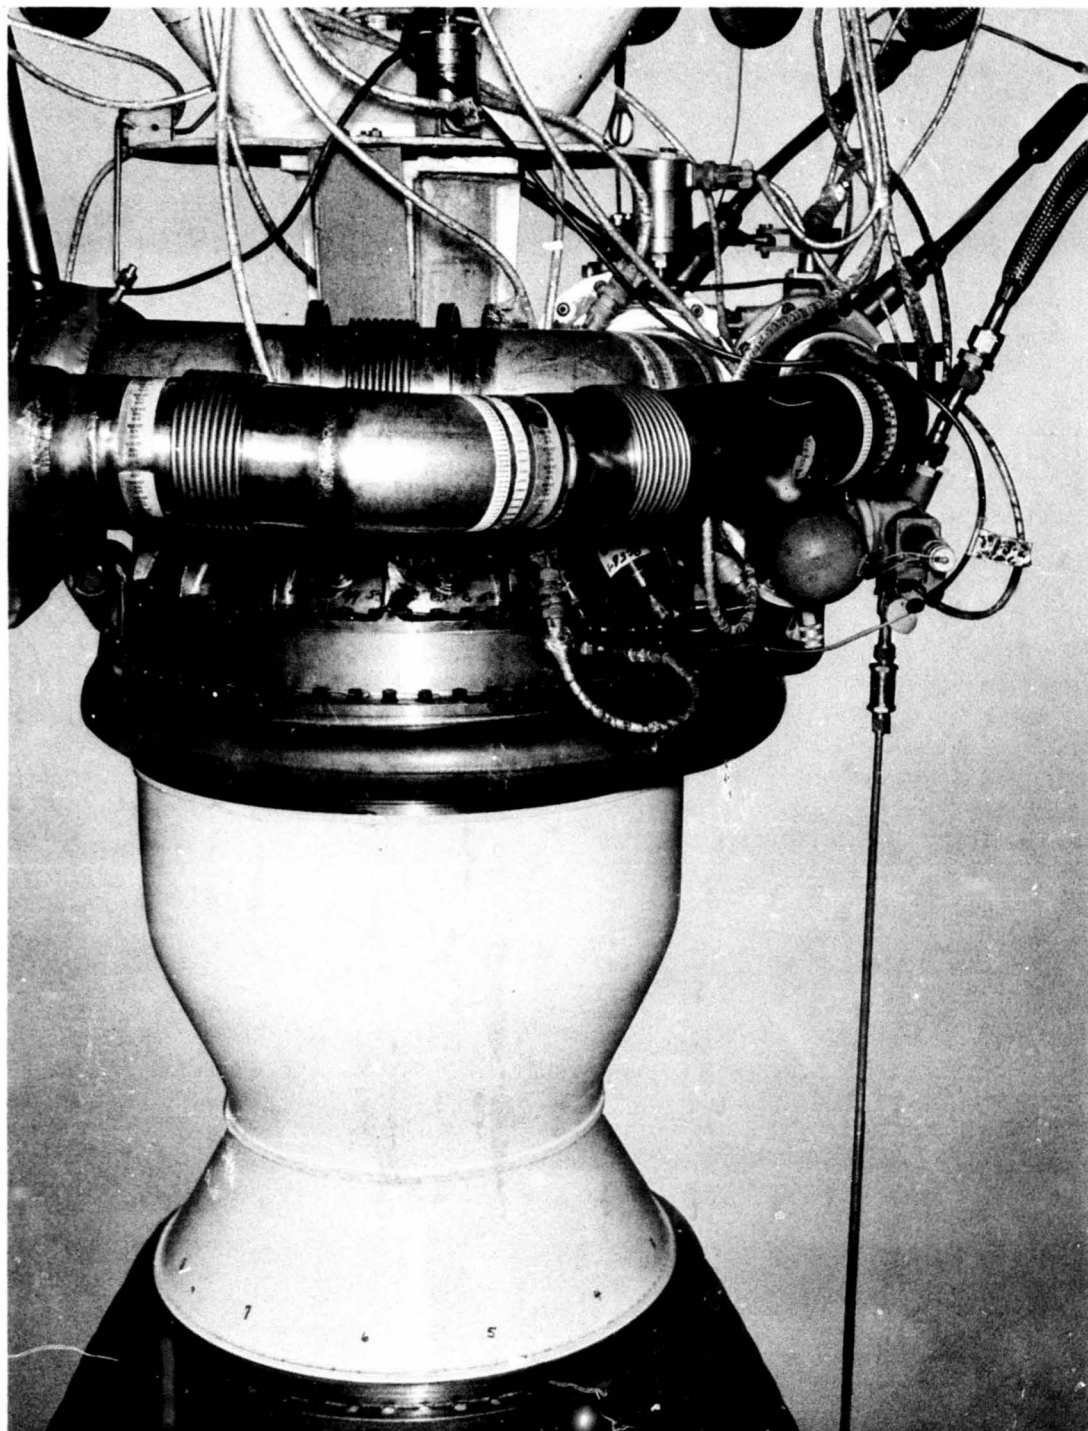
Figure 45 -- Chamber S/N 001 Prior to Test

Testing was initiated in May 1966, utilizing chamber S/N 001. The chamber was delivered to the test area without a shell in order to expedite testing because it was not scheduled to be tested in conjunction with a skirt. A prefire photograph of the TCA used in Test No. 001 is shown in Figure 45. The duration of the first test was approximately 31 sec with all parameters recording approximately the predicted values. Posttest hardware inspection indicated no heat marked tubes, no epon cracking, nor any other abnormalities.

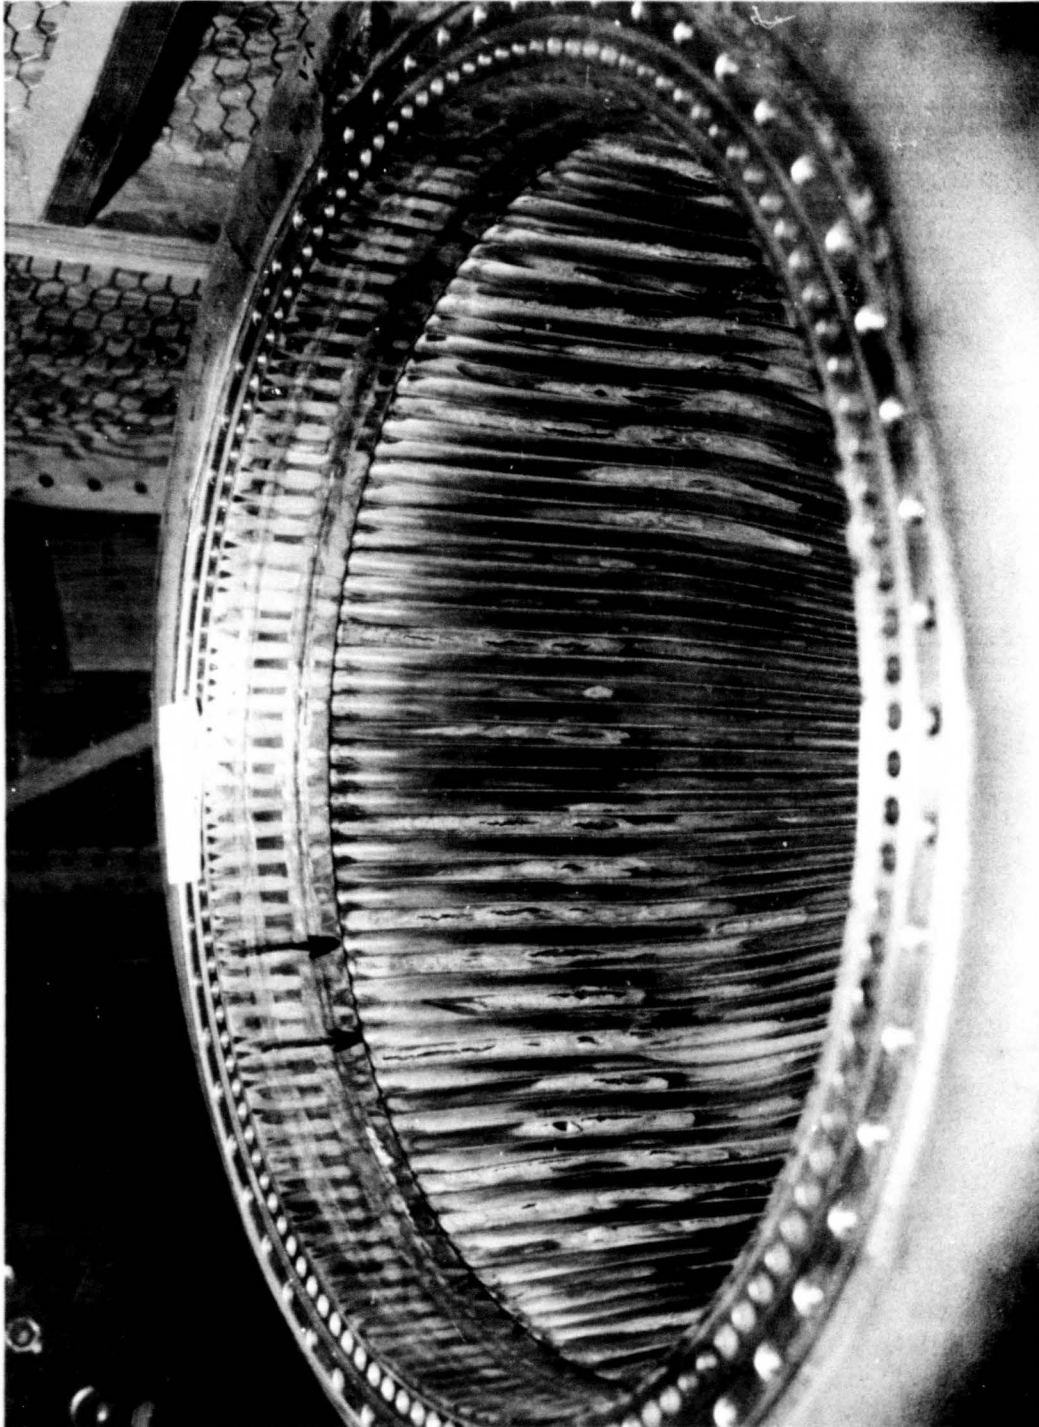
Figure 46 -- Chamber S/N 001 Posttest No. 3051-D01-1C-001

The test results showed that the 2BIE-38 injector was incompatible with the 87-11 chamber. The postfire inspection of the hardware revealed approximately 50 "up" tubes and 6 "down" tubes were failed (Figure 46) to the extent that chamber pressure and other parameters started dropping at $FS_1 + 4.5$ seconds.
