PROGRAM TITAN IIIM

STANDARD SPACE LAUNCH VEHICLE
COMPONENT DEVELOPMENT REPORT

FOR THE
TITAN IIIM STAGE I COMBUSTION CHAMBER

9180-941-DR-3

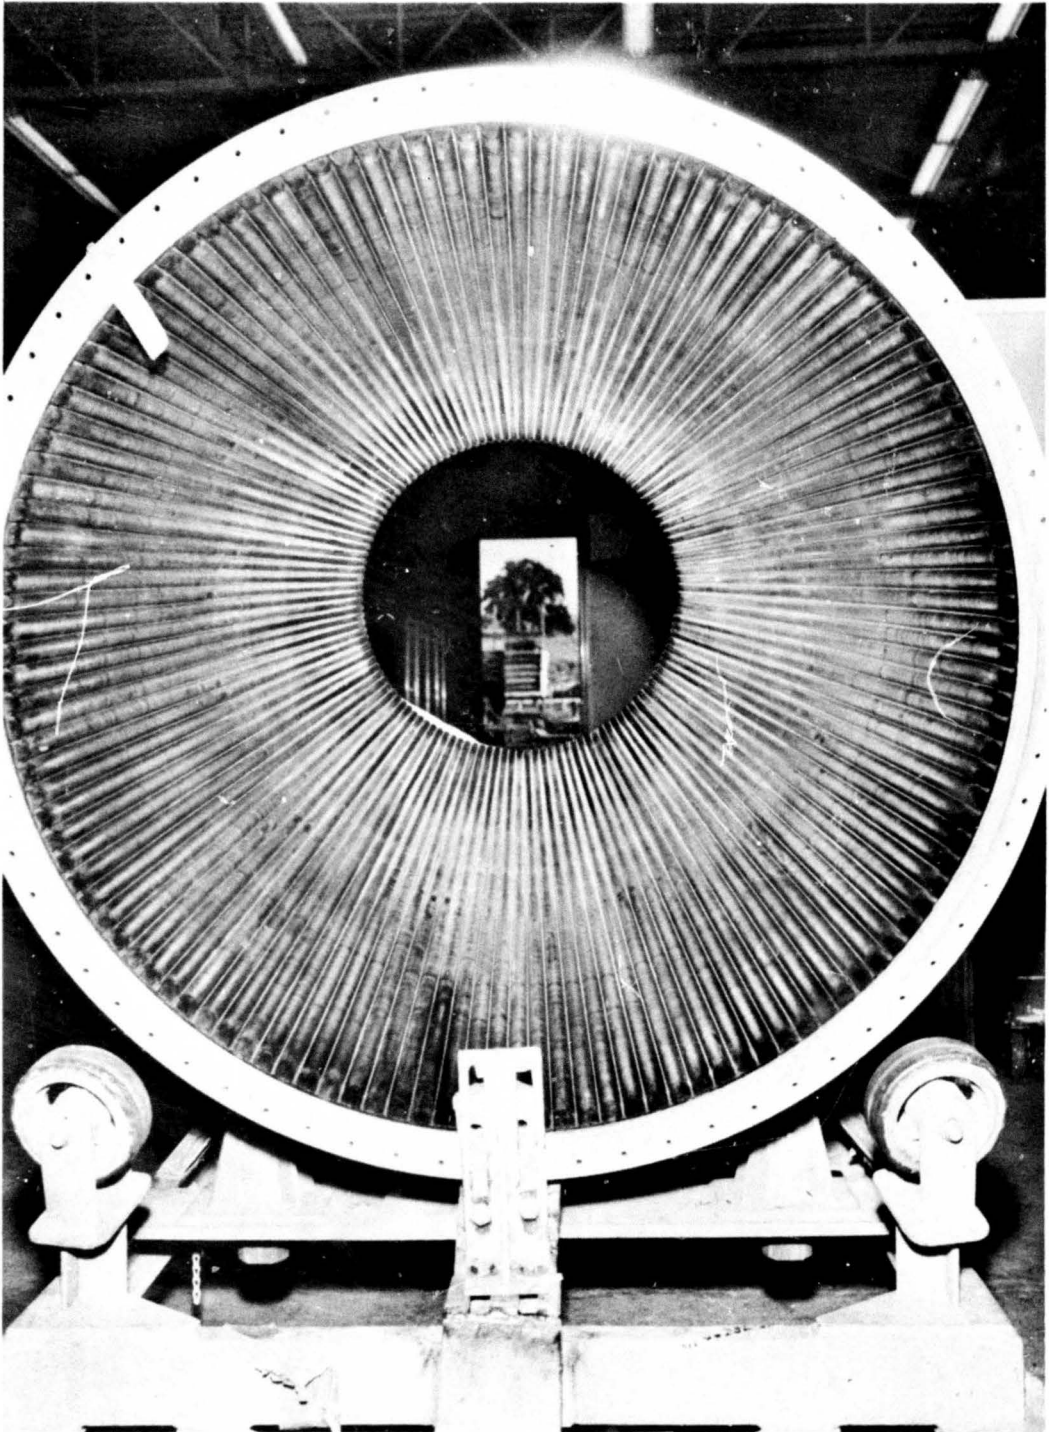
Figure 48 -- Combustion Chamber after Test No. 3051-D01-1A-005

Test -005 was conducted utilizing injector S/N 249 (AJ-9 with 16 percent film cooling) and an ablative skirt at the most adverse heat transfer conditions for the skirt. Posttest inspection of chamber S/N 002 after engine Test No. 3051-D01-1A-005 revealed that one chamber tube was heat marked in the divergent section from approximately 18 inches below the throat to the aft end of the tube. Figures 48 and 49 show the location relative to the chamber. Penetrating erosion had occurred in two places (Figure 7, supra). All other chamber tubes were in satisfactory condition.

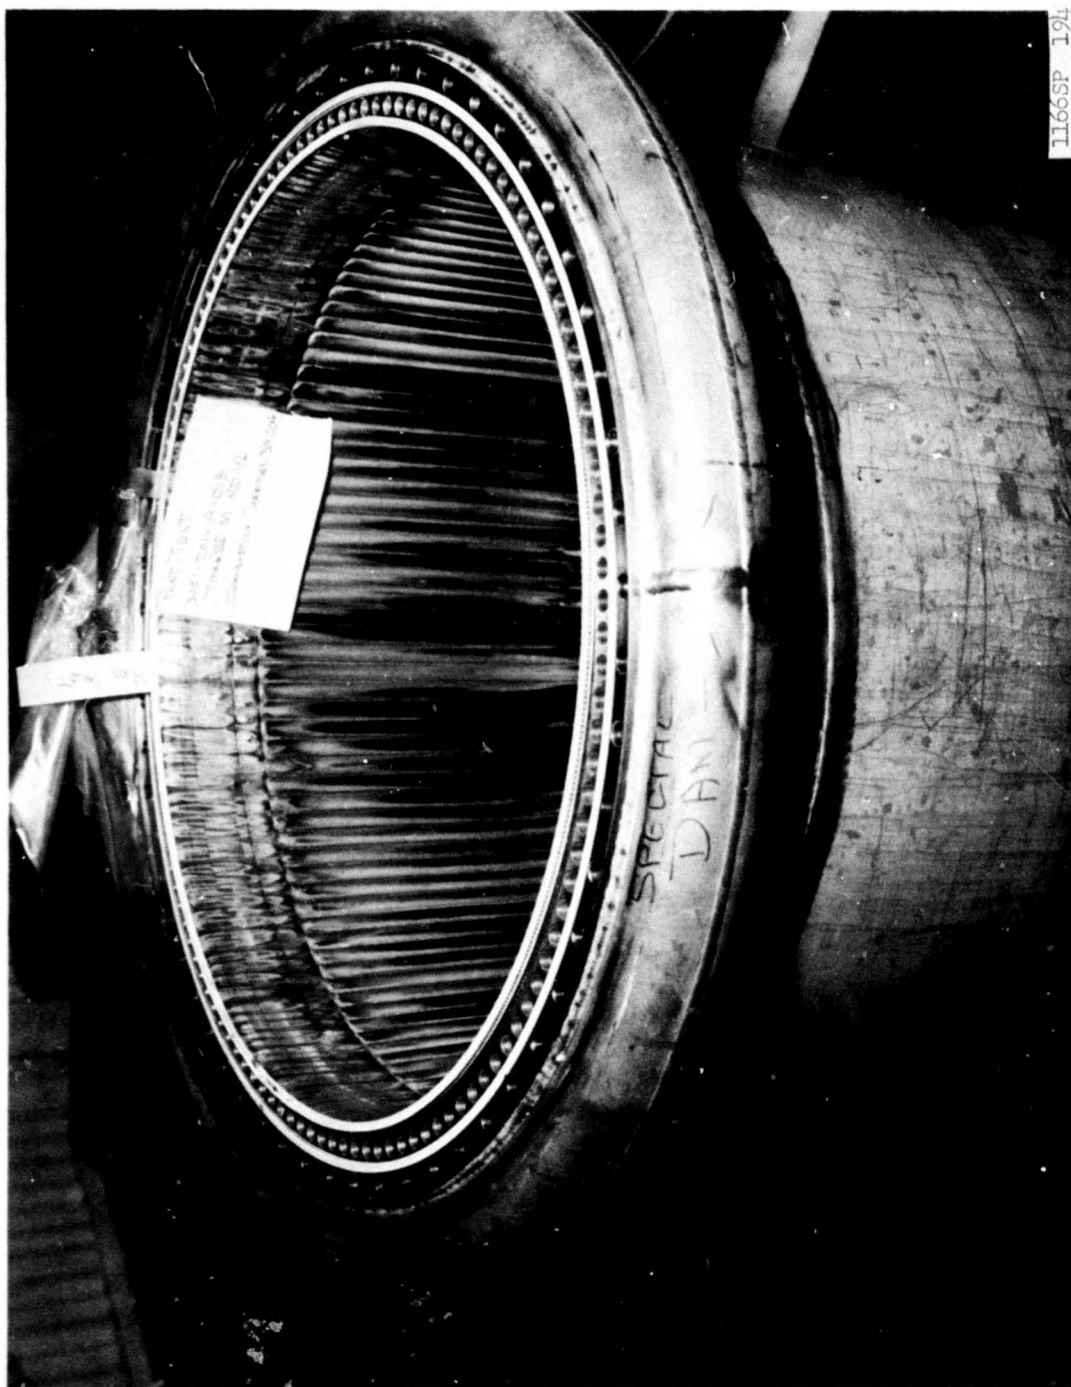
Figure 53 -- Acoustic Dam in Chamber Torus

Chamber S/N 004 had an acoustic dam in the torus (Figure 53) in an effort to reduce the magnitude of the feed system pressure amplitudes. The test was terminated after approximately 5 sec by the combustion stability monitor.

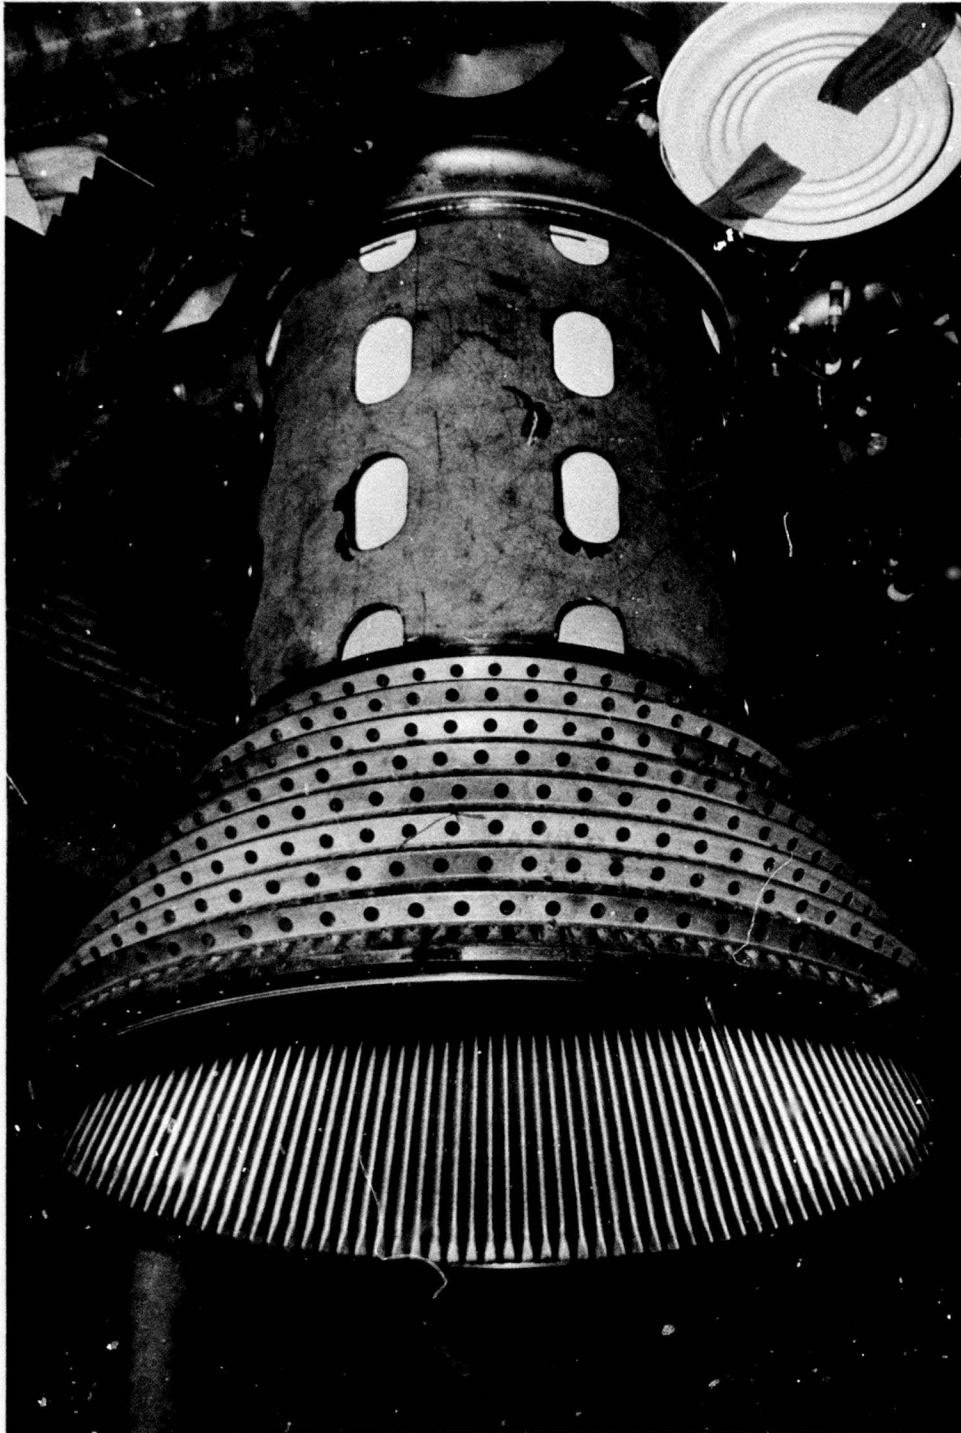
Figure 55 -- Chamber S/N 019 Prior to Start of Engine Demonstration

This unit had undergone considerable rework during fabrication; most notably, repair of the forward flange cover band which resulted in distortion to the flange that made remachining necessary. This chamber had therefore been withdrawn from the demonstration program but was substituted for chamber S/N 020 after Test No. -203.

Following Test No. -211, erosion was noted on the forward flange 2-in. above the joint with tube No. 64. The erosion was within the limits

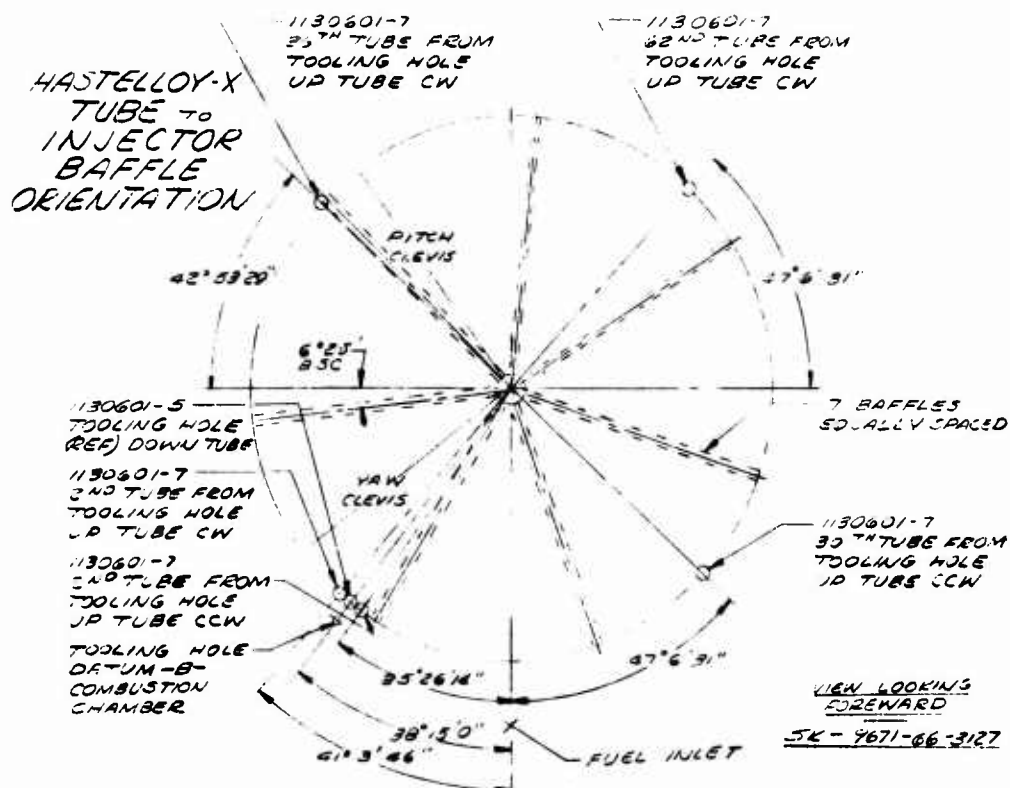
Figure 58 -- Location of Hastelloy Tubes in Chamber S/N 013

Figure 58 shows the location of Hastelloy-X tubes in the chamber relative to the injector mounting flange tooling hole.

This erosion occurred subsequently to the second braze cycle. Wax impressions were made of the eroded areas, bisected, and measured using an optical comparator. The depth of the erosion varied from tube to tube over a range of 0.005 in. to 0.020 in.

The eroded condition is attributed to the concentration of braze alloy which had been replaced in this area prior to the second braze cycle, coupled with the highest brazing temperature employed for the "A" revision braze alloy and the long duration of the braze cycle (30 minutes). The manganese-nickel binary equilibrium diagram shows a solid solution type diagram with a liquid phase occurring at 1840°F and 58 percent manganese. The reaction between the liquid manganese-base braze alloy with the nickel-base tube material at the brazing temperature resulted in the tube dissolution. The sixth tube did not erode because a tack weld joining the tube crown to the flange occupied this area.
