ROCKET ASSISTED PROJECTILE (RAP) DEVELOPMENT PROGRAM

Part 4. 5"/38 SAFETY TEST PROGRAM

ABSTRACT. The Safety Test Program for the 5-inch 38 caliber Rocket Assisted Projectile (5"/38 RAP) verified that RAP can be handled, stowed, and fired as safely as existing in-service projectiles loaded with Composition A-3 explosive. The presence of a solid-propellant rocket motor and percussion-actuated igniter did not present any unusual safety hazard. Sequential environmental, bullet impact, and slow and fast cookoff tests were conducted as required by WR-50 and MIL-R-23139. Optional and additional evaluations included rocket motor blast, adjacent detonation, propagation, ignition of unrestrained projectile, exposure to gun muzzle blast, gun-fired with clearing charge, and special igniter drop tests.

NAVAL WEAPONS CENTER
CHINA LAKE, CALIFORNIA * JANUARY 1970

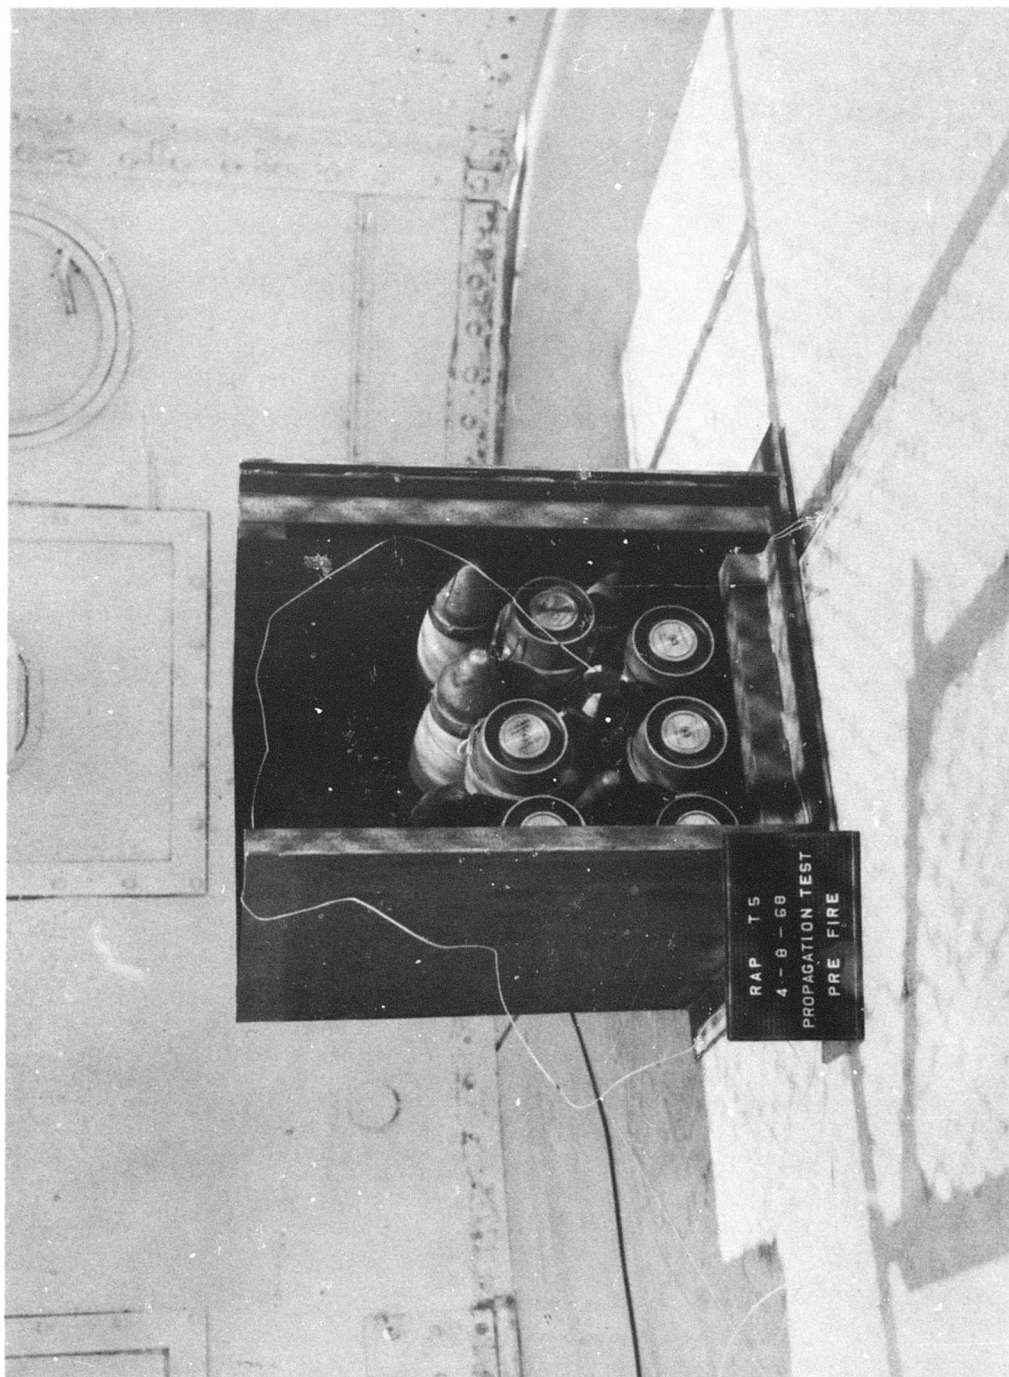
The 12 projectiles were then placed in the test fixture. Upon completion of loading, the fuze protector cap of projectile TM-12, the center projectile in the next to lowermost row, was removed and a 1-inch-diameter by 1-inch-long tetryl booster pellet and an HC-37 detonator placed in the fuze cavity. Figure 10 shows the arrangement of projectiles. The simulated steel batten was then set in place in the test fixture. Figure 11 shows the completed test setup. TM-12F was then detonated by applying a 117 vac pulse to the HC-37 detonator.

FIG. 10. Projectiles for Propagation Test Installed in Simulated Storage Bin. The detonator and booster charge are installed in the donor projectile (LHL 142887).

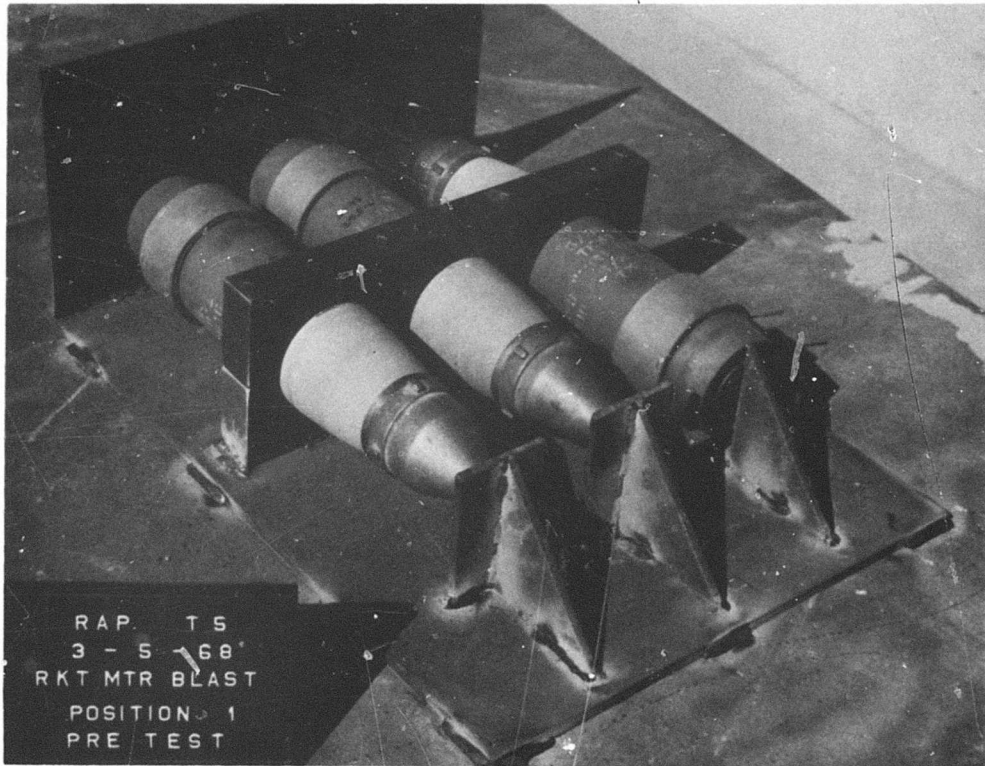
Test Position 1 was to simulate the effects of the flame impinging upon a standard batten or bulkhead in shipboard stowage and reflecting upon adjacent projectiles. Three all-up projectiles, TM-30F, TM-31F, and TM-34F, were utilized for this test. All projectiles were configured with a Mk 357 CVT Fuze and Adapter Assembly. The projectiles were placed in a three-place saddle block fixture welded to a fixed steel plate to prevent movement of the test fixture upon rocket motor ignition. Projectile TM-34F, the donor projectile, was placed in the center position with the base of the motor approximately 1 inch away from the deflector plate. The deflector plate was 1/4-inch mild steel. Projectile TM-30F, an acceptor projectile, was placed in the left outboard position with its base 1 inch from the deflector plate. Projectile TM-31F, also an acceptor, was placed in the right outboard position with the tip of the fuze protector cap 1 inch away from the deflector plate. The distance between the projectiles was 1 1/2 inches. Figure 13 shows the arrangement of projectiles.

FIG. 13. Setup for Rocket Motor Blast Test, Position 1. The donor projectile is in the center position (LHL 142821).

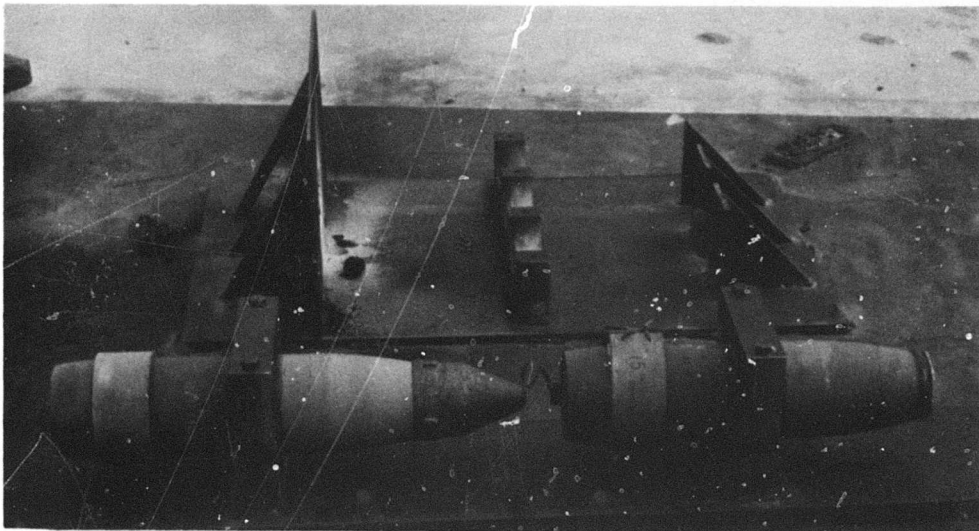
Test Position 2 was to simulate the effects of the rocket motor flame impinging directly upon the fuze of an adjacent projectile. Projectile TM-32F, the acceptor, was placed in the aft saddle block of a two-place tandem fixture welded to the steel plate. Projectile TM-35F, the donor, was secured in the forward saddle block with the base of the projectile 1 1/2 inches from the tip of the fuze protector cap of TM-32F (Fig. 14).

FIG. 14. Setup for Rocket Motor Blast Test, Position 2. The donor projectile is on the right (LHL 142827).

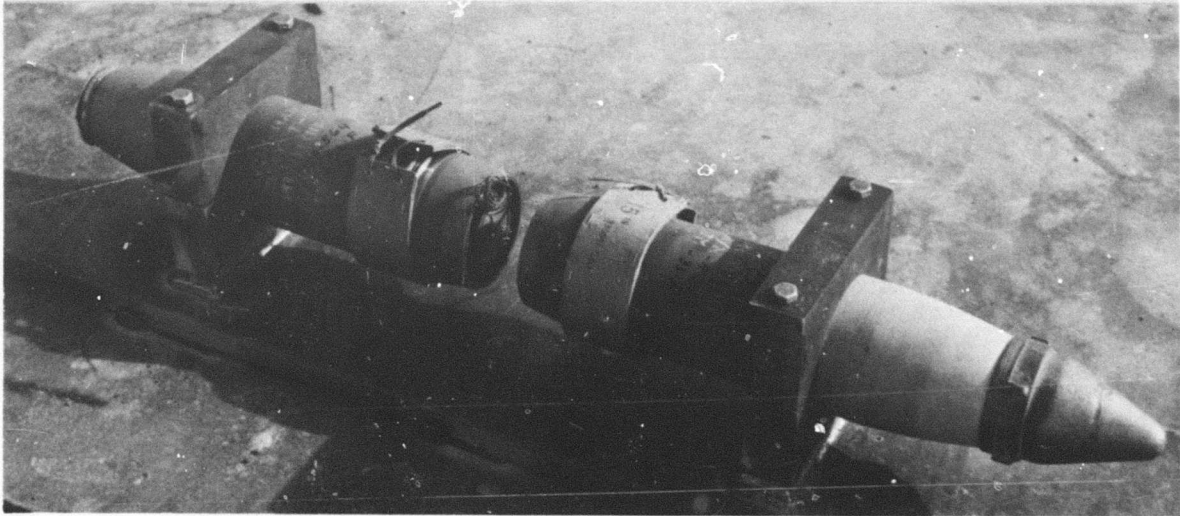
Test Position 3 was to simulate the effects of the rocket motor blast impinging upon the base of an adjacent projectile. Projectile TM-33F, the acceptor, was placed in the forward saddle block of a two-place tandem fixture and projectile TM-36F, the donor, placed in the aft saddle block (Fig. 15). The distance between the bases of the projectiles was 1 1/2 inches.

FIG. 15. Setup for Rocket Motor Blast Test, Position 3. The donor projectile is on the left (LHL 142820).

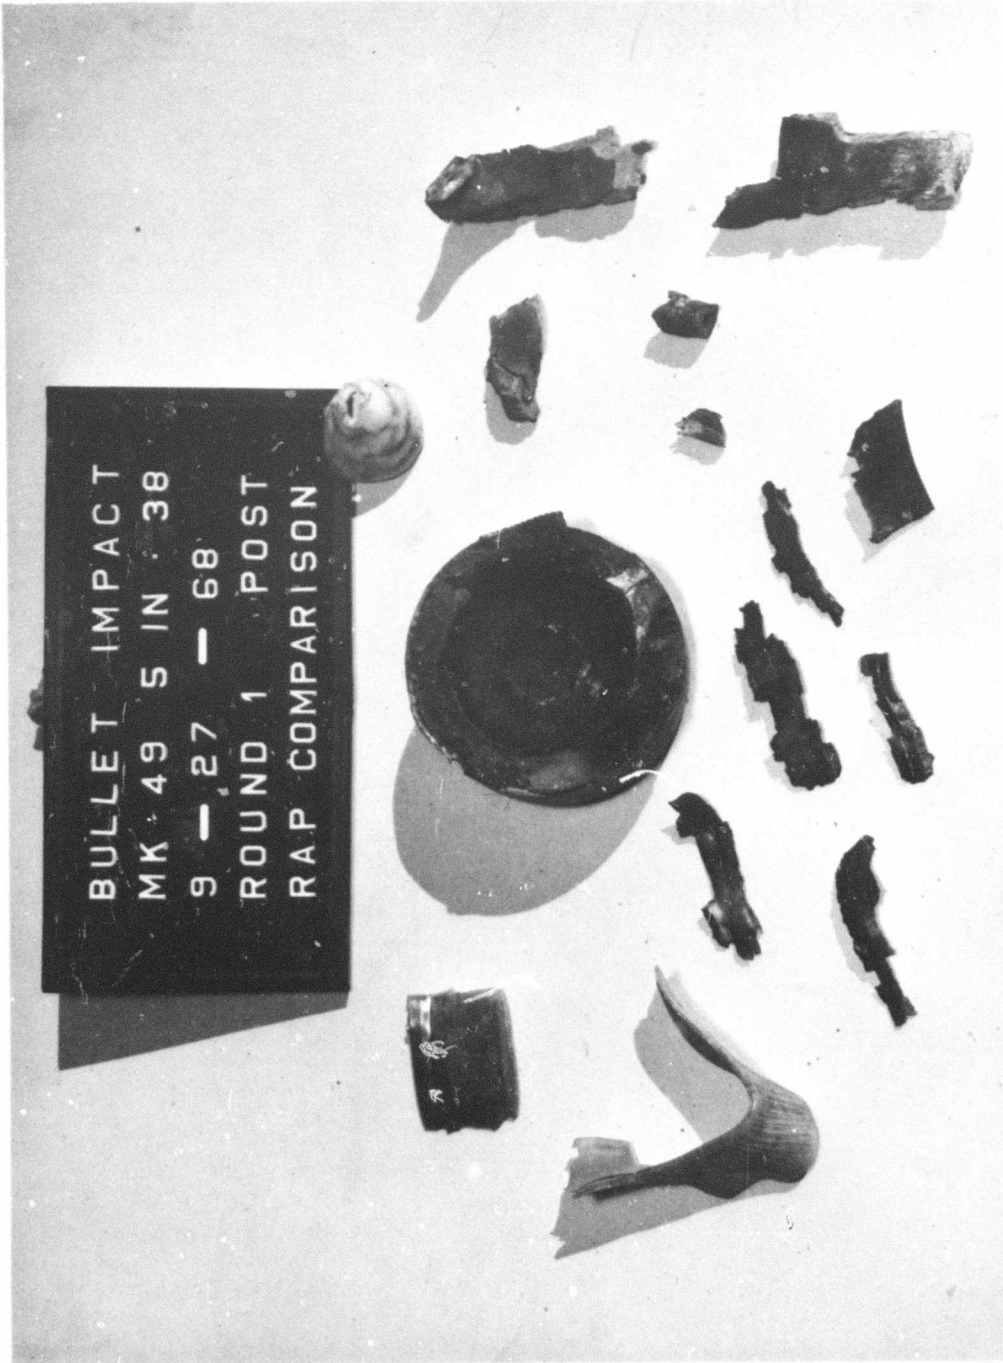
1. Smoke cloud and audible report at impact.
2. Projectile base still intact, 5 feet to the rear of stand.
3. Projectile fragments were scattered over an area of 55 yards radius from ground zero (Fig. 19).

1. 5"/38 projectile No. 1 suffered a low-order detonation.
2. 5"/38 projectile No. 2 suffered a deflagration.
3. 5"/38 projectiles No. 3 and 4 neither deflagrated nor detonated.
4. 5"/54 projectiles No. 5 through 8 suffered deflagrations.

FIG. 19. Recovered Fragments of Mk 49 Mod 1
5"/38 Projectile No. 1 (LHL 136354).
