**USAAVLABS TECHNICAL REPORT 70-71A**  
**ANALYSIS OF HELICOPTER STRUCTURAL CRASHWORTHINESS**  
**VOLUME I**

**MATHEMATICAL SIMULATION AND EXPERIMENTAL**  
**VERIFICATION FOR HELICOPTER CRASHWORTHINESS**

January 1971

**CONTRACT DAAJ02-69-C-0030**  
**DYNAMIC SCIENCE (THE AVSER FACILITY)**  
**A DIVISION OF MARSHALL INDUSTRIES**  
**PHOENIX, ARIZONA**

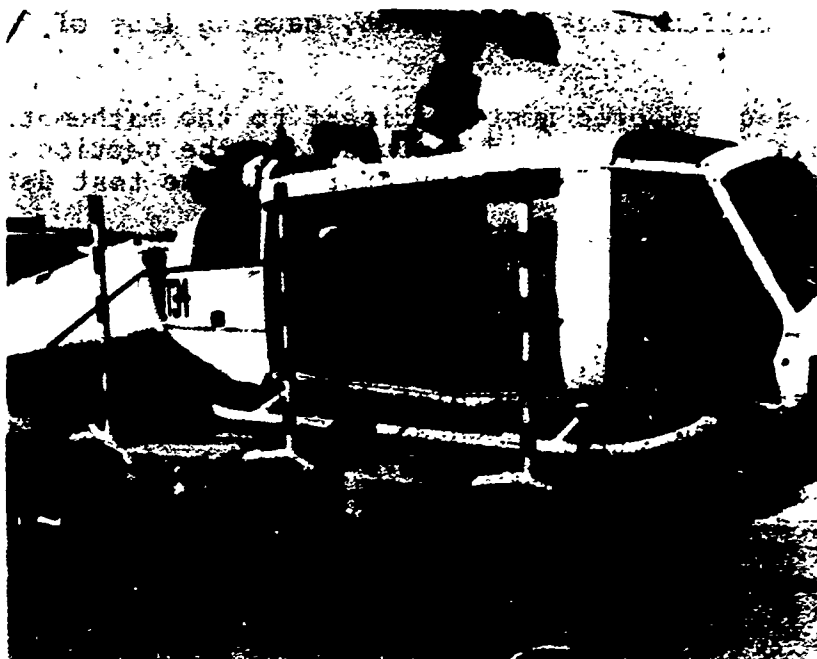
The landing gear cross tubes distorted outward and upward, permitting the fuselage to contact the concrete pad. The cross tubes did not fail but were permanently distorted, permitting the fuselage to rest on the concrete pad (Figure 58). The fuselage remained within 1 inch of the pad after all simulated fuel was drained from the tanks. The lowest point of the loaded fuselage prior to the drop was slightly over 14 inches.

Figure 58. Three-Quarter Posttest View.

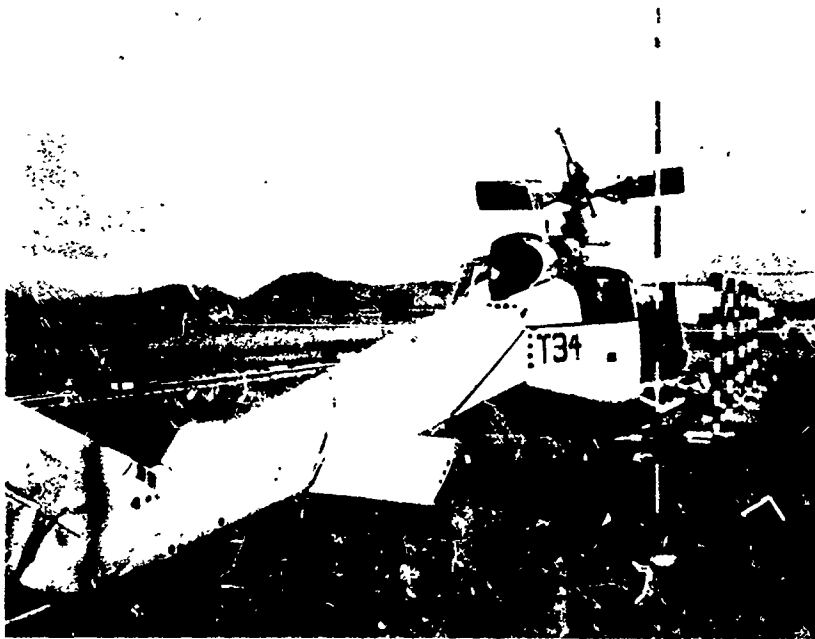
After the lower portion of the fuselage contacted the concrete pad, the tail boom continued downward, applying a moment to the fuselage. This tended to raise the front of the helicopter. The upper two tail boom attachment bolts then failed, permitting the tail boom to pivot about the lower attachment points. The end of the tail boom came to rest on the ground approximately 1 foot below the concrete surface (Figure 69).

Figure 69. Final Position of Tail Boom.

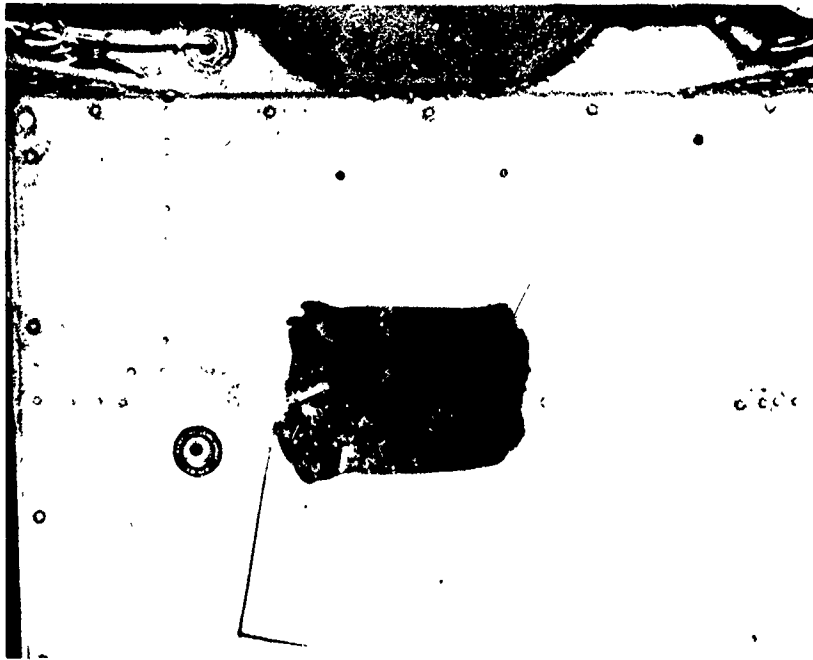
cargo area was held by only the two lower snaps following the impact (Figure 85; the two arrows indicate the two upper snap mount posts).

Figure 85. Posttest View of First-Aid Kit Installed in Rear of Cargo Compartment.

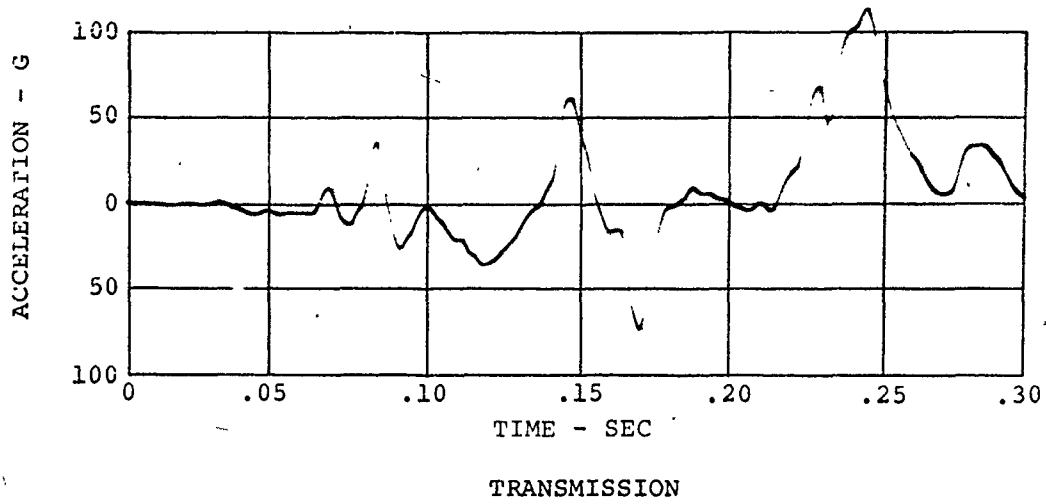
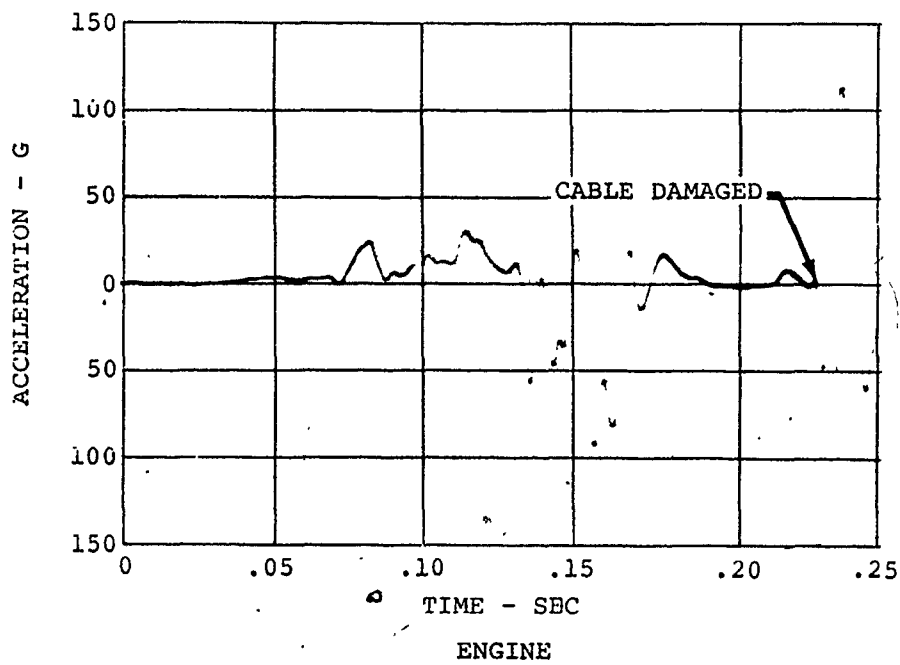
The area of least satisfactory correlation is the transmission. Figure 89 shows the acceleration-time history of the transmission. Failure of the front supports occurred at 0.13 second, causing the entire system to pivot forward about the rear supports and control linkage. This flailing action produced the usual acceleration response shown in Figure 89 - a delayed positive acceleration pulse occurs at approximately .240 second. The rotor support system programmed into the model was an approximate 8G vertical strength system, which did not permit the rotation and flailing action that occurred in the test. The computer simulation produced a total failure of the rotor support system, permitting the transmission and rotor to move vertically into the box structure of the aircraft fuselage. This total failure permitted increased deformation, and, consequently, a lower negative acceleration level of 43G compared to the test results of 70G. The nature of the failure of this rotor support system accounts for the large inconsistency of the test results and computer simulation.

Figure 89. Acceleration-Time Histories - Transmission and Engine.
