AIRCRAFT SHELTER EXPLOSIVES QUANTITY-DISTANCE EVALUATION, CONCRETE SKY, PHASE IXB

TECHNICAL REPORT NO. AFWL-TR-71-65

July 1971

AIR FORCE WEAPONS LABORATORY
Air Force Systems Command
Kirtland Air Force Base
New Mexico

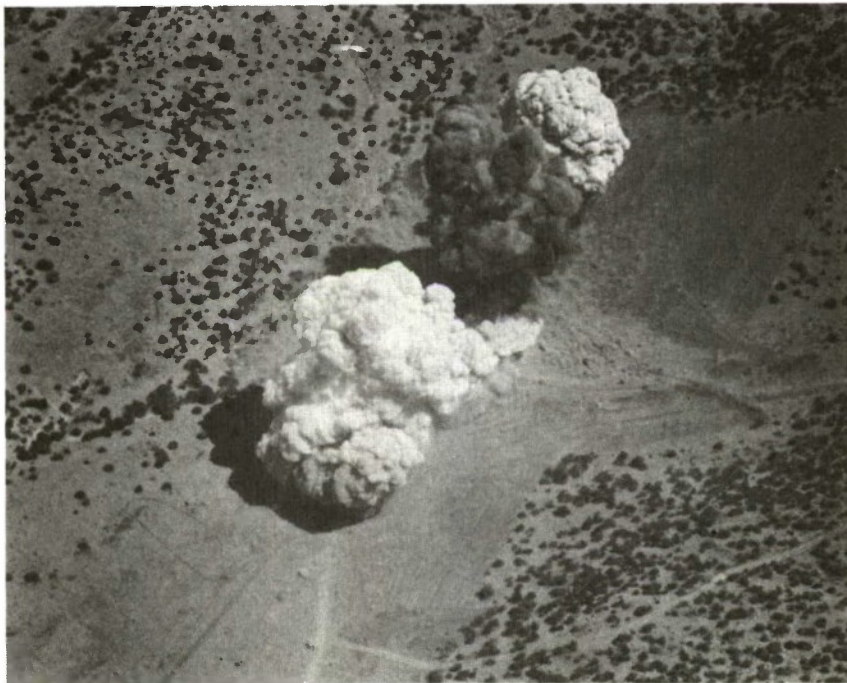
Figure 10. Aerial View of Detonation

Detonation of the munitions in the donor shelter and subsequent rupturing of the fuel tanks on the donor aircraft and explosion of the fuel resulted in large fireballs approximately 400 feet long, which jetted out the front and back of the donor shelter (figure 10). After the smoke and fireball lifted, it was immediately revealed that the two acceptor shelters were still standing; hence no propagation of the explosion occurred. The following paragraphs in this section describe the failure of the donor shelter, damage to acceptor aircraft and shelters, fragment data, and pressure data.

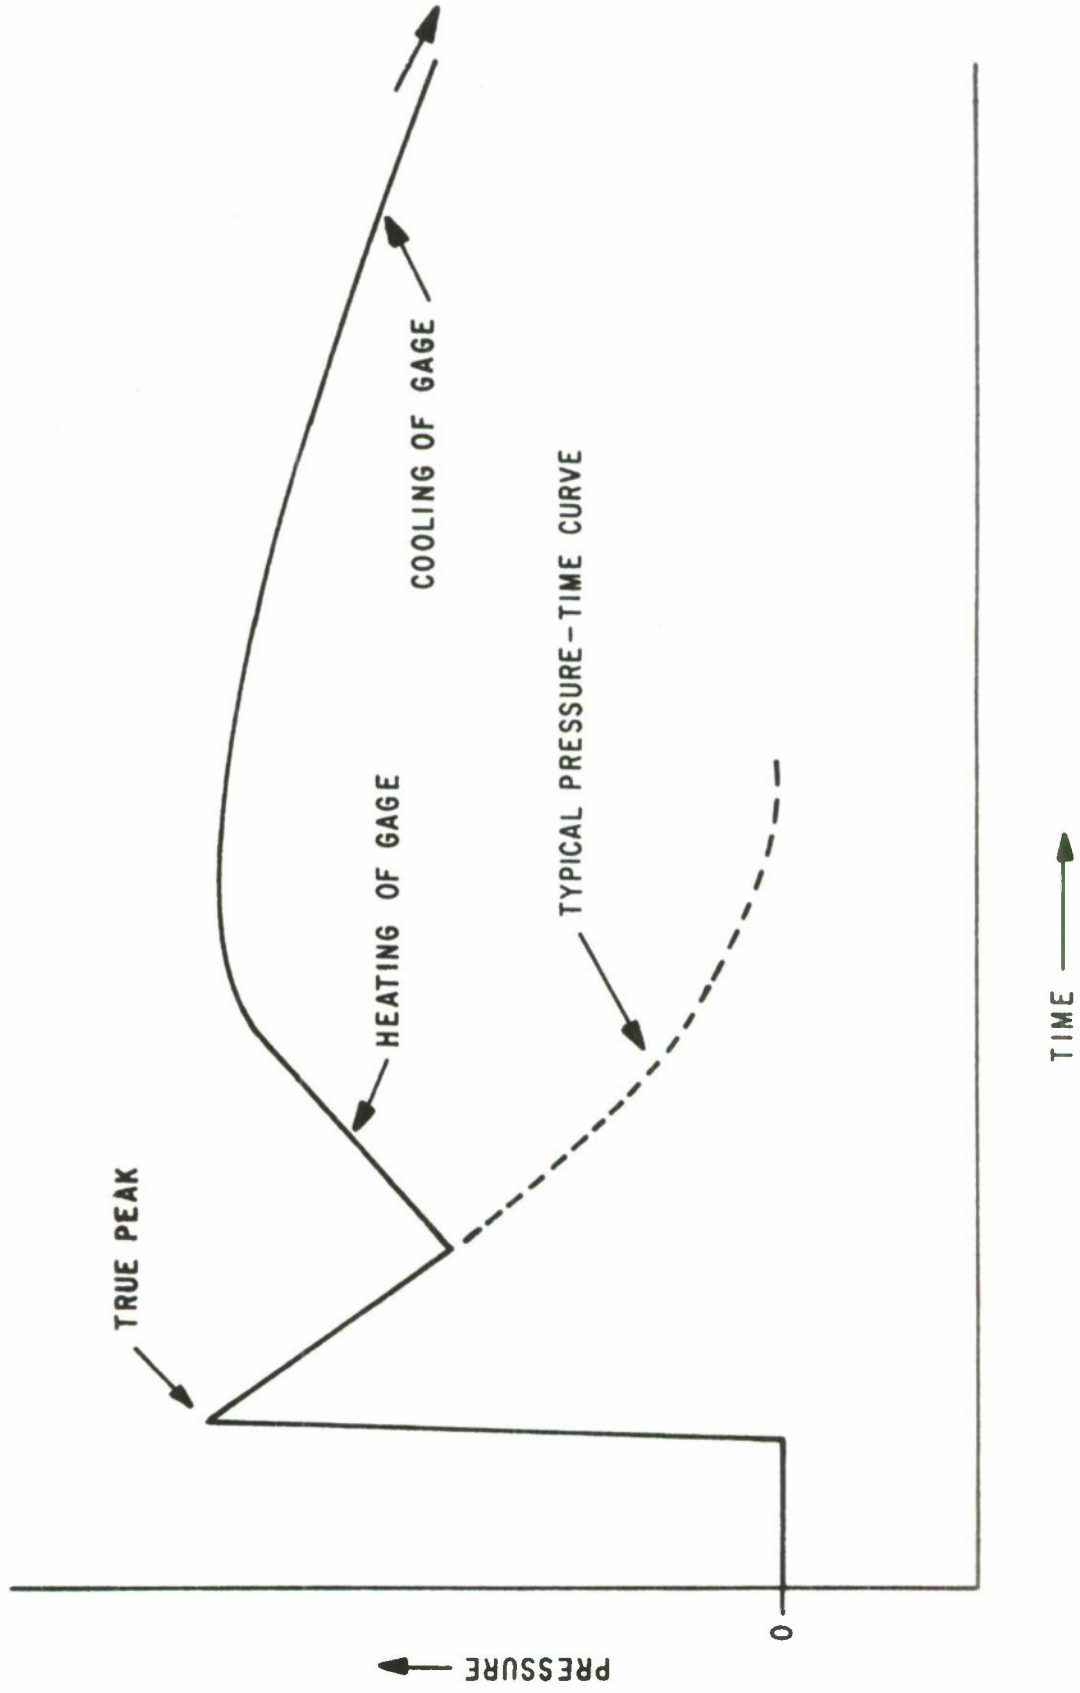
Figure 21. Schematic Representation of Data from Norwood Gages

Free-field gage 13 and in-shelter gages 1, 2, 5, 6, 7, 11, and 12 exhibited behavior that was considered nontypical and probably at least partially erroneous. Rather than a triangular pulse (discounting reflections), these gages produced data traces with several distinct regions. After an initial peak and the beginning of a normal fall-off, the pressure began to rise toward a second peak. This is followed by a long gradual decay back to ambient pressure. This is shown schematically in figure 21. It is felt that the initial peaks were representative of the true peak pressures at the corresponding locations. The second peak and long-duration decline to ambient pressure apparently were caused by rapid heating and subsequent cooling of the pressure gages after passage of the initial shock wave. All gages that displayed this effect were of the same type and model number, and were calibrated by the manufacturer to be linear in the temperature range from -65° to $+300^{\circ}$ Fahrenheit. These gages were all very close to the firball (gage 13 was engulfed by it) and were exposed to extreme temperatures. No data was available from the manufacturer to indicate the effect of such temperatures, but it is presumed that heat was the cause of the unusual shape of the pressure curves for these gages. Further, the diaphragm on this model gage was mounted flush on the surface of the instrument in a more exposed position than the remaining gages which had recessed diaphragms.
