# **UH-1N INSTRUMENT FLIGHT, TURBULENCE, AND ICING TESTS**

**TECHNICAL REPORT No. 71-9**

**MARCH 1971**

**AIR FORCE FLIGHT TEST CENTER  
EDWARDS AIR FORCE BASE, CALIFORNIA  
AIR FORCE SYSTEMS COMMAND  
UNITED STATES AIR FORCE**

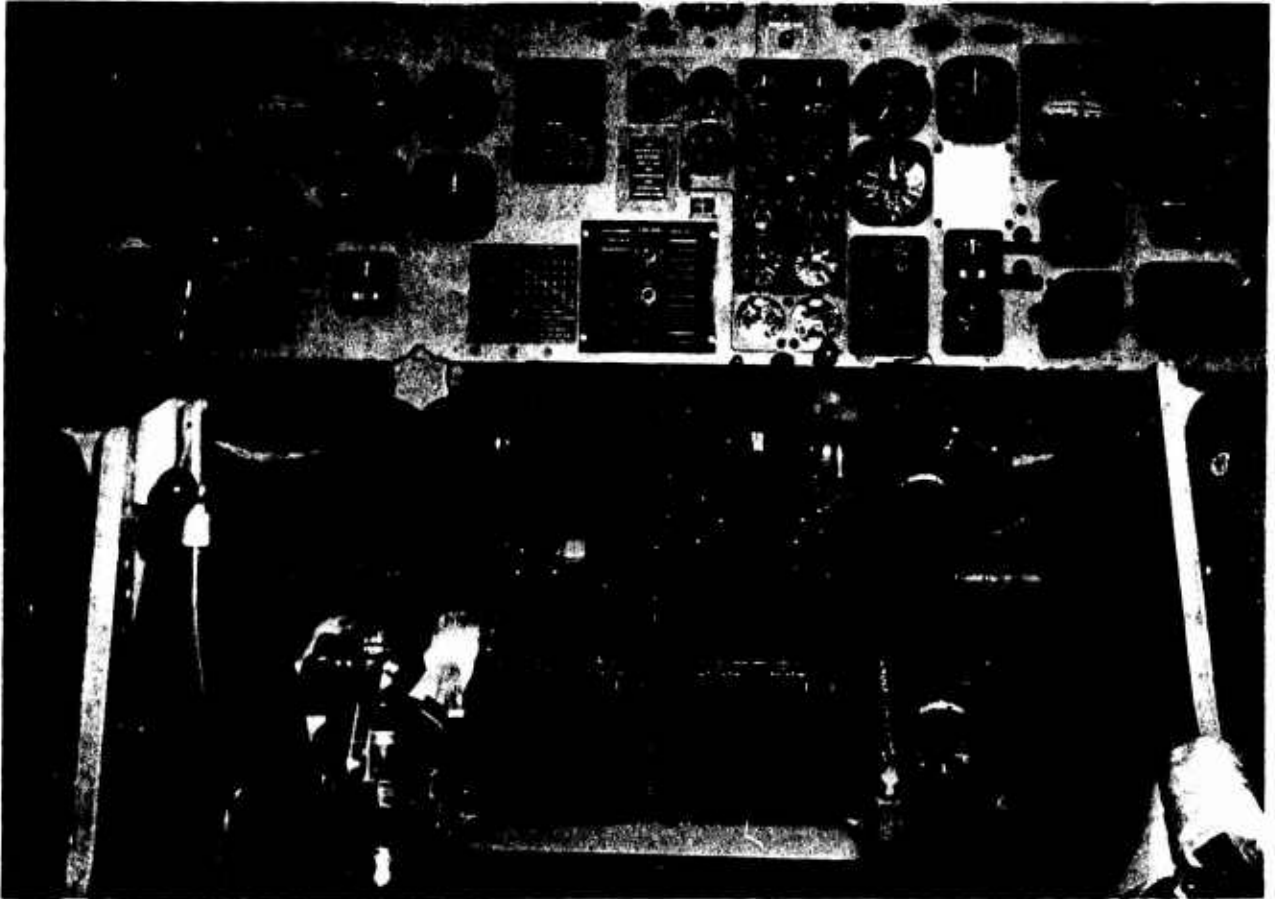
**Figure 1 UH-1N Instrument Panels**

In summary, the UH-1N was less unstable and therefore more comfortable to fly in actual weather conditions than previous models of the UH-1 helicopter. This improved stability, combined with an adequate display of basic flight instruments and navigational aids (figure 1), allows a pilot to fly safely in actual instrument weather conditions. However, because of the increased workload, basic instability, and vertigo inducing vibrations associated with all helicopters, two pilots are recommended for IFR flights.

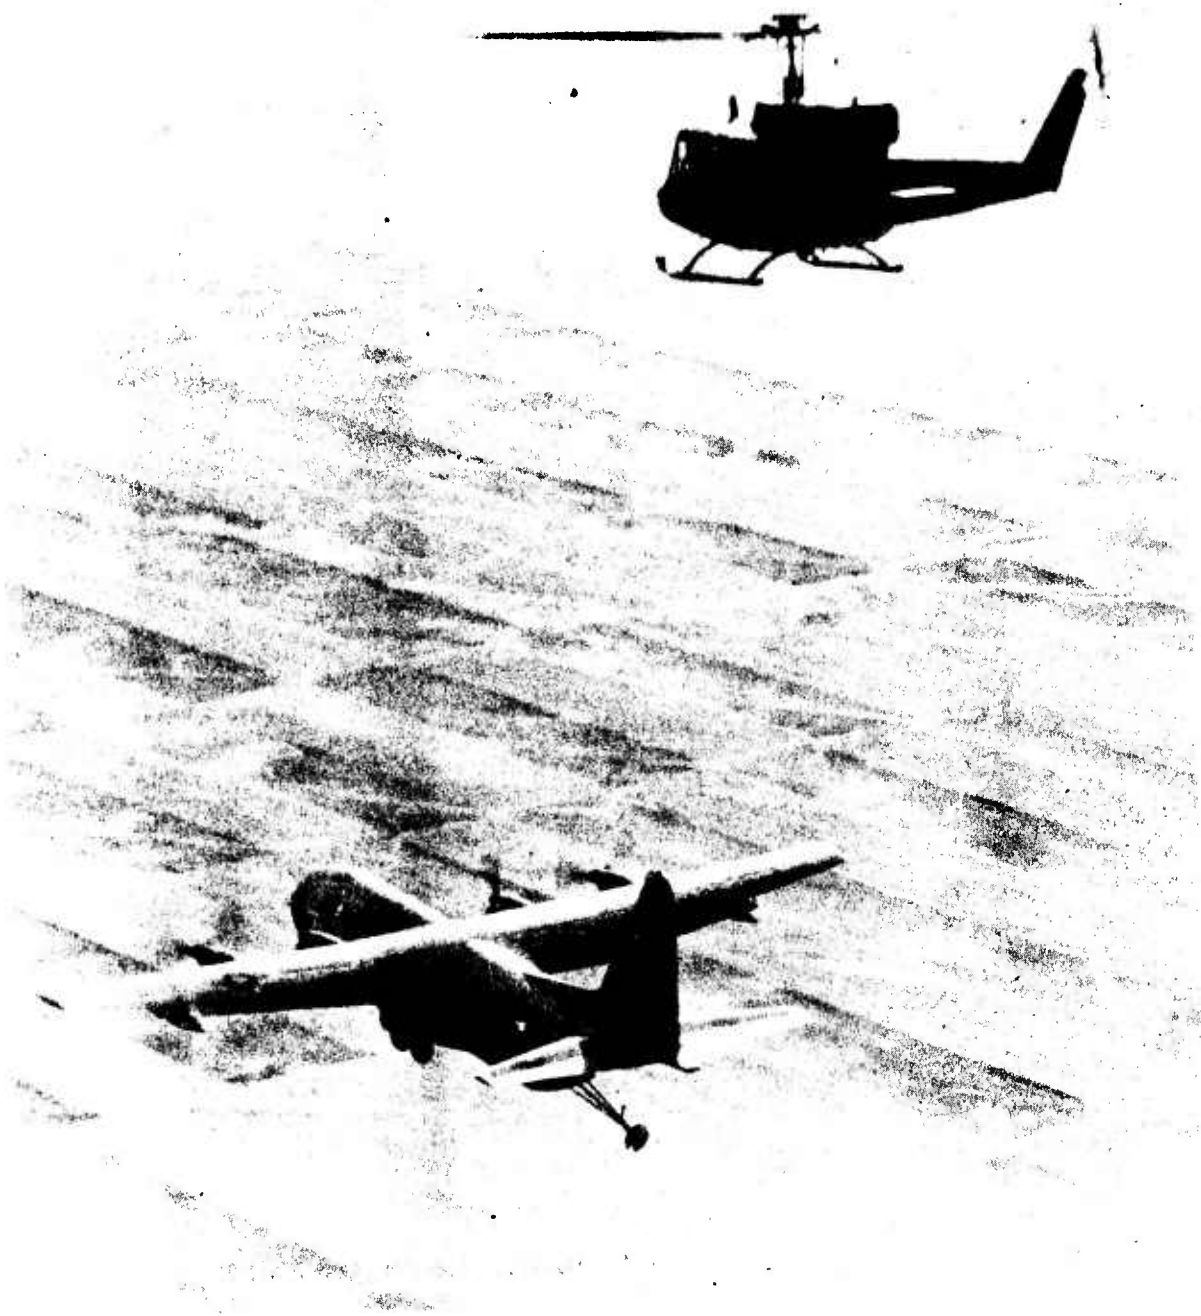
**Figure 4 Rendezvous of C-130 Water Spray Aircraft and UH-1N**

The UH-1N test helicopter, the chase helicopter (UH-1F), and C-130 spray tanker rendezvoused over a predetermined area 18 miles north of MAFB, Montana (figure 4). Testing was conducted between 5,500 feet and 9,500 feet pressure altitude with freezing temperatures at the surface. Trace, light, and moderate conditions of clear and rime icing were evaluated (appendix III). The UH-1N was iced enroute to MAFB, over barren, sparsely populated terrain. After being iced, the UH-1N landed at MAFB to have photographs taken, ice accretion evaluated, and ice removed. Table IV lists test points. The test helicopter then rendezvoused with the C-130 to continue testing. For all test points, the UH-1N weighed approximately 8,200 pounds.
