Technical Memorandum

DREA TM 2000-022

January 2000

**FLIGHT DECK REFUELLING HOSE FAILURE
HMCS PRESERVER**

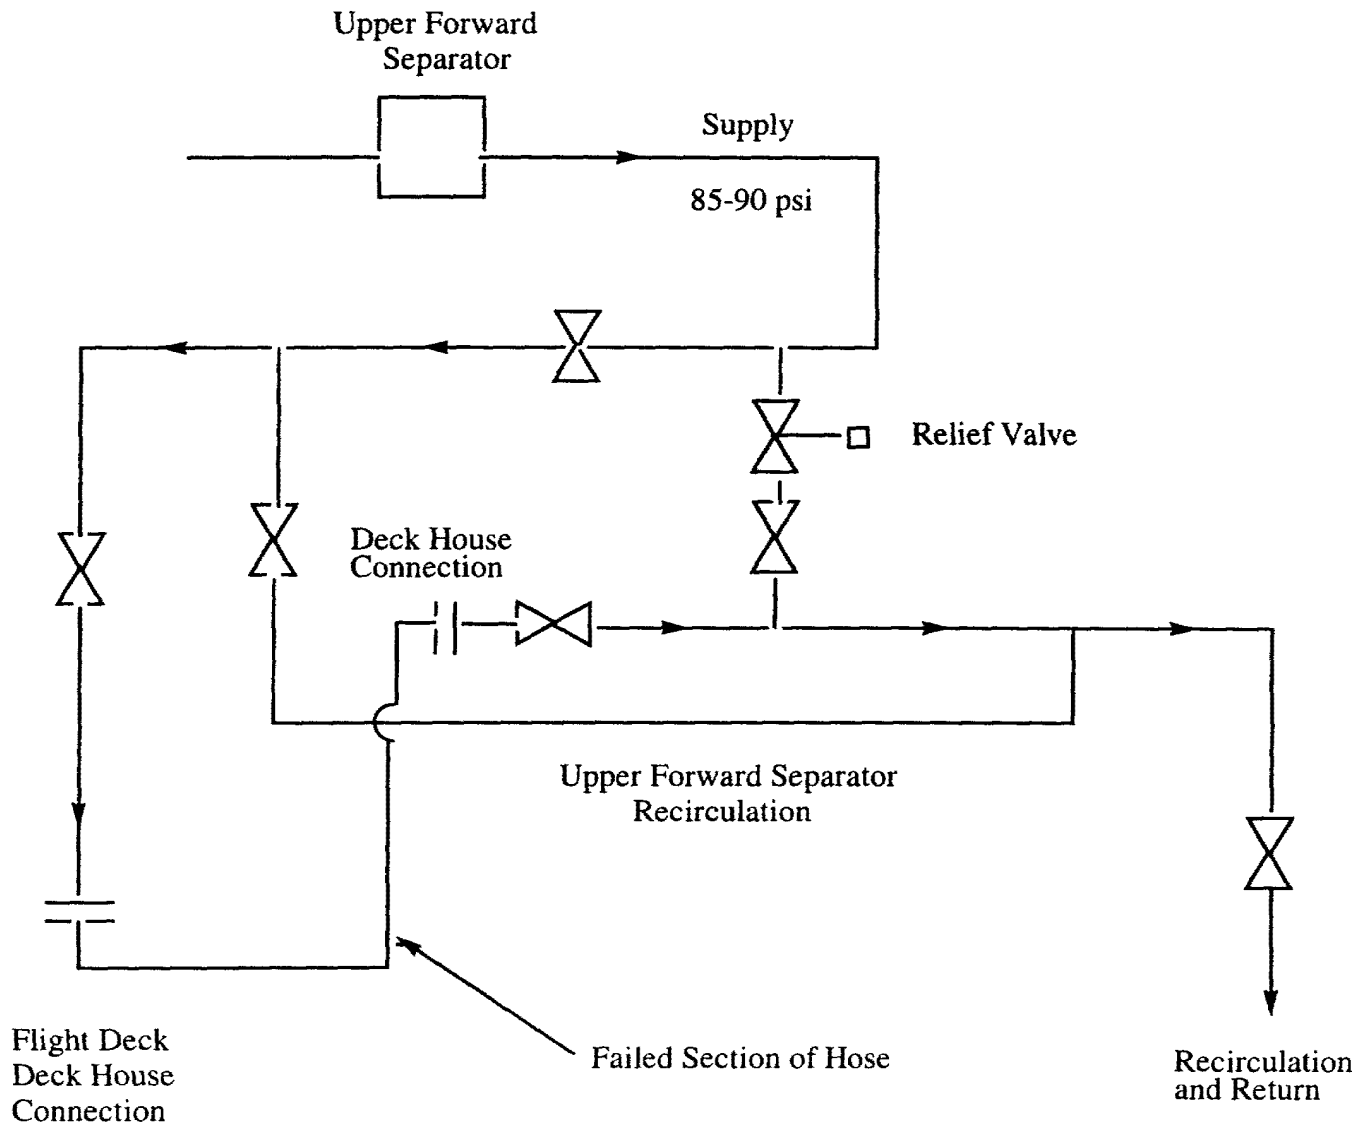
Figure 1 - Diagram of the flight deck aviation fuel delivery system HMCS Preserver.

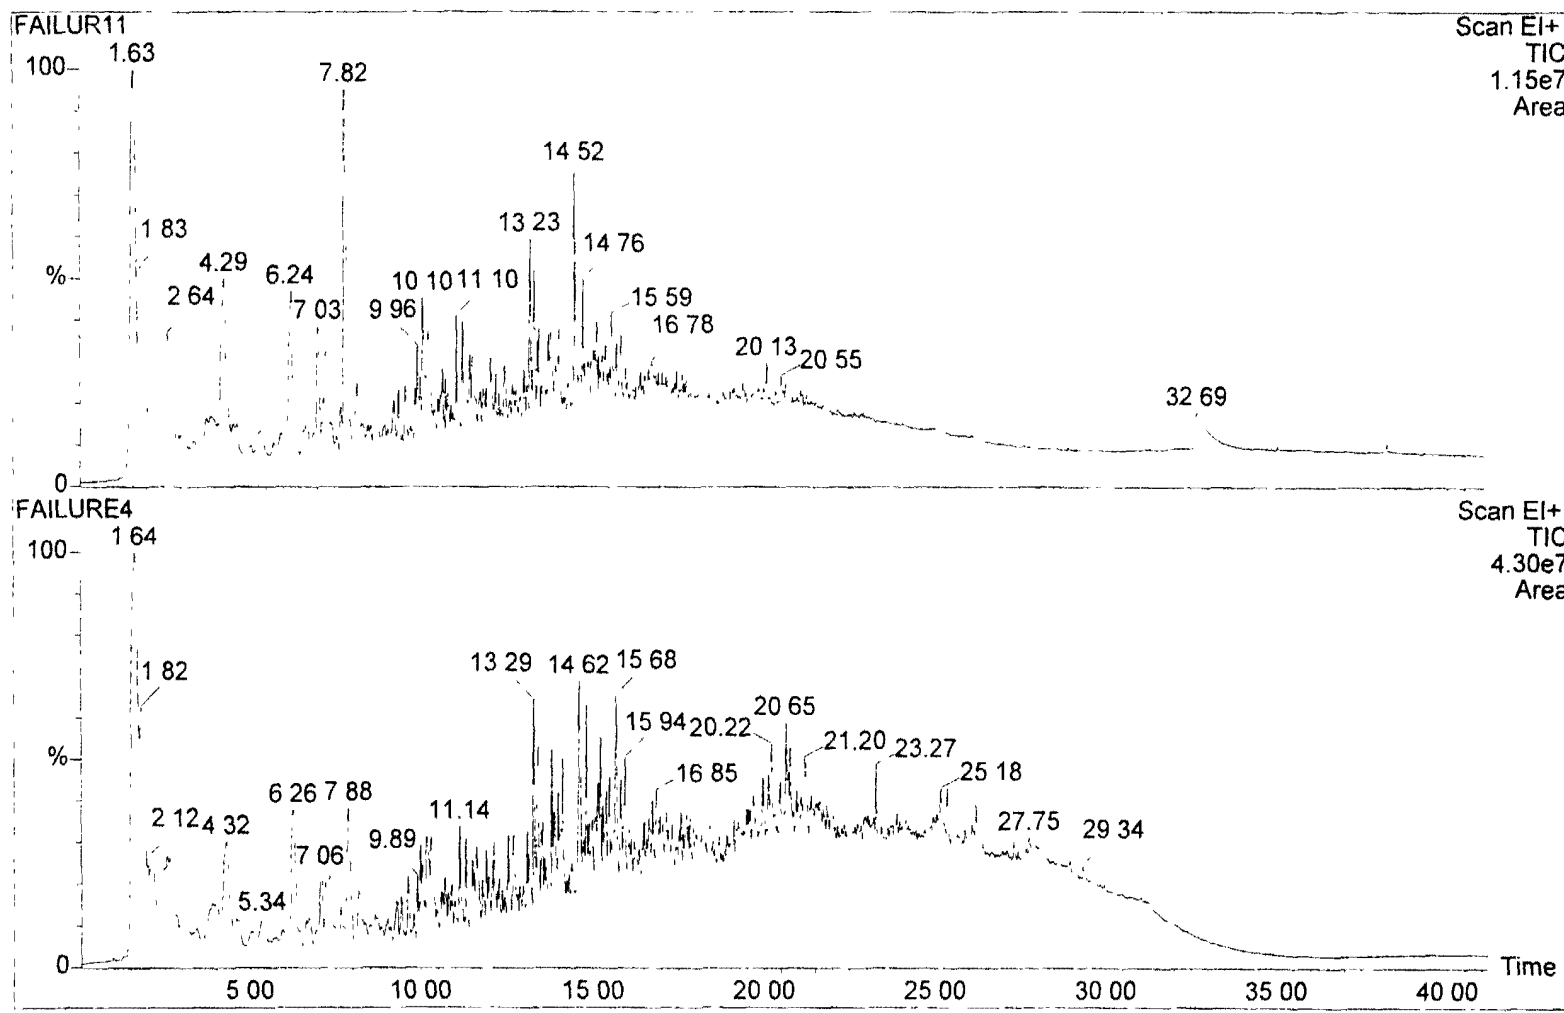
Figure 7 – Pyrograms of the outer rubber cover from a) an unused length and b) the failed length of Titan MIL-H-6615E batch SPO770-98-MYN62 refueling hose.

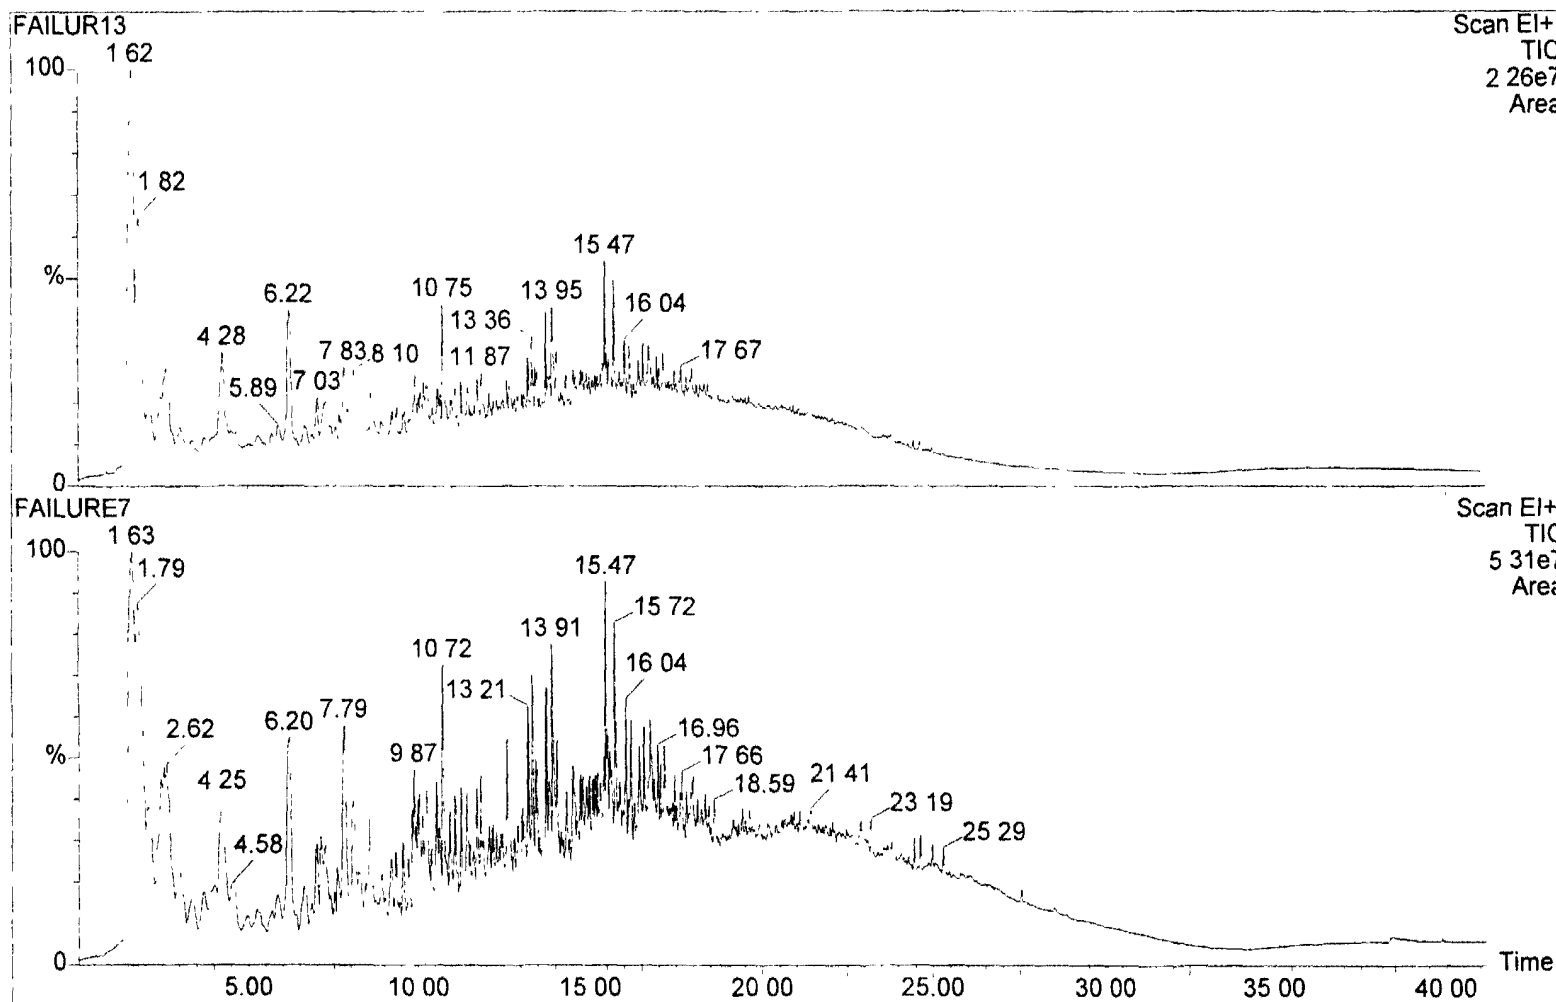
Figure 8 - Pyrograms of the inner rubber tube from a) an unused length and b) the failed length of Titan MIL-H-6615E batch SPO770-98-MYN62 refueling hose.

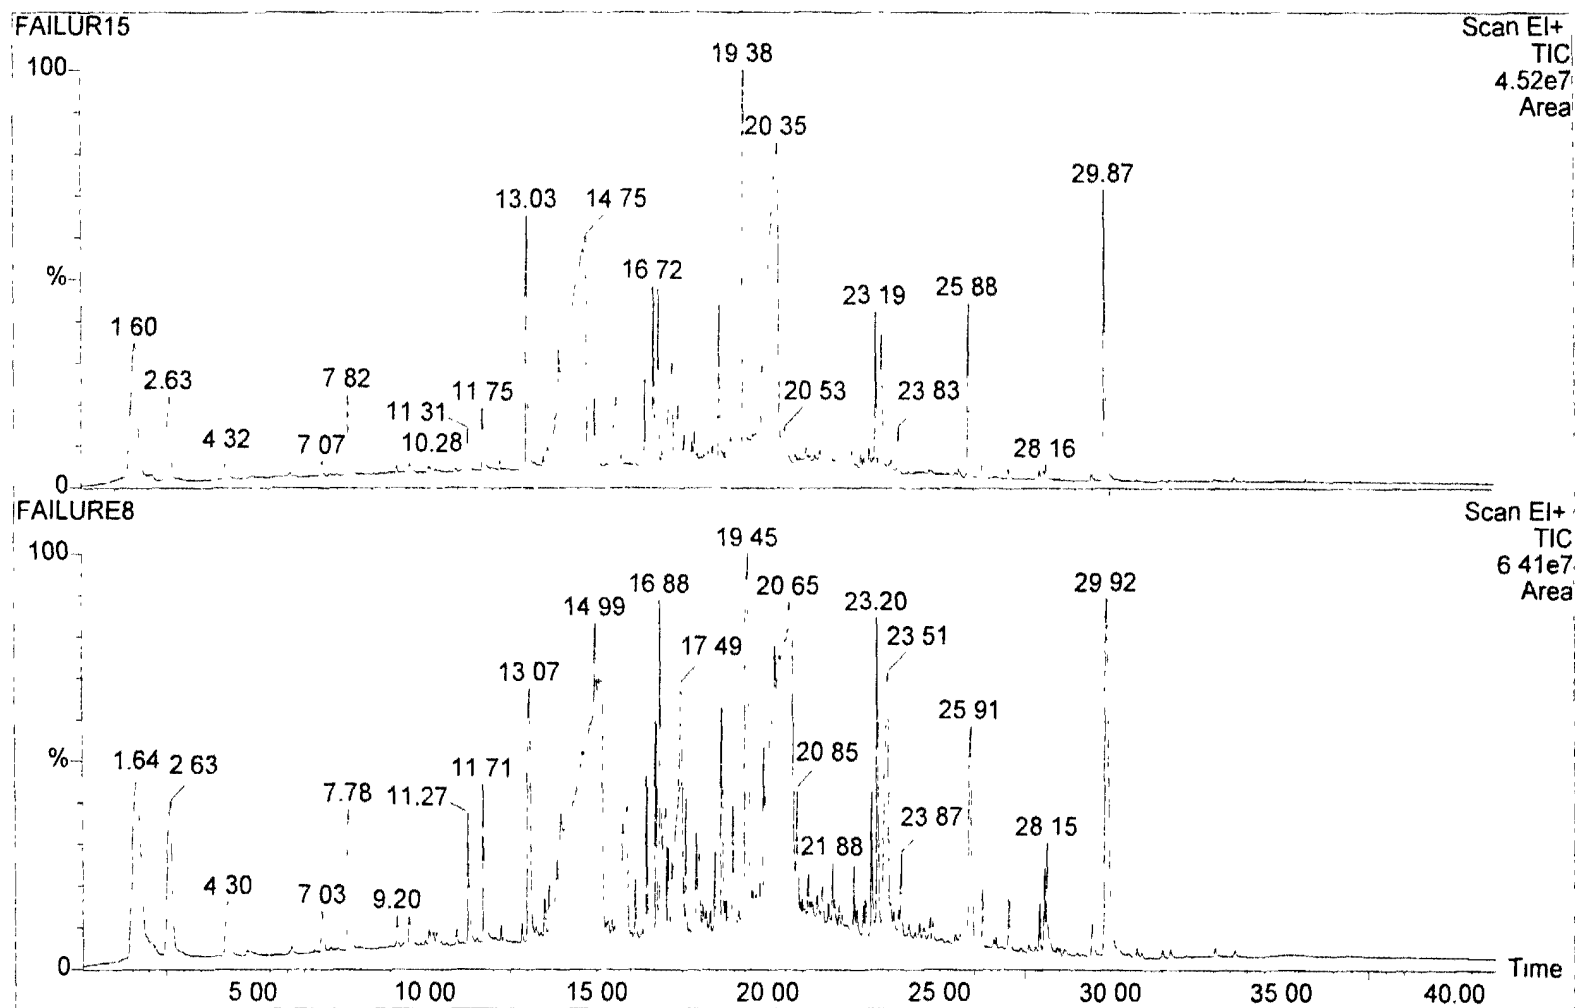
Figure 9 - Pyrograms of the reinforcing fibre from a) an unused length and b) the failed length of Titan MIL-H-6615E batch SPO770-98-MYN62 refueling hose.

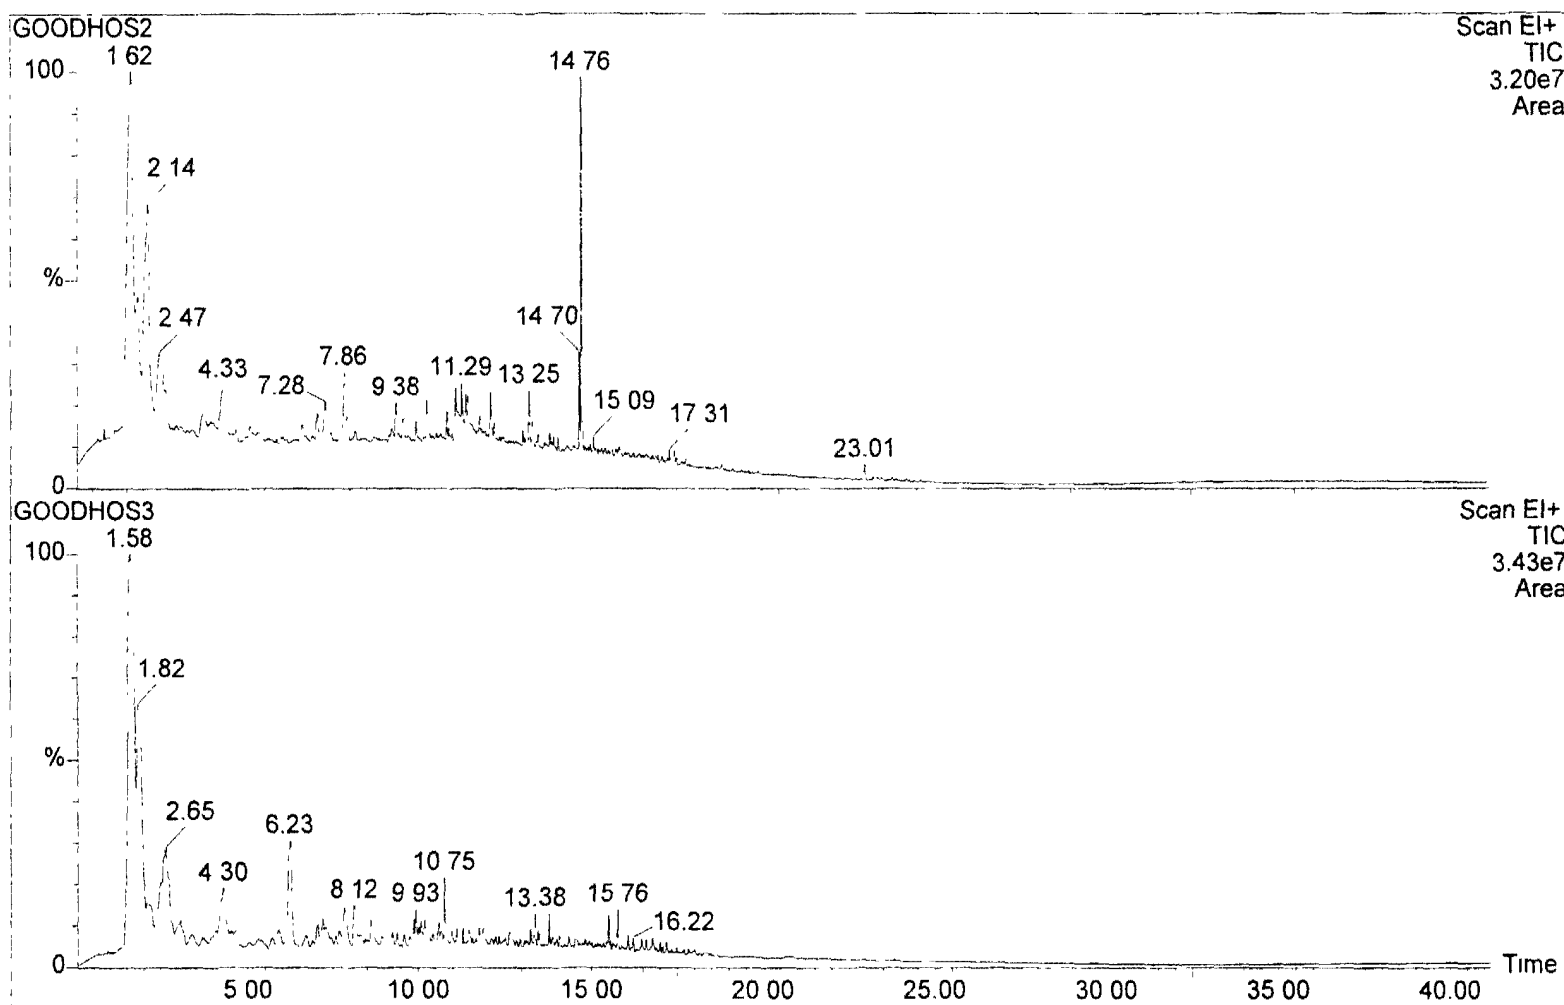
Figure 10 - Pyrograms of the outer cover and inner tube of the 'German' hose.

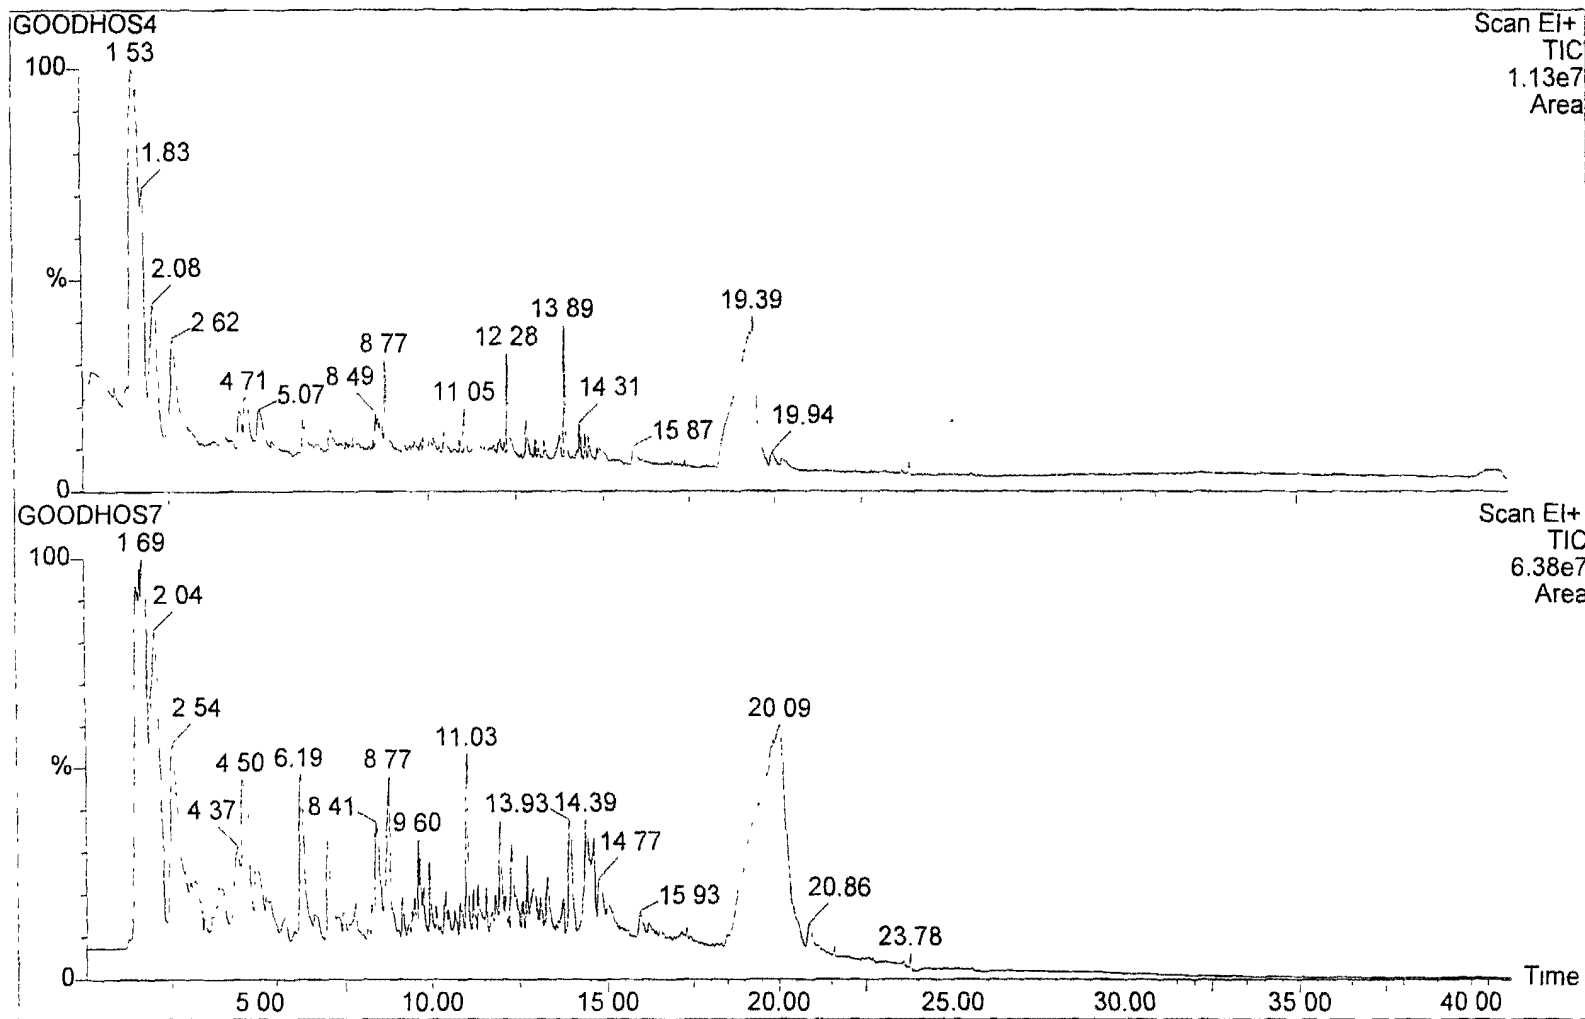
Figure 11 - Pyrograms of a) the reinforcing fibres from the 'German' hose and b) a sample of cotton.

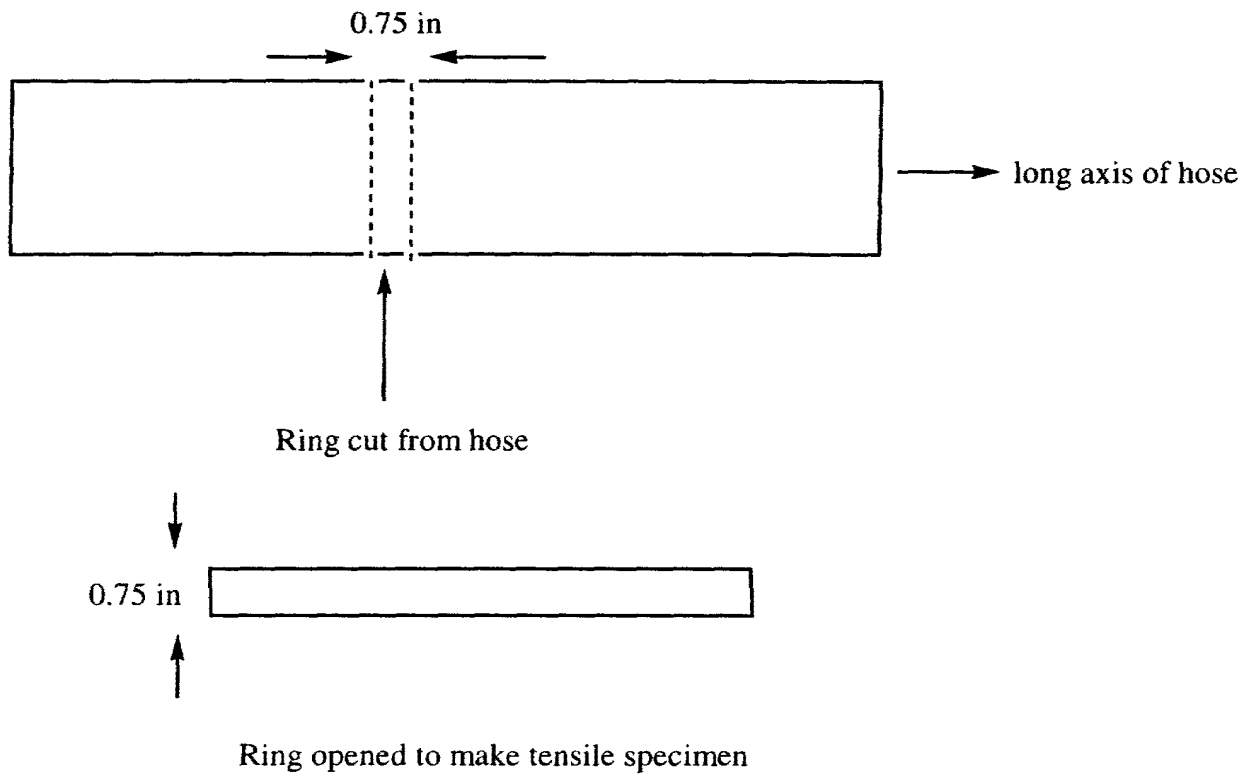
Figure 13 - Diagram showing preparation of tensile test specimens from hose samples.

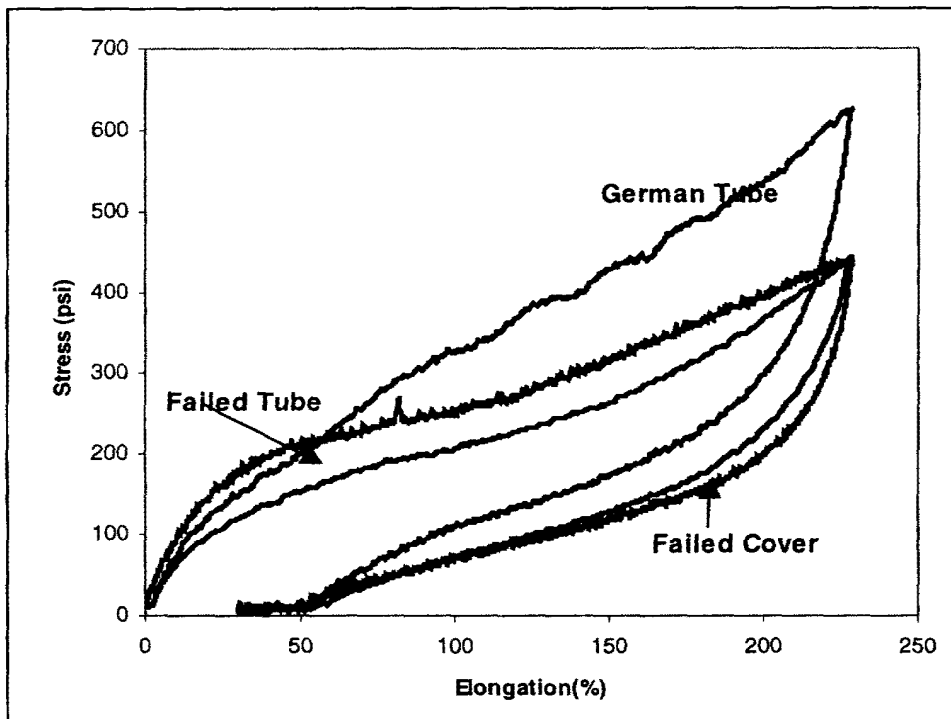
Plots of stress versus elongation for tensile specimens taken from the outer cover and inner tube of the Titan hose, and the inner tube of the German hose are shown in Figure 15. The slopes of the stress versus strain plots indicate that the inner tube from the German hose has a slightly larger modulus of elasticity than the inner tube of the failed hose. The German inner tube reached a stress of 630 psi at 230% elongation while the inner tube and outer cover of the failed hose reached stresses of 440 psi at 230% elongation.

Figure 15. Plots of stress versus elongation for tensile specimens from the outer cover and inner tube of the Titan hose, and the inner tube of the German hose.

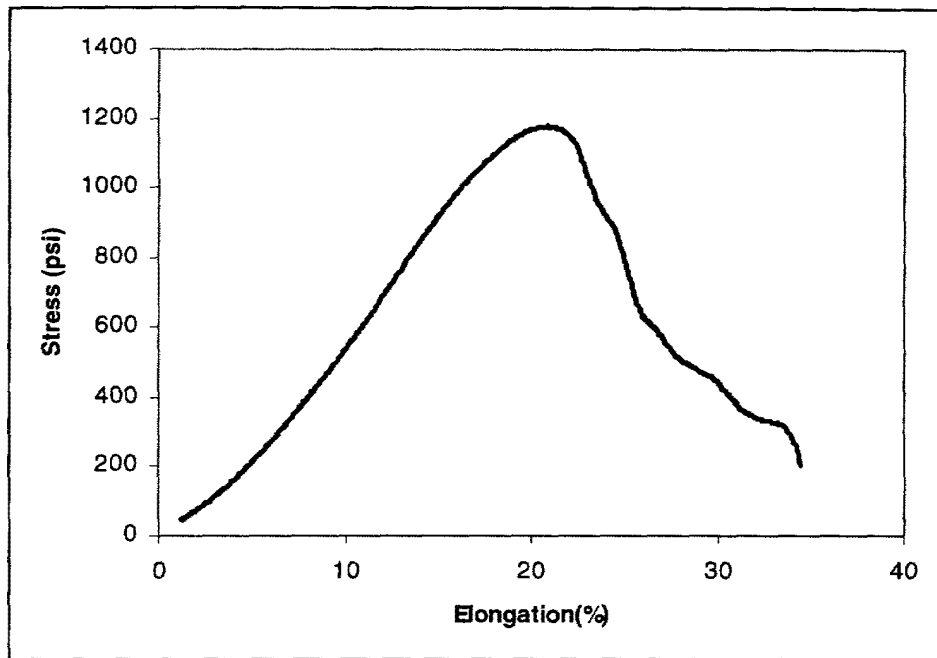
The tensile test result for the outer cover of the German hose is shown in Figure 16. This was plotted separately because it was not possible to separate the outer layer of reinforcing fibres from the outer cover. It can be seen in Figure 16 that the reinforcing fibres had a significant effect on the performance of the sample, i.e., the maximum stress increased to 1200 psi and the sample failed at 34% elongation.

Figure 16. Plot of stress versus elongation for tensile specimen from the outer cover of the German hose. This sample had the outer layer of reinforcing material attached.
