SIO Shipyard Representative Bi-Weekly Progress Report

Project: AGOR 28	Contract No.: N00014-12-C-0305	Shipyard: Dakota Creek Industries
Prepared by: Paul D. Bueren Scripps Institution of Oceanography (SIO) 297 Rosecrans St. San Diego, CA 98106	Date: 24 March 2016	Program Officer: Robert (Tim) Schnoor Office of Naval Research 875 Randolph St ONR 321 Arlington, VA 22203-1995
Distribution Statement A: Approved for public release; distribution unlimited.		Report No. A002.096

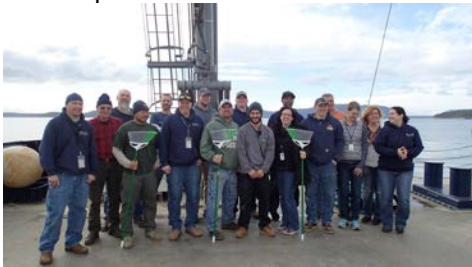
- AT completed!

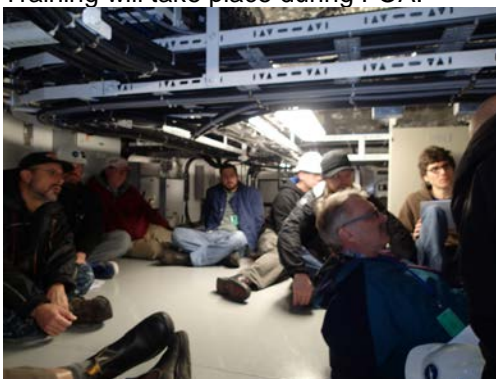
- **Crew Fam** – All complete except for 2-days of Mackey training as they failed to show up. Training will take place during FOA.

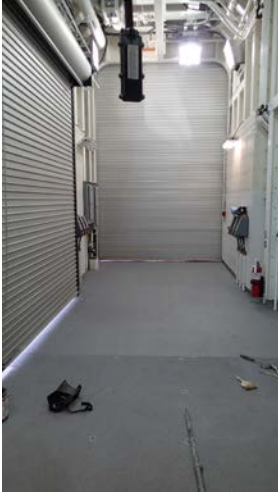
- Phase III Preparations Underway –
 - Overheads in way of HiPap have been taken down.
 - Owner furnished equipment from Kongsberg and SIO scheduled for delivery next week.
 - DCI is running cables for Sea Chest Anti-Fouling System. Provided assistance in locating associated panels and j-boxes.
 - SIO providing assistance and clarifications on a daily basis.
- Deck Preservation – Exterior painting in continues, weather permitting.
