SIO Shipyard Representative Bi-Weekly Progress Report		
Project: AGOR 28	Contract No.: N00014-12-C-0305	Shipyard: Dakota Creek Industries
Prepared by: Paul D. Bueren Scripps Institution of Oceanography (SIO) 297 Rosecrans St. San Diego, CA 98106	Date: 18 May 2016	Program Officer: Robert (Tim) Schnoor Office of Naval Research 875 Randolph St ONR 321 Arlington, VA 22203-1995
Distribution Statement A: Approved for public release; distribution unlimited.		Report No. A002.099

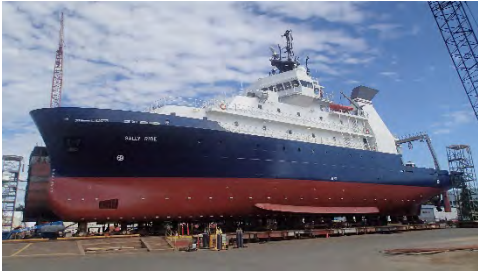
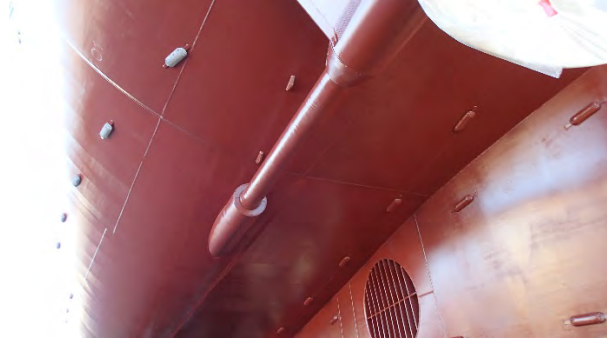
- Underwater Coating – Failed areas prepped, primed and two coats of AF applied. Entire underwater hull received one coat of red AF. All markings painted in white. One coat AF to all transducers except for the three ADCP windows.

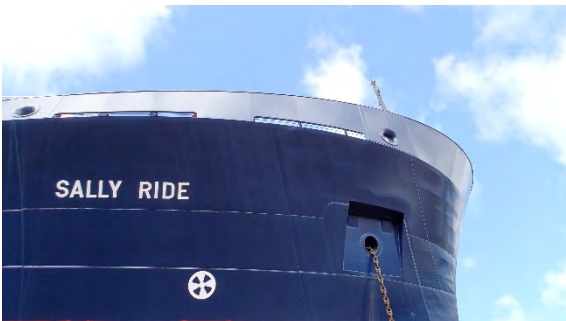
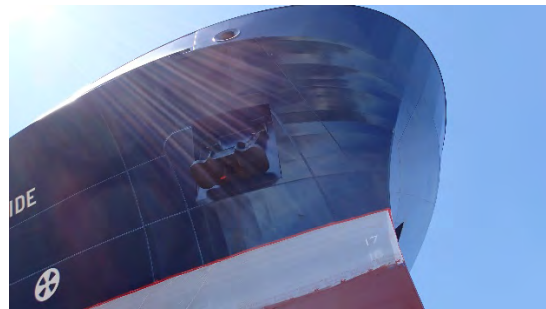
- Uncontaminated Sea Chest – Work completed. Welds and piping inspected and tested.
- Anchor Pocket Shims – Work completed and anchors shipped.

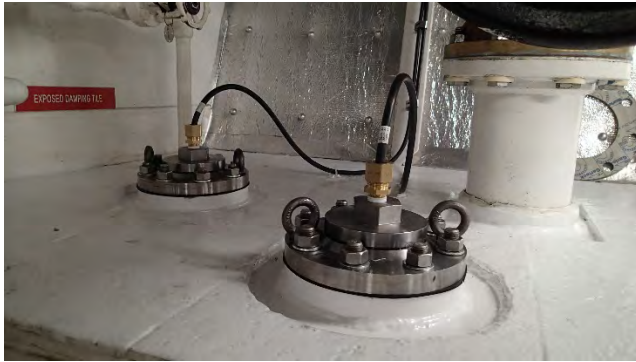
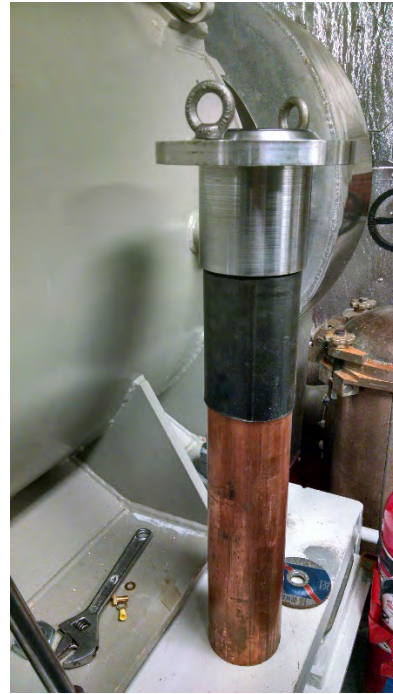
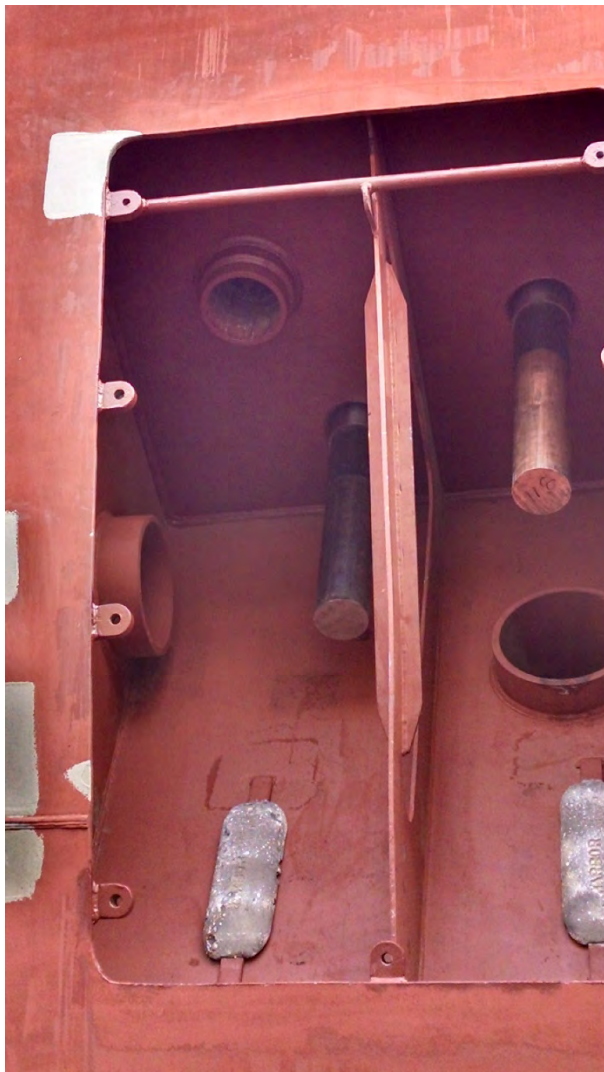
- Anti-Fouling System – DCI installed the controls and anodes for the Port, Starboard and Fire Pump sea chests. All penetrations and welds inspected and tested with ABS in attendance.

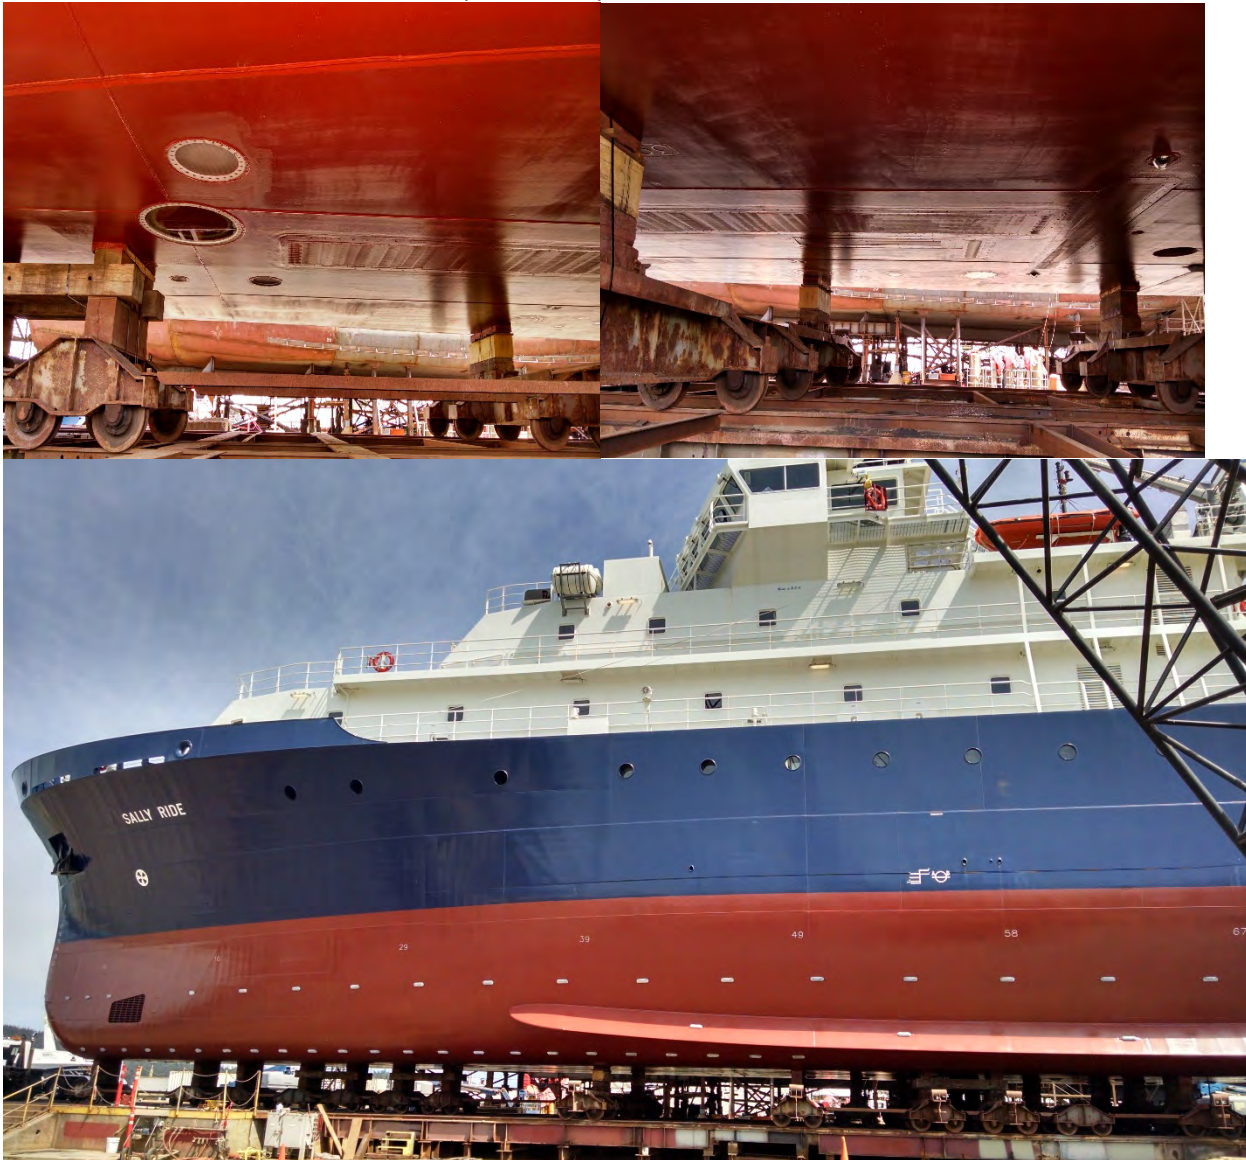
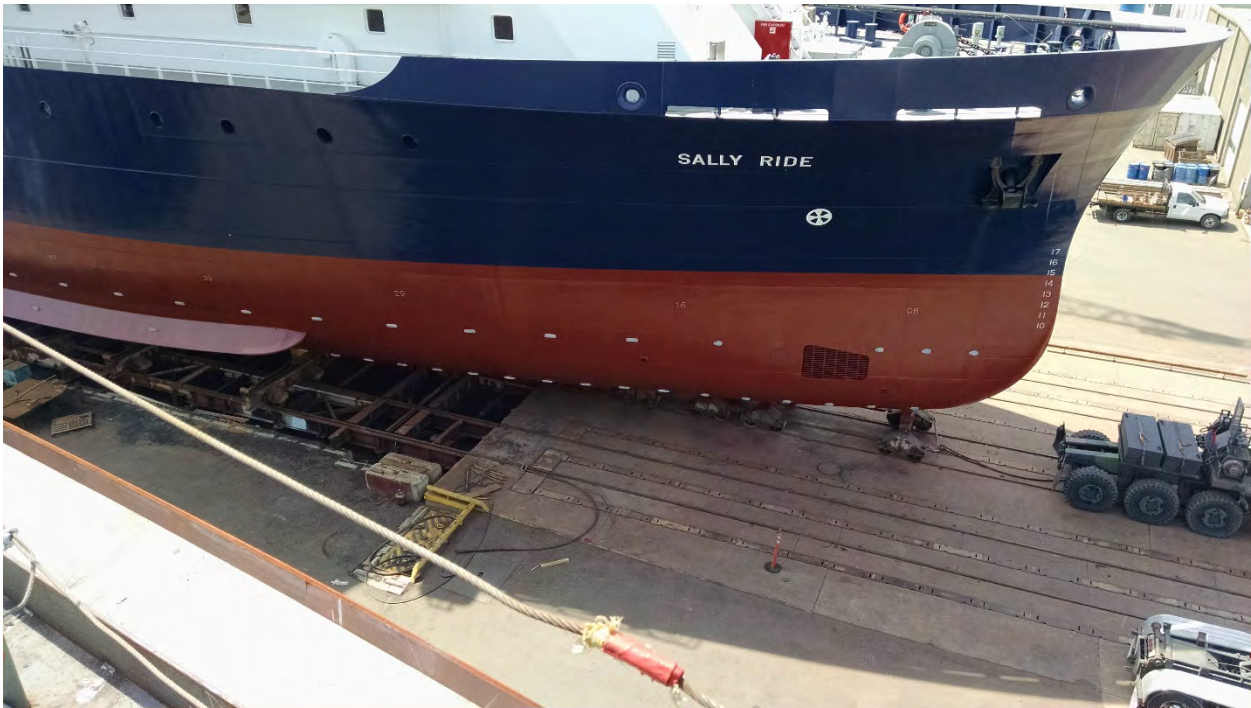
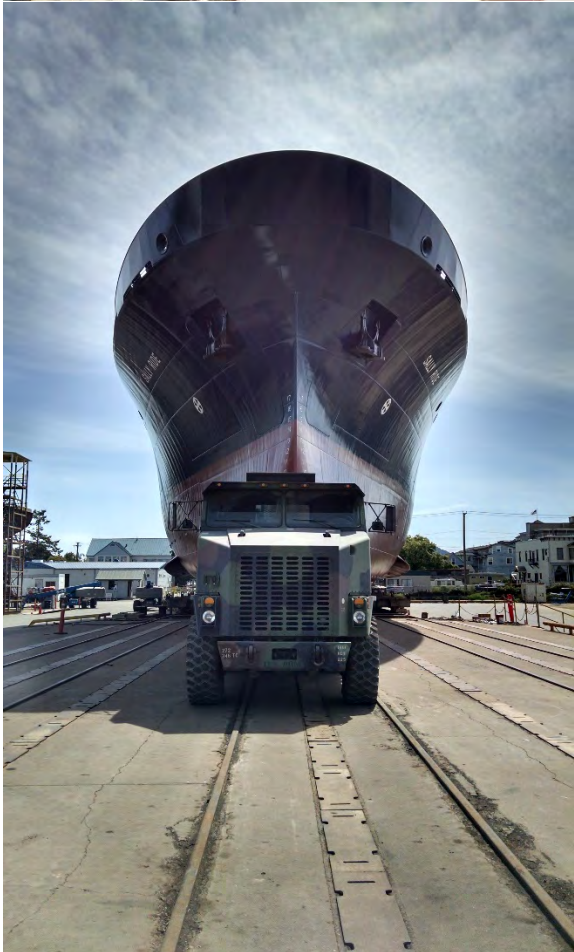
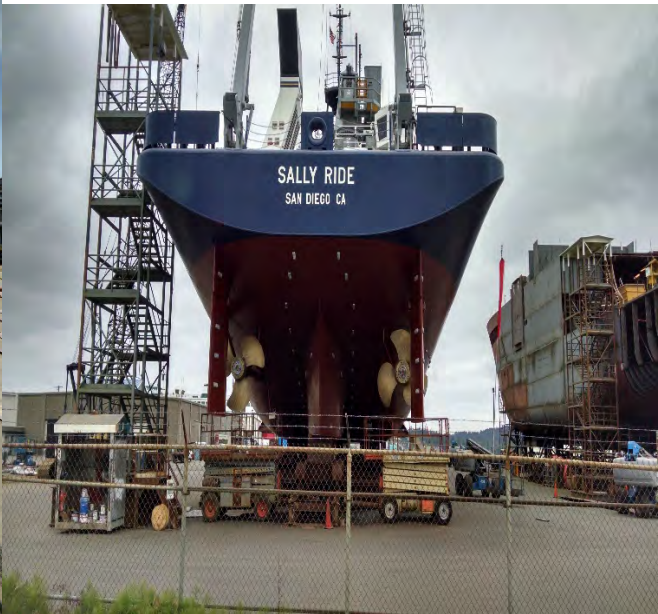
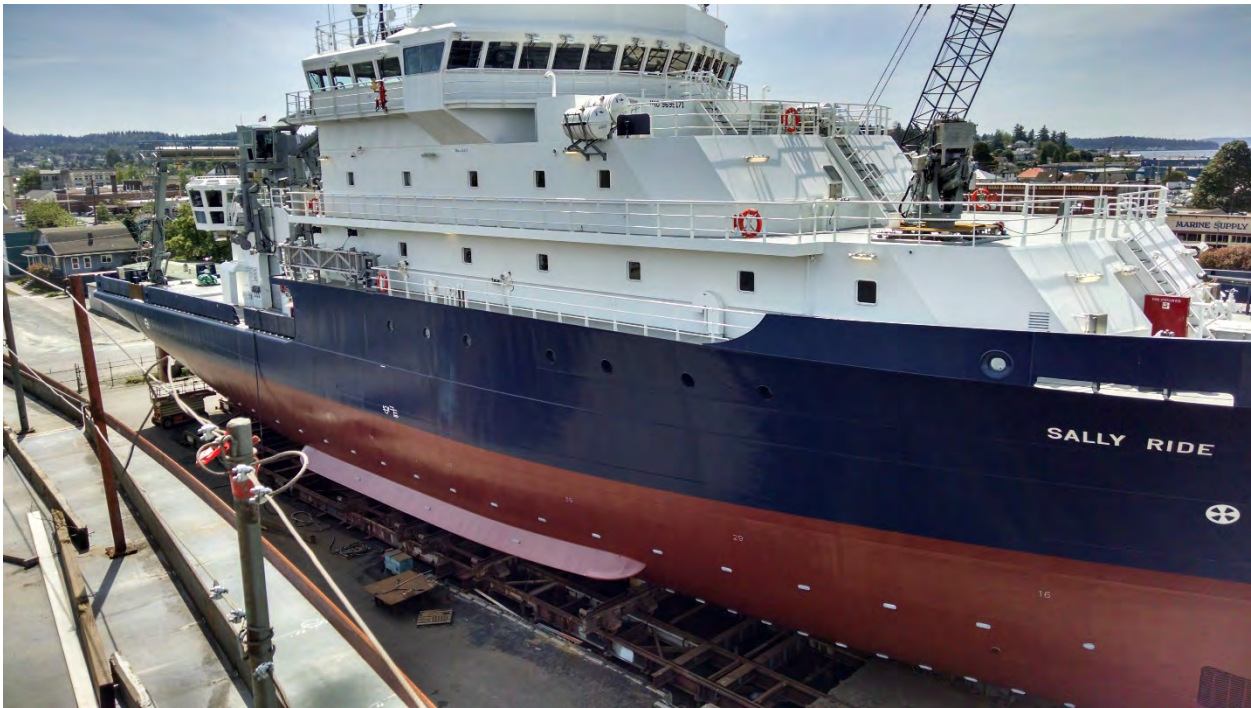
Launch scheduled for Tuesday. Phase III work requiring ship out of the water completed. Pleased to note all docking blocks are all flat topped. Ship does not require complicated double angle side blocks. Docking plan seems to be very simple. This should simplify future drydockings. Paint looking good. New hull sensors flush to hull and where required nicely faired in

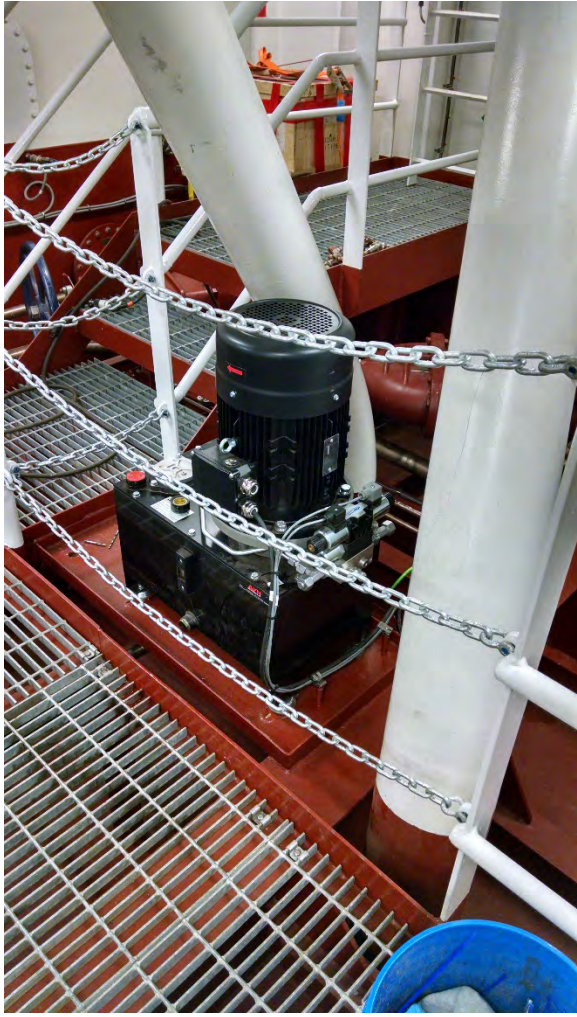
Transducer Room looking good, hydro-electric valve for Hypap .
