Evaluation of the Structural Performance of CTS Rapid Set Concrete Mix®

Lucy P. Priddy, Haley P. Bell, Lulu Edwards,
William D. Carruth, and James F. Rowland

August 2016

Final report

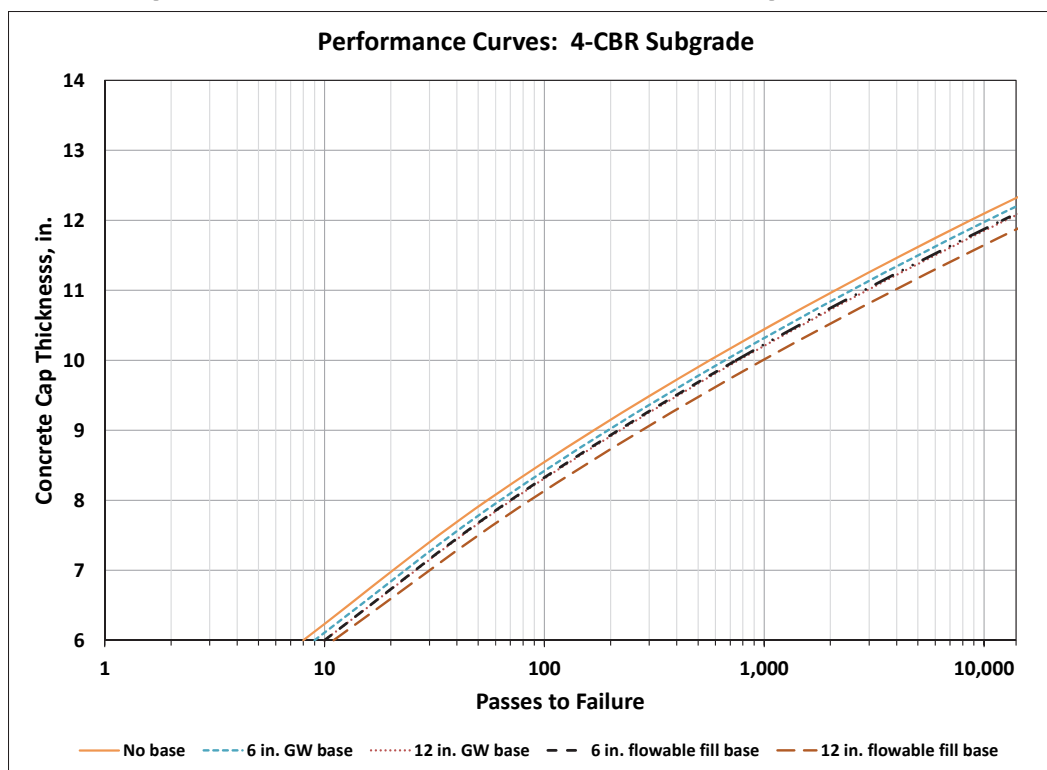
Figure 35. Predicted repair performance for a 4-CBR subgrade (PSeven).

The performance curves for the various pavement structures on a 4-CBR subgrade are presented in Figure 35. These curves take into account all five series of repairs' structures (no base, 6-in.-thick weak base, 6-in.-thick strong base, 12-in.-thick weak base, and 12-in.-thick strong base).

The results shown in Table 11 indicate that the theoretical performance curves shown in Figure 35 underpredict the field performance of all repair series of tests. This would be expected, as design procedures are generally conservative. The mode of failure (spalling versus shattered slab) was also different.

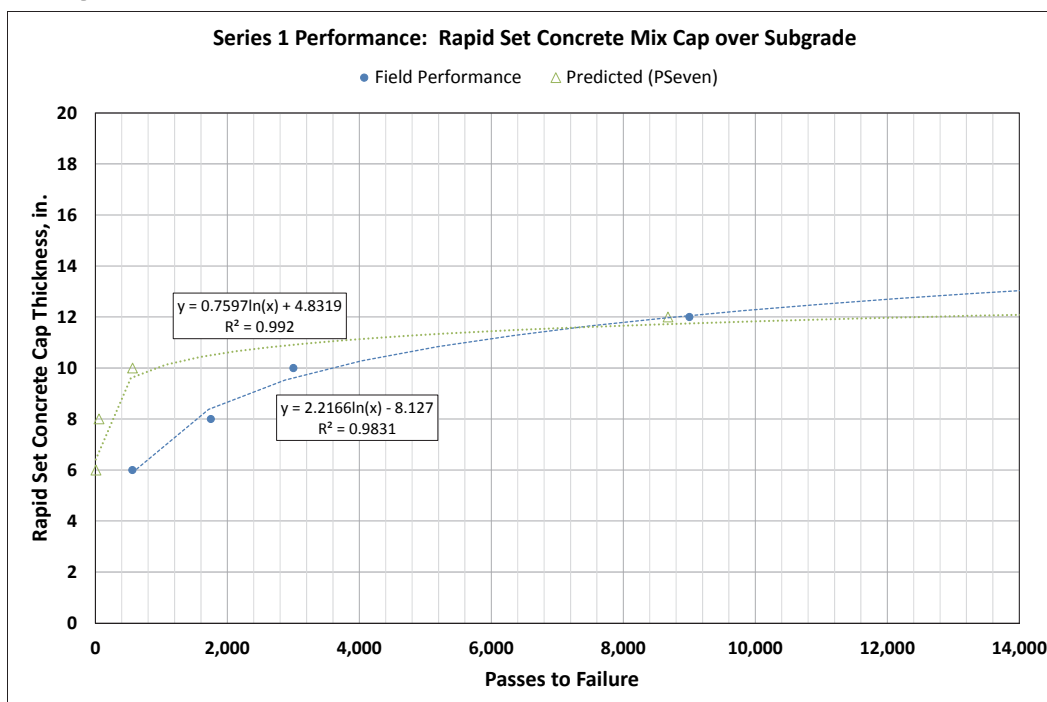
Figure 37. Series 1 field performance and predicted Rapid Set Concrete Mix[®] Curves.

Figure 37 and 38 present the theoretical and performance curves for the Series 1 and 5 repairs, respectively. The curves for both series of tests show that the PSeven linear elastic analysis software under-predicts the field performance of Rapid Set Concrete Mix[®], especially with Series 5. The coefficient of determination, or R^2 , for the Series 1 data was much higher than the R^2 for the Series 5 data, indicating a better performance prediction for Series 1. The lower R^2 value for the Series 5 performance curve was not surprising due to the segregation near the surface of the Rapid Set Concrete Mix[®] cap for Repair 15 and the early failure of Repair 17. The Series 5 repairs, particularly Repairs 15 and 17, should be repeated to validate the unanticipated data.
