*Airfield Damage Repair Modernization Program*

## **AM2 Brickwork Pattern Evaluation**

December 2016

Final report

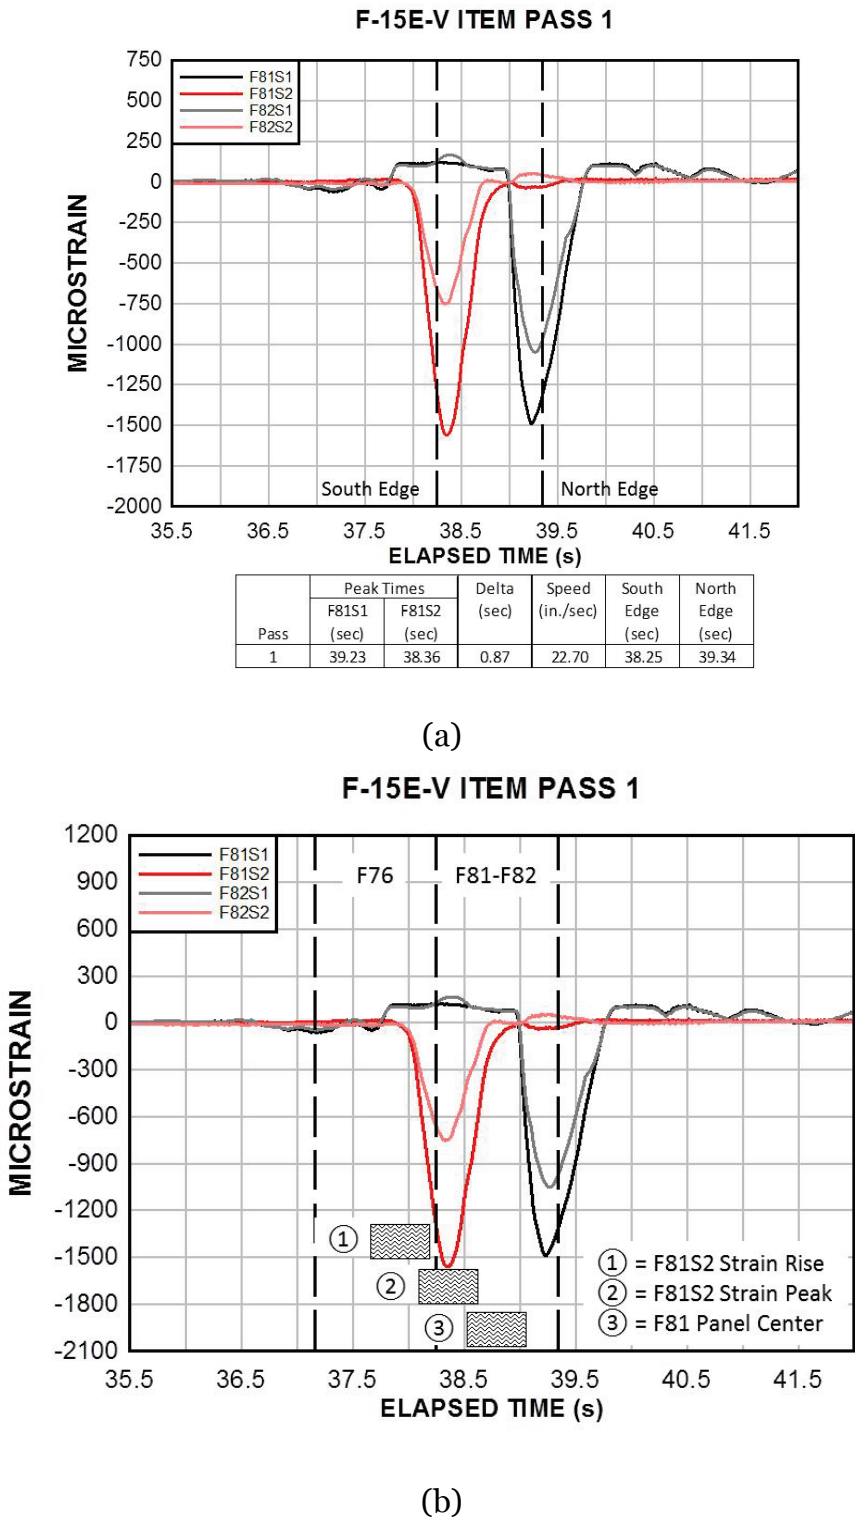
Figure 7.18. (a) F81-F82 joint strain data during pass 1 and (b) tire load footprint locations.

Figure 7.18a shows F81-F82 strains during the first traffic pass, 18 in. east of the joint. The vertical dashed lines represent the north and south hinge edges using the F81S1 and F81S2 strain peaks to establish the load cart speed, then calculating the time to travel the 2.5-in. distance from the hinge edges to each strain gauge location. The 9-in.-wide tire footprint has a 12.05-in. north-south dimension for a 35,235-lb load and 325-psi tire pressure. This 12.05-in. dimension equates to a 0.53-sec tire load duration footprint for pass 1, 18 in. east of the F81-F82 joint. Figure 7.18b shows tire load duration footprint locations, centered on the time when gauge F81S2 first measured a rising strain ①, peak strain was recorded ② and at the panel midpoint ③.

Figure 7.18 illustrates that load is transferred across the transverse joints well before the wheel hits the joint. The absence of an appreciable strain when the tire is centered on the panel confirms that the joints see the highest loads when the panels are eccentrically loaded. Each of these behaviors makes it difficult to accurately estimate an effective width for the cantilevered prongs and calculate a corresponding load or moment for a measured strain/stress.
