*Monitoring Completed Navigation Projects (MCNP) Program*

## **Use of Dolos Armor Units to Repair Hurricane Sandy-Damaged Great Lakes Harbor Breakwaters**

Michael C. Mohr, Gerlyn J. Hinds, Weston P. Cross,  
Shanon A. Chader, and Jeffrey A. Melby

June 2018

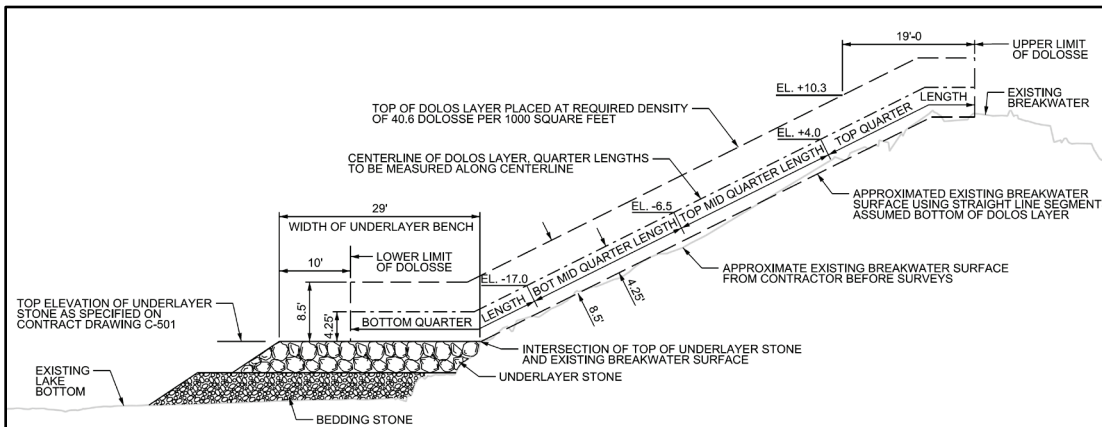
Figure 4-4. Cleveland Breakwater repair section definition of estimated quarter lengths.

The contractors were also required to (1) use the provided EXCEL spreadsheet to determine the dolosse placed in each 25 ft length of breakwater by quarters, (2) track the number of placed dolosse and their coordinates, and (3) calculate the density of the placed dolosse. A separate table for each 25 ft length was updated daily and divided into quarters as shown in Figure 4-4.

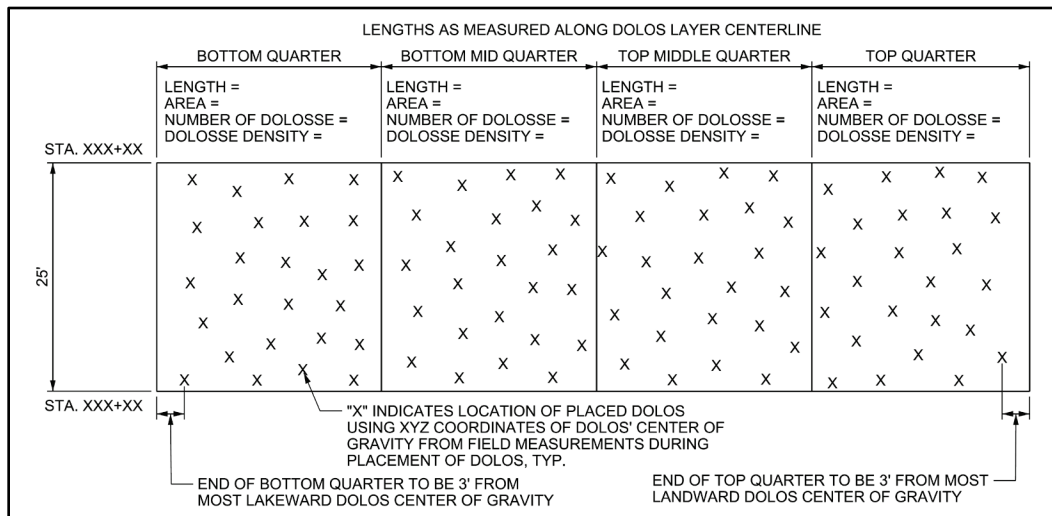
Figure 4-5. Cleveland plan of placed dolos centers of gravity.

The contractor plotted each placed dolos daily as shown on the typical template presented in Figure 4-5. For Cleveland, the dolosse had to be placed at an average density of 40.6 per 1,000 ft<sup>2</sup> with a minimum density of 38.6 per 1000 ft<sup>2</sup>, but no more than a maximum of 42.6 per 1000 ft<sup>2</sup>. To ensure maximum interlocking, each quarter could not reach the required density until dolosse were placed at least 5 ft into the adjoining quarter (both within the 25 ft length and adjoining 25 ft lengths), where possible. As each quarter was completed, any dolos density outside of the acceptable dolos density tolerance was to be brought to the immediate attention of the government. Extreme limits of the density tolerance were not to be continuous over an area greater than 1000 ft<sup>2</sup>. If the density were below the tolerance, then the government could direct the contractor to place additional dolosse, at the contract bid item price. If the density were above the tolerance, then the extra dolosse placed would be at no cost to the government. For Oswego, the required density of dolosse was 23.3 dolosse per 1,000 ft<sup>2</sup> with a tolerance of  $\pm 1$  dolos per 1,000 ft<sup>2</sup>.

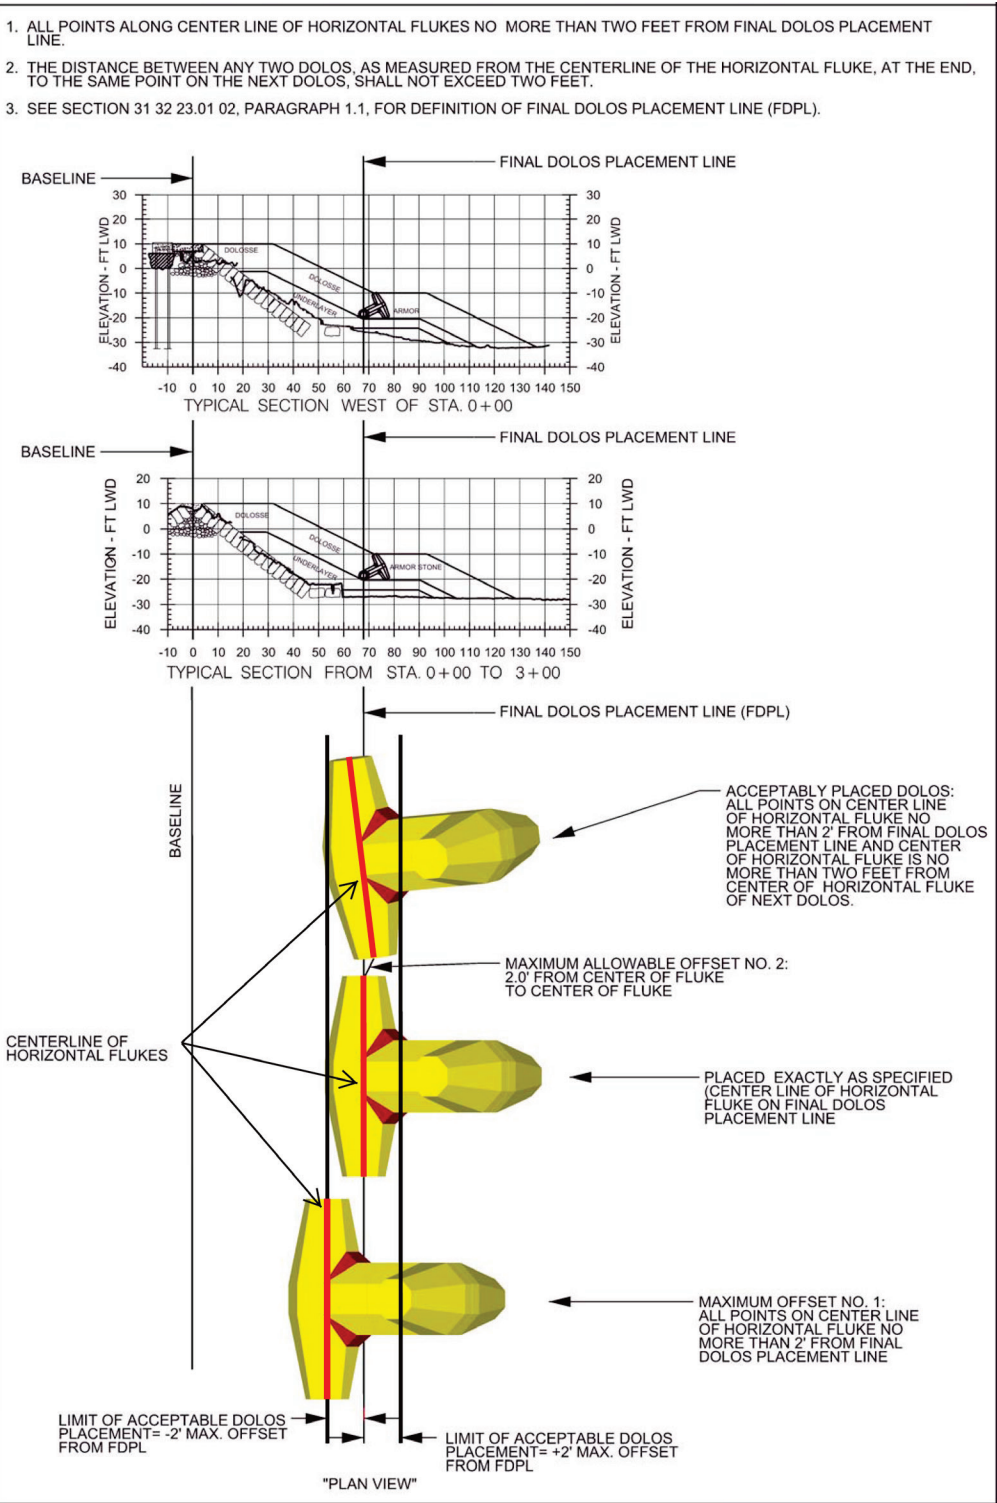
Figure 4-6. Allowable offsets for the placement of the first row of Oswego dolosse.

Since the bottom row of Oswego dolosse were specially oriented to ensure slope stability, an additional requirement for placement tolerance was specified as illustrated in Figure 4-6.

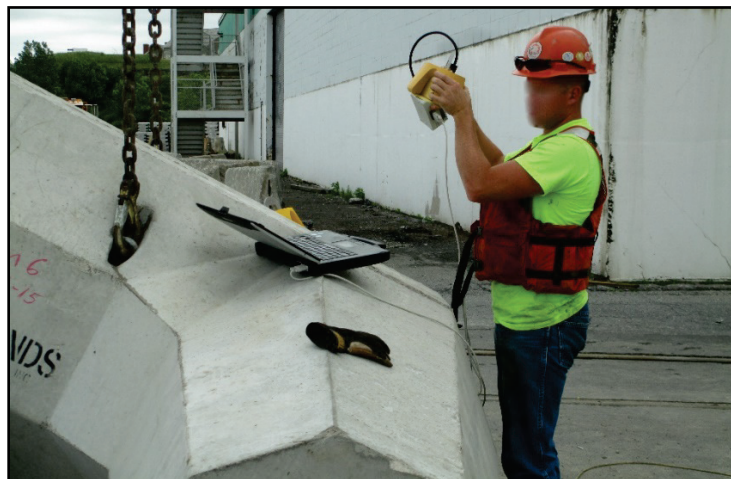
Figure 4-7. Calibrating BIB on Oswego dolos.

Prior to placement of the dolosse, the BIB (sensor for block attitude computation) was calibrated on the first unit of the day to ensure the system was recording properly (Figure 4-7).

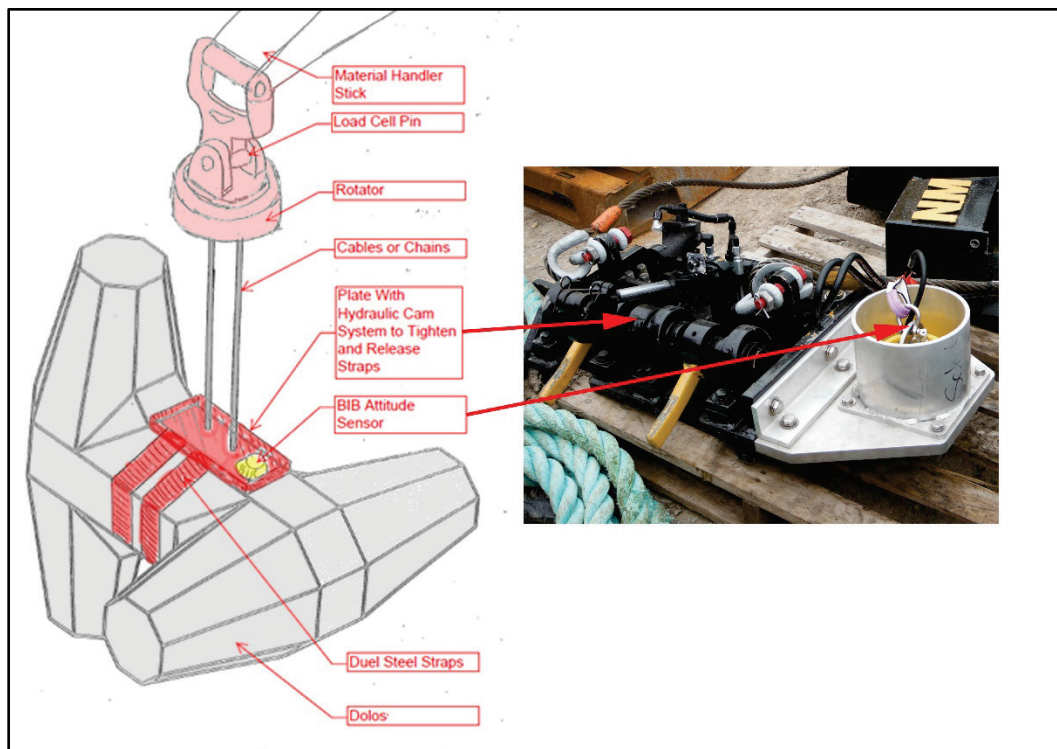
Figure 4-8. Cleveland dolos lifting arrangement.

For the Cleveland dolosse, the contractor created a special lifting mechanism that used a hydraulic cam system to tighten and release the lifting cables. This unit also housed the BIB (Figure 4-8). For the lifting assembly to be placed at the same location on the dolos, the saddle (positioning jig) was first placed, and then the lifting mechanism was butted up against this template. Figure 4-9 through Figure 4-13 present a sequence of views captured from video that show a dolos being placed. Note the saddle in Figure 4-9, which is subsequently removed (Figure 4-10) once the lifting cables are taut.

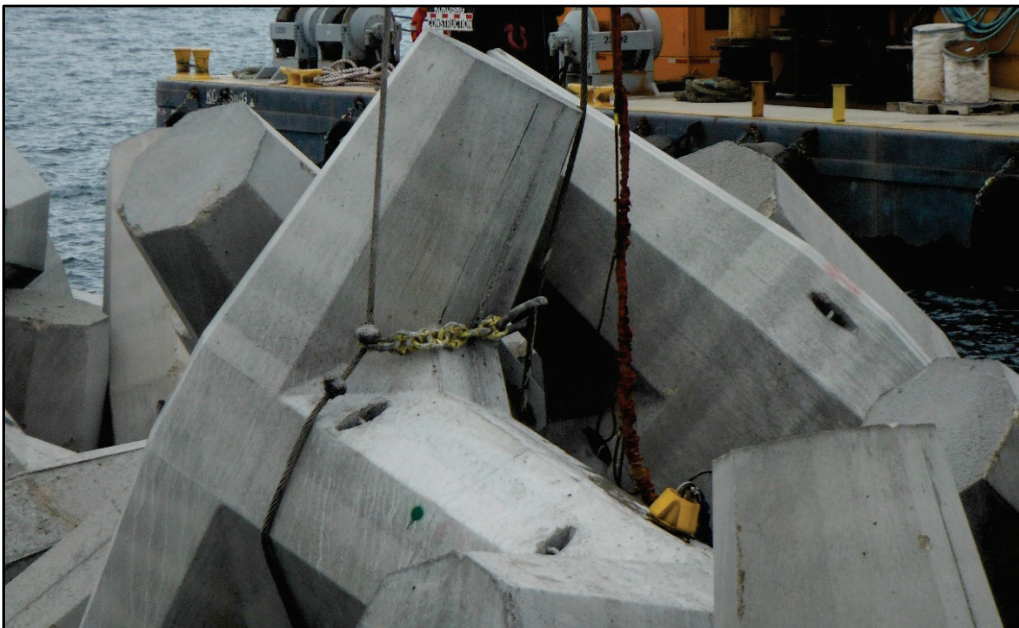
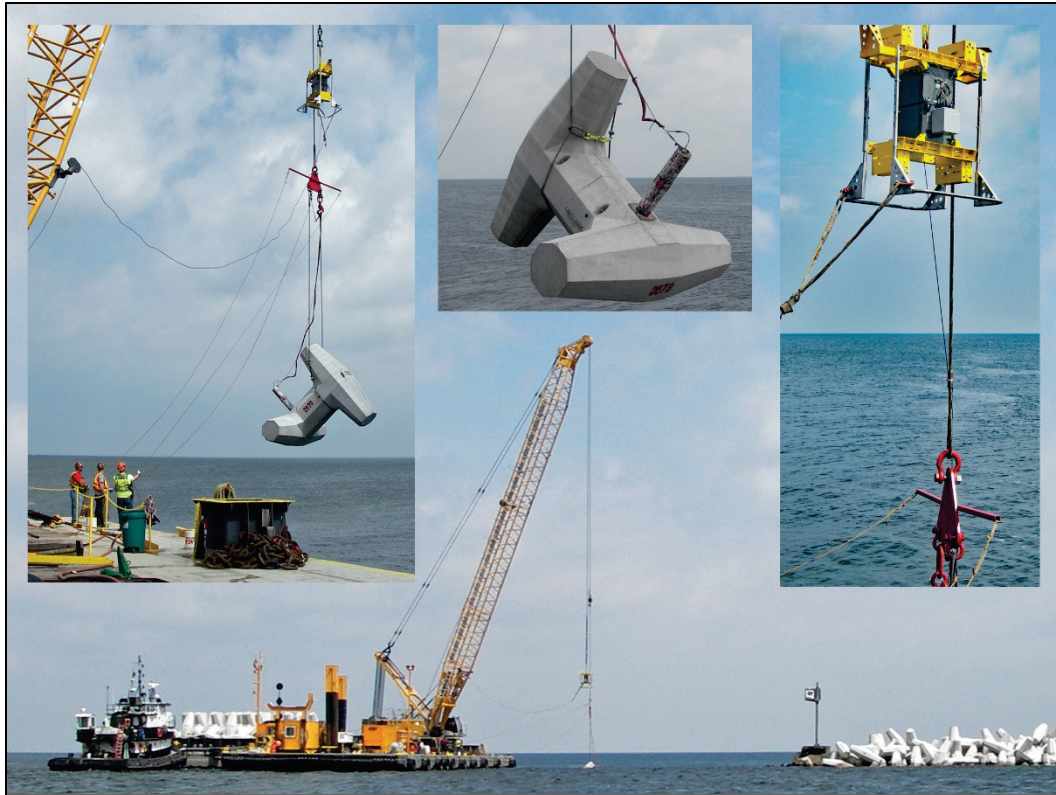
For the Oswego dolosse, the contractor elected to use cables with the BIB temporarily attached to the dolosse with plastic pins (Figure 4-15 and Figure 4-16).

Despite significant project planning and communication among parties to avoid unexpected complications during placement, a complication still arose. An unexpected problem with the Oswego AUPPS arose with the steel reinforcement within the dolosse interfering with the attitude sensor (electromagnetic compass) in the BIB, requiring the sensor to be calibrated for each unit to show actual pitch and roll. The contractor worked on solutions to insulate the BIB and finally settled on placing the BIB on a removable stanchion (riser pipe). This may be seen in Figure 4-16, center top photo. Due to the potential project delays from having to recalibrate the BIB on each dolosse, it was agreed to recalibrate only those at the base that formed the specially oriented toe. Despite this setback, the AUPPS accurately showed the center of gravity for density computation, and by placing the dolosse at random orientations, good interlocking was assured.

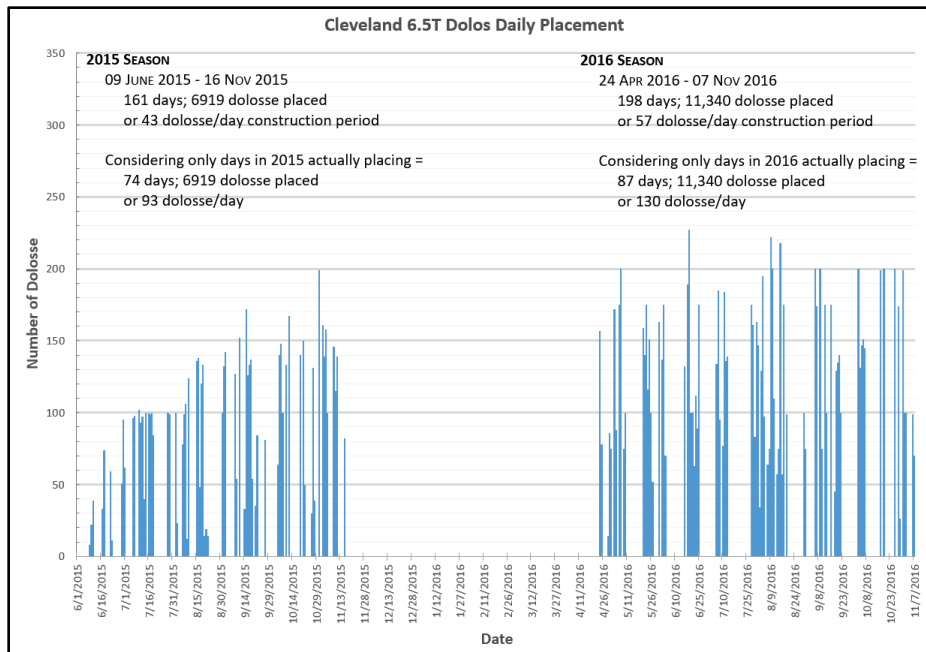
Figure 4-21. Cleveland 6.5-ton dolos placement rate.

The Cleveland East Breakwater repair required the placement of 18,259 6.5-ton dolosse, which occurred over two construction seasons. Minimal breakage during handling and placement occurred and resulted in only four dolosse to be deemed unsuitable. During the 2015 season, 09 June to 16 November, which spanned 161 calendar days, 6,919 dolosse were placed

for an average of 43 dolosse/day. However, during that time period, the contractor placed dolosse only during 74 of those days suggesting an average rate of 93 dolosse/day. During the 2016 season, 24 April to 07 November, which spanned 198 calendar days, 11,340 dolosse were placed for an average of 57 dolosse/day. However, during that time period, the contractor placed dolosse only during 87 of those days suggesting an average rate of 130 dolosse/day. The minimum placement rate occurred on the first day when only 8 dolosse were placed, and the maximum placement occurred when 227 dolosse were placed. Figure 4-21 presents the daily placement rate. Table 4-2 presents the Cleveland dolos daily placement rate descriptive statistics.

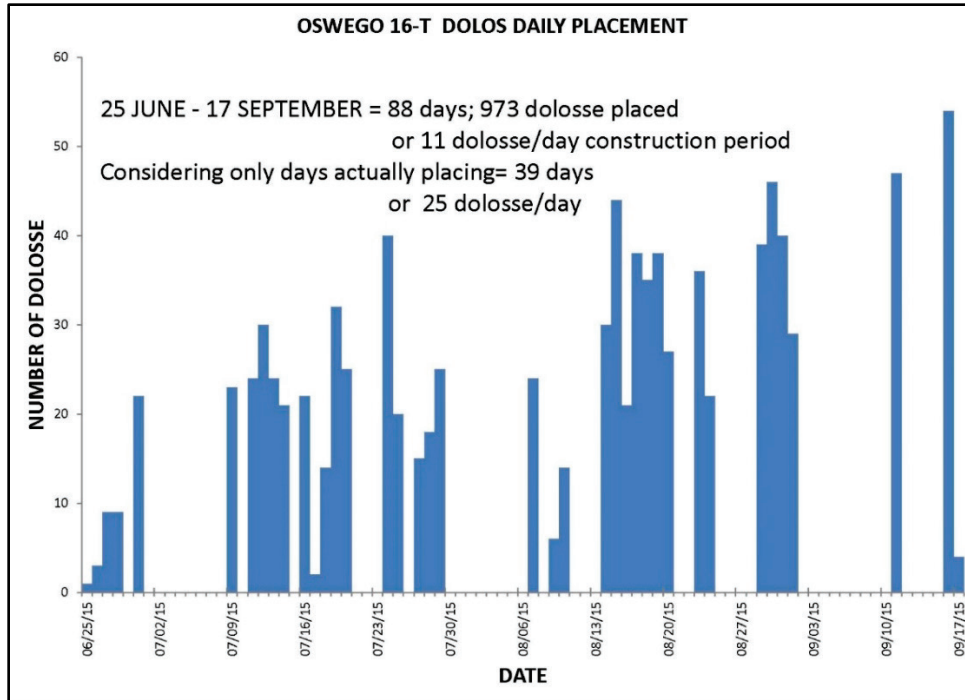
Figure 4-22. Oswego 16-ton dolos placement rate.

The Oswego Detached Breakwater repair required the placement of 973 16-ton dolosse during one construction season. During the period 25 June to 17 September 2015, which spanned 88 calendar days, 973 dolosse were placed for an average of 11 dolosse/day. However, during that time period, the contractor placed dolosse only during 39 of those days, suggesting an average rate of 25 dolosse/day. The minimum placement rate occurred on the first day when only 1 dolos was placed, and the maximum placement occurred on the next-to-last day when 54 dolosse were placed. Figure 4-22 presents the daily placement rate.
