US Army - TARDEC

Bootloader-Application Transition Failure Investigation

GVR-BOT Technical Report

Valascho, Ty
3-27-2017

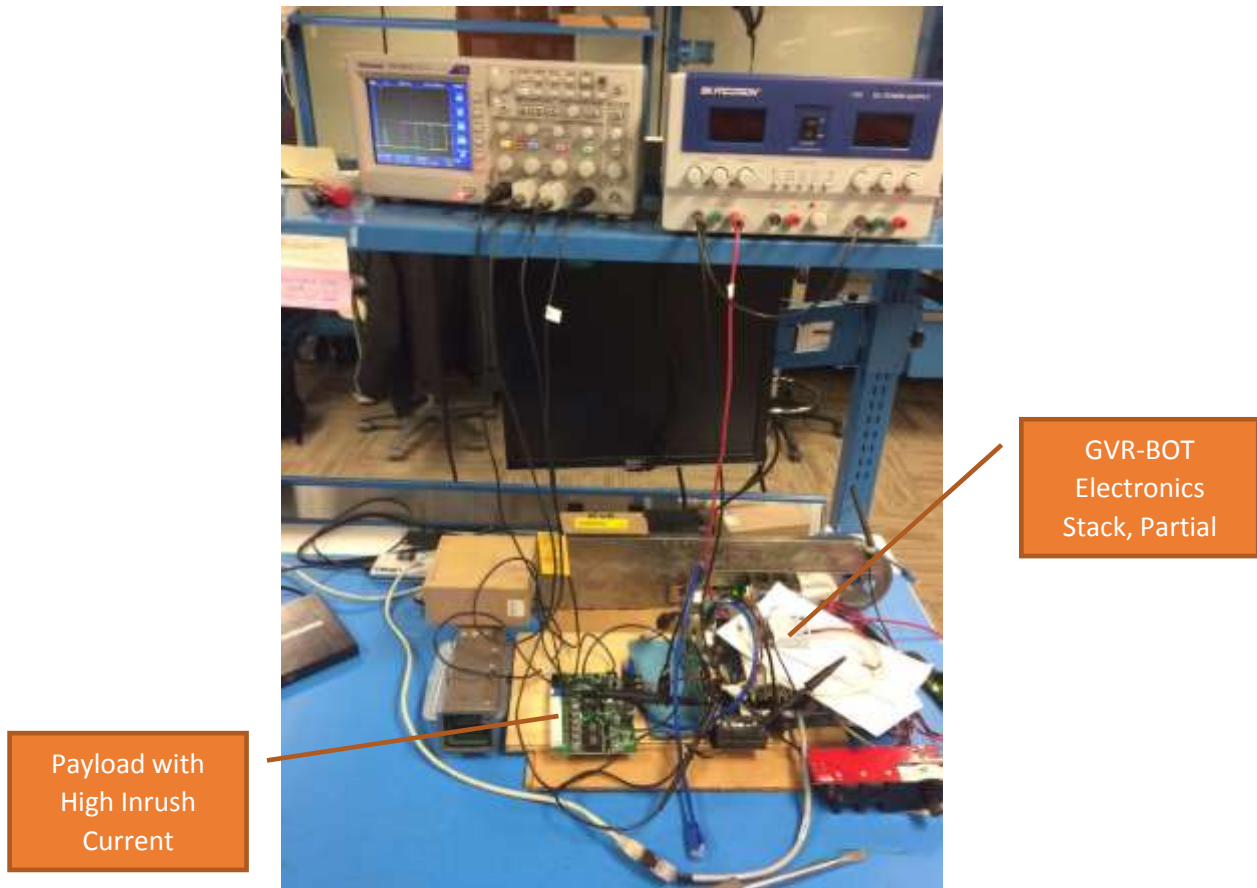
Figure 5 - "Window of Vulnerability" Test Bench Setup

The "High Inrush Payload" was a M4-ATX-HV ATX Power Supply made by Mini-Box, serial number EEC21154712036. Previous testing determined that this power supply will pull more than 100 Amps of inrush current for ~0.4 milliseconds while powering up. This was found to exceed the ability of the robot's battery to supply current and cause a dip in system voltage from 34 VDC down to less than 5 VDC during the inrush event.

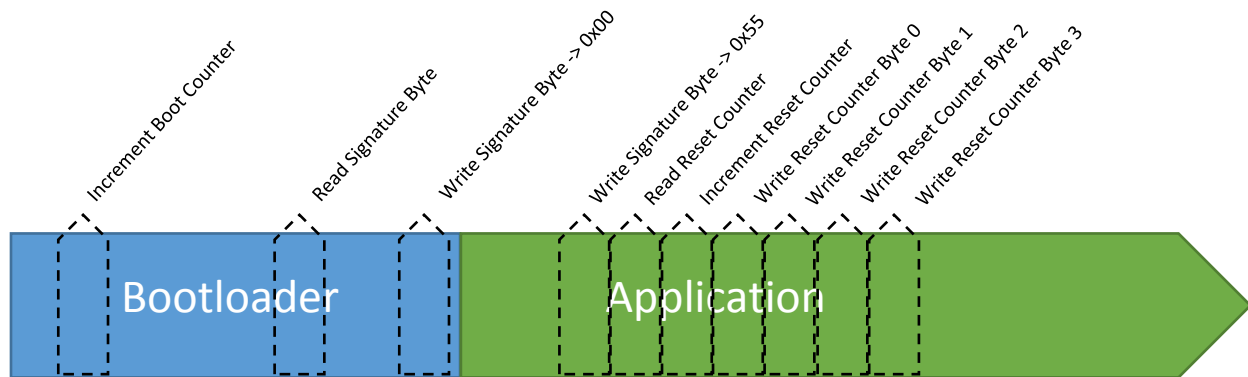
Figure 7 - Detailed Sequence of Embedded Board Power-On Sequence

Processor execution starts on the left in this diagram and moves to the right as the instructions are executed. Instructions not relevant to this discussion are not labeled and are represented as “blank space” in the execution flow. The labelled instructions are the source code instructions written in the C programming language. Many of these instructions represent tens – sometimes hundreds – of assembly code instructions to the processor.

The window of vulnerability was found to exist in the Category 1 area and results in a robot system failure – the Mobility board remains in bootloader.
