# Payload Inrush Investigation

GVR-BOT Technical Report

Tyrus Valascho, Kayla Gomes  
3-10-2017

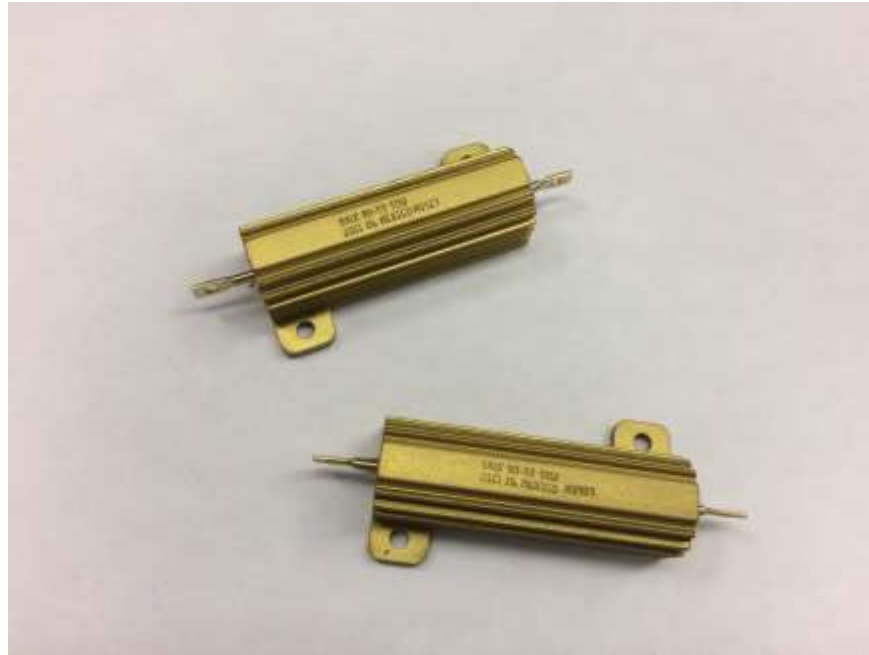
Figure 6 - Dale-Vishay Wire-wound Resistors

Both resistance values successfully solved the problem. However, these resistors became very warm which was not an acceptable solution. It was also felt that such high resistances were not necessary to correct the problem and merely wasting energy by generating waste heat. This wasted energy would be consumed the entire time the robot is running, not just at startup. The lowest resistance necessary to solve the problem would be preferred.

First, high power resistors were placed in between the ATX Power Supply and the robot's Payload Port. A 20 Ohm resistor and a 25 Ohm resistor was used for this testing. The specific parts were the Dale-Vishay RH05025R00FC02 (25 Ohm) and Dale-Vishay RH05020R00FC02 (20 Ohm), images of which are provided in Figure 6.
