NAVAL FACILITIES ENGINEERING SERVICE CENTER  
Port Hueneme, California 93043-4370

## **SITE SPECIFIC REPORT SSR-2525-SHR**

### **PIPELINE COATING CONDITION ASSESSMENT AND INSTALLATION ASSESSMENT, SAN NICOLAS ISLAND**

November 1999

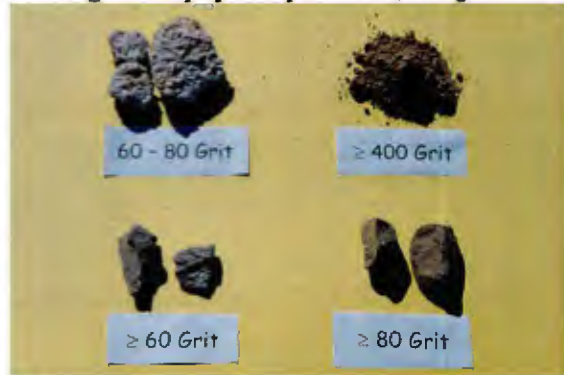
In an attempt to quantify soil and rock abrasion on the coating, representative rock and soil samples, taken from the island, were lightly rubbed against the coating. The resulting scratches were visually matched to equivalent sandpaper scratches made from known grit sizes. San Nicolas Island rock and soil produced coating scratches equivalent to 60 – 400 grit sandpaper. In the laboratory investigation, the sandpaper equivalent of island soils and rocks were used (see section titled "Abrasion Resistance").

Top to Bottom (L to R): Shell embedded soil, soil, pumice type rock, and sand stone.

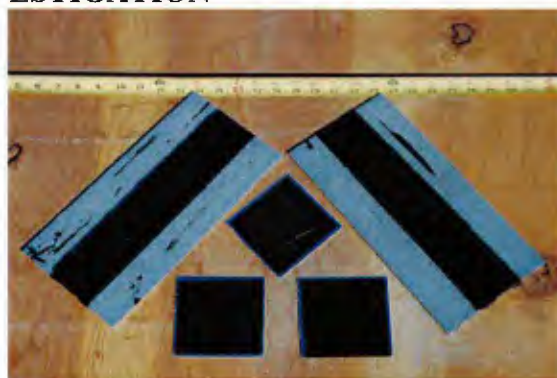
Coal tar urethane samples.

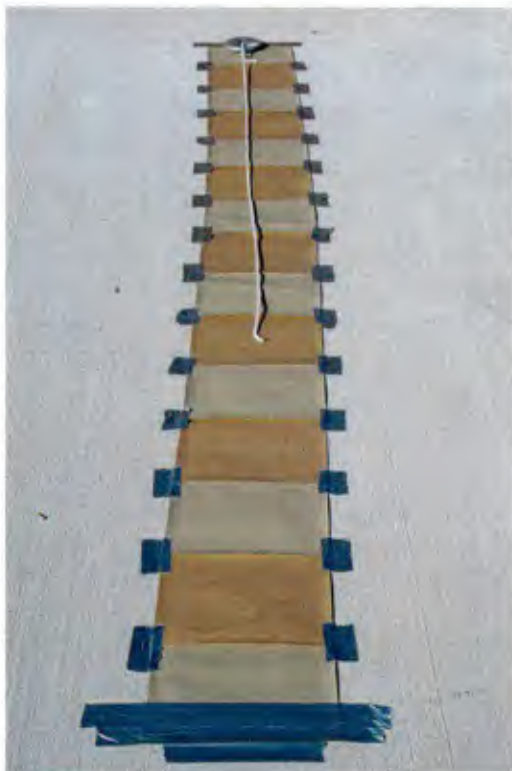
*Test Parameters:* A) Coated sample size, 7.854 in<sup>2</sup>, B) Initial sample weight, 149.62735 g, C) Coating thickness on sample, 75 – 85 mils, D) Shore A Hardness of coating, 95 (full cure), E) Weight attached to sample, 2.5 lbs (0.361 psi), F) Sandpaper type, 100 grit (7 sheets) & 120 grit (8 sheets), G) Total length of sandpaper, 10 feet, and H) Weighted sample pulled 9 times through the complete length of sandpaper.

Ten feet total of alternating 100 and 120 grit sandpaper.

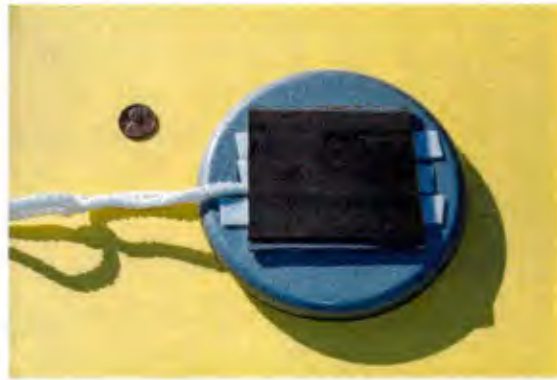
Coating sample attached to a 2.5 pound weight.

*Results:* 1) Coating weight loss, 0.76355 g (over a 7.854 in<sup>2</sup> area), and 2) Coating thickness loss, 5 – 10 mils (0.0194436 – 0.0097218 g/mil, in<sup>2</sup>).
