RUNWAY FRICTION MEASUREMENTS AND PAVEMENT CONDITION  
SURVEY, NPTC EL CENTRO, CALIFORNIA, by

R. B. BROWNIE,

SEPTEMBER 1976,"

## CIVIL ENGINEERING LABORATORY

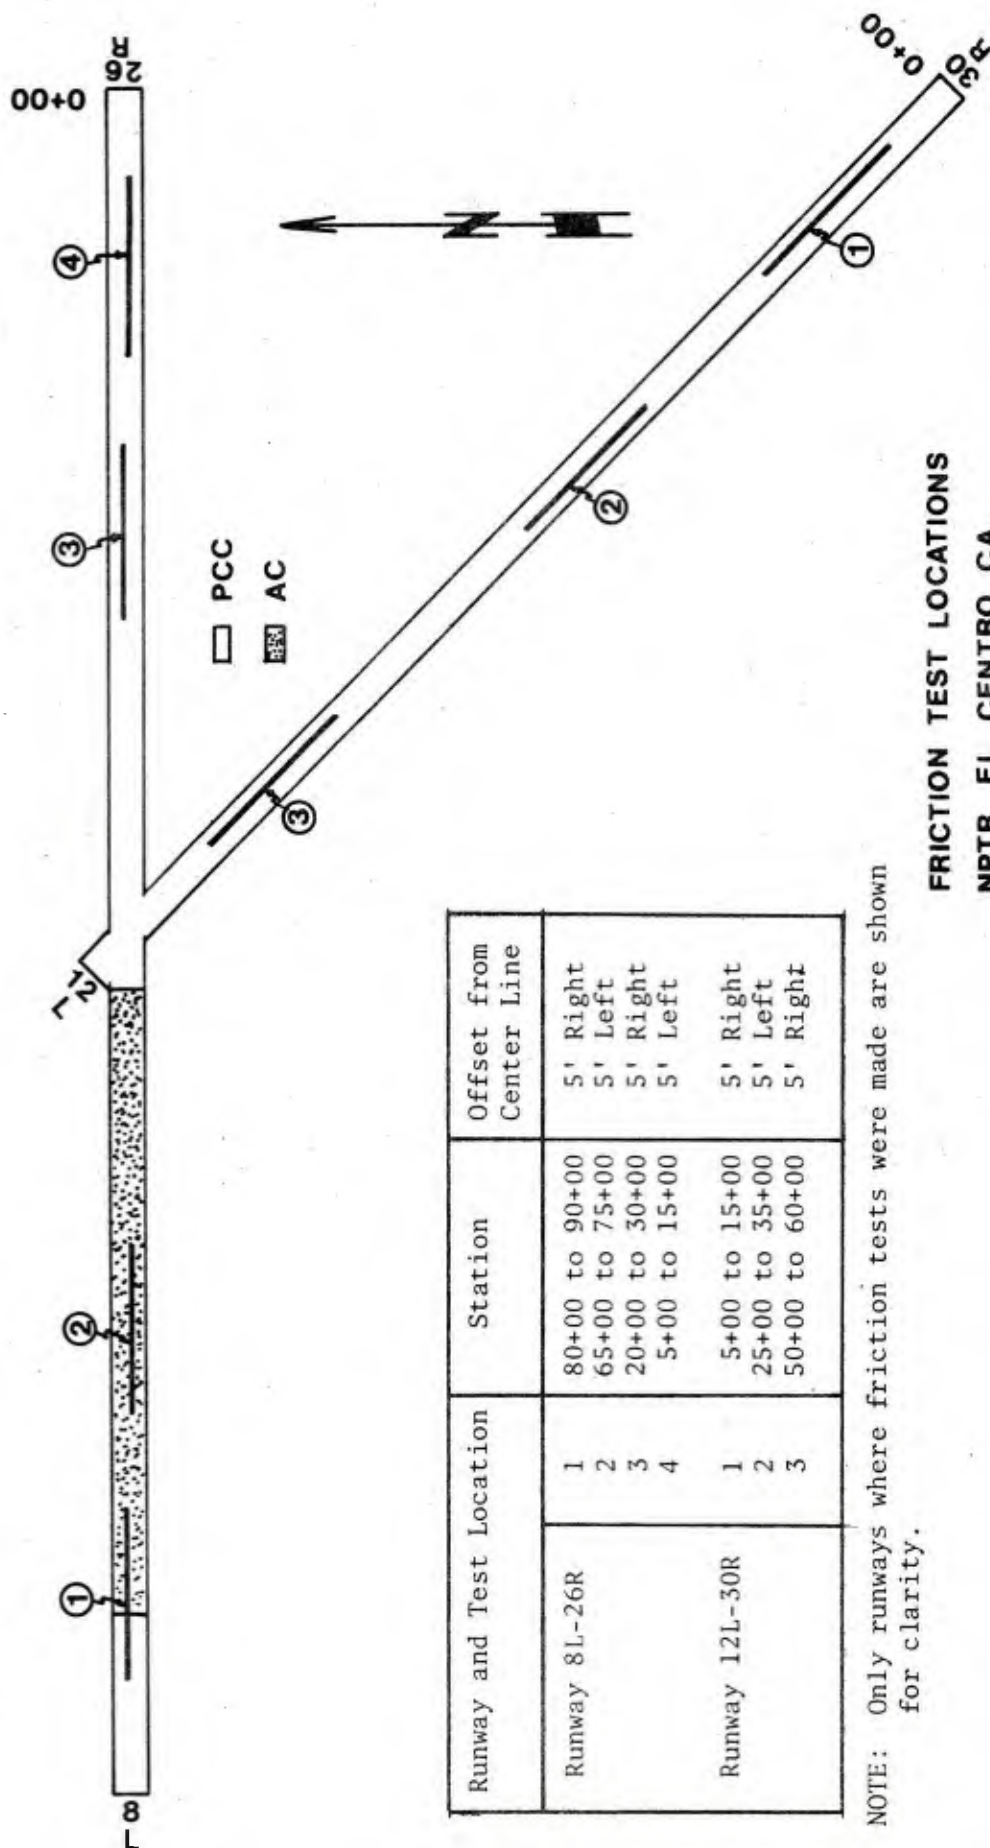
FIGURE 6

Test sections on each runway were selected to provide a representative sample of the skid resistance properties of each runway. The test section layout is shown in Figure 6. The test sections were selected to provide pavement friction data in: (a) the aircraft touchdown areas, and (b) the runway interior where maximum braking is normally developed. No friction tests were made on Runway 8R-26L as it is rarely used.

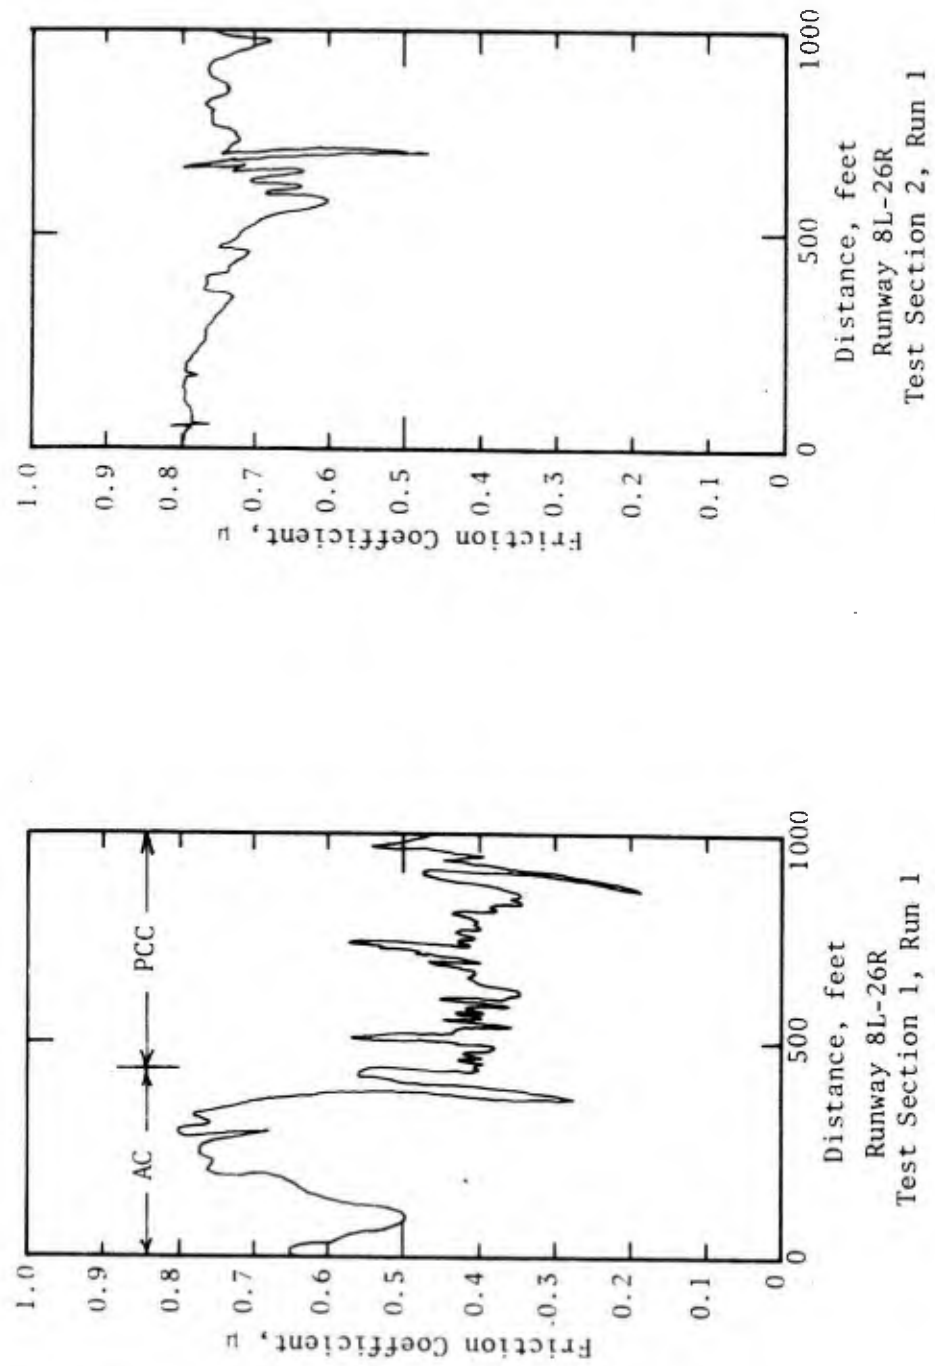
Figure 7. Friction Coefficient versus Distance,  
NPTR El Centro, California

The pavement skid resistance results are reported in terms of  $\mu$ , coefficient of friction, as measured by the Mu-Meter. The actual friction coefficient versus distance traces as recorded by the Mu-Meter during the first run after wetting for each test section are shown in Figures 7 through 10. The traces show the variation of friction coefficient within each test section. Appendix D contains all test results for each Mu-Meter test section.
