# TECHNICAL MEMORANDUM

" EVALUATION OF RUBBER-ASPHALT BINDER FOR SEAL COATING  
ASPHALTIC CONCRETE, NPTR EL CENTRO, CALIFORNIA,  
MARCH 1974 - JULY 1977, by

WESTERN DIVISION, NAVAL FACILITIES ENGINEERING COMMAND

## CIVIL ENGINEERING LABORATORY

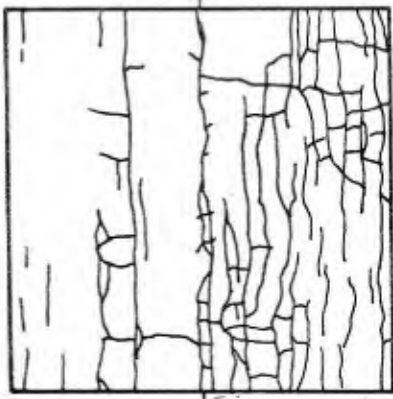
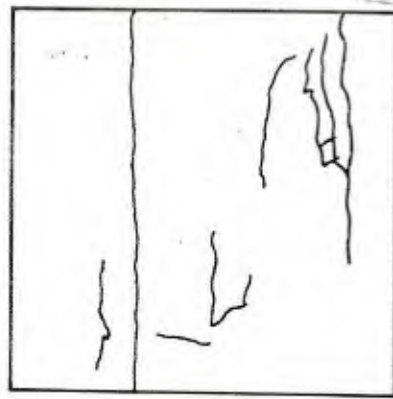
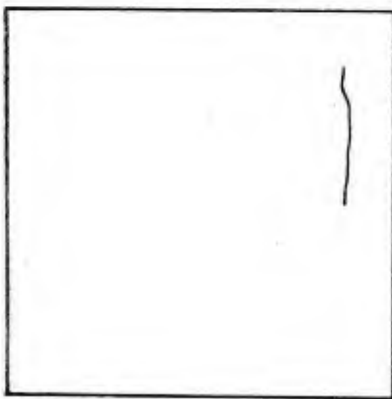
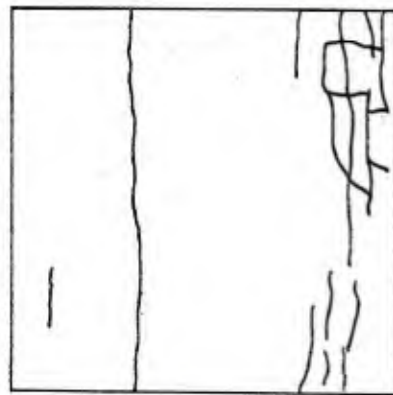
Figure 3. Crack Survey Plots, Taxiway A  
NPTR El Centro, California

22 July 1975  
Pre-seal condition

3 February 1976

27 May 1976

1 February 1977

Plot 2  
Taxiway A  
Seal Coated 14-15 October 1975

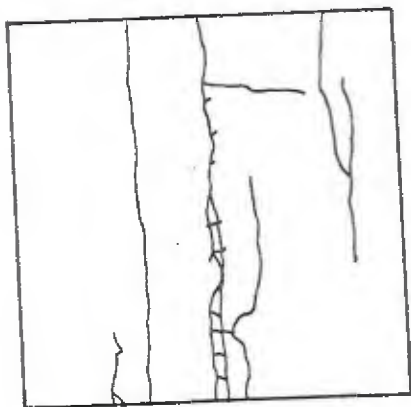
Figure 3a. Crack Survey Plots, Taxiway A  
NPTR El Centro, California

11 July 1977

Plot 2  
Taxiway A  
Seal Coated 14-15 October 1975

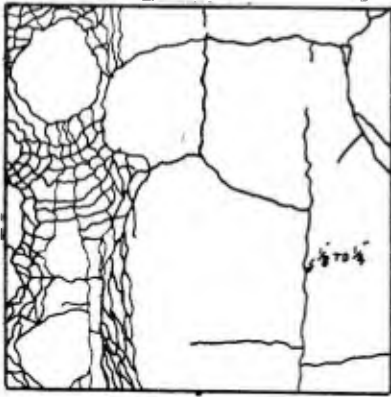
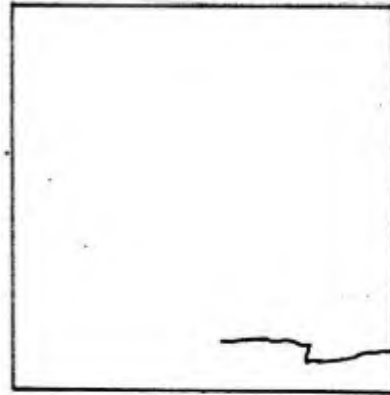
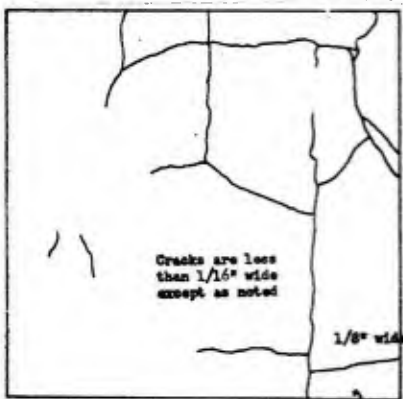
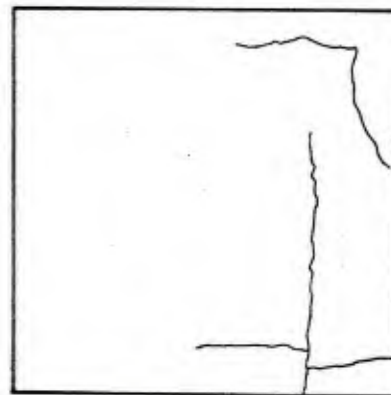
Figure 5. Crack Survey Plots, Taxiway B  
NPTR El Centro, California

11 March 1974  
Pre-seal condition

1 May 1975 and 22 July 1975

Note: No cracks visible on  
7 November 1974

3 February 1976

27 May 1976

Plot 2  
Taxiway B  
Seal Coated 25 March 1974

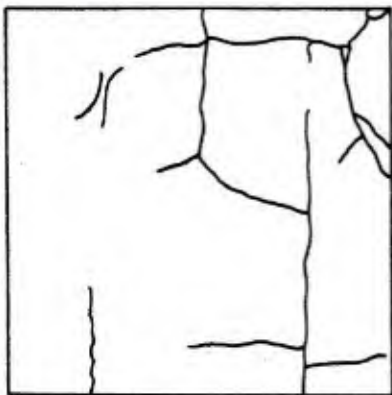
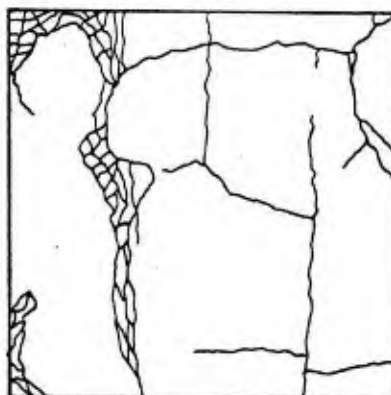
Figure 5a. Crack Survey Plots, Taxiway B  
NPTR El Centro, California

1 February 1977

11 July 1977

Plot 2  
Taxiway B  
Seal Coated 25 March 1974

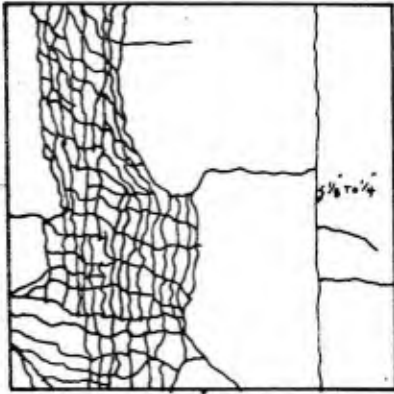
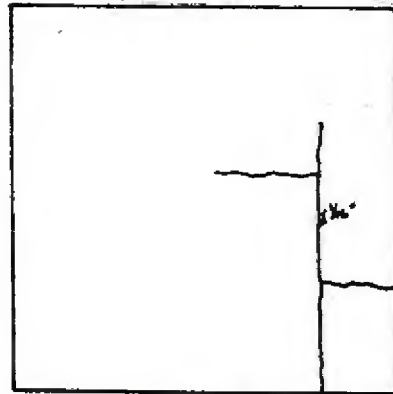
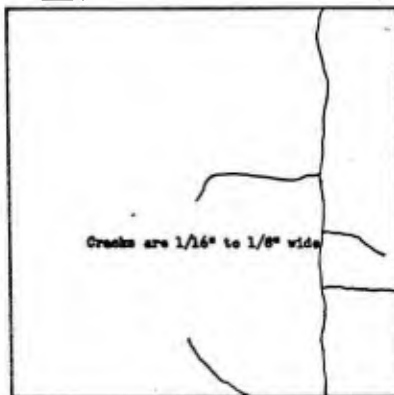
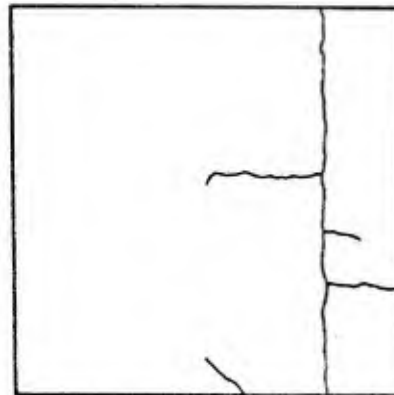
Figure 6. Crack Survey Plots, Taxiway B  
NPTR El Centro, California

11 March 1974  
Pre-seal condition

1 May 1975 and 22 July 1975

Note: No cracks visible on  
7 November 1974

3 February 1976

27 May 1976

Plot 3  
Taxiway B  
Seal Coated 25 March 1974

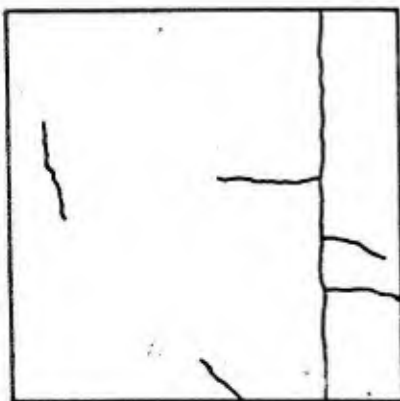
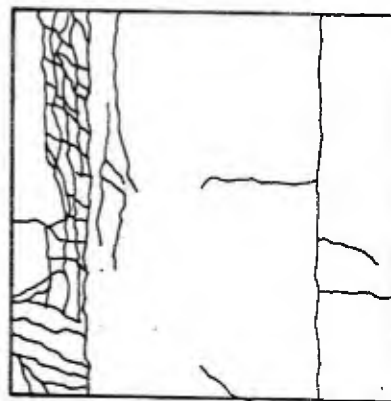
Figure 6a. Crack Survey Plots, Taxiway B  
NPTR El Centro, California

1 February 1977

11 July 1977

Plot 3  
Taxiway B  
Seal Coated 25 March 1974
