## **Geophysical Investigation at Eielson Air Force Base, Alaska**

Subsurface Features Influencing Building 6385

June 2019

Final Report

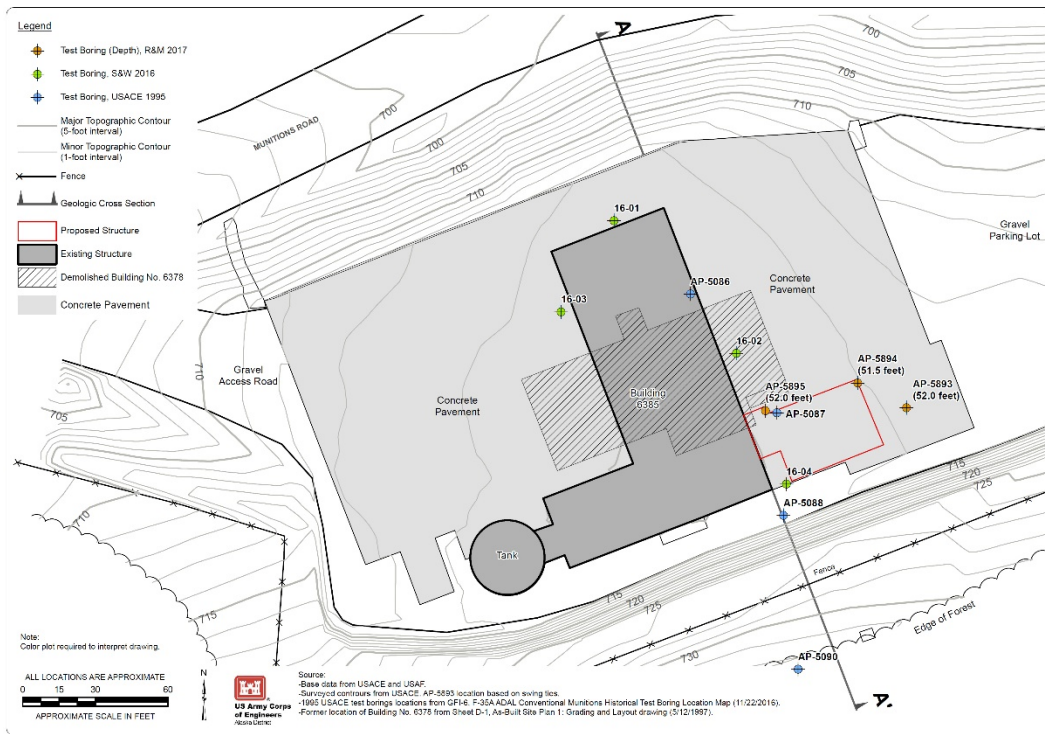
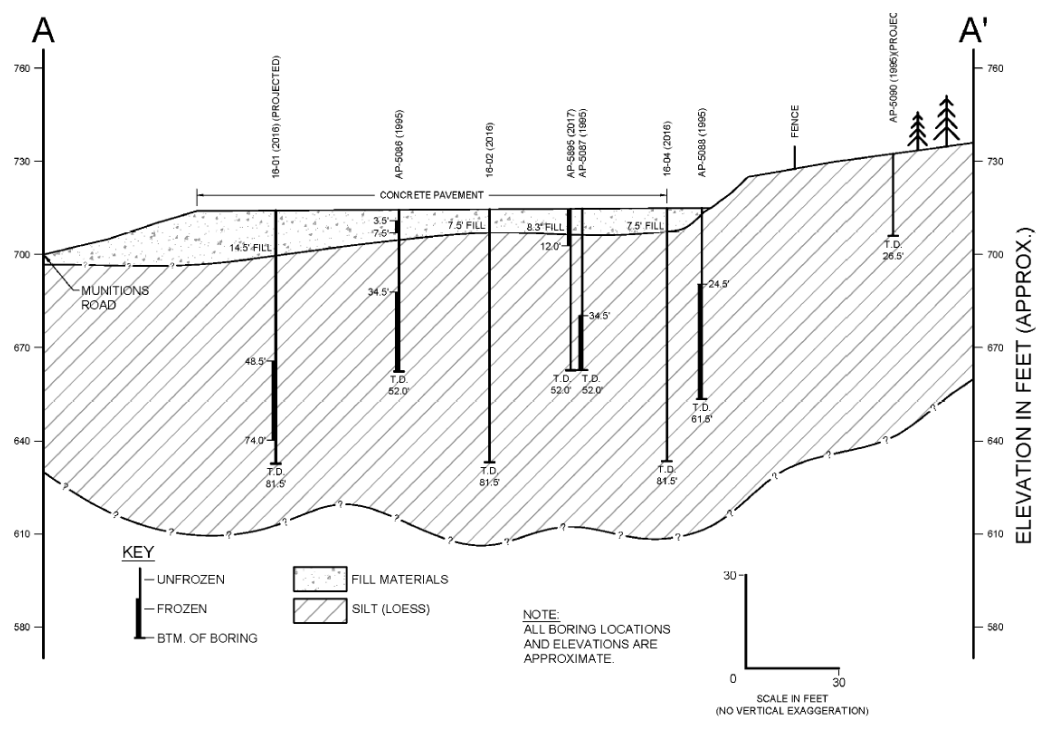
Figure 2. Key features of Building 6385 and the associated fence diagram (R&M Consultants 2017).

This study centers on Building 6385 (Figure 2) (6385 is a building within the facility EIE431), which is experiencing differential settlement. This geophysical investigation was conducted to provide data to aid foundation design for the replacement and redesign of Building 6385.

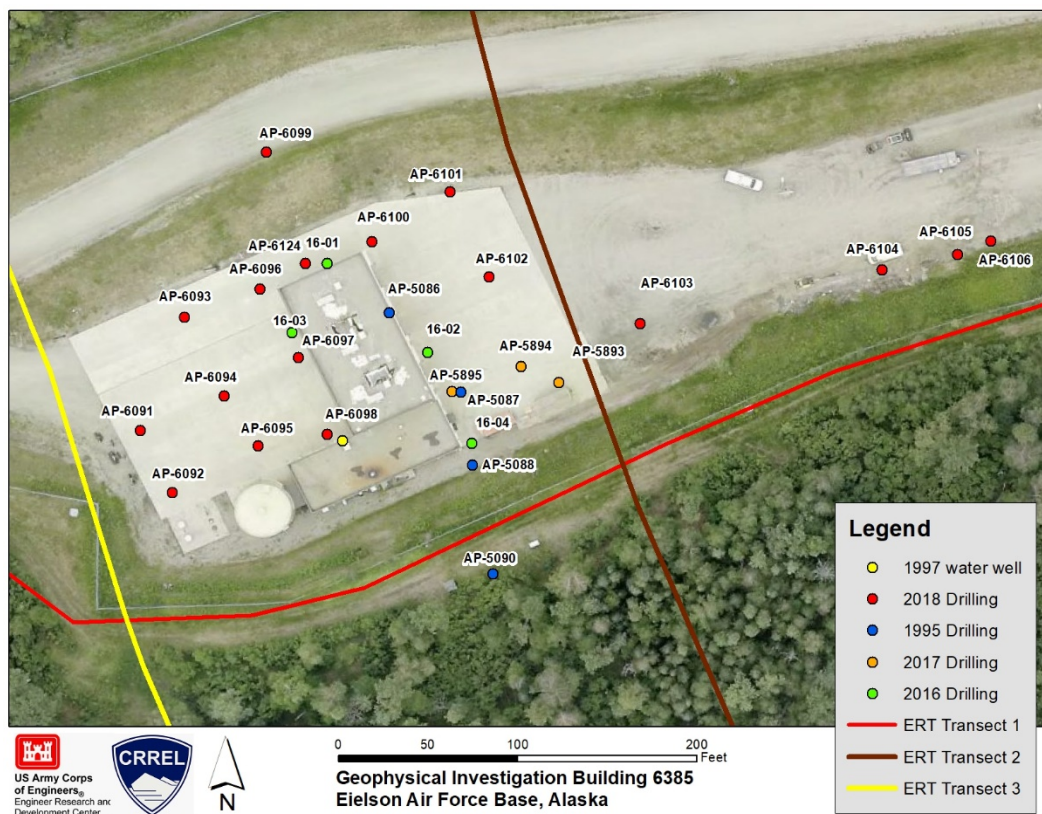
Figure 8. Drilling data overview.

- AP-5895 (52 ft drilled in 2017) and AP-5087 (52 ft, 1995) were drilled approximately 5 ft apart. AP-5087 (1995) encountered frozen soil from a depth of 34.5 ft to the bottom of the test hole, while AP-5895 (2017) encountered thawed soil to a depth of 52 ft. This contrast illustrates the extent to which thaw has propagated into the subgrade over the 23 year span.
- 16-02 (81.5 ft, 2016) encountered thawed soil from the ground surface to a depth of 81.5 ft, and 16-04 (81.5 ft, 2016) encountered thawed soil to a depth of 81.5 ft.

- AP-5086 (52 ft, 1995) and AP-5088 (61.5 ft, 1995) both intercepted frozen soil at depths of 34.5 and 24.5 ft, respectively. These test holes are both located relatively close to more recent borings (16-02 and 16-04) that encountered thawed soil to depths greater than 80 ft. This relationship suggests frozen soil documented by AP-5086 and AP-5088 is now thawed.

- AP-5893 (52 ft, 2017) was drilled in March and encountered 12 ft of seasonal frost and frozen soil beneath a perched water table from depths of 32 ft to the bottom of the test hole. AP-5894 (51.5 ft, 2017) was drilled in March 2017 and encountered 9 ft of seasonal frost and frozen soil from a depth of 30 ft below the ground surface to the bottom of the test hole. AP-6103 (22 ft, 2018) was drilled 22 ft away from AP-5893 and intercepted thawed soil to the bottom of the test hole.

- **Bedrock**—This unit is delineated in Figure 9 with dashed pink lines and question marks to illustrate uncertainty. Bedrock in the area was encountered by the well drilled in 1997, AP-6098, and possibly AP-6097 (Figure 8). In the pseudosection, bedrock is shown as broad, generally high resistive areas with signals trending up from depth. There is localized low resistivity within this interval that is likely related to the groundwater in the fractured upper interval of the bedrock. Conductivity in this unit correlates with saturated fractures intercepted by the well log at a depth that is consistent with the change from low to high resistivity in the pseudosection. Based on this pseudosection, it appears that the bedrock has a shallow west apparent dip. AP-6098, AP-6097, and the 1997 well log have bedrock encounter depths that support the interpretation that the top of bedrock, as it is shown in Transect 1, has an apparent shallow west dip.
