## **Guided-Wave Inspection of California Department of Water Resources Tainter Gate Trunnion Rods**

Inspection of Oroville Dam, Thermalito Bypass, and Pyramid Dam

Jason D. Ray, Richard D. Brown, and James A. Evans

September 2019

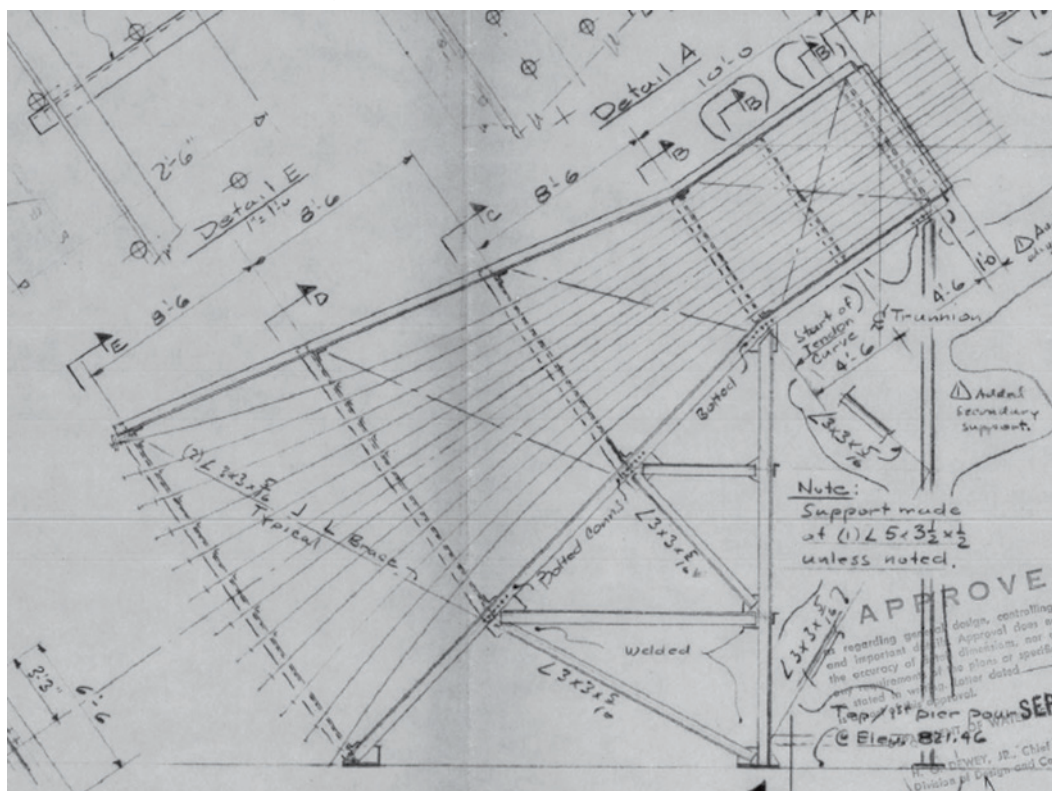
**Figure 3. Rod curvature at Oroville Dam.**

Drawings of the trunnion bundles at the Oroville Dam, Oroville, California, Thermalito Bypass, Oroville-Thermalito Complex, and Pyramid Dam, near Castaic, Southern California, show that the original installation of the tendons required them to be installed in such a fashion, that while the exposed ends run parallel to each other, the dead end is curved to a higher and higher degree, proceeding up and down the rows of the bundles. Oroville Dam is shown in Figure 3 and the Thermalito Bypass is shown in Figure 4. Due to the smaller number of rods, it is assumed that greater curvature was not necessary at the Thermalito Bypass. Pyramid Dam is shown in Figure 5.

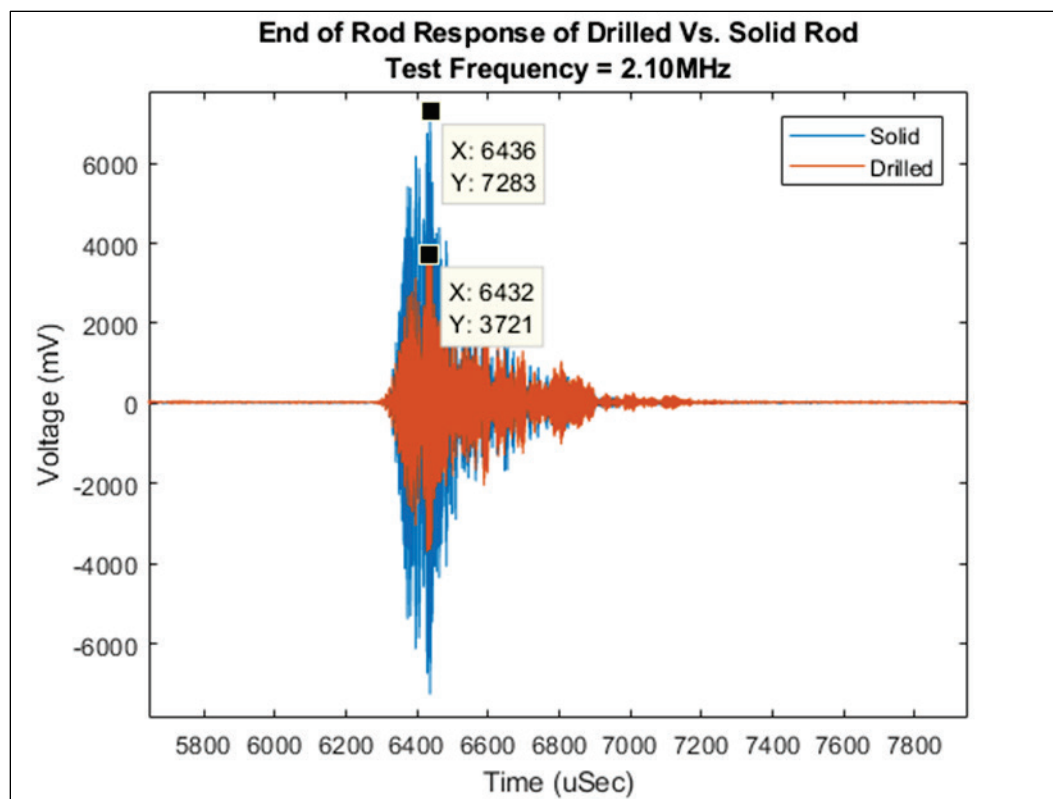
Figure 6. Drilled vs. solid tendon.

Through the use of the trunnion rod test bed at ERDC, the effects of having the end drilled on a 60 foot long, 1.25 in. diameter rod was compared to a solid specimen. The results of the first end of rod rebound at the test bed are shown in Figure 6.

The drilled tendon end resulted in a decrease in end of rod response amplitude of 5.8 decibels (dB). This showed that while there is a decrease in how much initial energy is injected, enough energy transfers to propagate the rod length.

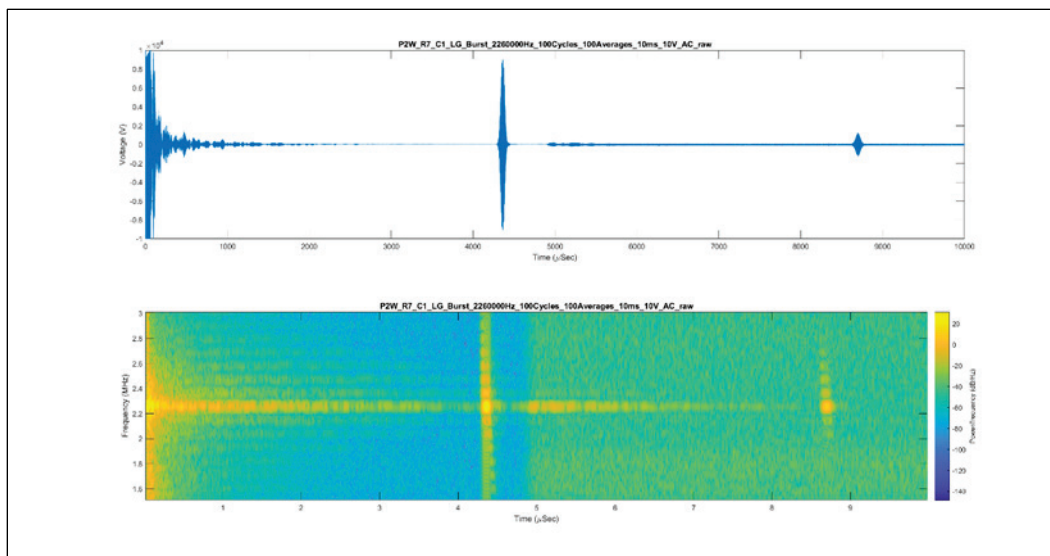
Figure 10. Oroville Dam: Gate 4, west; Row 1, Column 1; no issue.

Rod condition is labeled in one of the following three categories: No Issue, Anomaly, and Possible Defect. The No Issue category represents a rod where based upon the majority of the responses obtained across the dam, these rods provide a clean signal between end of rod rebounds. An example of a No Issue response is shown in Figure 10.

Figure 10 contains two plots that determine rod condition during post processing. The top plot is received when the testing is complete, the return amplitude of the signal expressed in volts on the y-axis and time on the x-axis. The second plot is a time-frequency representation of the same signal. One characteristic of the guided wave response is that the higher mode frequencies return slightly faster than the lower mode frequencies. This provides a fingerprint that surrounds the centralized testing frequency. Any response from an actual reflector would look like this, but more attenuated. The two echoes shown in Figure 10 are from end of rod rebounds.

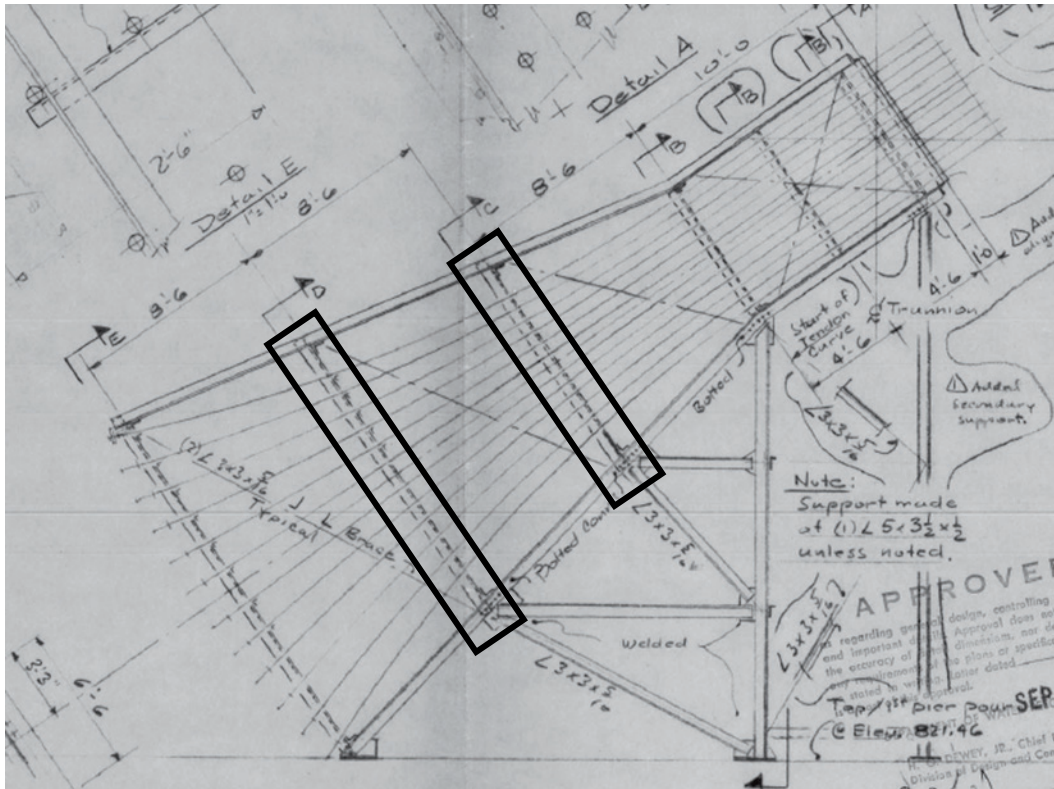
**Figure 11: Anchor guide distance.**

The Anomaly category is mostly limited to the upper and lower most rods. In addition to the attenuated signal response, the reflectors were noticed before the end of rod response. These reflectors appear at roughly the same point in time for the rods labeled as anomaly. As detailed in 2.1.2, these rods were curved during installation. Due to the frequency of occurrence within the curved rods, it appears that the curvature is the cause for these anomalies. One possibility for this occurrence would be sleeve contact where the rod sleeve rests on internal guides as seen in Figure 11. According to the original drawings, the first of these guides appear at a rod length of 18'6" plus the exposed length of rod. The first anomaly reflector appears around 15' in the rod according to the received data.

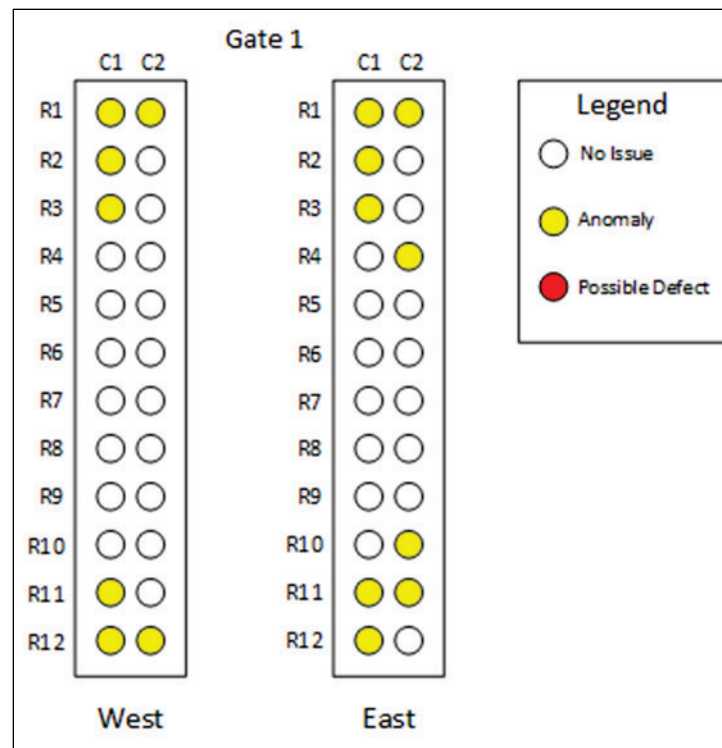
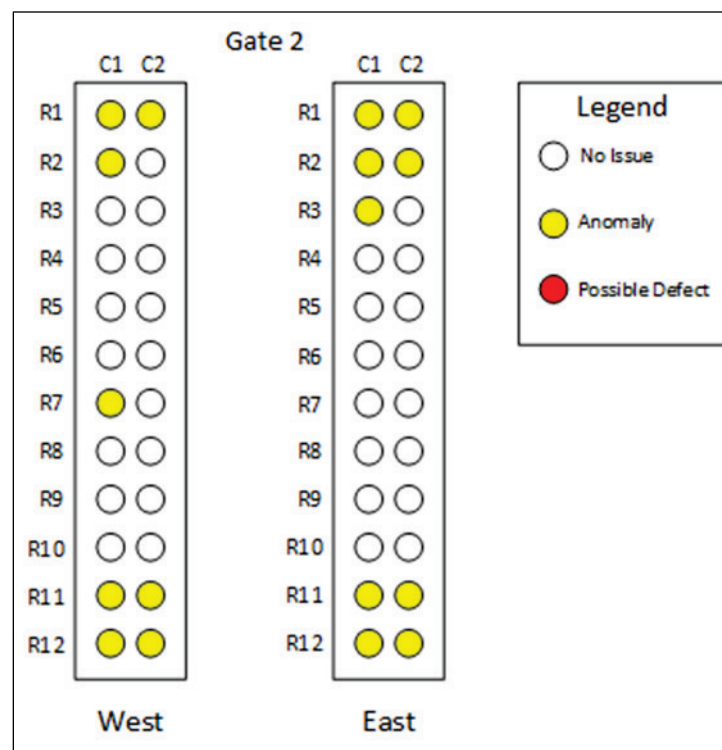
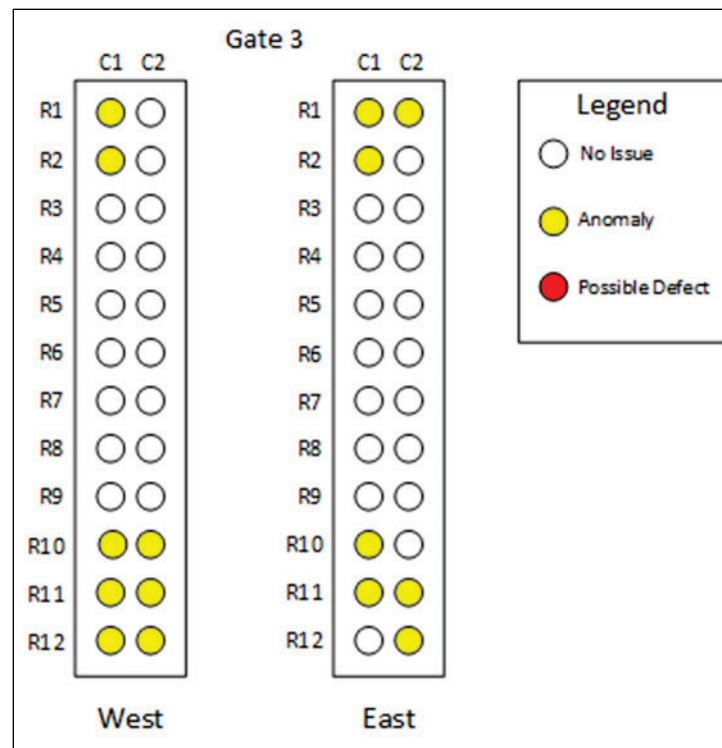
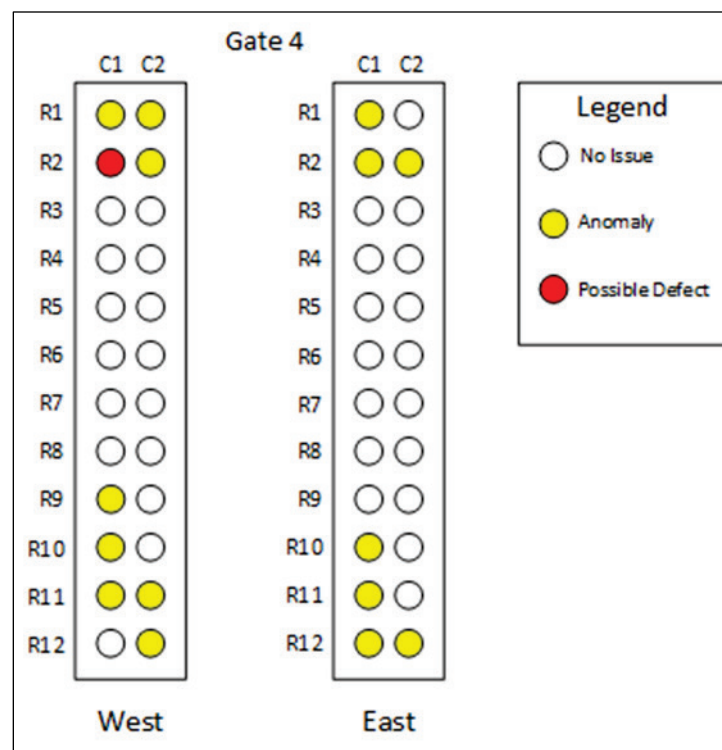
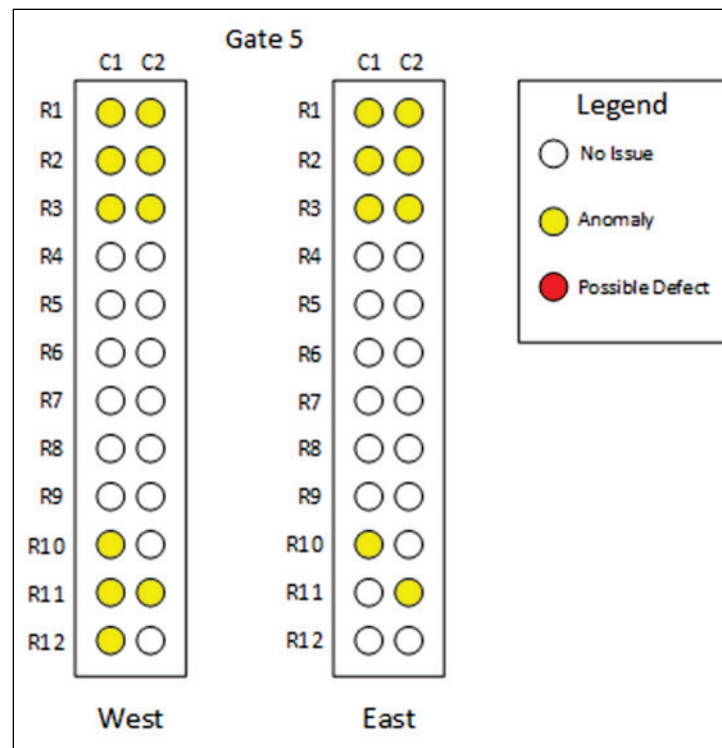
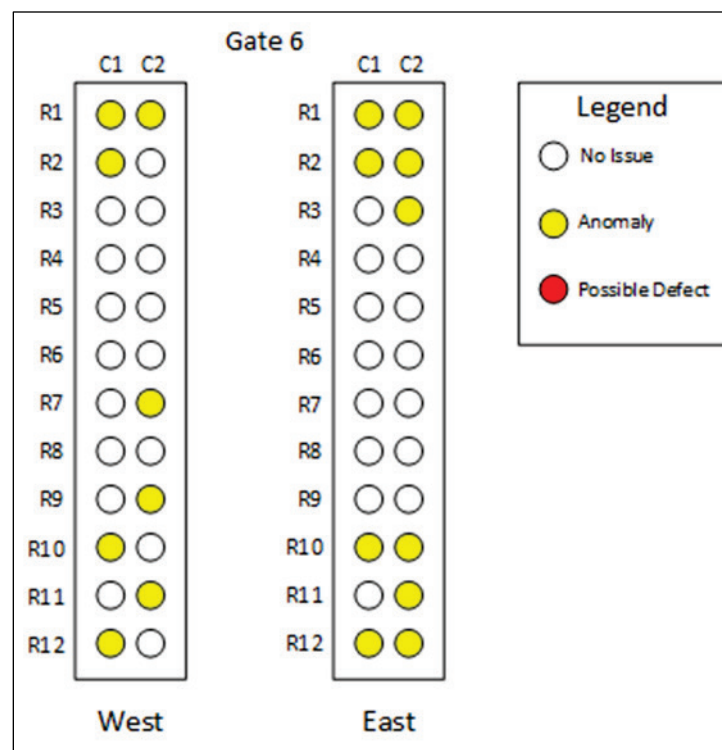
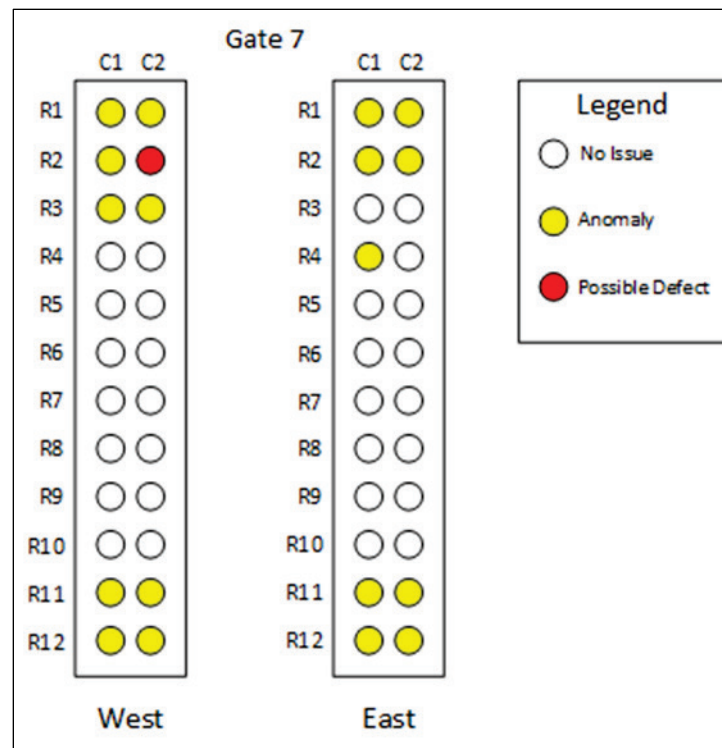
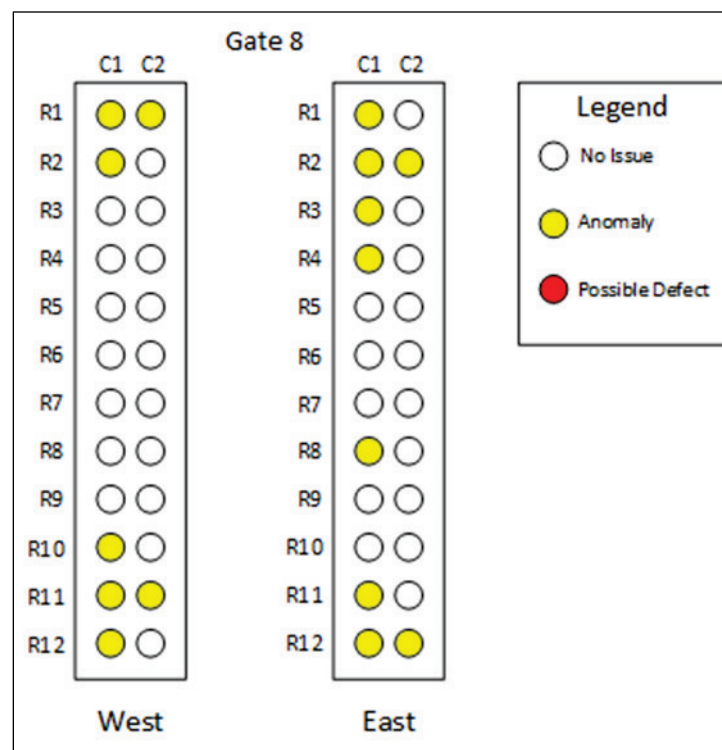
Of the 384 rods tested, two rods are labeled as possible defects — Gate 4, west bundle; Row 2, Column 1, and Gate 7, west bundle; Row 2, Column 2. The responses of these two rods are shown in Figure 14 and Figure 15.

Figures 16–23 show the results of the 384 rods tested at Oroville Dam. Rods labeled as No Issue are white; Anomaly are yellow; Possible Defect are red. The gate order of the dam in Figure 16 is from the orientation of looking upstream.

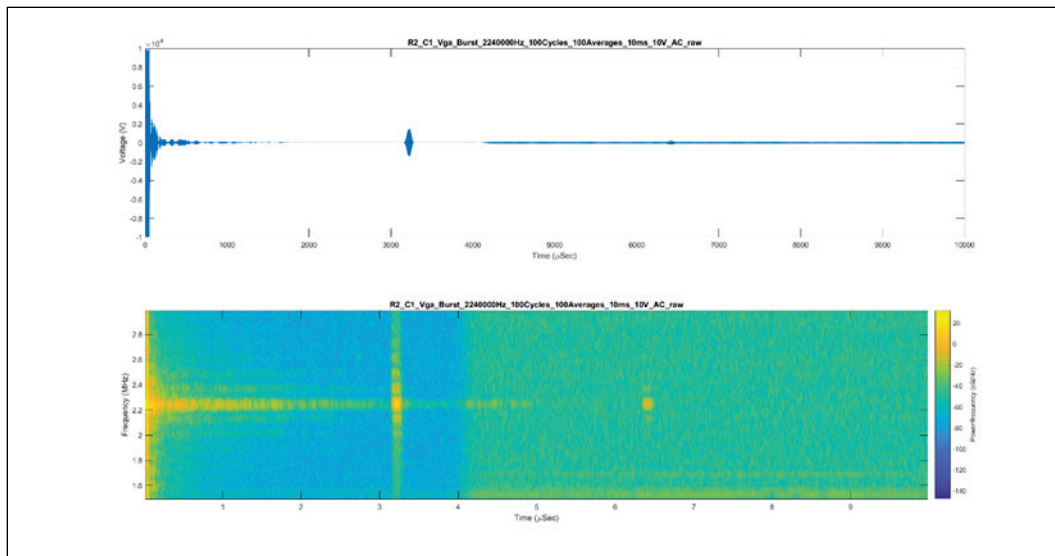
Figure 26. Thermalito Bypass: east; Row 2, Column 1; no issue.

As with Oroville Dam, the more curved rods showed evidence of reflectors while the straighter rods came back with no evidence of issues. 16 rods were tested, Figure 26 shows the results of one of the rods showing No Issue. Figure 27 shows the results of one of the rods being labeled as an anomaly.

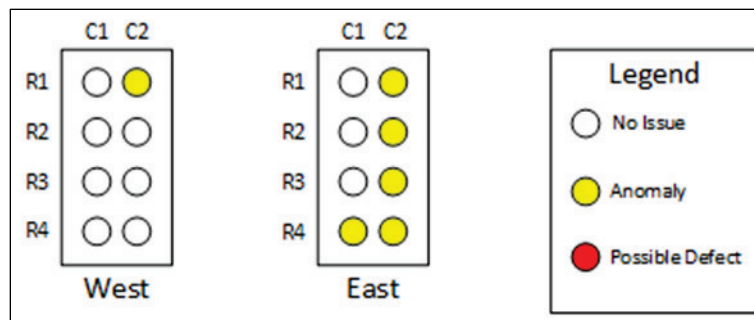
Figure 28. Thermalito Bypass rods testing results.

Figure 28 shows the results of the 16 rods tested at the Thermalito Bypass gate. Rods labeled as No Issue are white; Anomaly is yellow; Possible Defect is red.

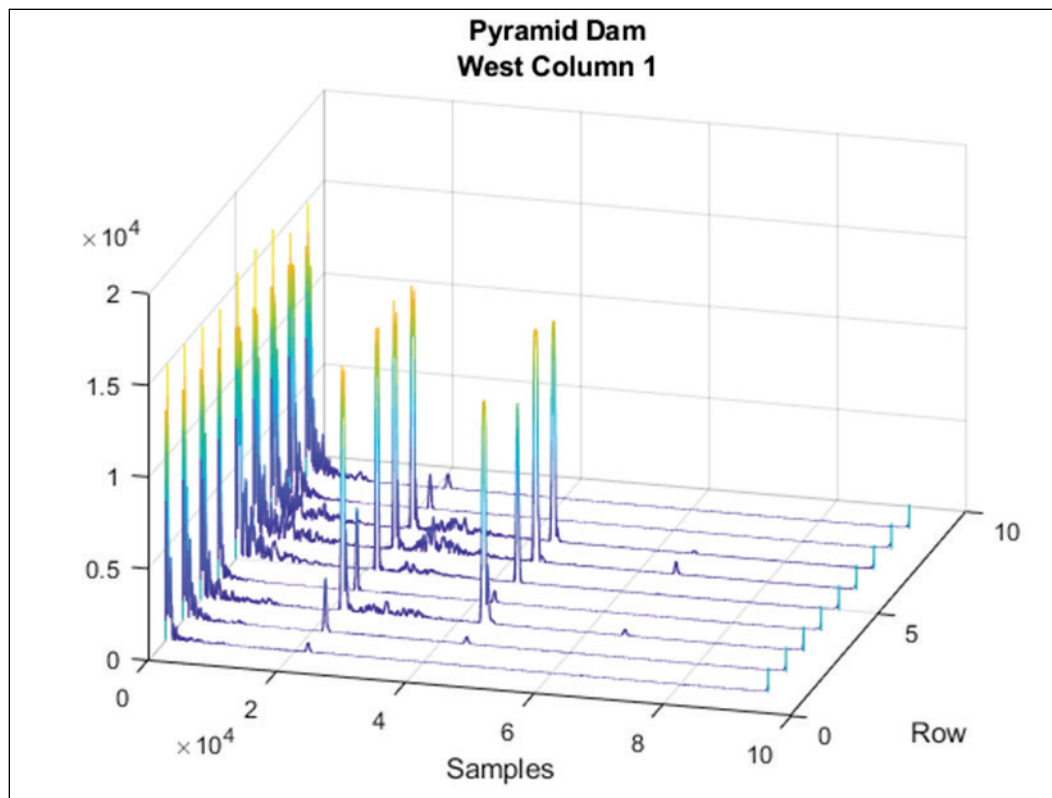
Figure 30. Pyramid Dam rod curvature effects.

Like Oroville Dam and Thermalito Bypass, Pyramid Dam contains rods that are curved. The rods of a single column in a bundle were plotted together to show the effects the curvature has on the signal. The results are shown in Figure 30.

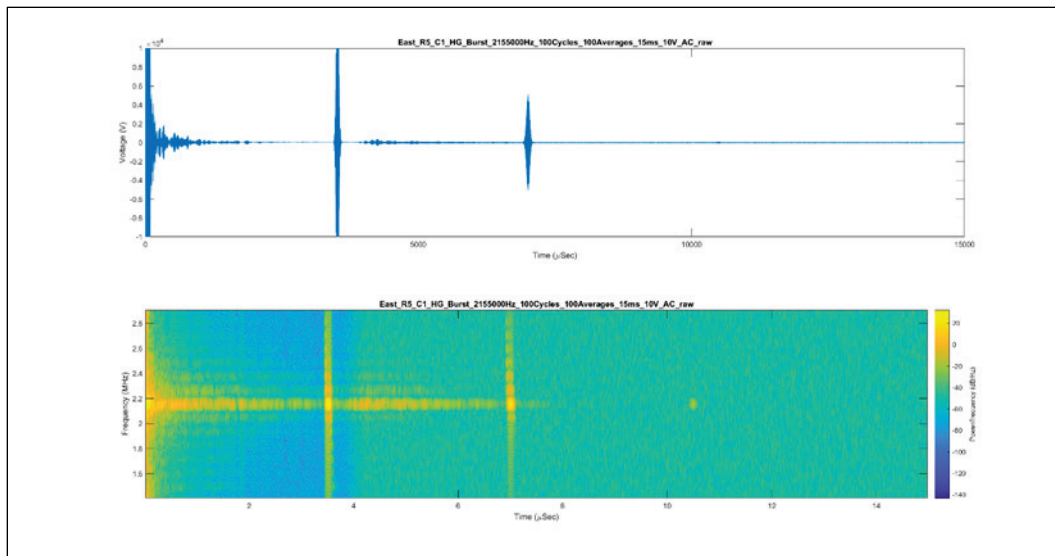
Figure 31. Pyramid Dam: east; Row 5, Column 1; no issue.

Figure 31 is an example of a rod showing No Issues. Further evidence supporting the theory that rod curvature causes anomalies in the data; the rods at Pyramid Dam exhibited reflectors on the rods that bend upward and downward within the dam. This effect is seen in Figure 32.

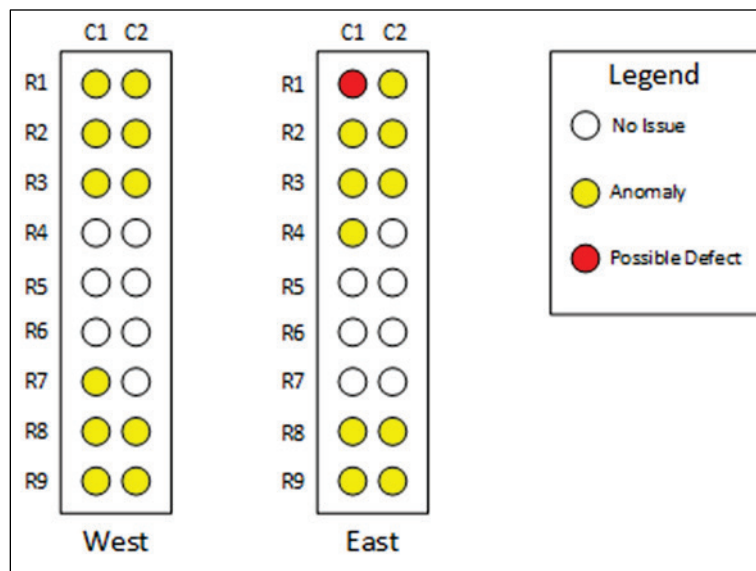
Figure 34. Pyramid Dam rods testing results.

Very similar to the Oroville rod response of Figure 14, Figure 33 shows a possible defect on rod east bundle; Row 1, Column 1. Even though the response time of this anomaly is similar to the other curved rods, the amplitude is much greater than the others.

Figure 34 shows the results of the 36 rods tested at the Pyramid Dam. Rods labeled as No Issue are white; Anomaly is yellow; Possible Defect is red.
