# **FINAL REPORT**

## **Demonstration and Validation of LHE Zn-Ni Plating Process**

**ESTCP Project WP-201107**

**May 2018**

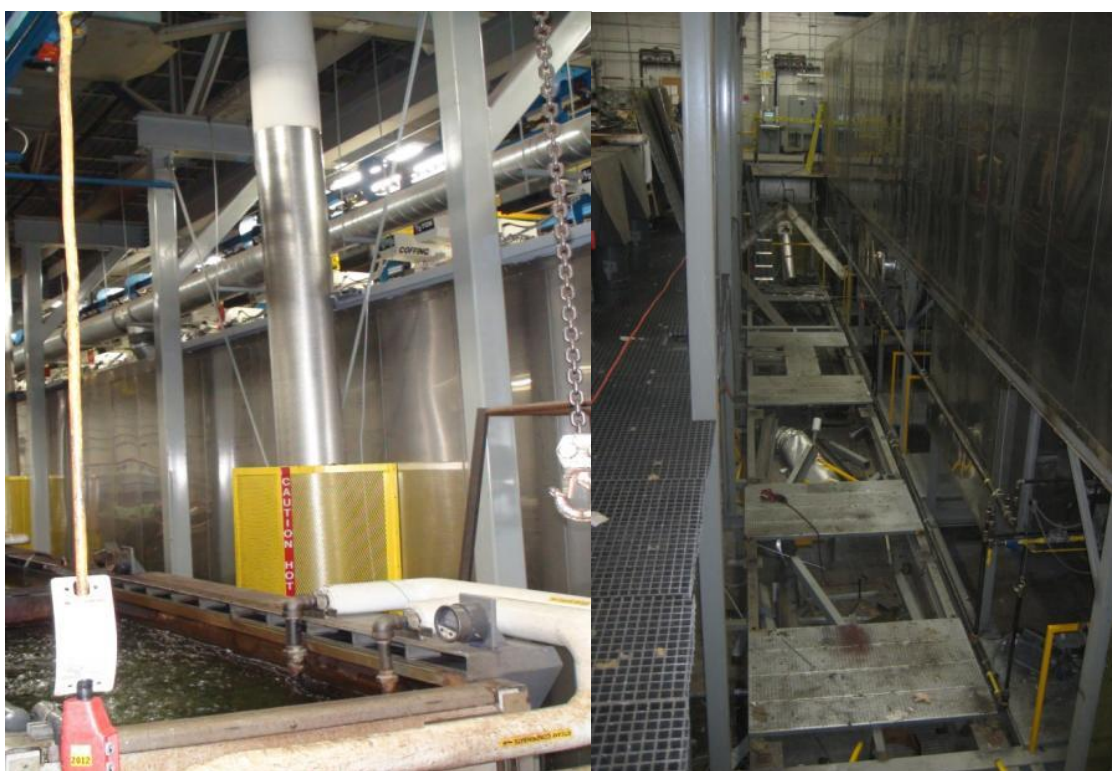
**Figure 5: Industrial Oven Removal**

Making space available for the new plating tanks required removal of a large industrial oven (Figure 5), removal of the current chiller, and four tanks from the current Cd line were relocated to the area where the industrial oven was removed.

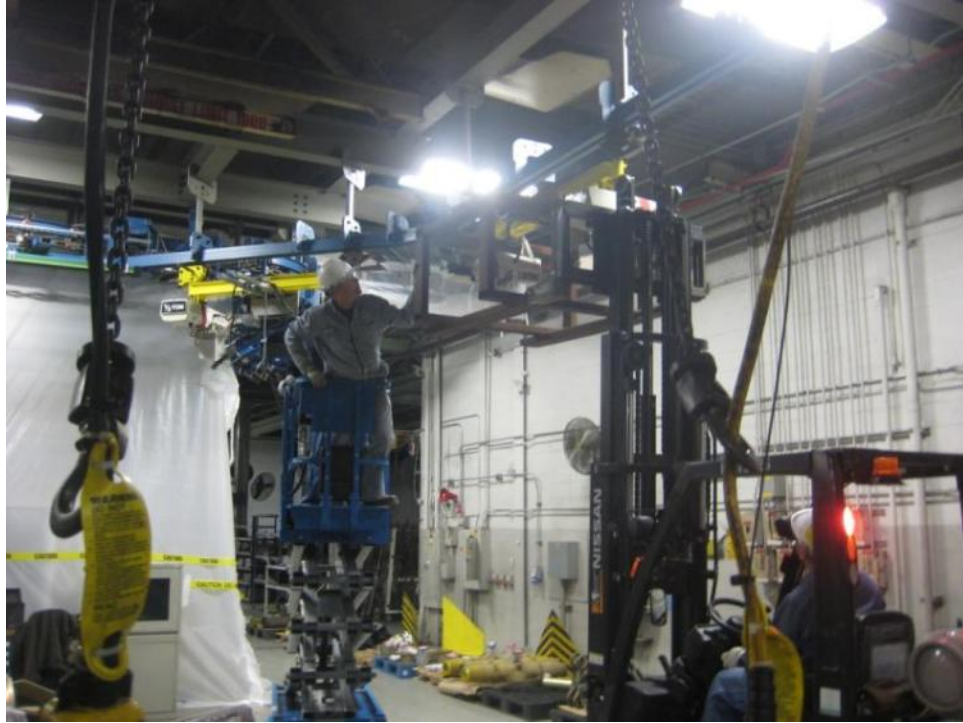
**Figure 6: Overhead Trolley Removal**

Modification and removal of a section of the overhead trolley hoist system was required for both the ovens and the plating line to allow for a monorail hoist system (Figure 6).

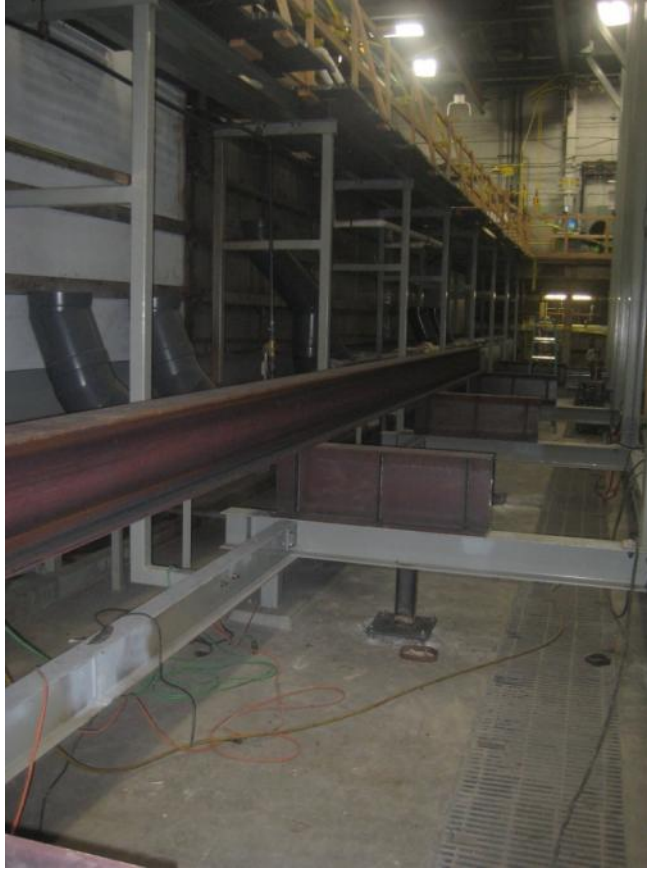
**Figure 7: Footing and Structure Re-Establishment**

Upon completion of the demolition and removal of the equipment, a survey of the structural members was completed and structural calculations were performed to determine any additional support structure required for the tank installation and overhead monorail. It was found that 14 footings were required to be re-established to ensure structural integrity of the plating line and monorail (Figure 7). Additional structural steel was required to raise the tanks to working level above floor.

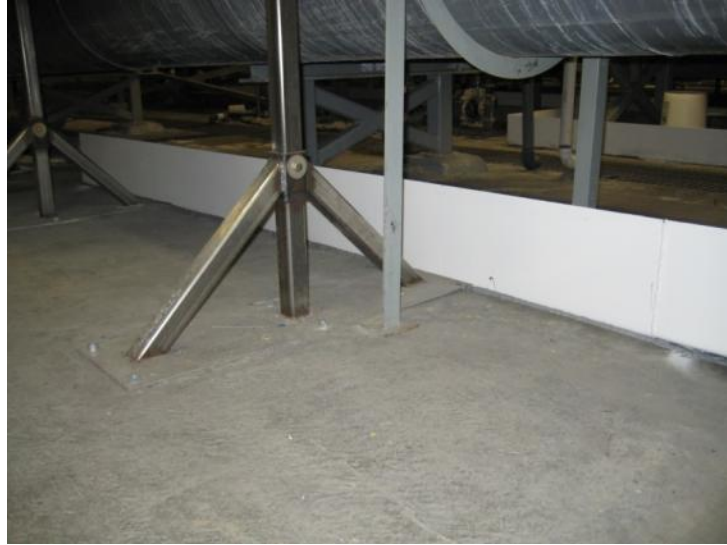
**Figure 8: Containment Barrier**

A containment barrier was added in the basement of the building (Figure 8) to prevent the possibility of any acid leaks from mixing with any Cd waste water or leaks from the Cd plating line (mixture of acid solutions with Cd plating solutions will release cyanide gas which is very poisonous and dangerous to plating personnel).

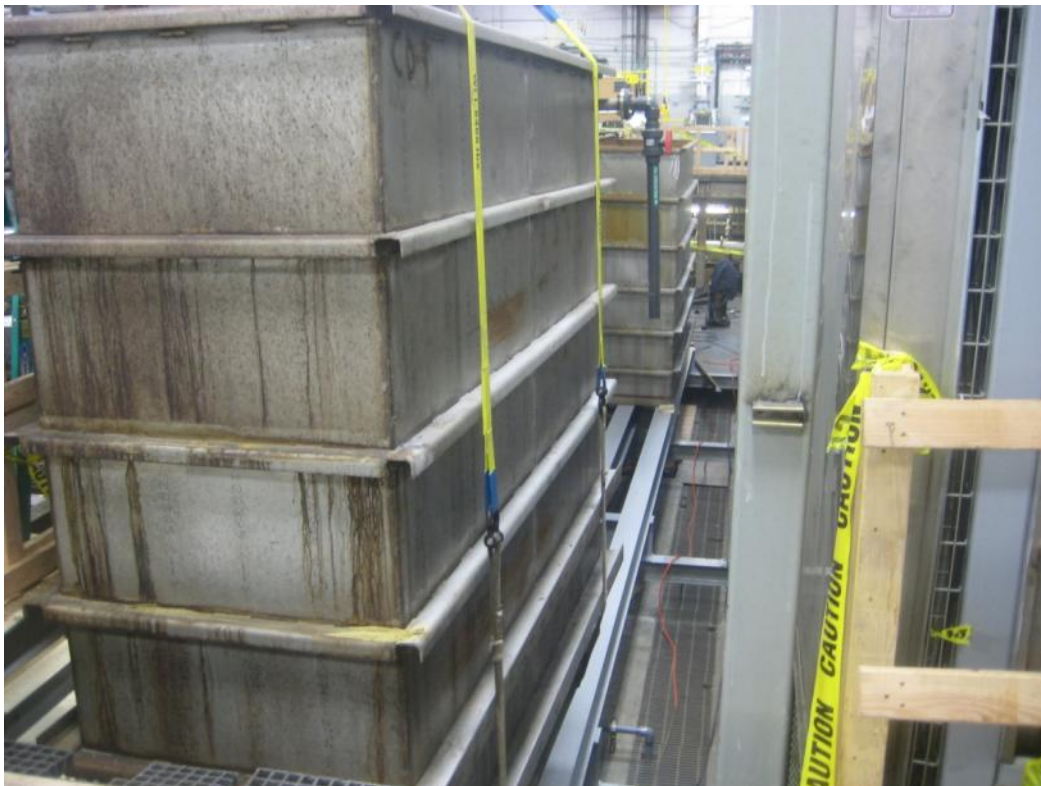
**Figure 9: Iridite Tank Line Relocation**

For waste stream containment purposes, the iridite tank line was relocated to the vacated oven space. Four tanks including all piping, electrical, and exhaust were moved to the newly established structure where the industrial oven had been removed (Figure 9).

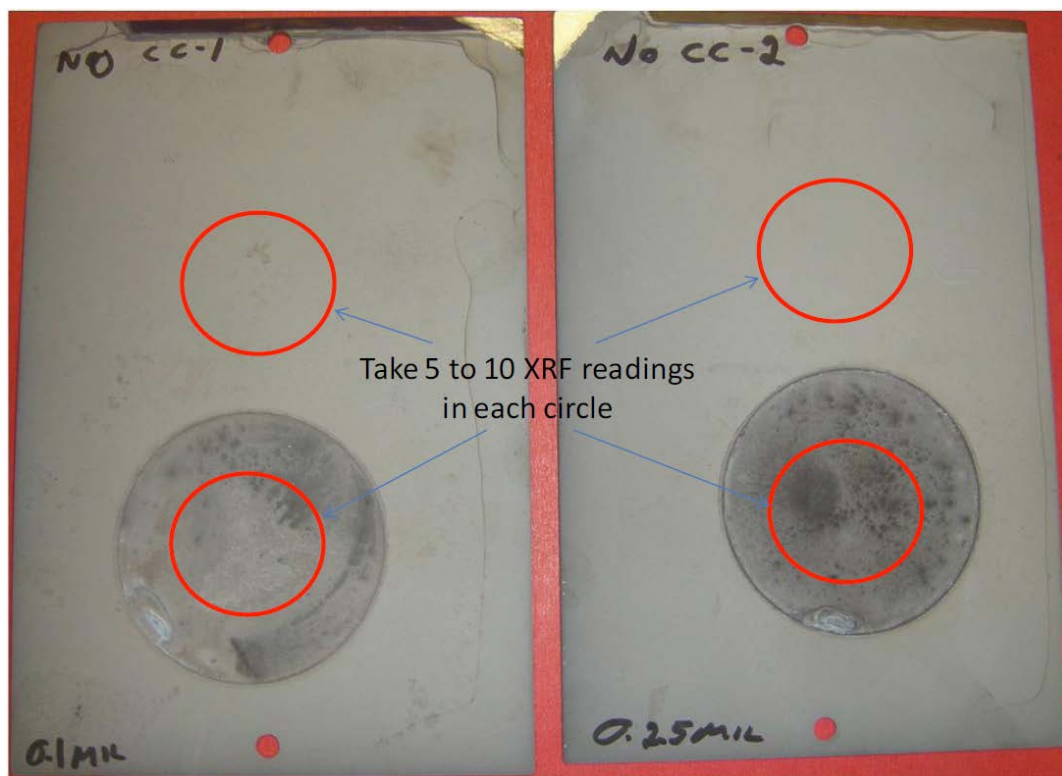
**Figure 26: LHE Zn-Ni Panels NO-CC-1 and NO-CC-2 After Anodic Etching**

CC-2 and NO-CC-2 were placed in 3.5 % Na-Cl water solution and then anodically etched (using polarization data of  $2 \times 10^{-5}$  A/cm<sup>2</sup> from 6.1.2.3 of this report) in order to remove 0.25 mils of LHE Zn-Ni.

Figure 26 shows pictures of NO-CC-1 and NO-CC-2 after 0.1 and 0.25 mils of LHE Zn-Ni were removed and Figure 27 shows pictures of CC-1 and CC-2 after 0.1 and 0.25 mils of LHE Zn-Ni were removed.

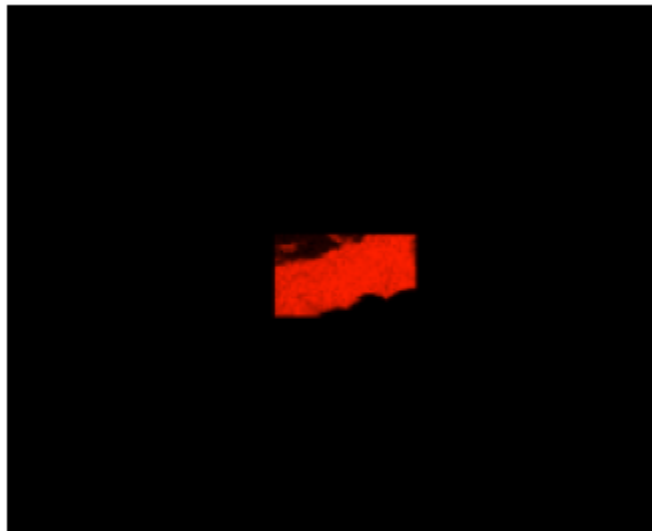
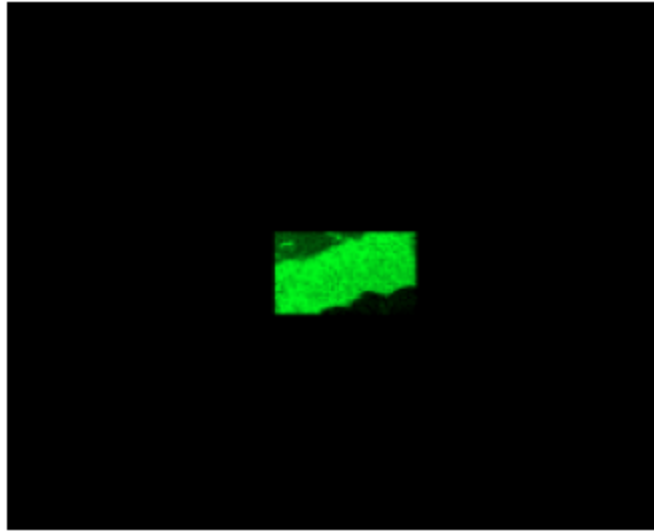
The plating was cross sectioned using FIB in corroded and un-corroded regions of the samples along with EDS chemical analysis to determine the LHE Zn-Ni ratio in the cross-sectioned areas. This showed the LHE Zn-Ni composition change with depth due to corrosion. The EDS area scans shown in Figure 29 and Figure 30 show uniform stable distribution of Zn and Ni. There are no concentrations of either element rather a homogeneous structure of Zn and Ni.

**Figure 29: Zn Concentration from NCC Area Scan**

**Figure 30: Ni Concentration from NCC Area Scan**

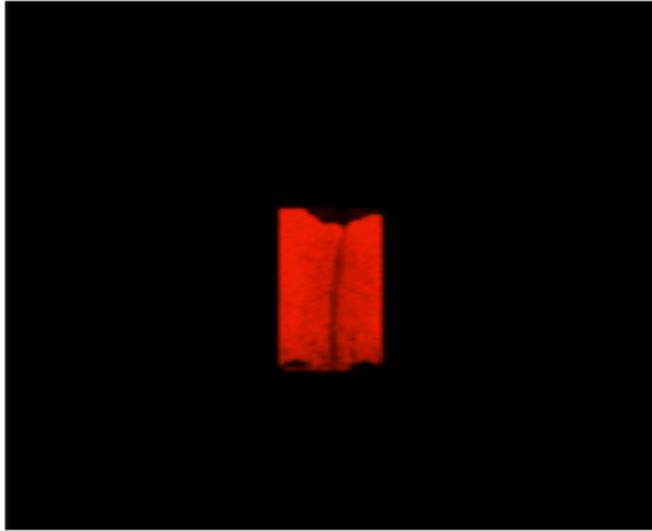
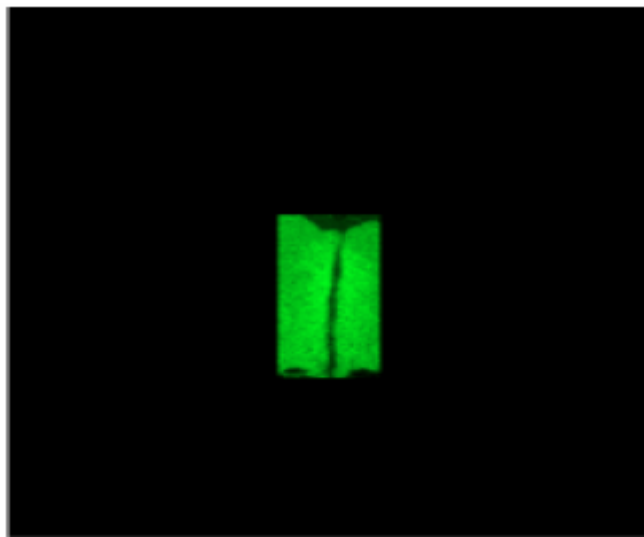
**Figure 32: Zn Concentration from CC Area Scan**

**Figure 33: Ni Concentration from CC Area Scan**

Results from all of the scans show that there may be slight loss of percent weight of Zn during corrosion and that the LHE Zn-Ni ratio may also be varying in depth, however there was a large fissure in the cross-section area that may have affected the results (see Figure 31 - Figure 33). The normalized percent weight of the samples are shown in Table 10. It is noted that the concentrations of Ni are higher than the correct concentrations of Ni. This is due to the fact that there was no standard for the EDS equipment to calibrate against. There can only be a comparison made from the Un-corroded %wt and the Corroded %wt.

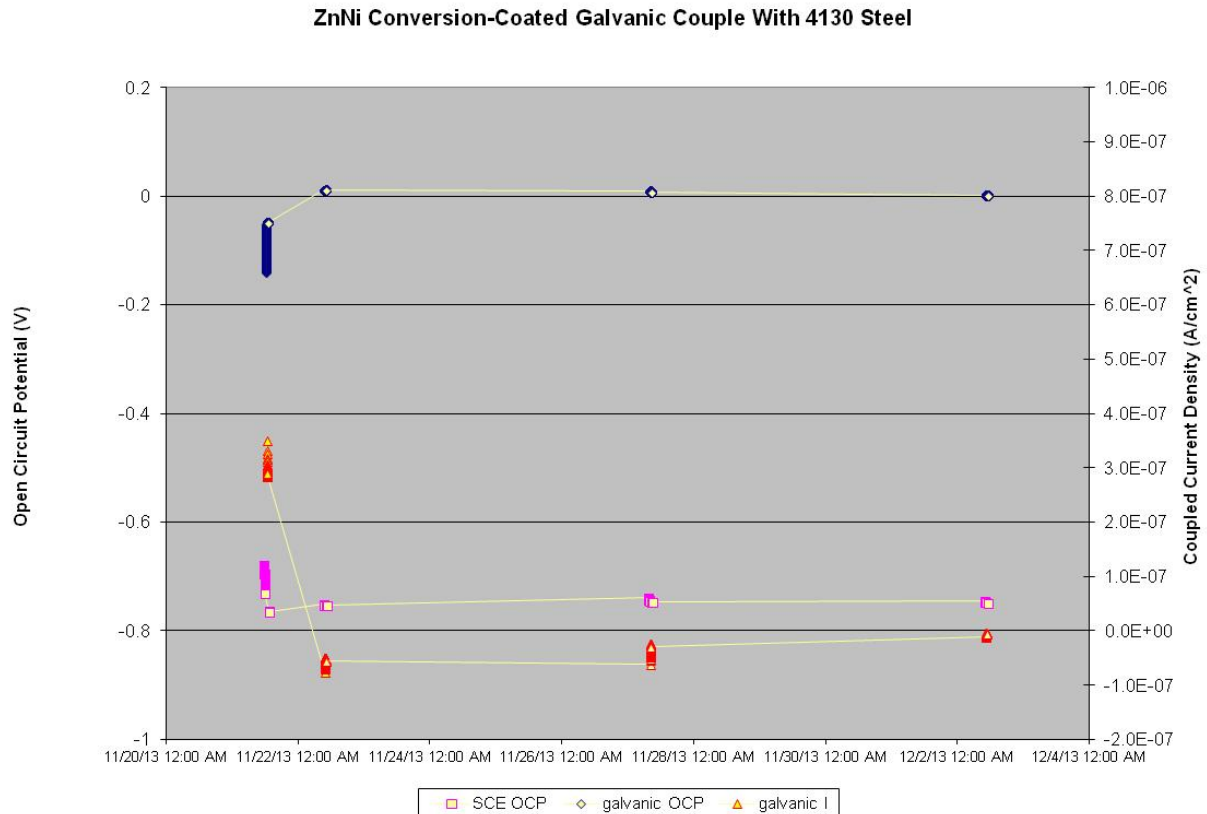
**Figure 36: ZRA of LHE Zn-Ni CC Coupled with 4130 Steel**

The data in Figure 36 shows that LHE Zn-Ni with CC had a very steady OCP (open circuit potential) of -0.74 to -0.76 V vs. SCE (steel is typically -0.6 to -0.7 V vs. SCE) during the 10 day test and the OCP for LHE Zn-Ni when coupled to steel was -0.050 V. The initial galvanic current flow between the LHE Zn-Ni and bare steel was  $2.8 \times 10^{-7}$  A/cm<sup>2</sup> (LHE Zn-Ni is anodic to the steel) but the galvanic current flow quickly dropped within one day to zero or slightly cathodic to the steel.

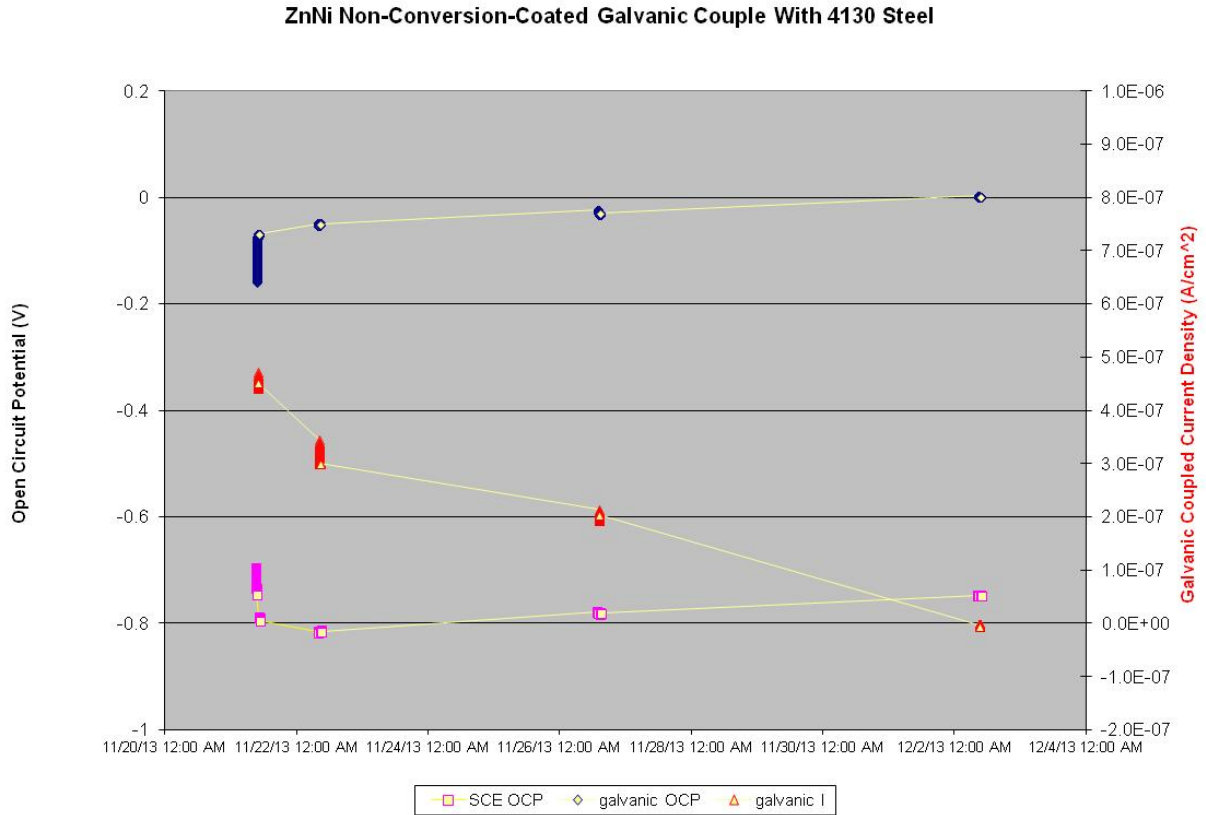
**Figure 37: ZRA of LHE Zn-Ni NCC Coupled with 4130 Steel**

The data Figure 37 shows that LHE Zn-Ni without CC had an initial OCP of -0.82 V vs. SCE and then it dropped to -0.75 V vs. SCE after 10 days and the OCP for LHE Zn-Ni when coupled to steel was -0.080 V. The initial galvanic current flow between the LHE Zn-Ni and bare steel was  $4.5 \times 10^{-7} \text{ A/cm}^2$  (LHE Zn-Ni is anodic to the steel) and then the galvanic current flow slowly dropped to zero or slightly cathodic to the steel after 10 days.

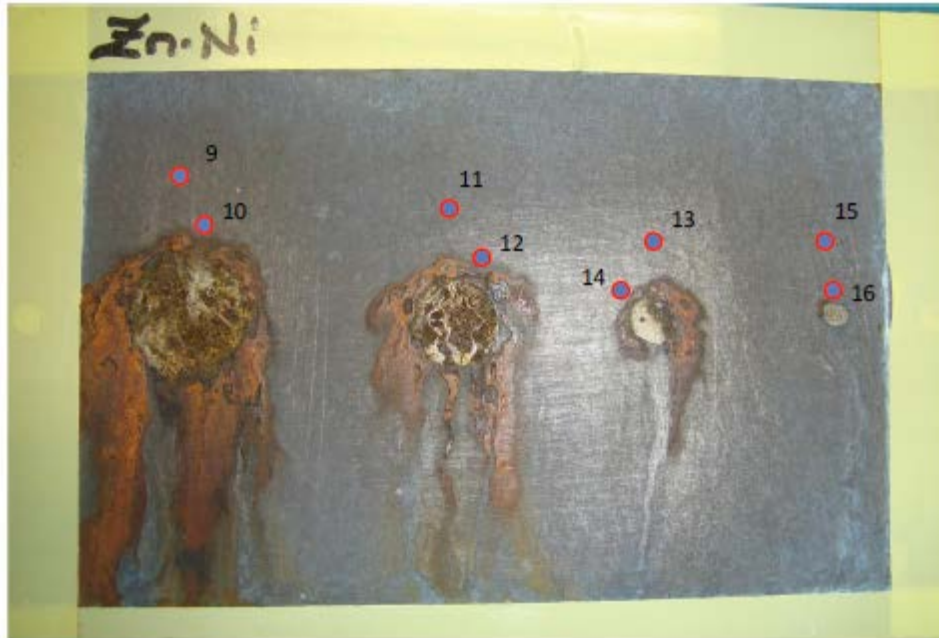
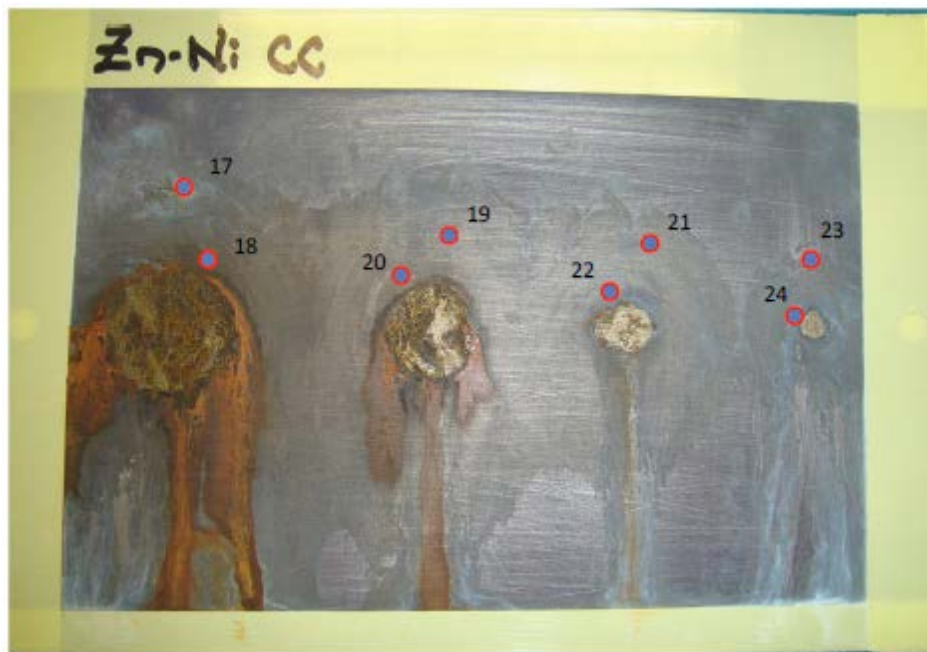
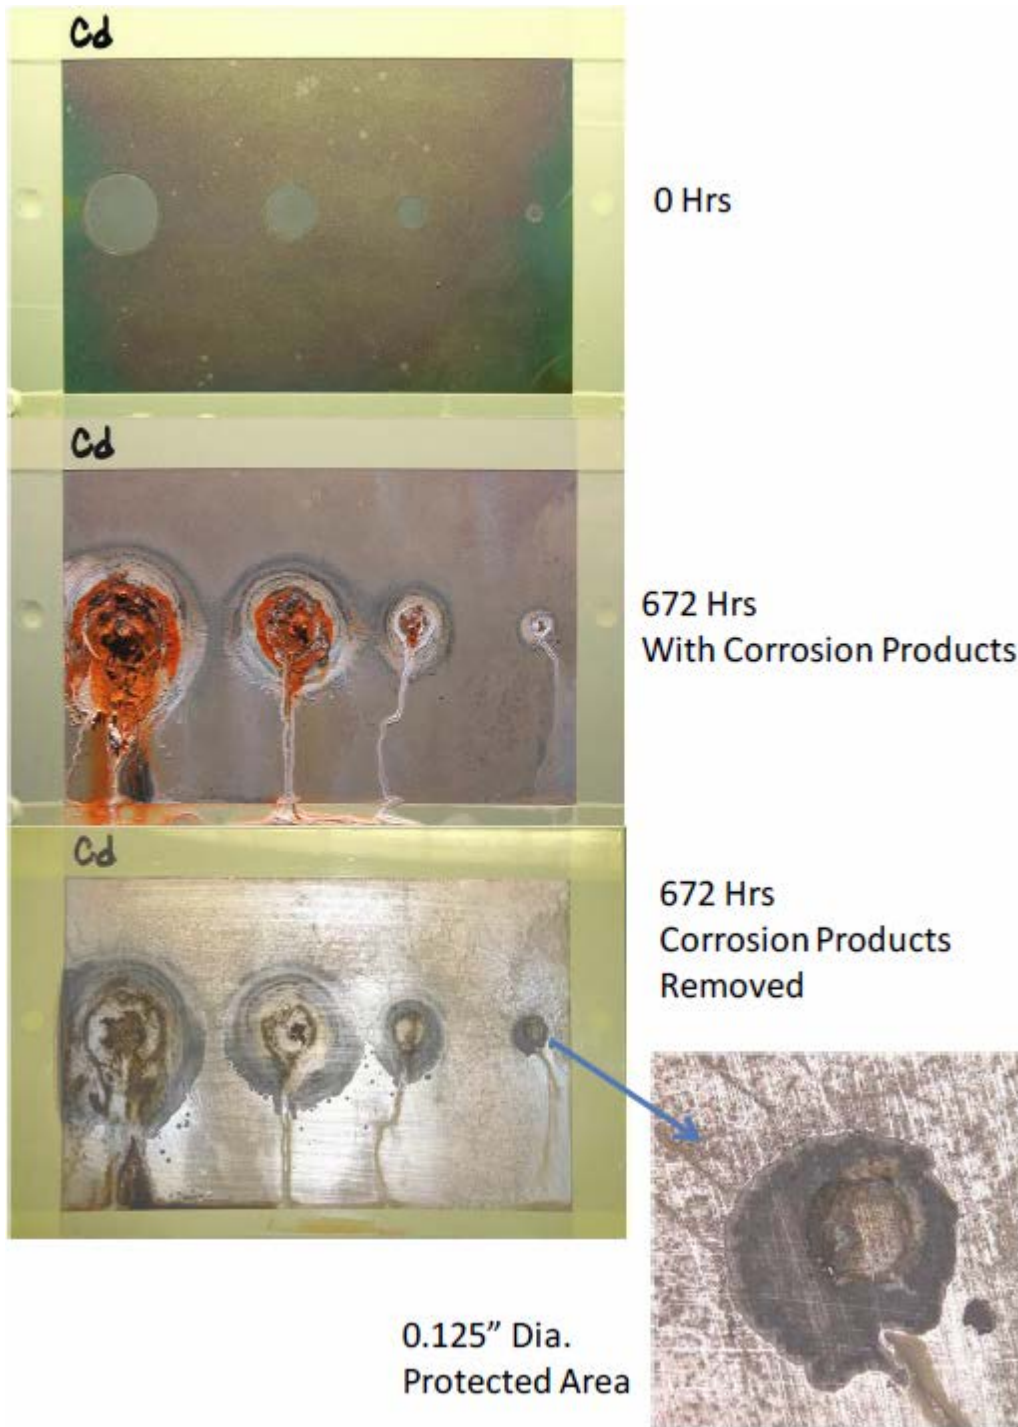
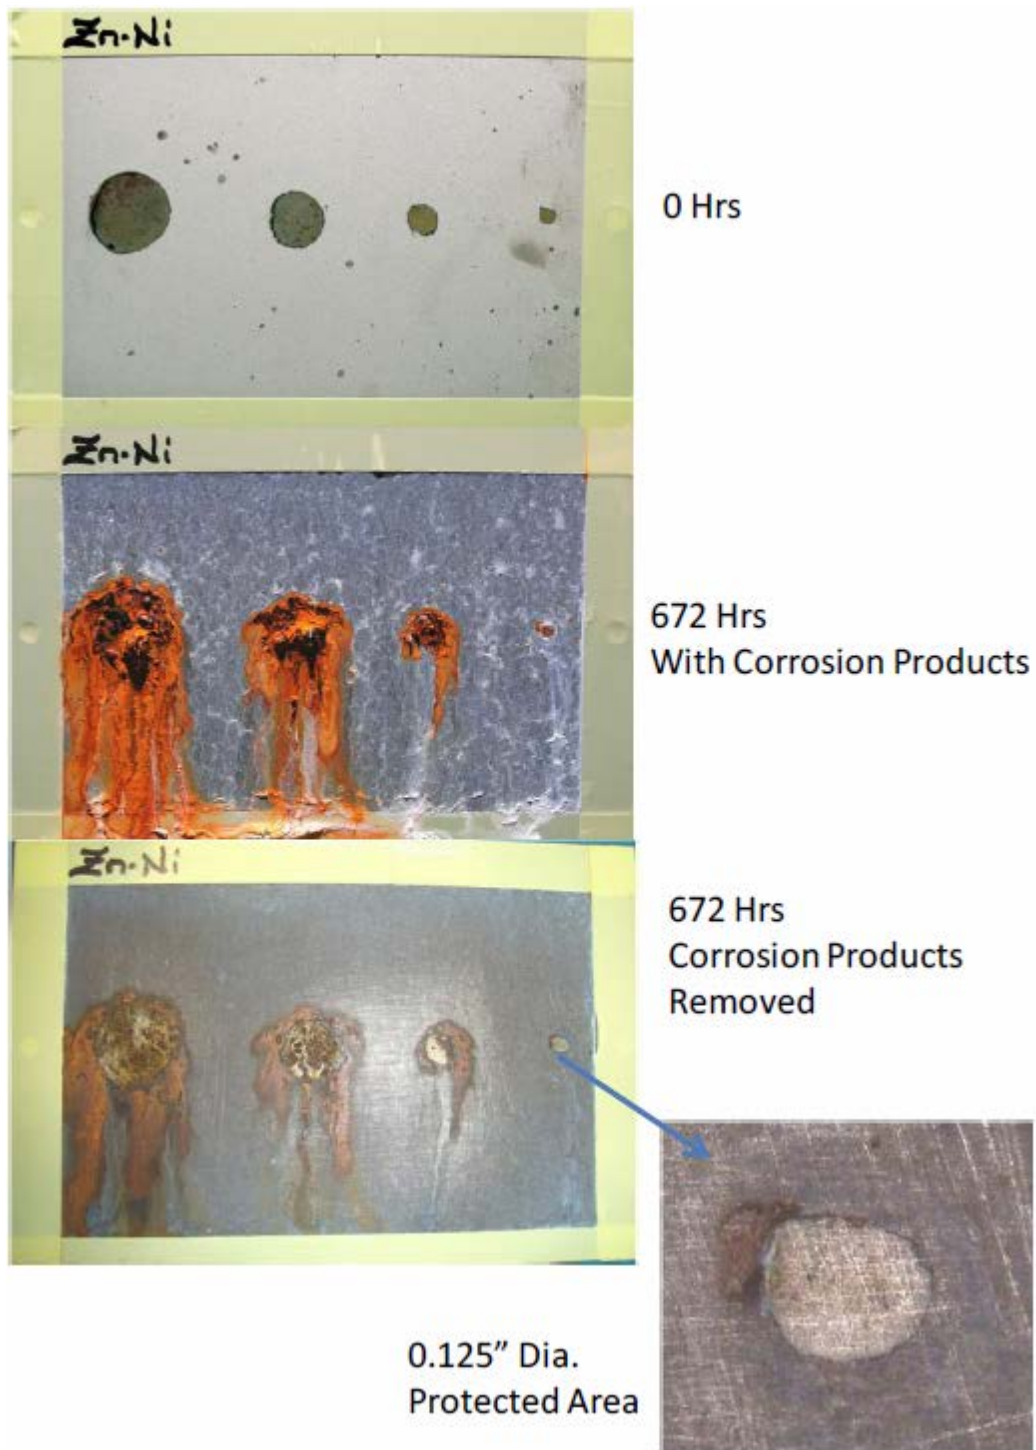
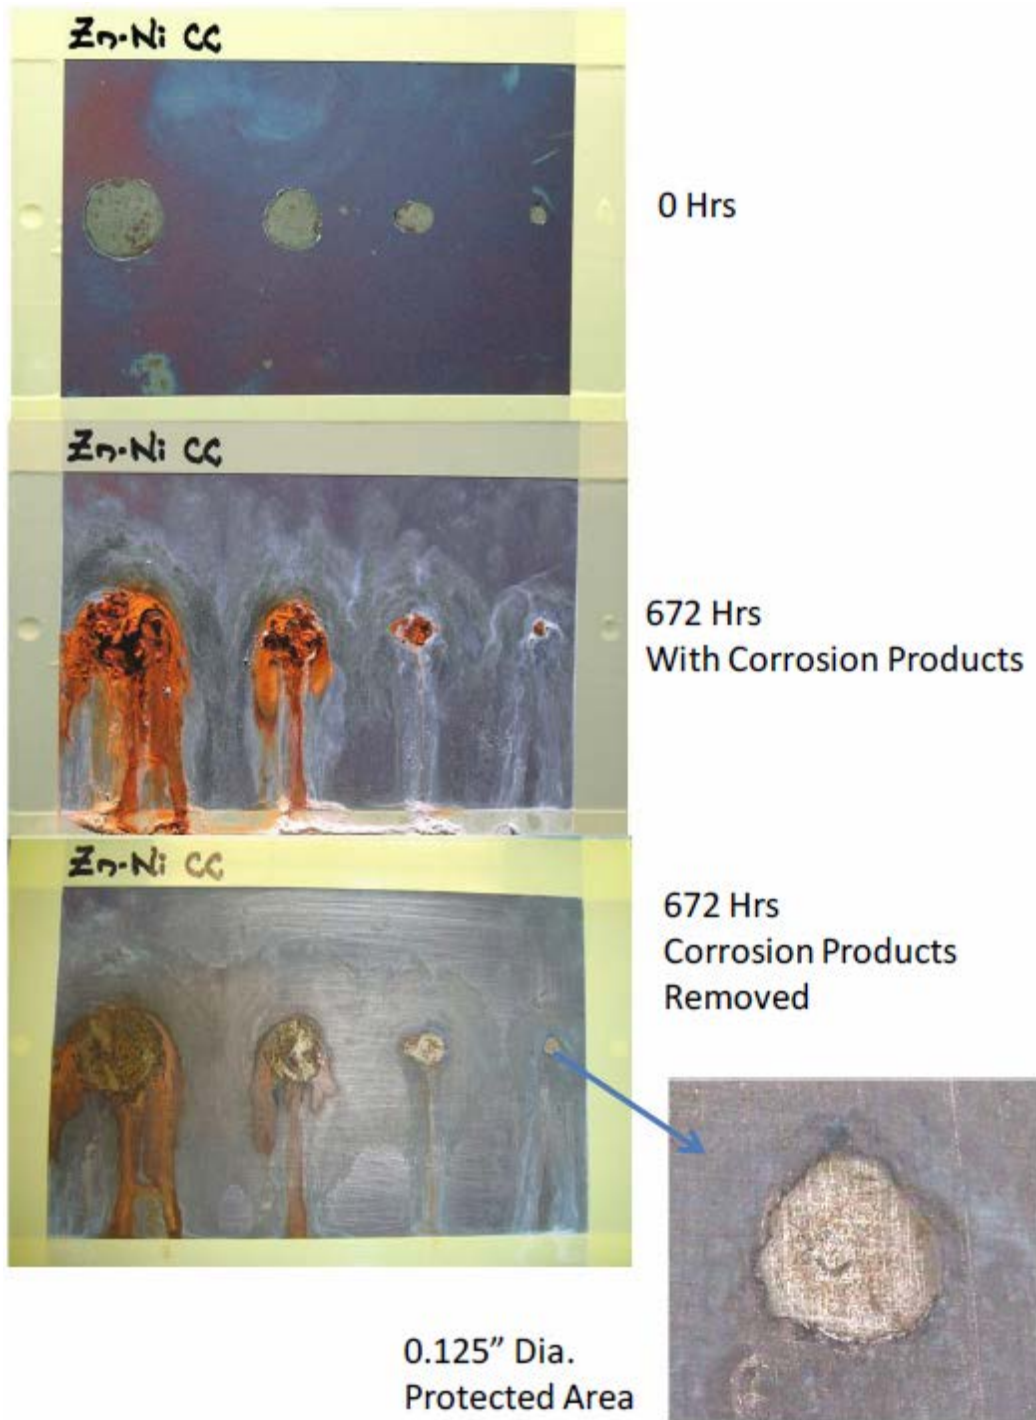
LHE Zn-Ni plated test panel with conversion coating (identified as LHE Zn-Ni CC), LHE Zn-Ni plated test panel with no conversion coating (identified as LHE Zn-Ni) and a Cd plated test panel, had the plating materials removed in 4 areas on each test panel. The three test panels were then placed in an ASTM B 117 salt spray cabinet for 672 hours and then removed after 672 hours of salt spray exposure. Heavy corrosion products were removed by scrubbing with water and then the cleaned corroded test panels were sent to Dipsol of America for XRF analysis to determine the wt. % Zn near the bare corroded areas and away from the bare corroded areas. Figure 35 and Figure 36 show the areas on the test panels where XRF analyses were taken. Figure 37 - Figure 39 show the test panels before exposure to salt spray, after exposure to 672 hours of salt spray and after cleaning excess corrosion products. Dipsol could not perform XRF analysis on the Cd plated test panel, so that test panel was not analyzed.

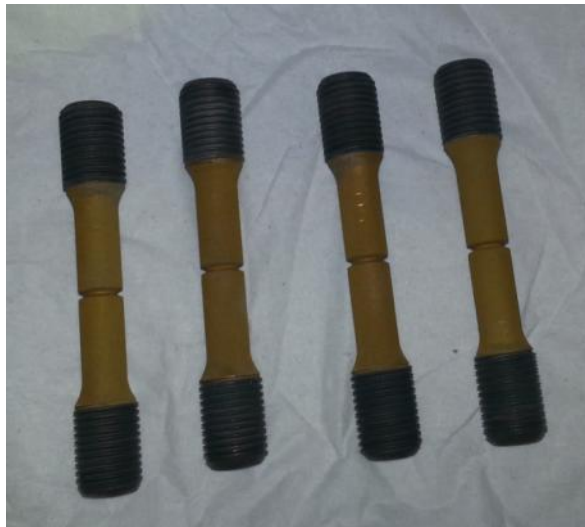
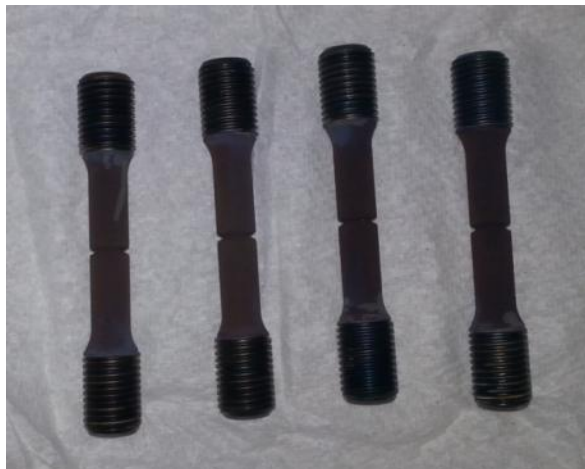
Plating of both LHE Zn-Ni and Cd test coupons were both performed with a fixture to ensure uniform plating thickness across the coupon. Visual inspection showed plating in the notch area of both test groups.

**Figure 43: Cd Plated Re-embrittlement Coupons**

**Figure 44: LHE Zn-Ni Plated Re-embrittlement Coupons**

testing procedures. Test results in Table 12 show all Cd plated test specimen failing in less than one hour. No LHE Zn-Ni plate coupons failed.

Coupons were returned and cross-sectioned to measure plating in the root of the notch area. Plating on the LHE Zn-Ni coupons looked uniform through the notch. Plating on the Cd coupons was thin in the notch.

LHE Zn-Ni performed better than Cd, however upon microscopic inspection of the notch for the Cd coupon it was found that the plating in the root of the notch was very thin and may have not protected the base material from embrittlement in the salt water. It is suggested that additional coupons be plated and cross-sectioned before testing to identify proper plating in the notch.

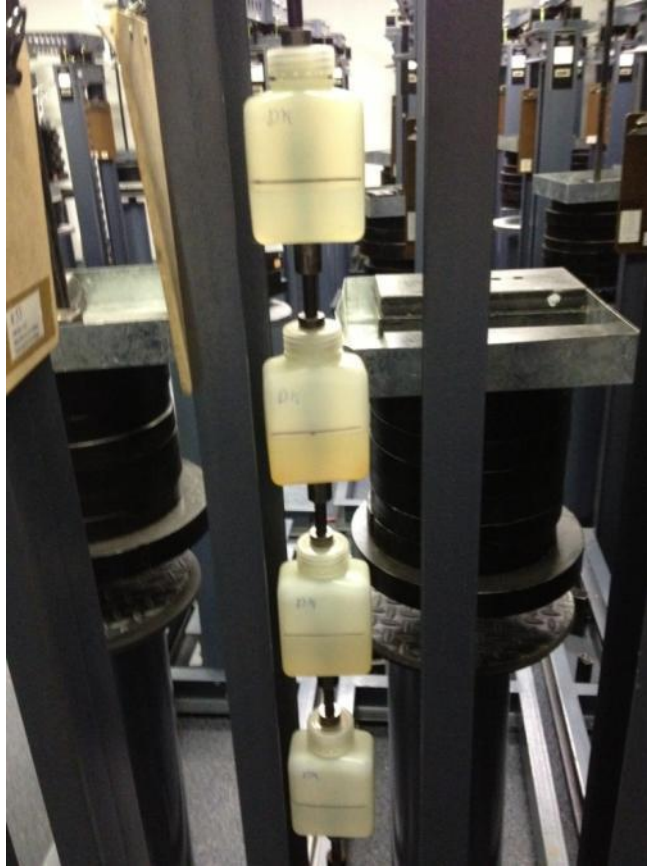
Coupons were sent to Omega Research for testing. Each coupon was loaded at 45% NFS in the test frame in a container with the 3.5% NaCl water solution per ASTM F519

**Figure 45:Re-embrittlement Test Setup**
