# **FINAL REPORT**

## **Demonstration and Validation of LHE Zn-Ni Plating Process**

**ESTCP Project WP-201107**

**May 2018**

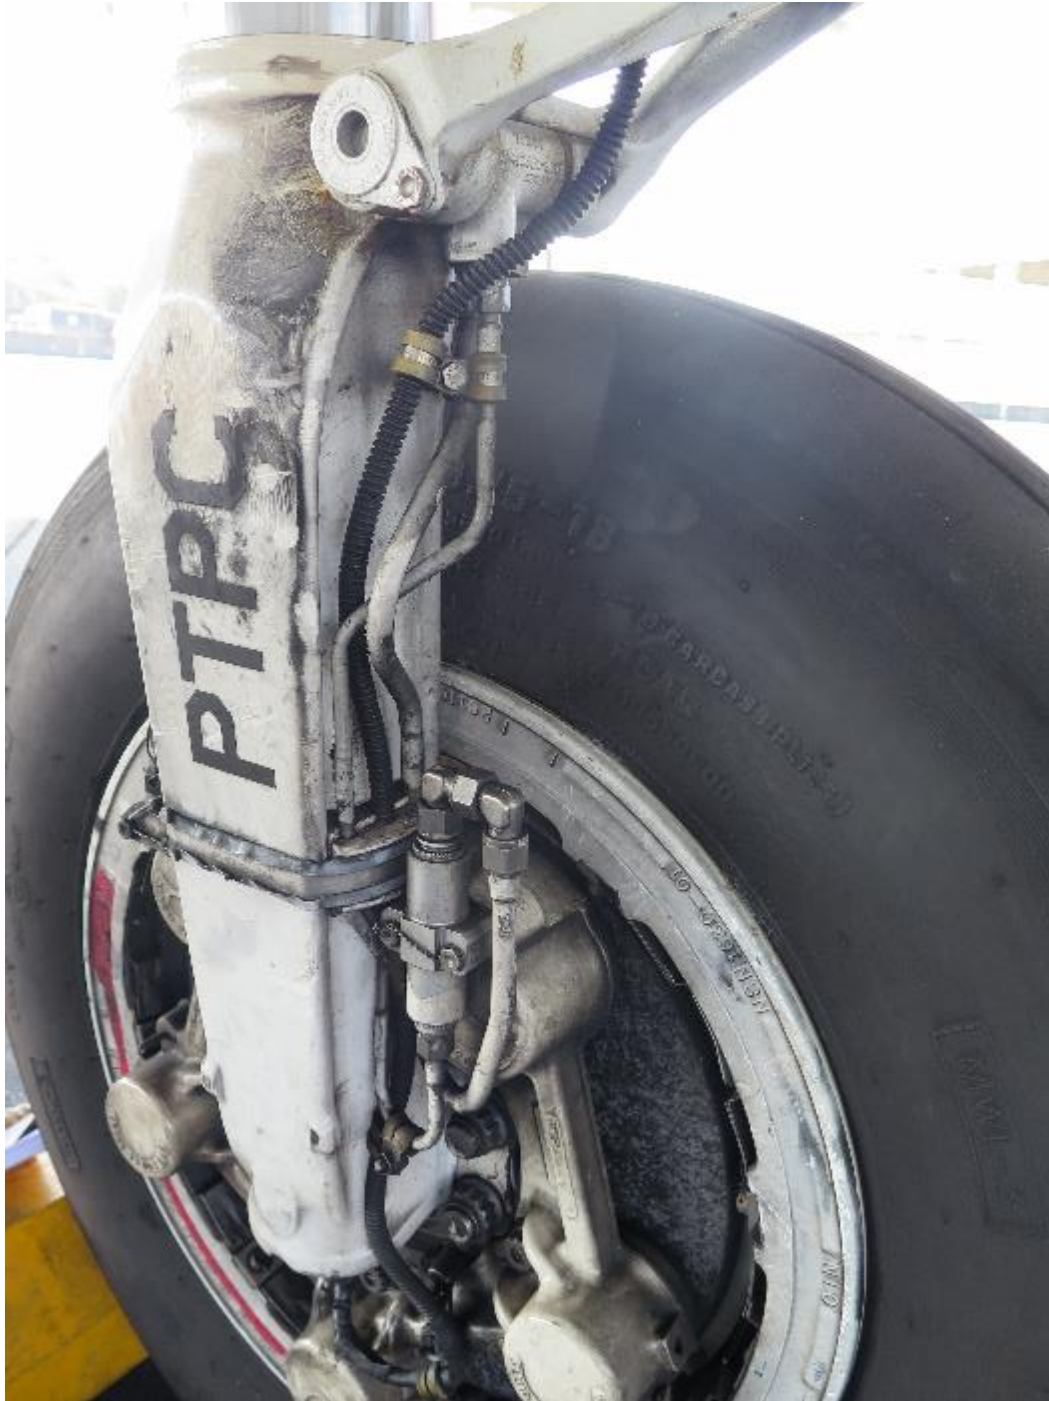
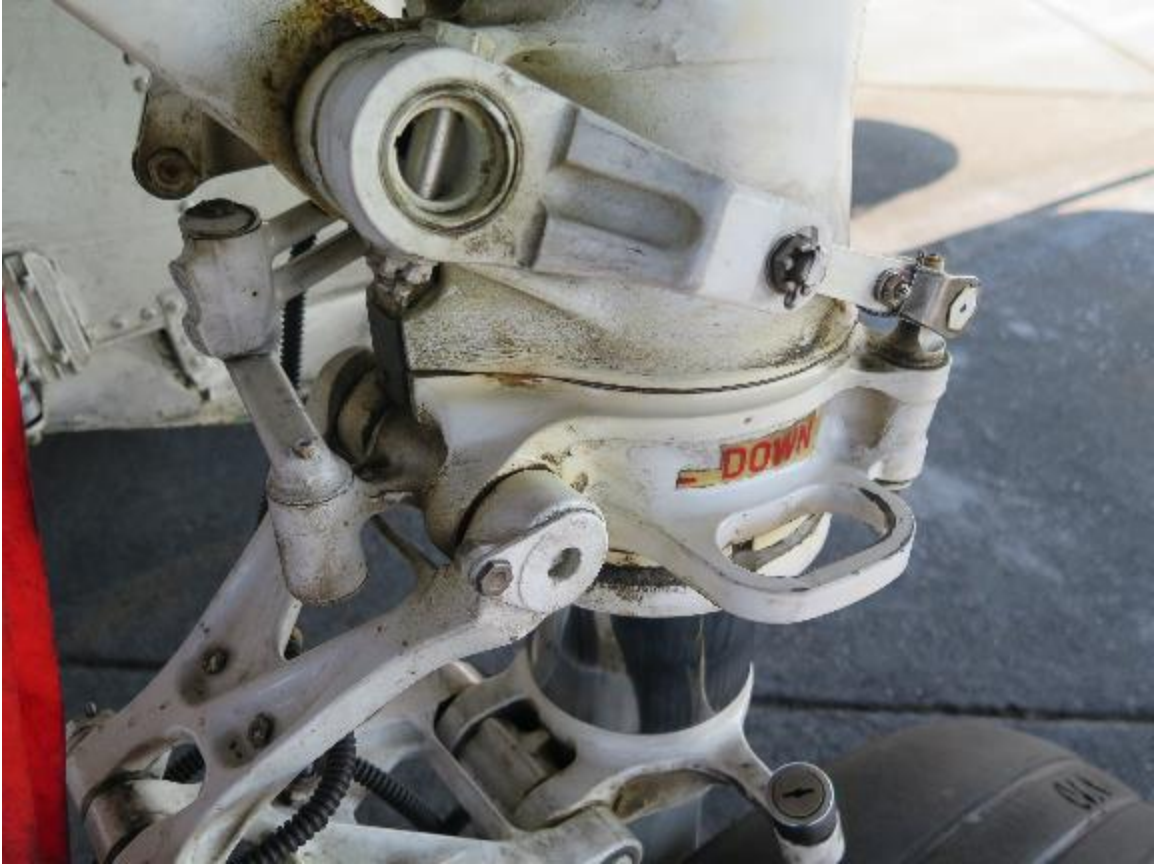
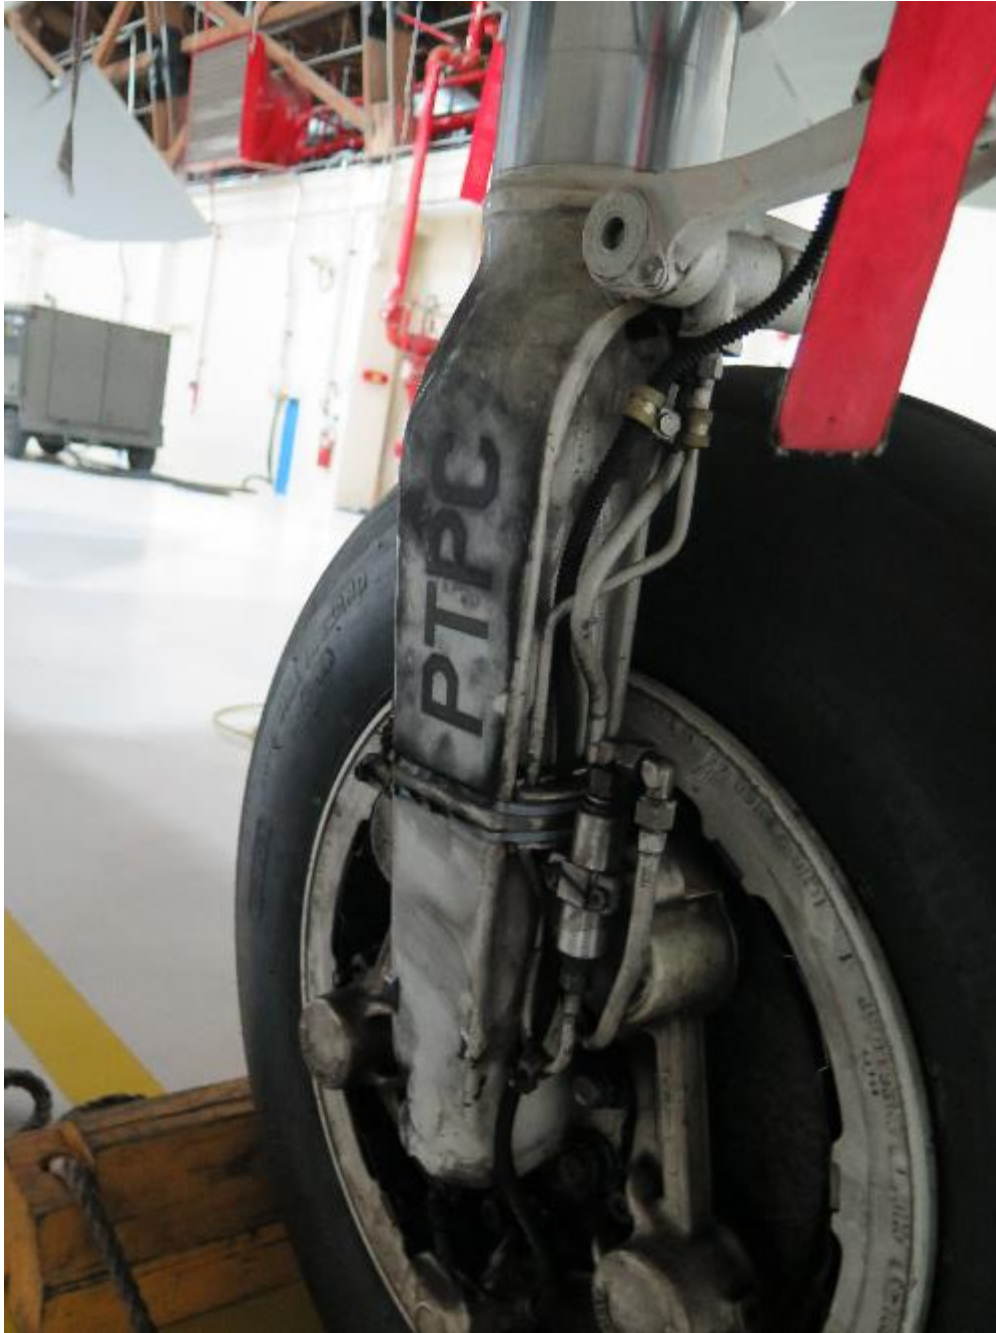
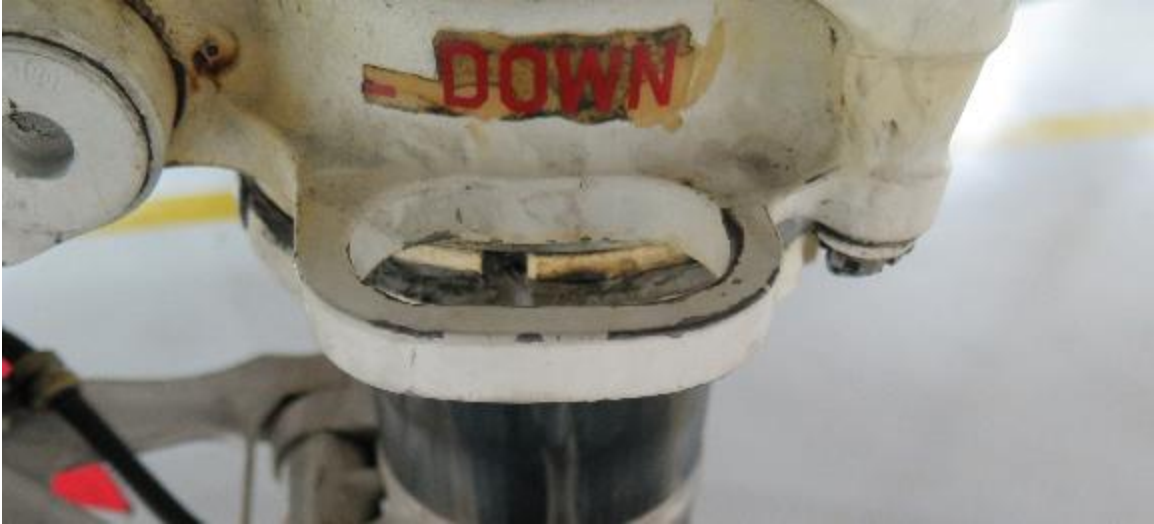
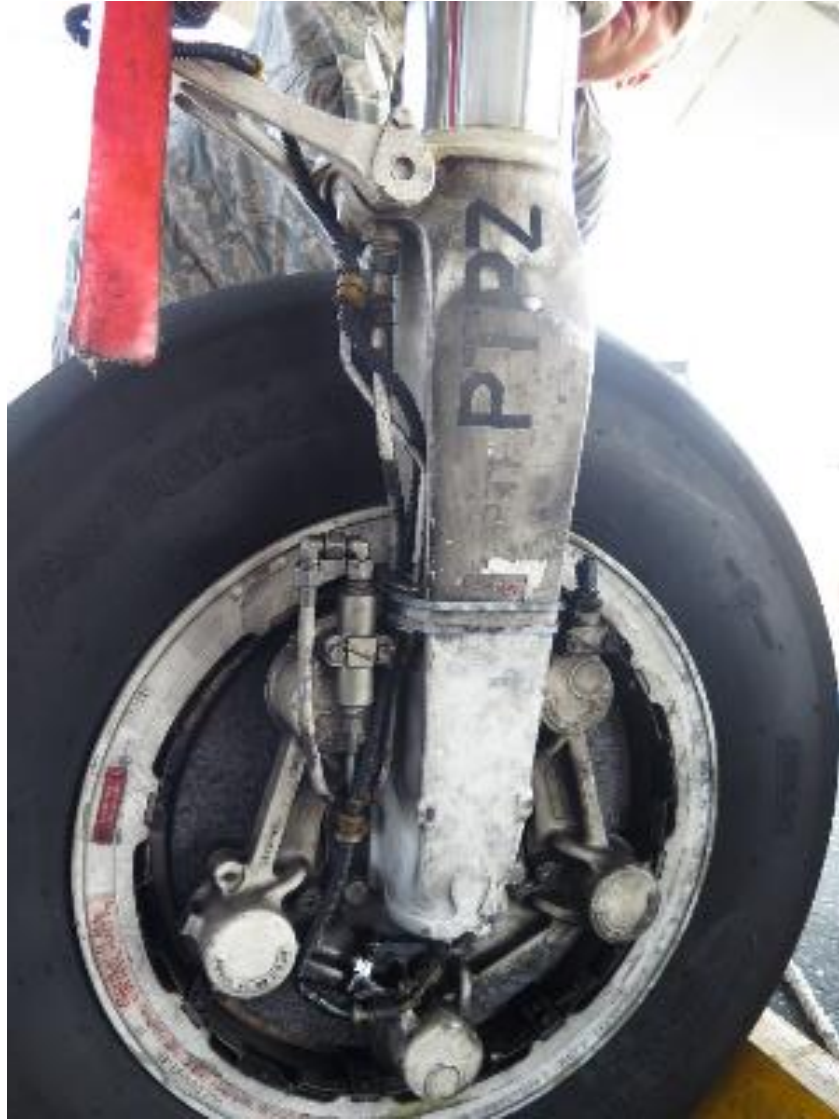
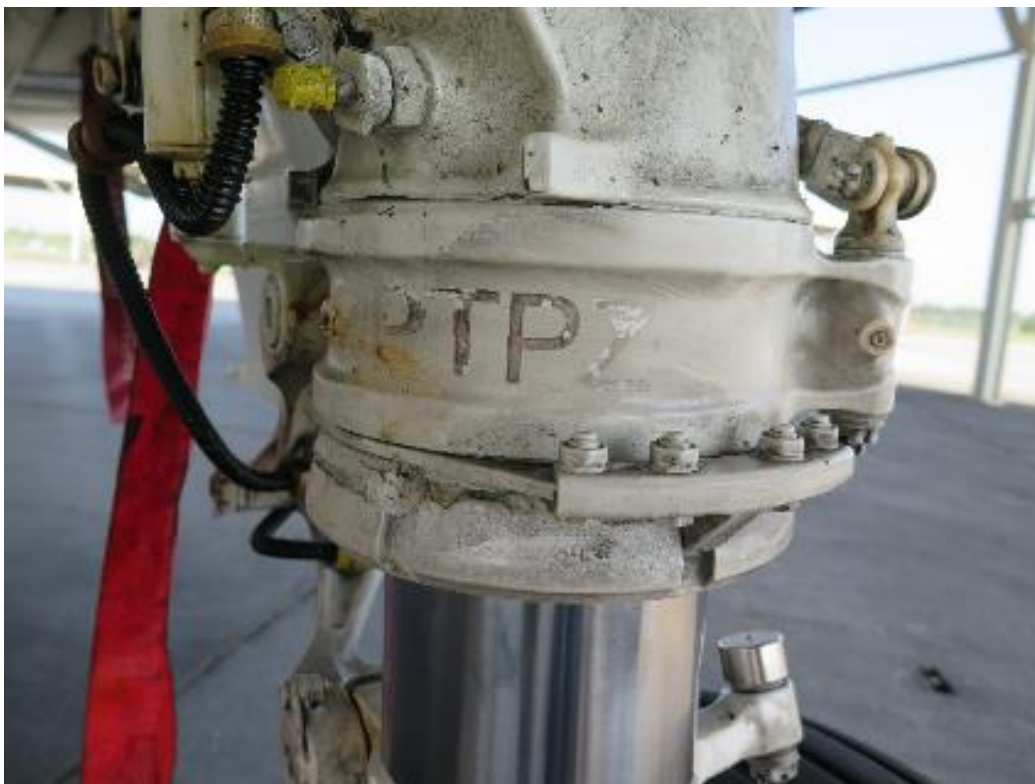
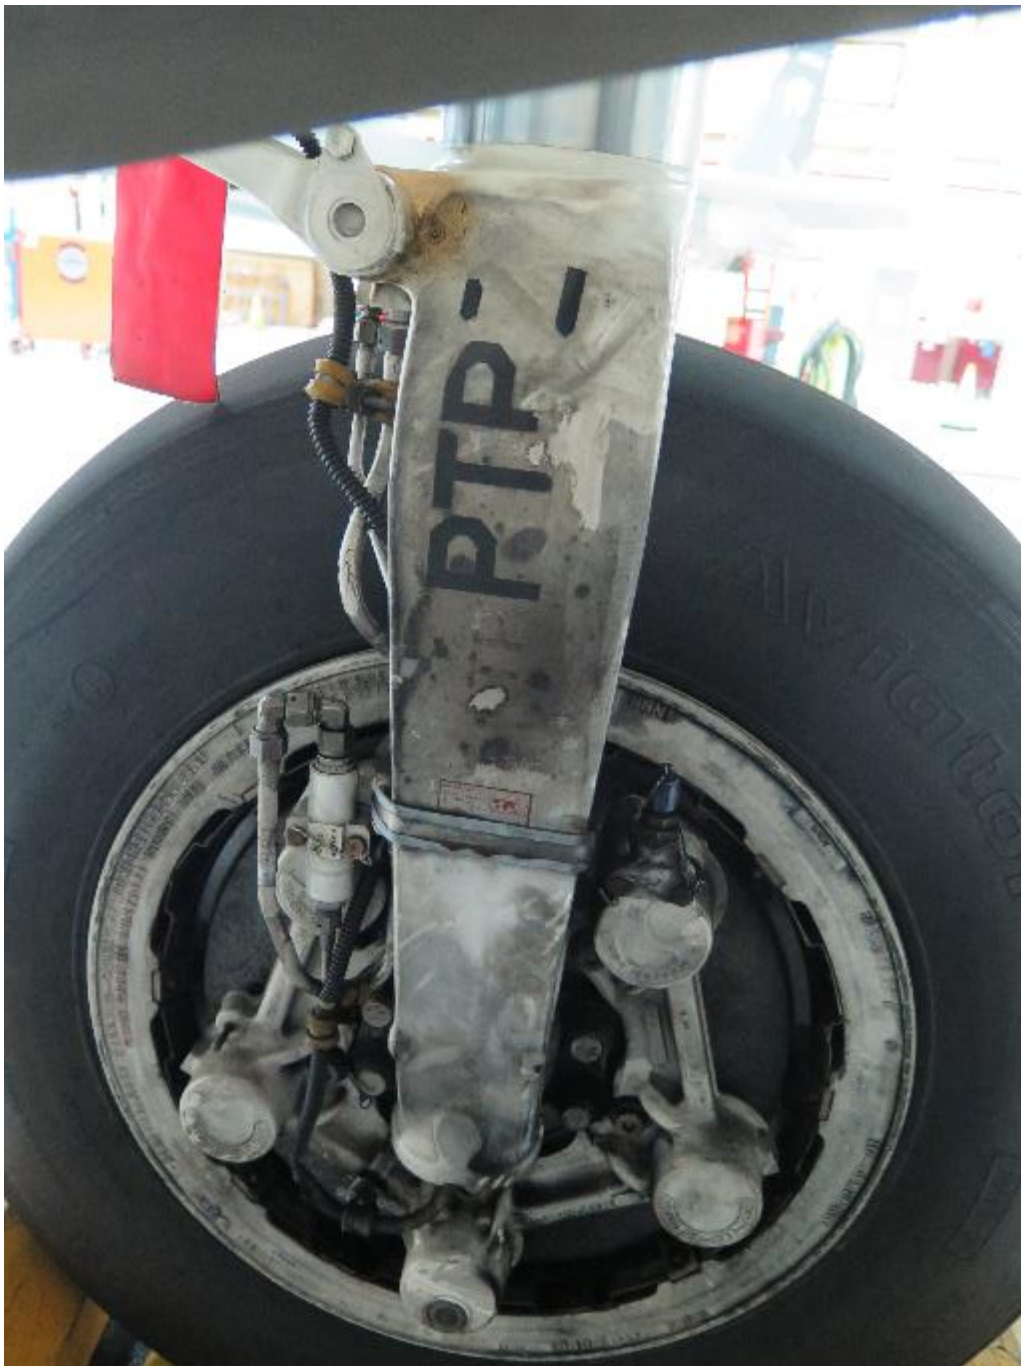
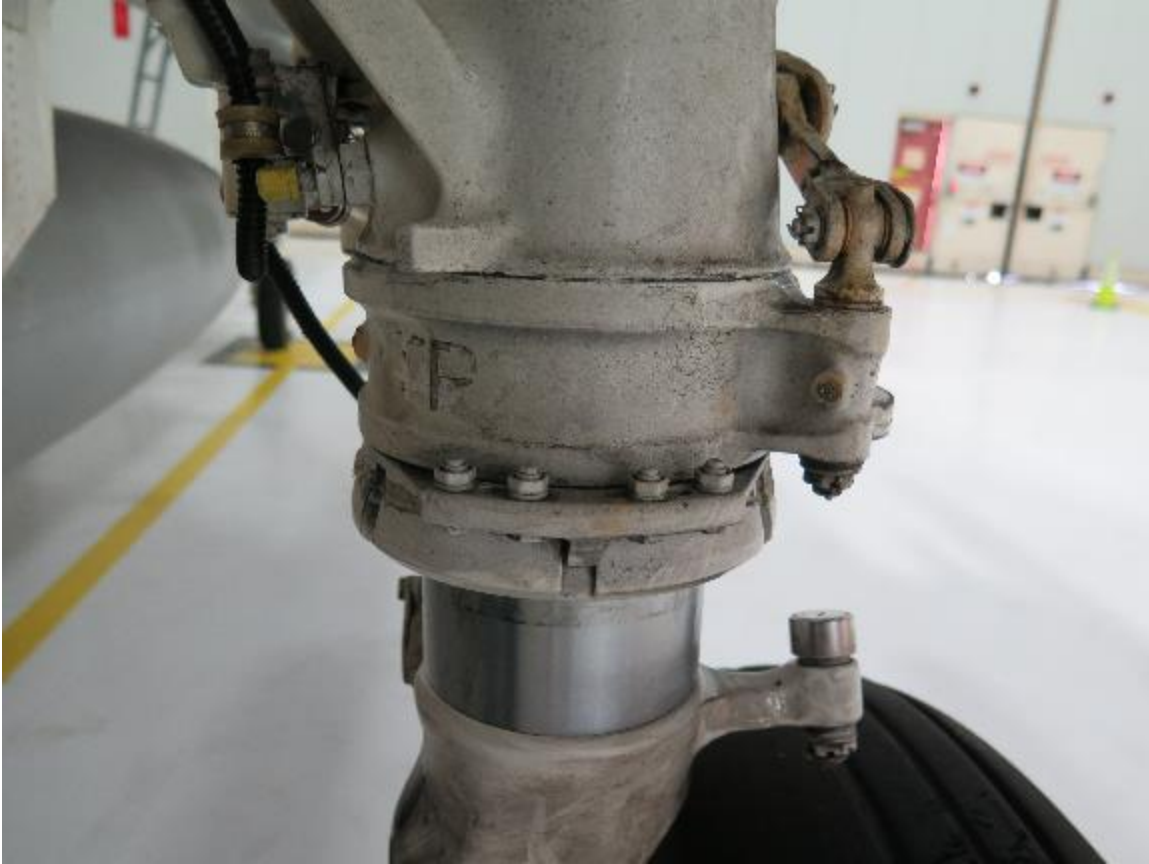
LHE Zn-Ni and Cd components were installed on aircraft # 83-048 on 30 October 2014. Annual visual inspections for corrosion and corrosion products were conducted on 28 October 2015 and 25 August 2016. The aircraft was transferred to Klamath Falls, OR where the final inspection took place 9 November 2016. LHE Zn-Ni components passed visual inspection on both occasions with no corrosion products visible. Paint and primer had both been chipped off of some plated components. The LHE Zn-Ni plating was still visible and intact, however the cadmium looked to be rubbed and worn. Figure 9 - Figure 16 are photos taken of the PTP MLG components during installation and inspection.

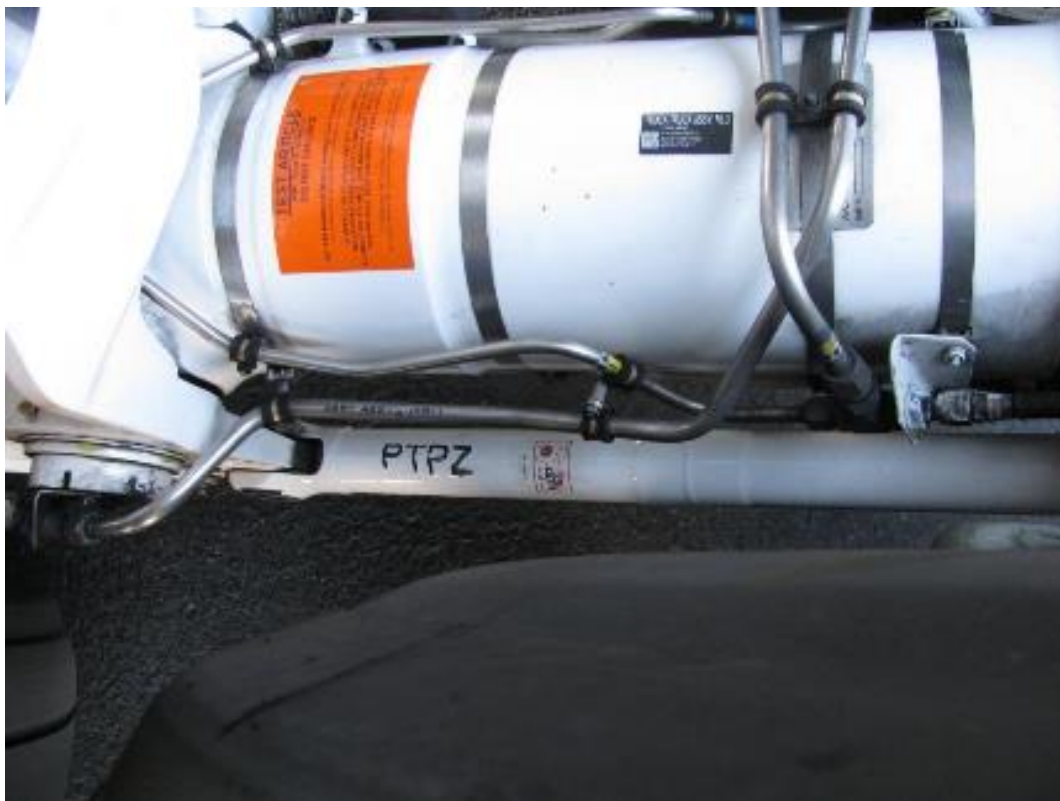
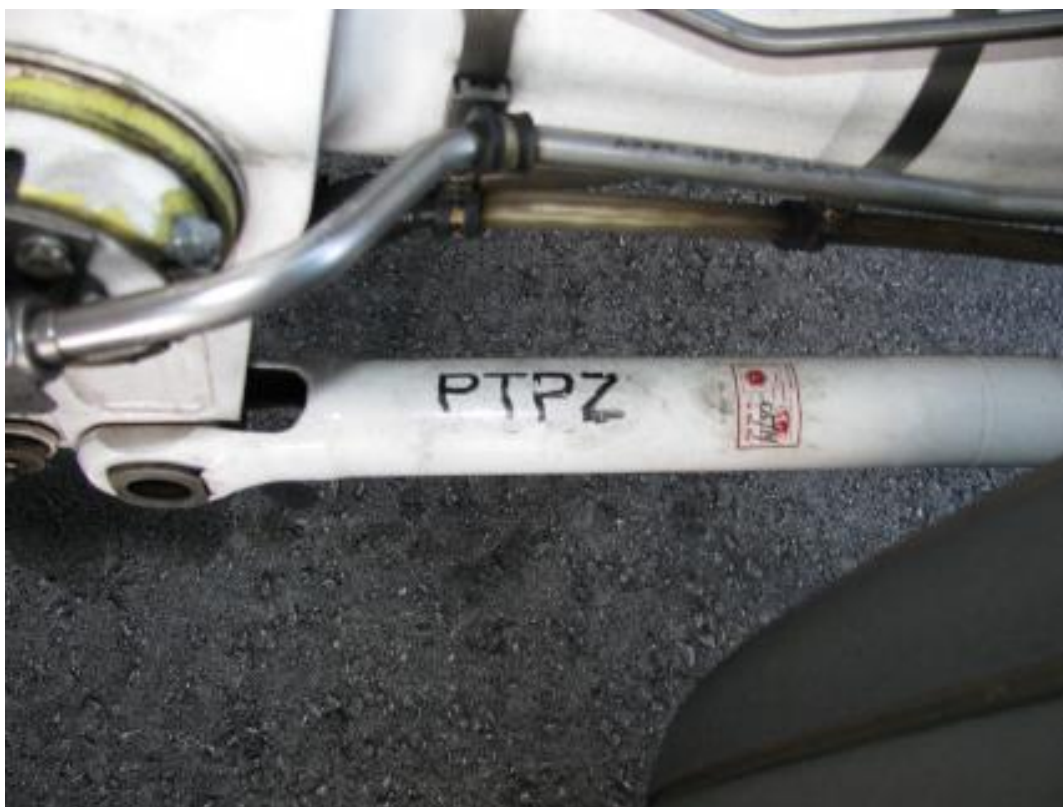
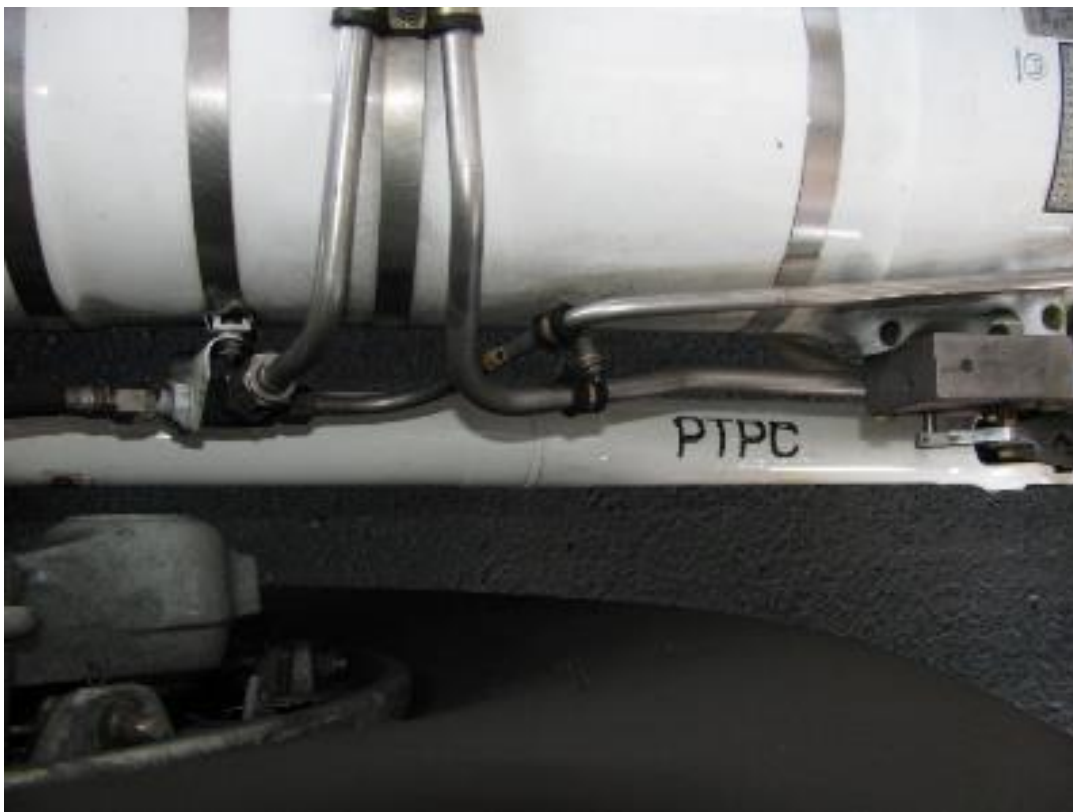
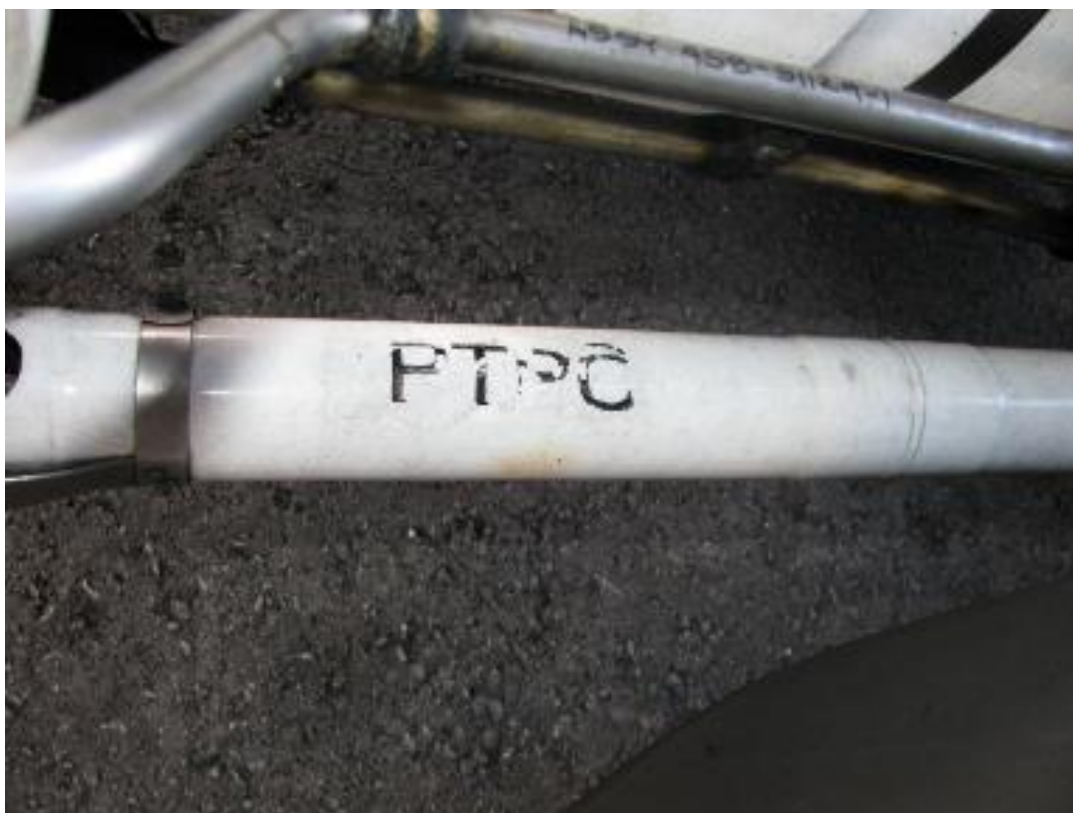
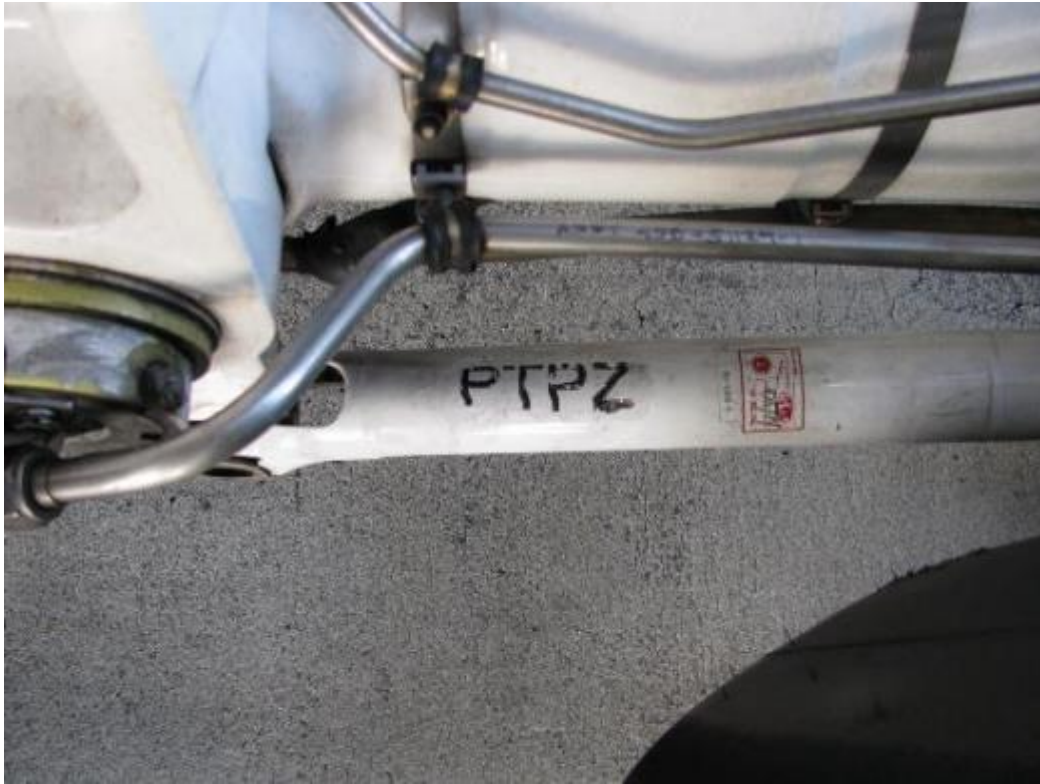
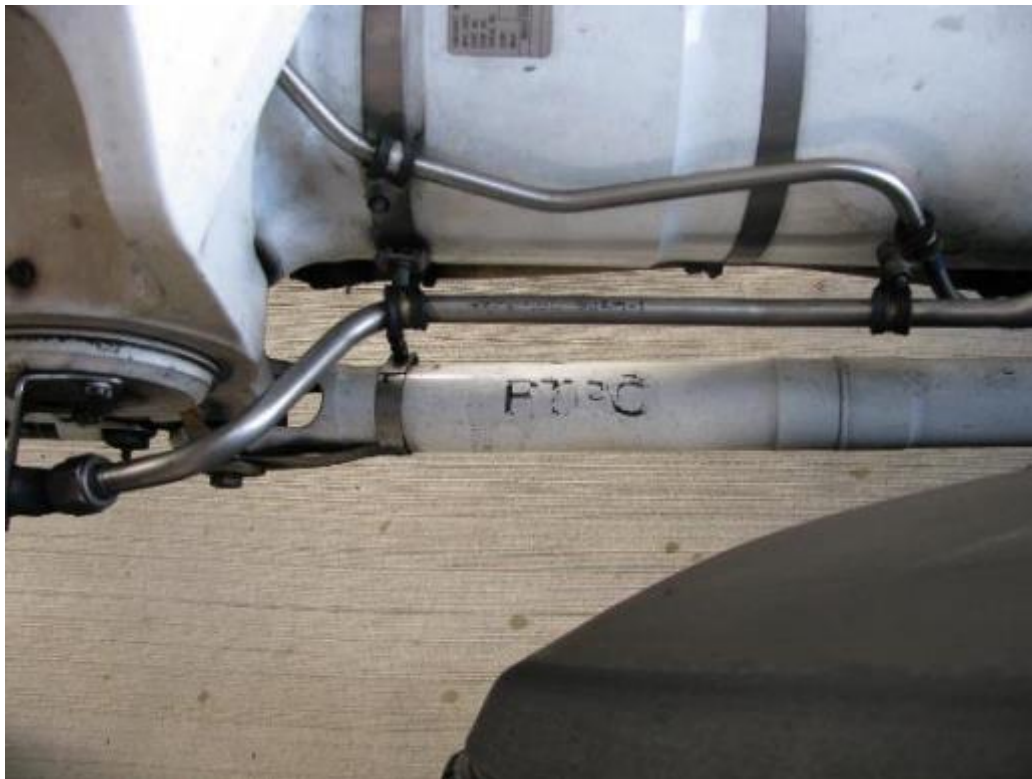
LHE Zn-Ni and Cd components were installed on aircraft # 36-8030 on 22 September 2015. Annual visual inspections for corrosion and corrosion products were conducted on 29 June 2016, and 17 May 2017. LHE Zn-Ni components passed visual inspection on both occasions with no visible corrosion products similar to the cadmium components. Figure 64 - Figure 69 are photos taken of LHE Zn-Ni and Cd plated components during the visual inspections.

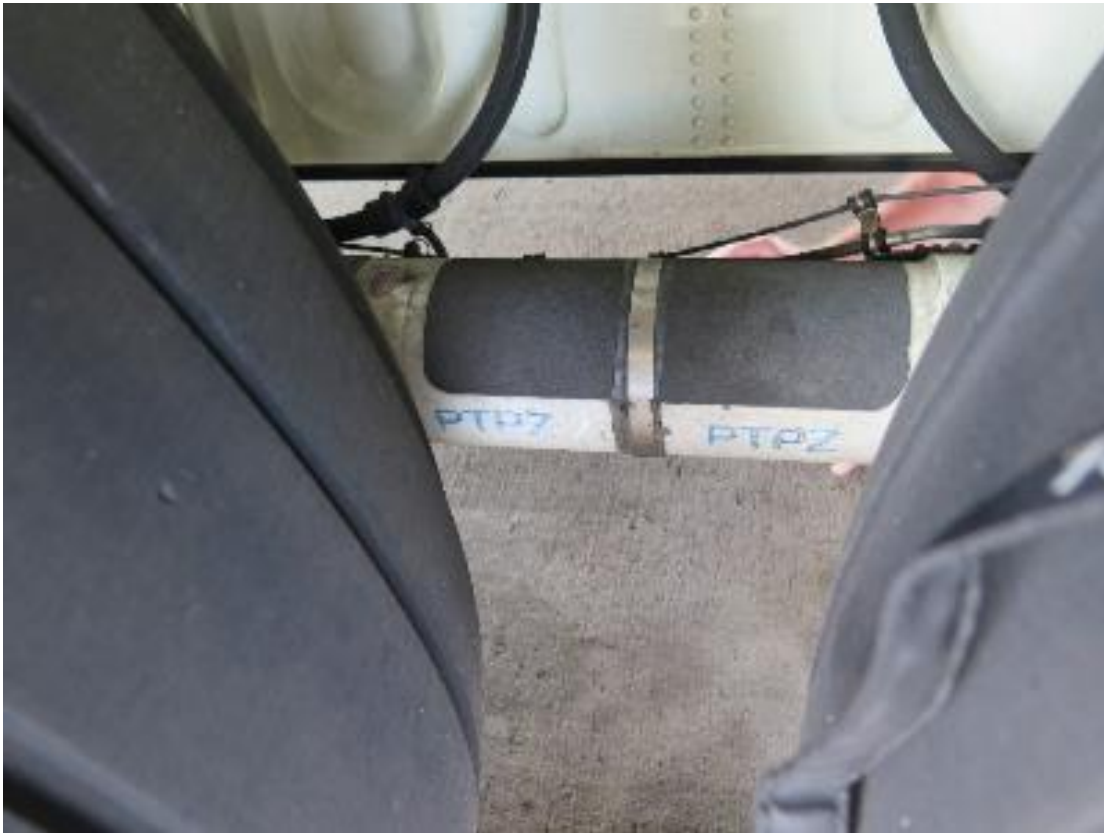
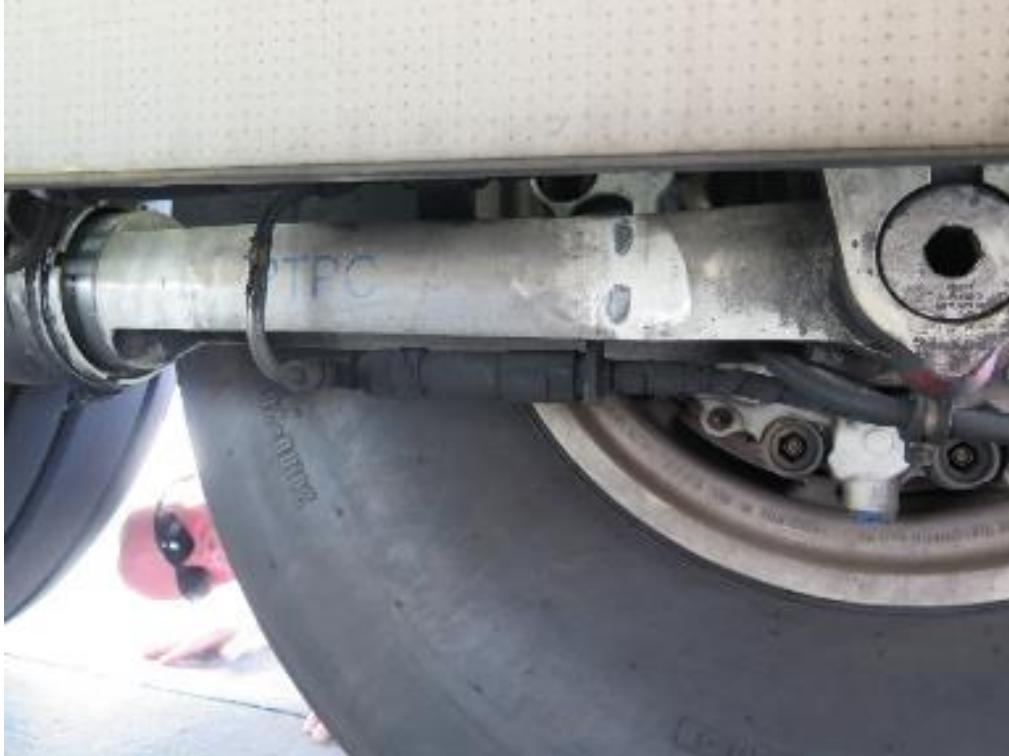
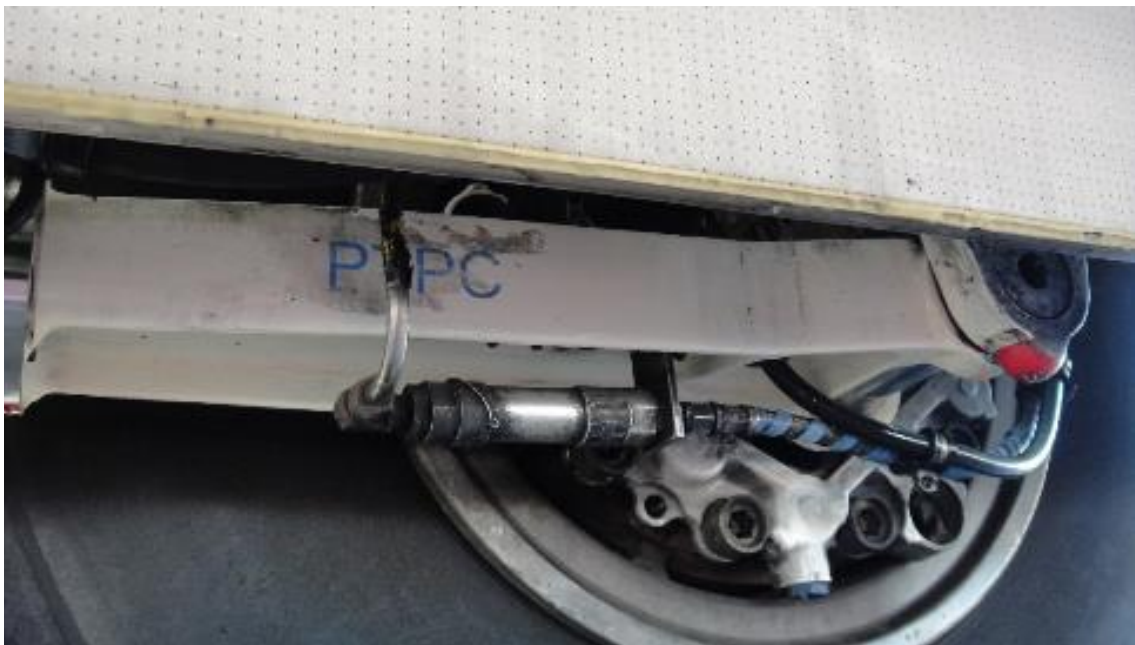
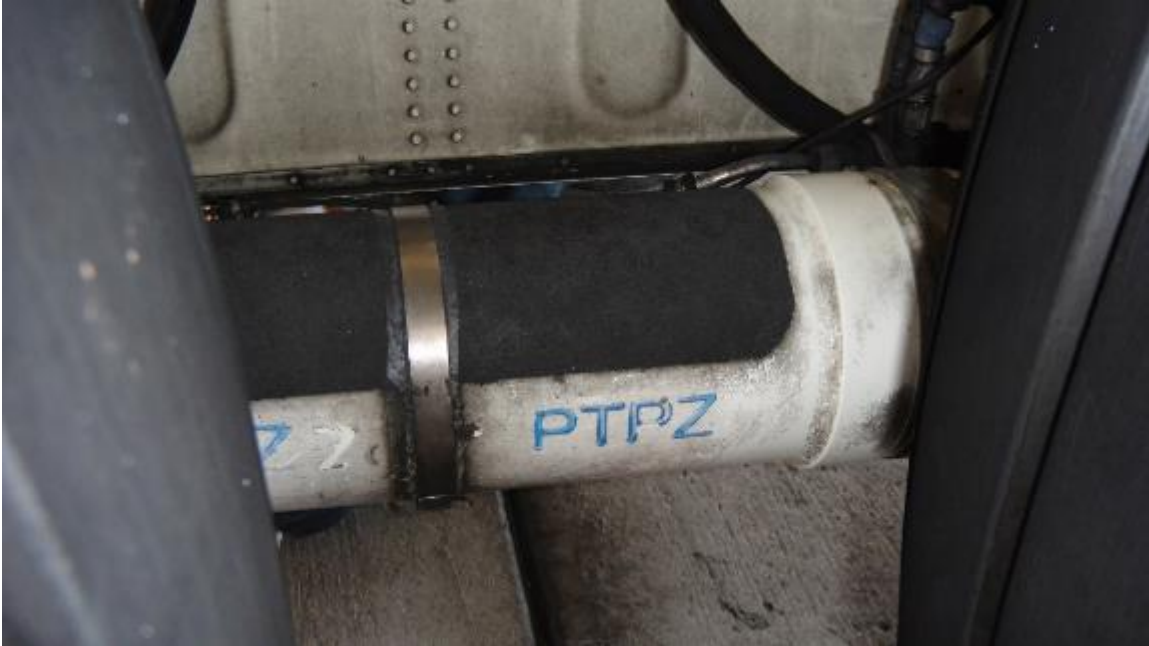
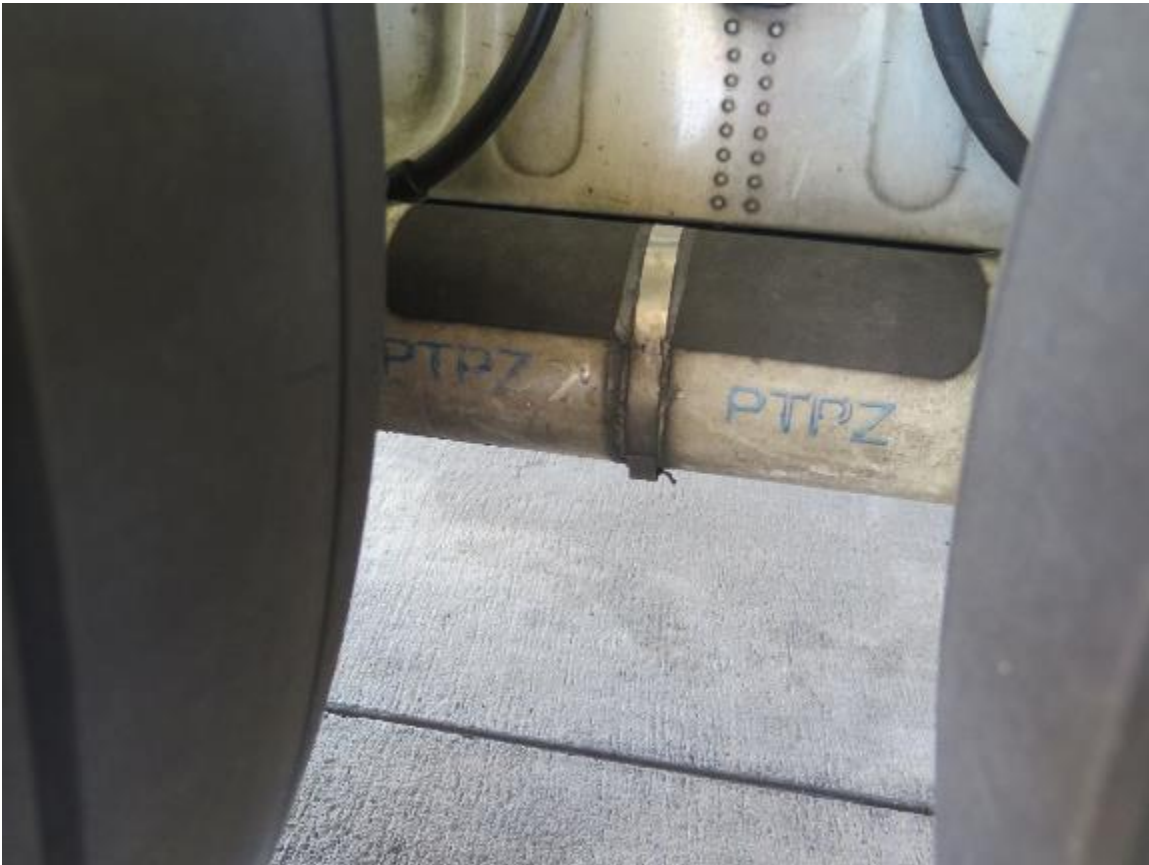
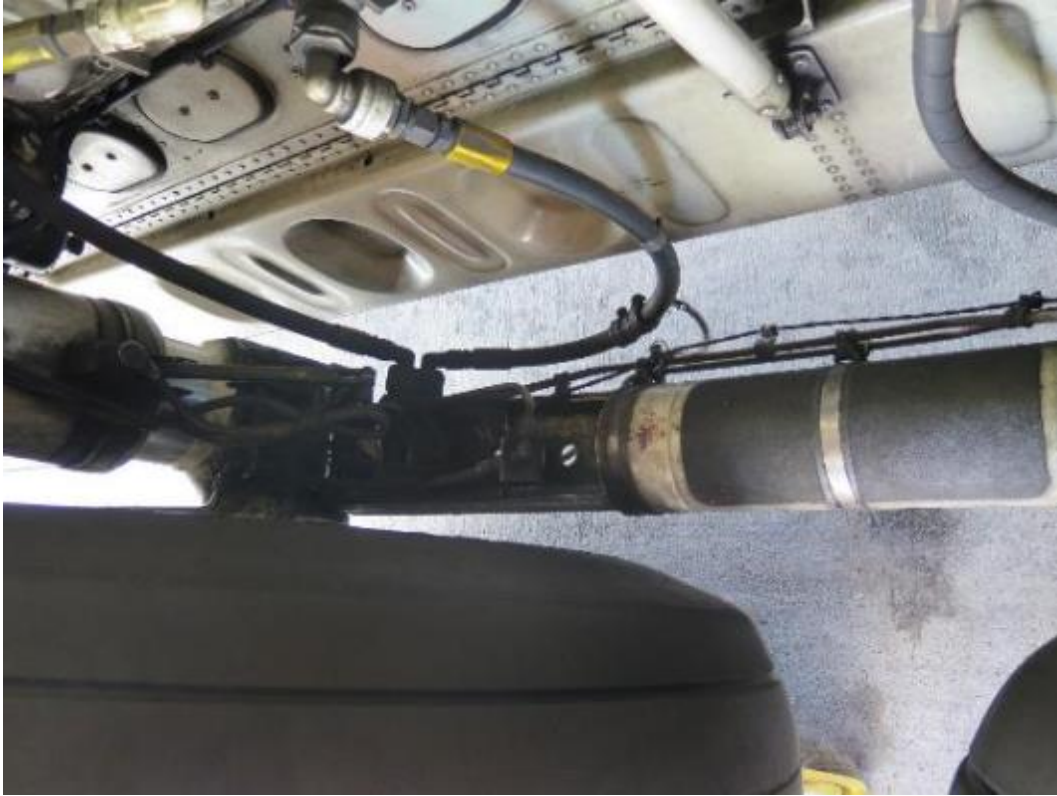
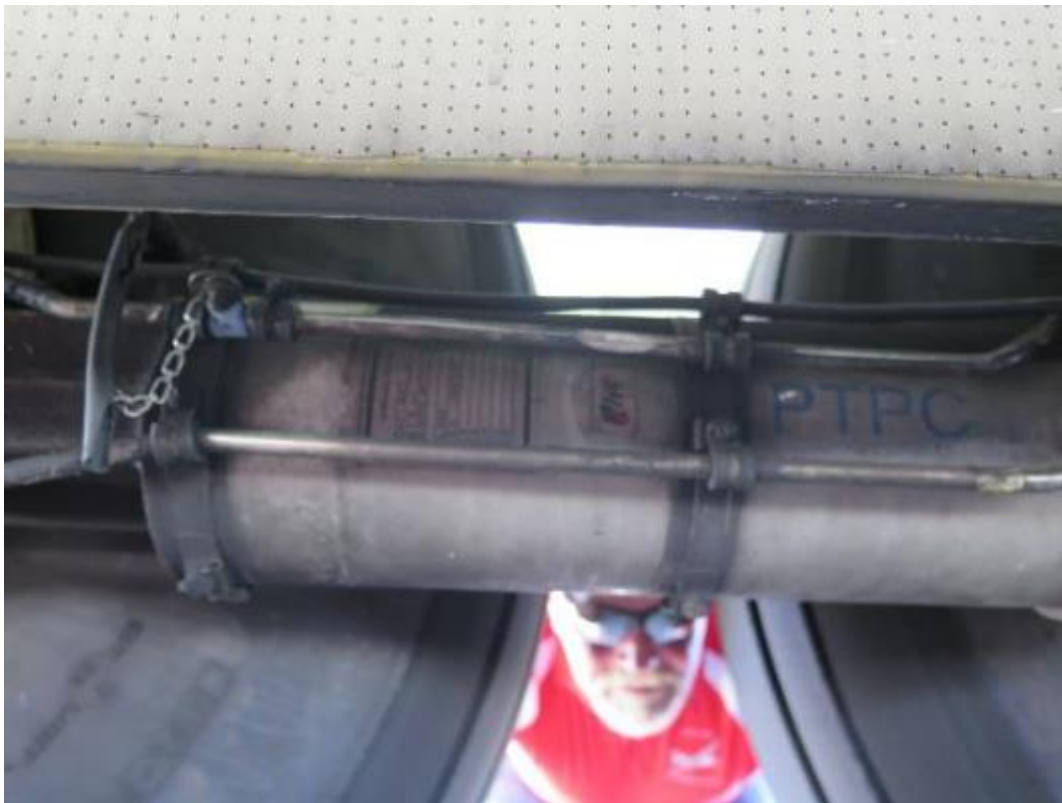
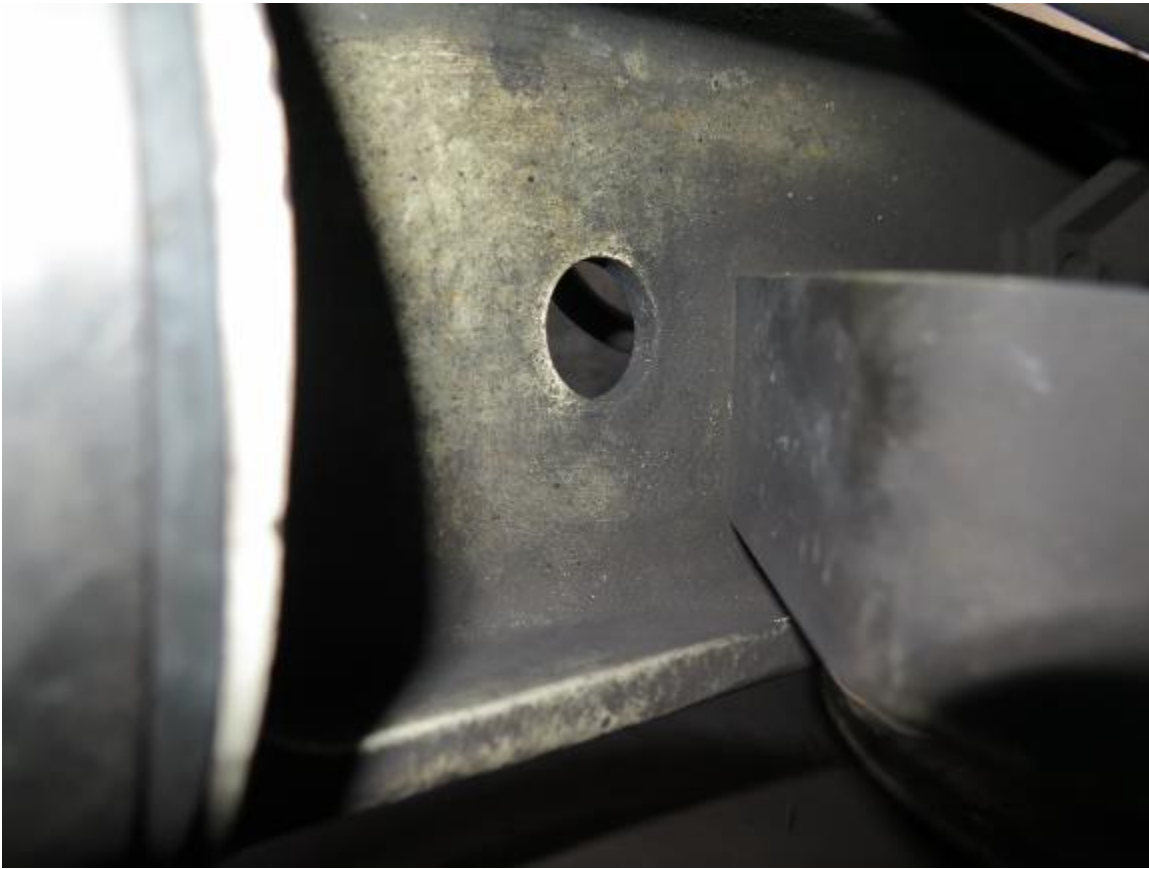
LHE Zn-Ni and Cd components were installed on aircraft # 1716 on 27 August 2015. Annual visual inspections for corrosion and corrosion products were conducted on 23 September 2015, 28 June 2016, and 16 May 2017 LHE Zn-Ni components passed visual inspection on all occasions with no visible corrosion products similar to the cadmium components. Figure 70 - Figure 77 are photos taken of LHE Zn-Ni and Cd plated components during the visual inspections.
