# **FINAL REPORT**

## **Demonstration and Validation of LHE Zn-Ni Plating Process**

**ESTCP Project WP-201107**

**May 2018**

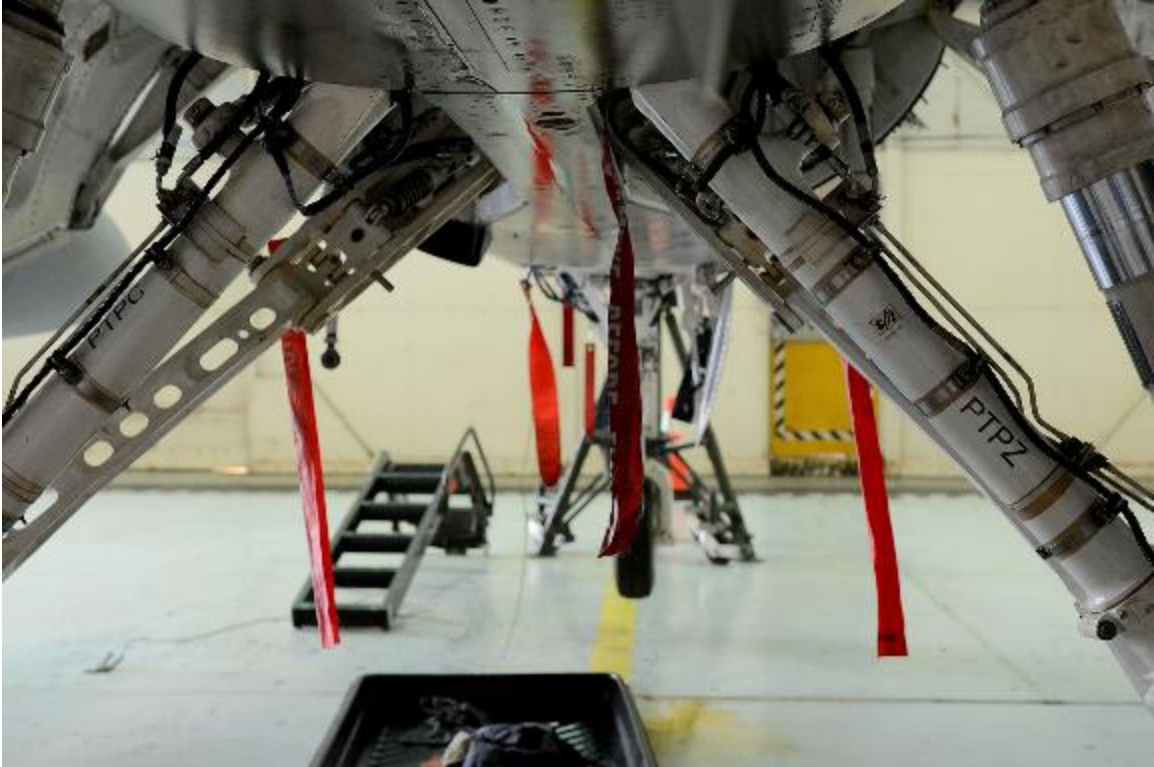
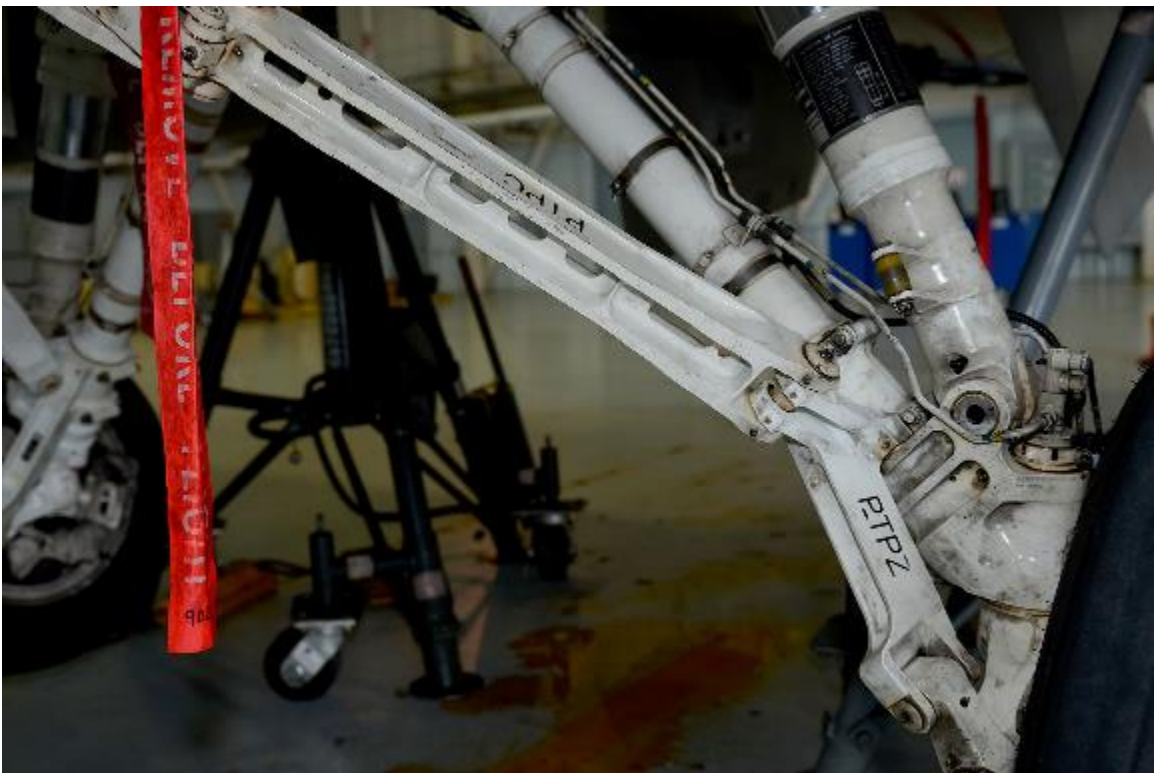
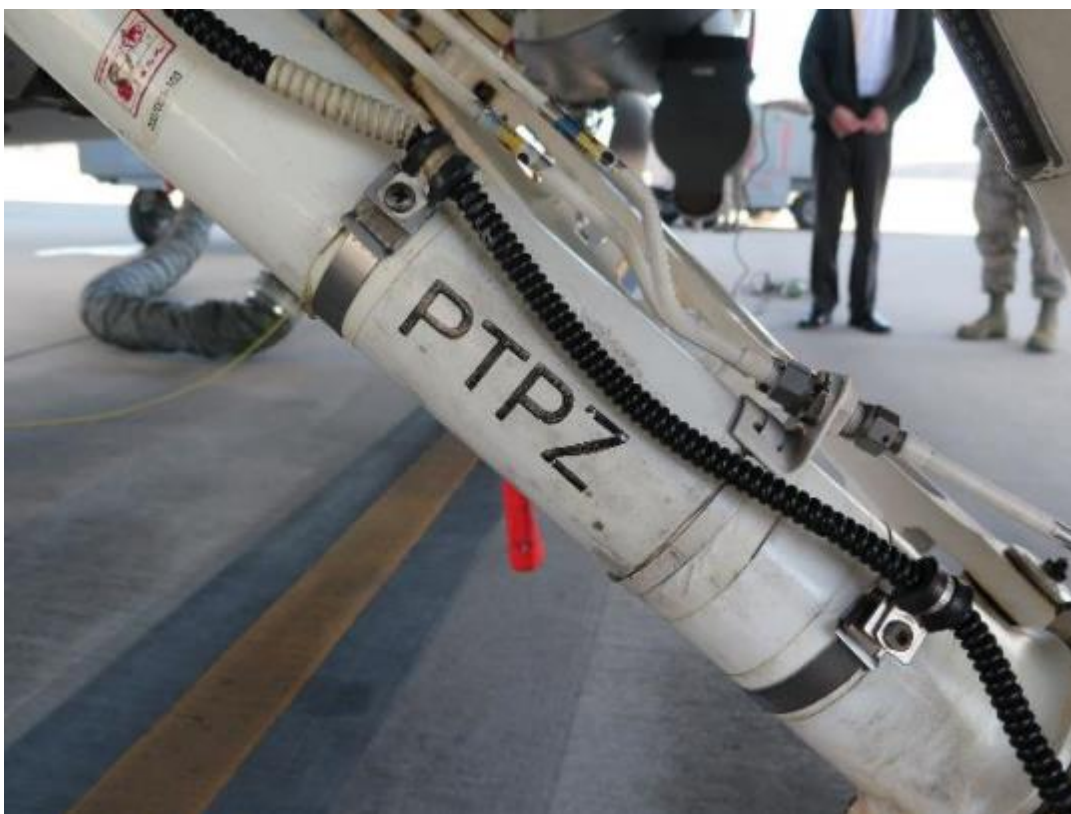
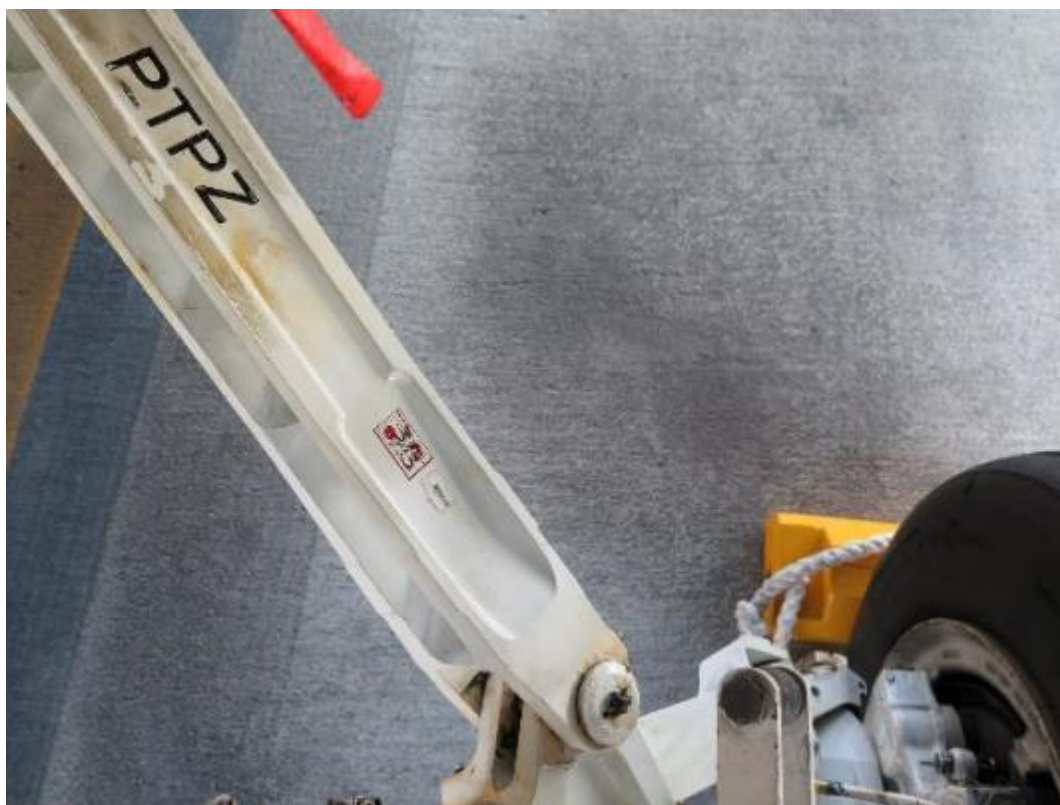
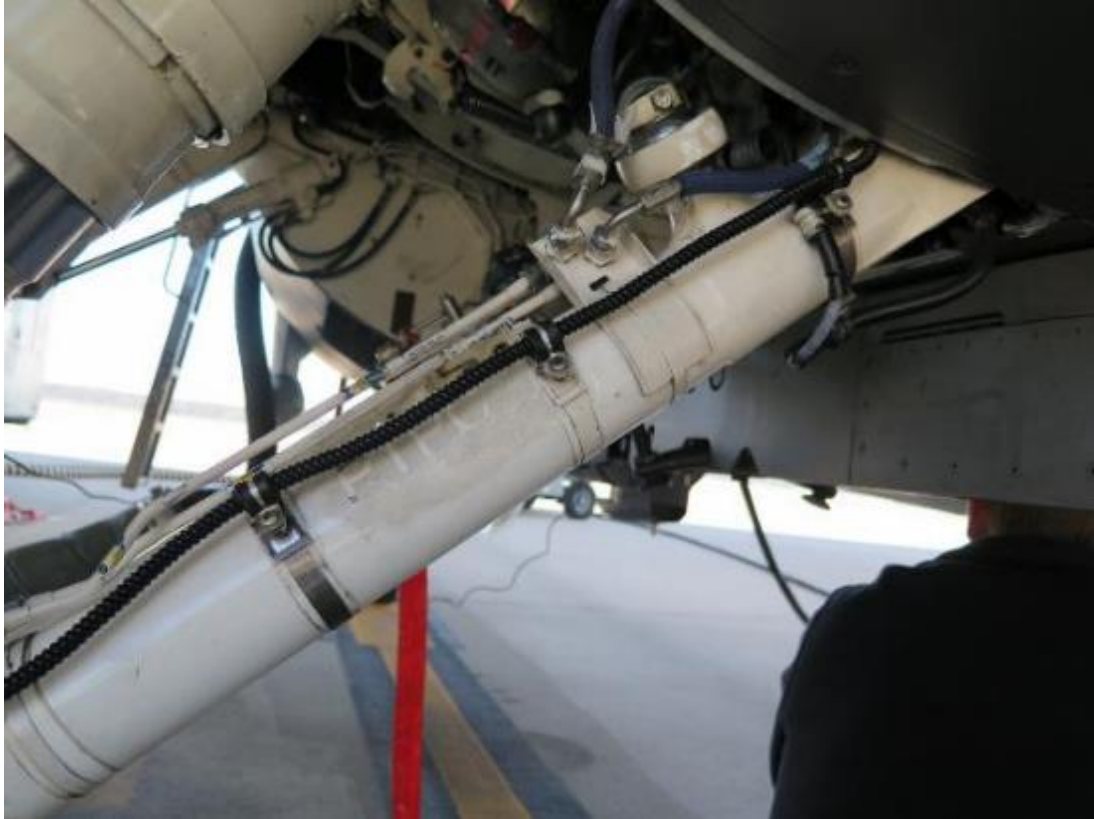
LHE Zn-Ni and Cd components were installed on aircraft # 92-902 on 16 December 2014. The first annual visual inspection occurred on 20 January 2015. A brake fire occurred before the second visual inspection and the components were removed and condemned. The condemned components were removed and shipped to ES3 where a visual inspection occurred on 16 April 2016. Prior to the brake fire, LHE Zn-Ni plated components passed visual inspections with no corrosion products similar to the cadmium components. LHE Zn-Ni appeared to be more robust in wear areas than cadmium. Figure 78 - Figure 86 are photos taken of LHE Zn-Ni and Cd plated components during the visual inspections.

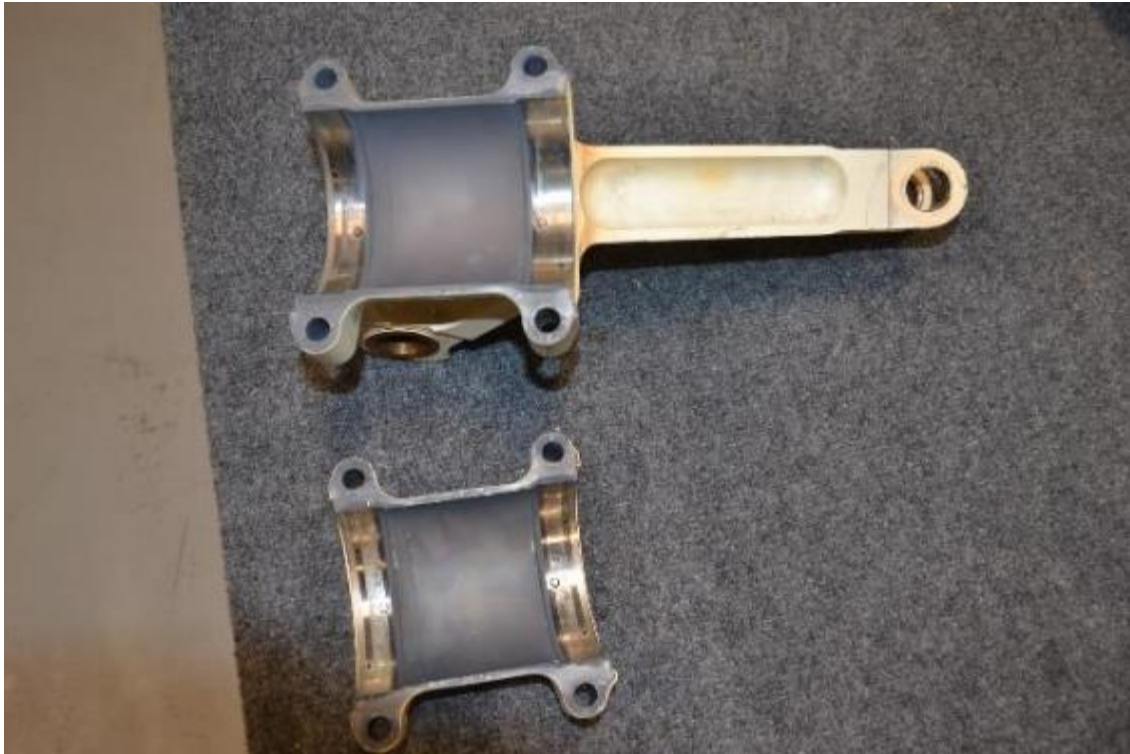
**Figure 84: LHE Zn-Ni Component Brake Fire Inspection (4/16/2016)**

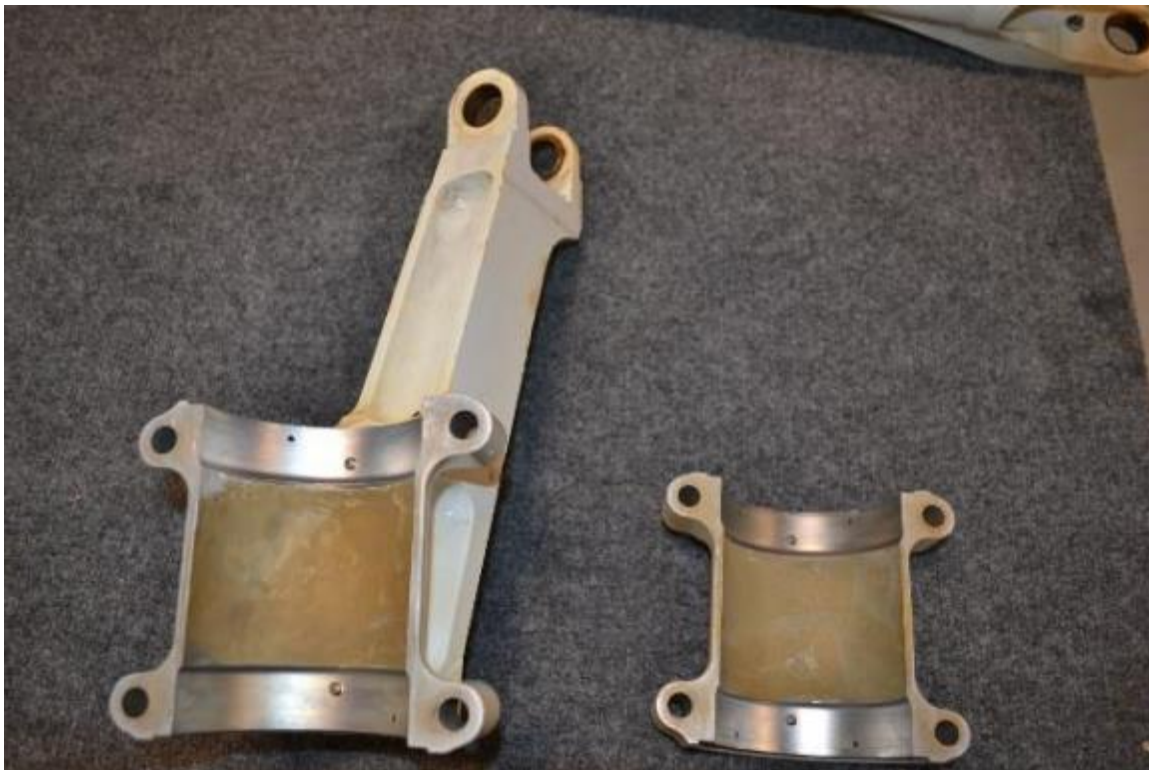
**Figure 85: Cd Component Brake Fire Inspection (4/16/2016)**

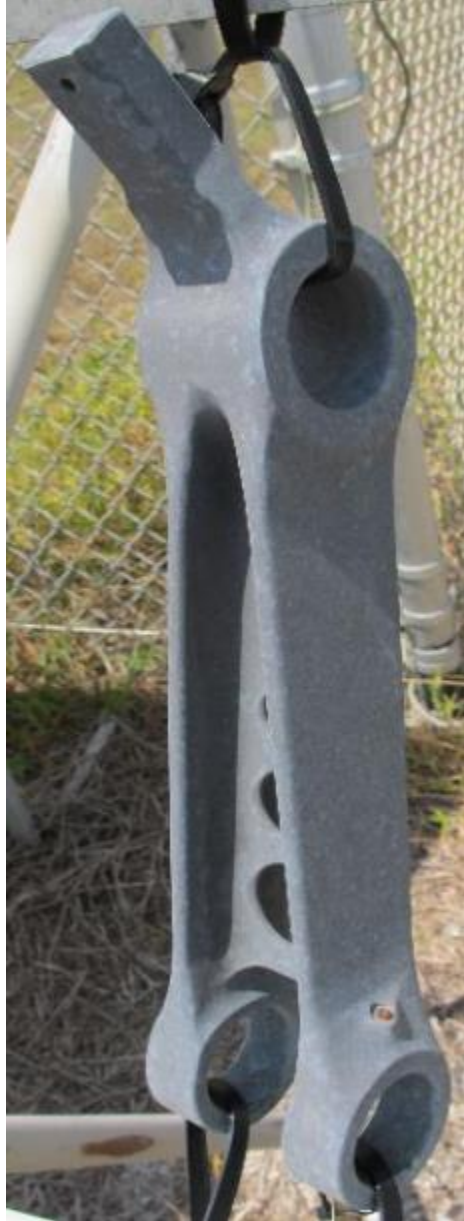
| <b>Test Component Installation Date: 10/22/2014</b> | | |
|---|---|---|
| | LHE Zn-Ni Drag Brace | Slight white corrosion products |

**Figure 96: LHE Zn-Ni Plated Drag Brace (7/13/2015)**

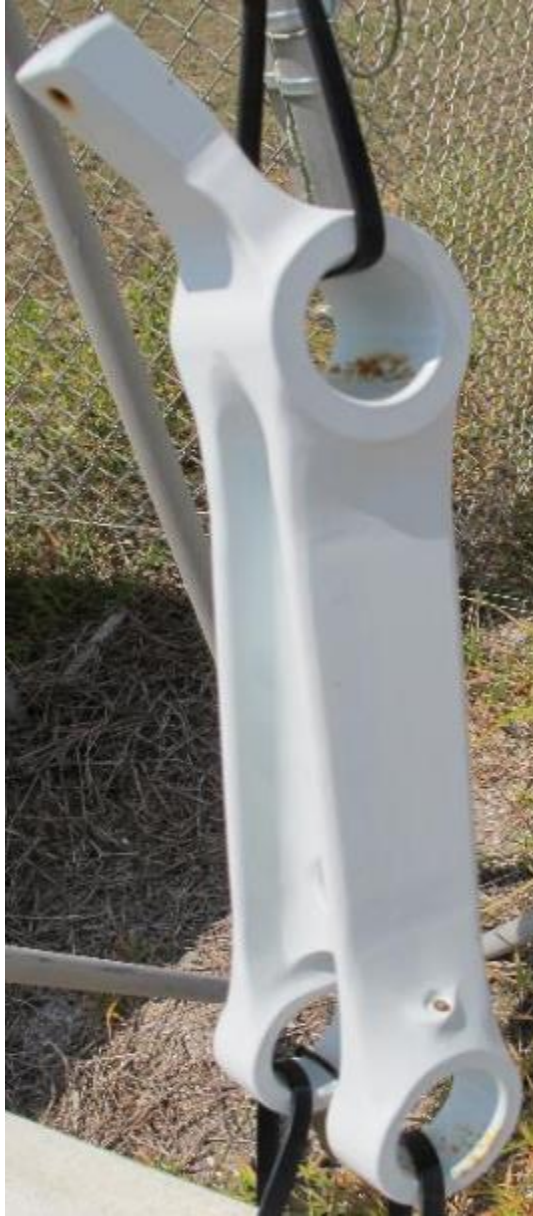
| <b>Test Component Installation Date: 10/22/2014</b> | | |
|---|---|---|
| | LHE Zn-Ni Drag Brace (Painted) | Visible rust/red corrosion products |

**Figure 97: Painted LHE Zn-Ni Plated Drag Brace (7/13/2015)**

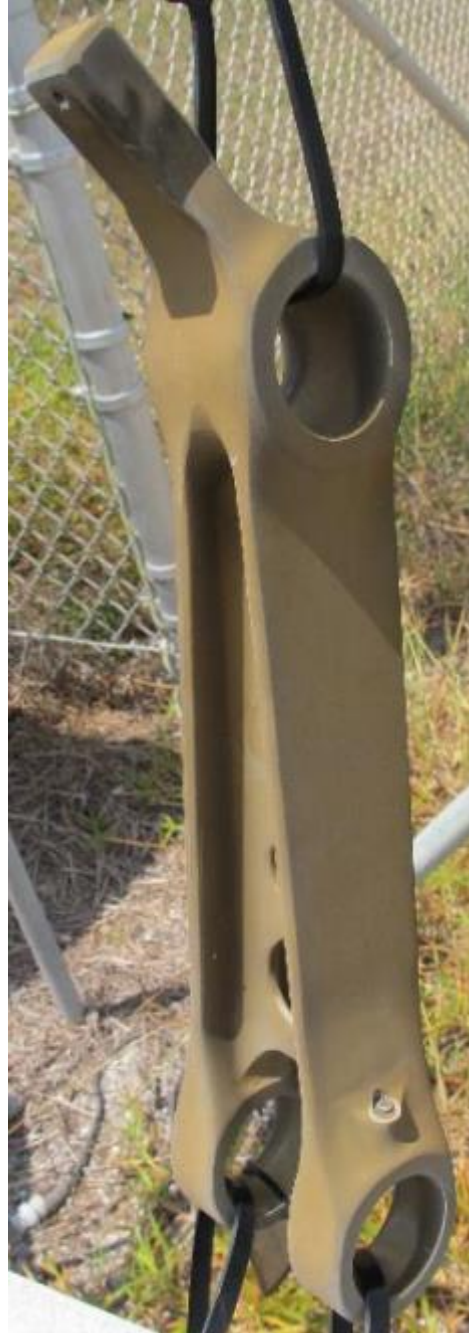
| <b>Test Component Installation Date: 10/22/2014</b> | | |
|---|---|---|
| | Cd Drag Brace | Slight white corrosion products |

**Figure 98: Cd Plated Drag Brace (7/13/2015)**

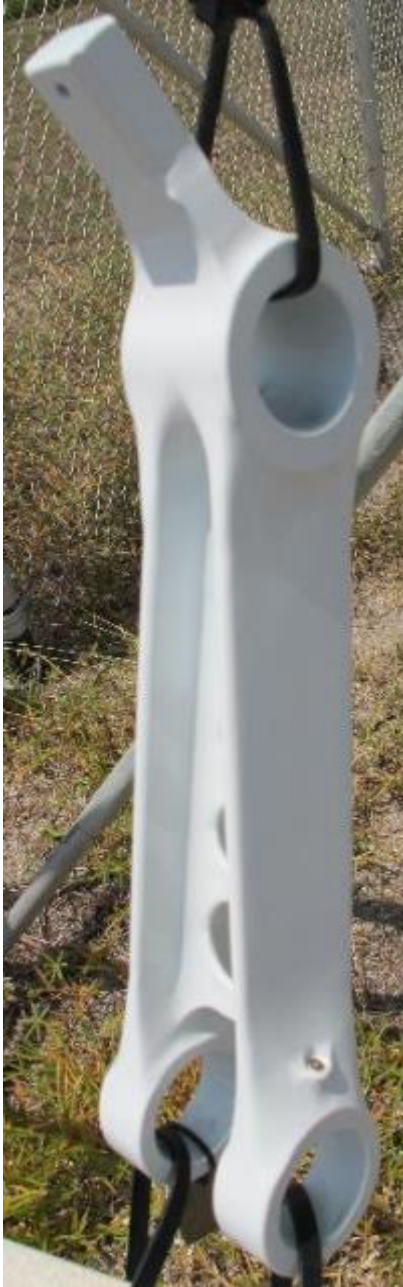
| <b>Test Component Installation Date: 10/22/2014</b> | | |
|---|---|---|
| 7/13/2015<br>264 days<br>exposure | Cd Drag Brace (Painted) | Slight Corrosion products visible |

**Figure 99: Painted Cd Plated Drag Brace (7/13/2015)**

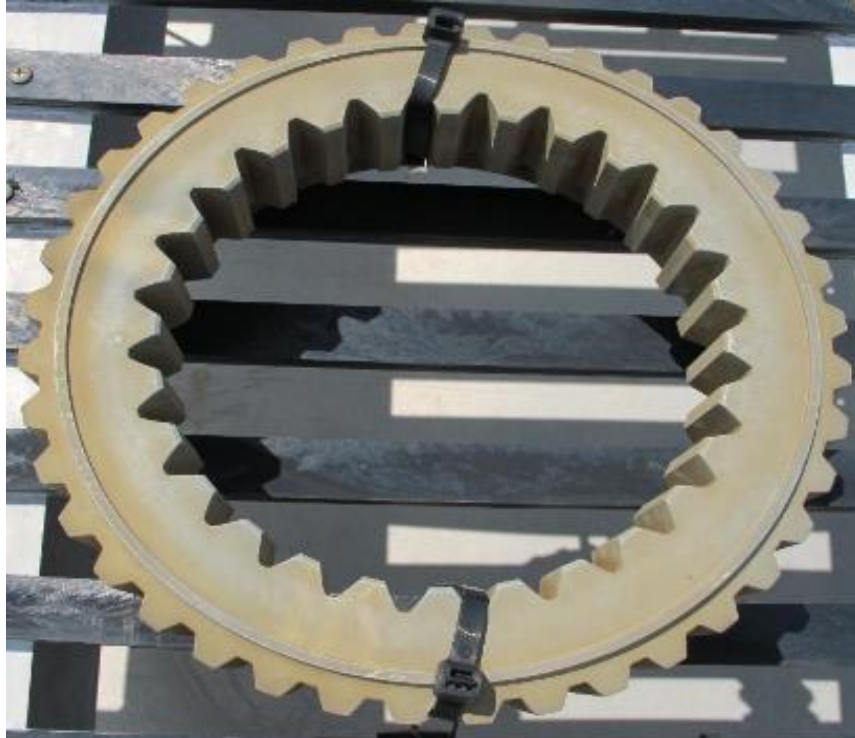
| <b>Test Component Installation Date: 10/22/2014</b> | | |
|---|---|---|
| | Cd Rotational Collar | Slight white corrosion products |

**Figure 100: Cd Plated Rotational Collar (7/13/2015)**

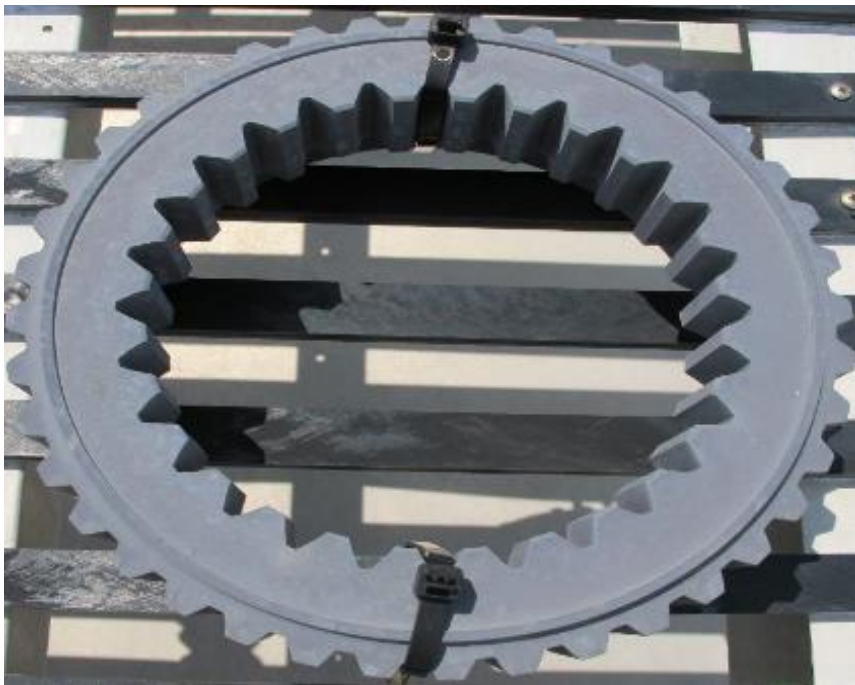
| <b>Test Component Installation Date: 10/22/2014</b> | | |
|---|---|---|
| | LHE Zn-Ni Rotational Collar | Slight white corrosion products |

**Figure 101: LHE Zn-Ni Plated Rotational Collar (7/13/2015)**

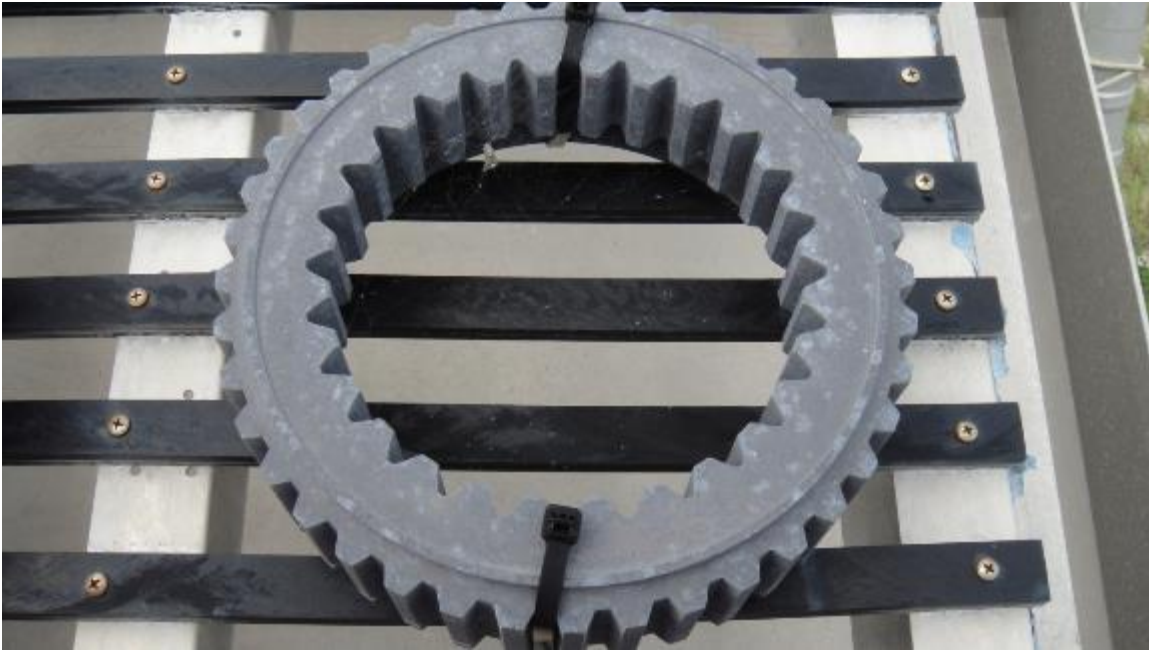
| <b>Test Component Installation Date: 10/22/2014</b> | | |
|---|---|---|
| | LHE Zn-Ni Rotational Collar | Moderate white corrosion products |

**Figure 114: LHE Zn-Ni Plated Rotational Collar (8/26/2016)**

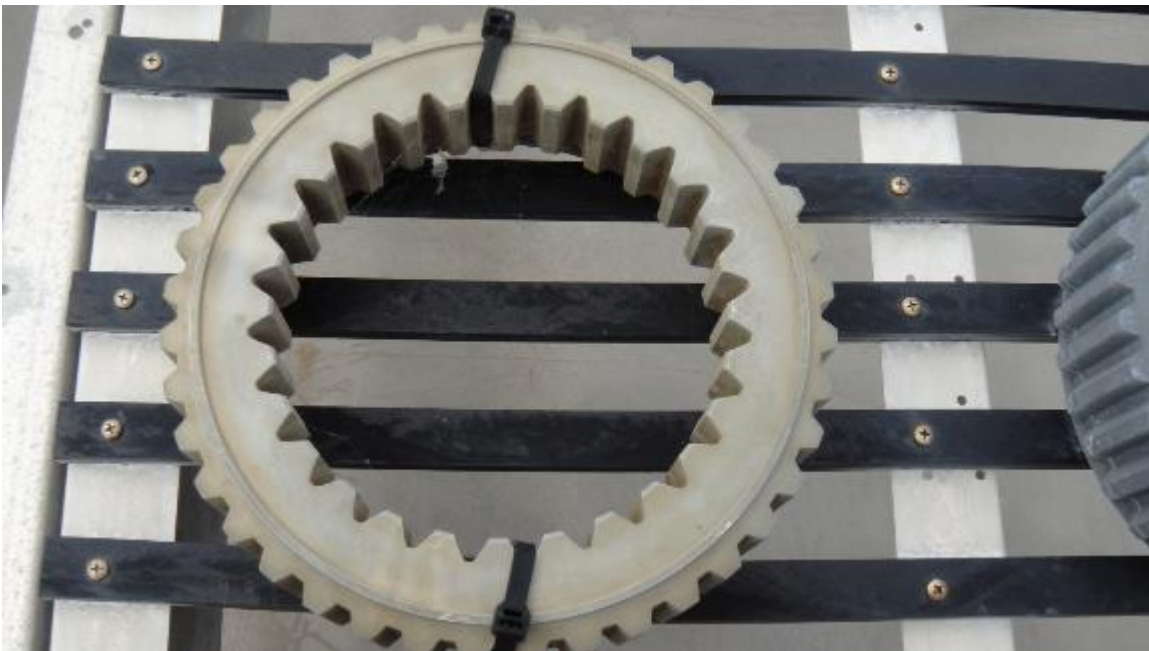
| <b>Test Component Installation Date: 10/22/2014</b> | | |
|---|---|---|
| | Cd Rotational Collar | Moderate white corrosion products |

**Figure 115: Cd Plated Rotational Collar (8/26/2016)**

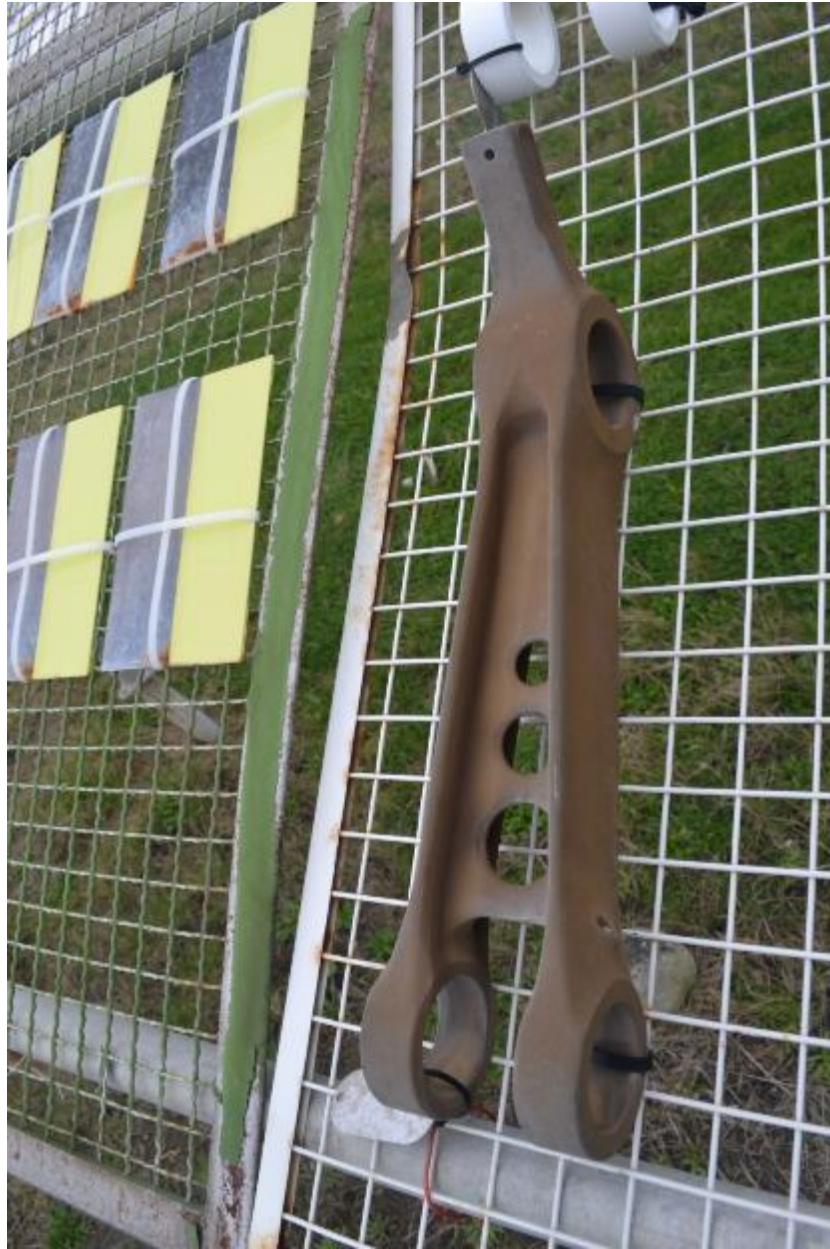
| | Cd Drag Brace | Moderate white corrosion products |

**Figure 164: Cd Plated Drag Brace (3/2/2016)**

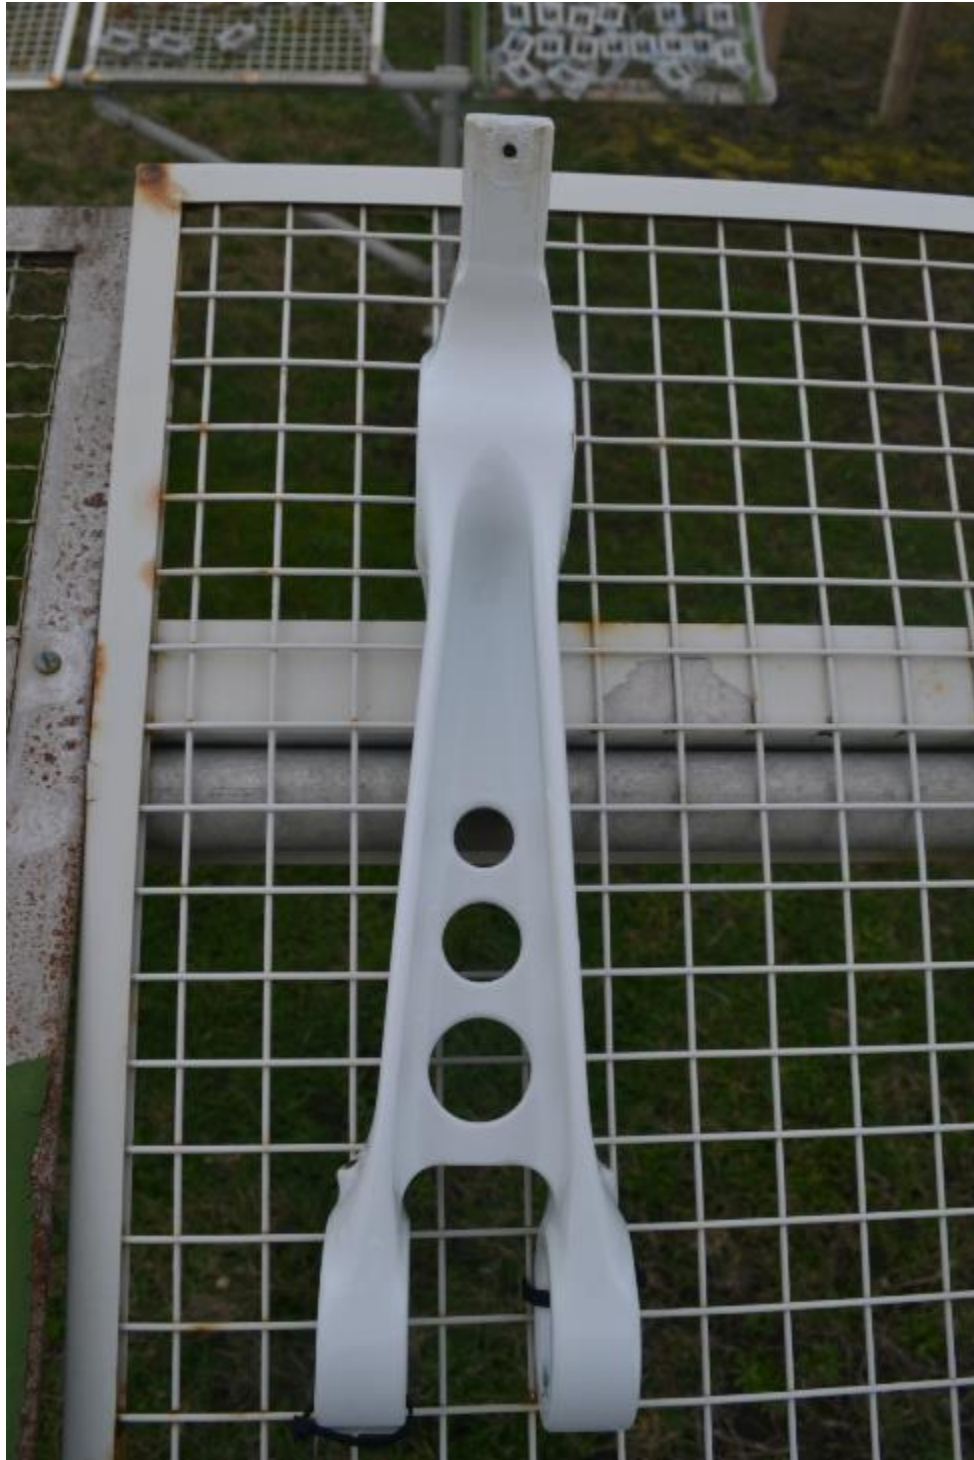
**Figure 165: Painted Cd Plated Drag Brace (3/2/2016)**

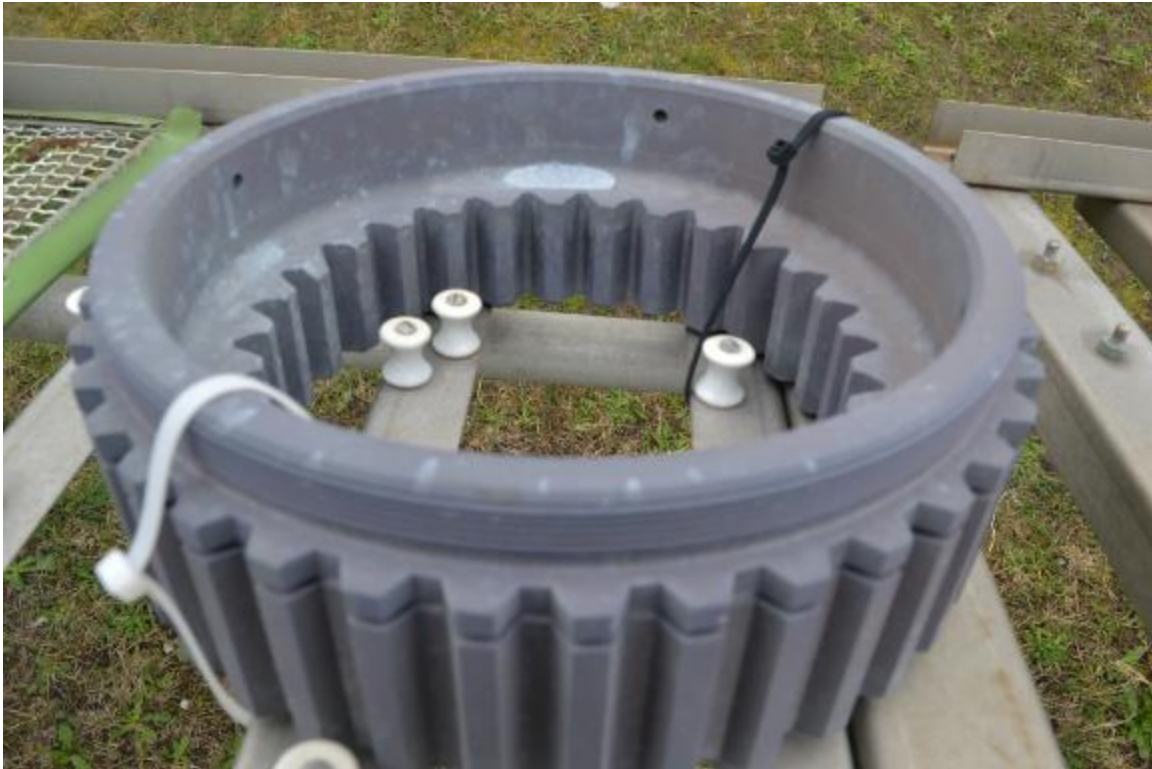
**Figure 166: LHE Zn-Ni Plated Rotational Collar (3/2/2016)**

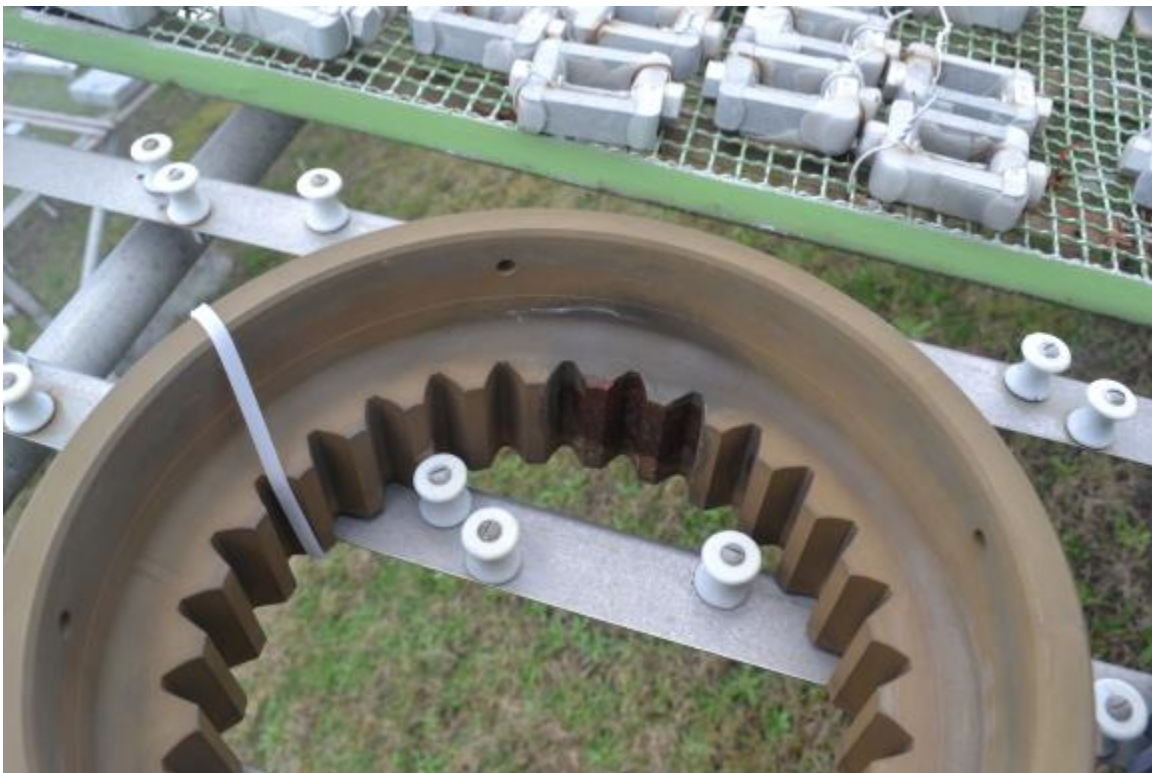
**Figure 167: Cd Plated Rotational Collar (3/2/2016)**
