# Contribution of Two Eroding Banks to Multipurpose Pool Sedimentation at a Midwestern Reservoir

**PURPOSE:** This US Army Corps of Engineers (USACE) National Regional Sediment Management Technical Note (RSM-TN) documents the sediment contribution of two eroding banks to multipurpose pool sedimentation at Kanopolis Lake, KS. The analysis is based on a 2009 LIDAR and an August 2019 unmanned aircraft systems (UAS)-based structure from motion survey.

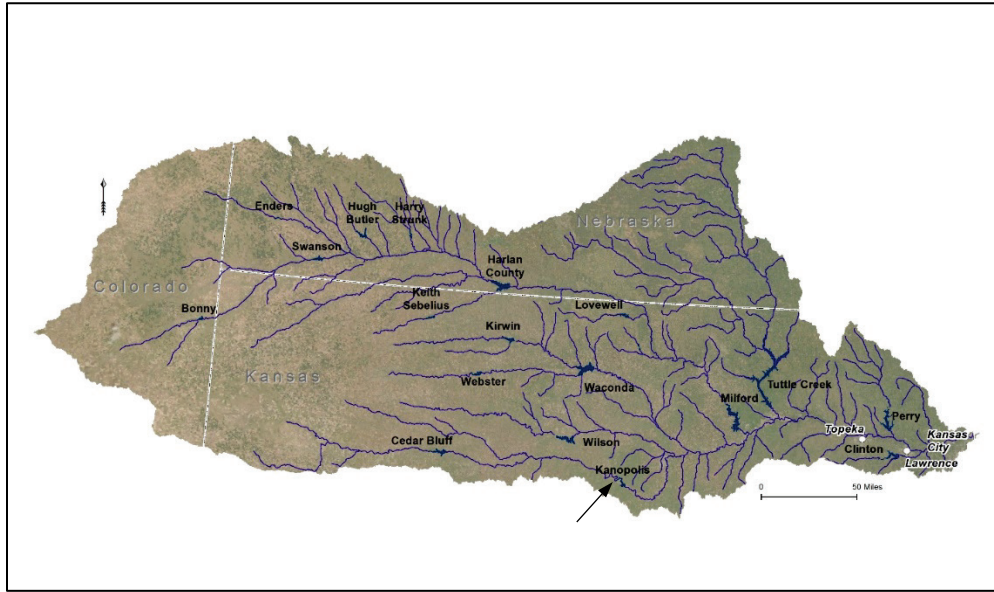
Figure 1. Kanopolis Lake in the Kansas River basin.

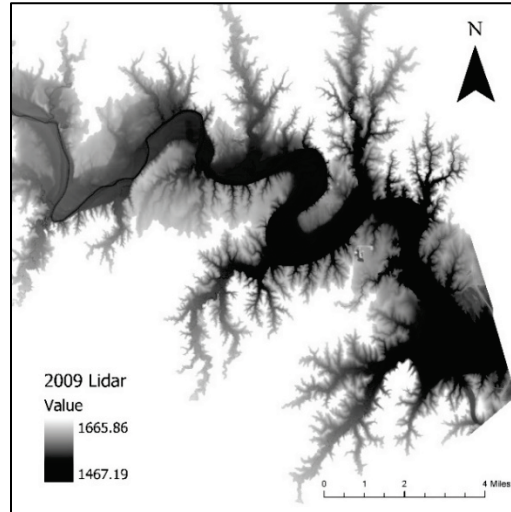
**DATA AND PROCEDURES:** The volumetric computation was accomplished by differencing two surfaces generated from a 2009 LIDAR and a 2019 structure-from-motion (SfM) survey. The 2009 LIDAR data set, depicted in Figure 5, was captured at a 2 m cell density with a hydro-flattened water surface of 1469.7 ft.

Figure 5. Digital Elevation Model (DEM) surface from 2009 LIDAR.

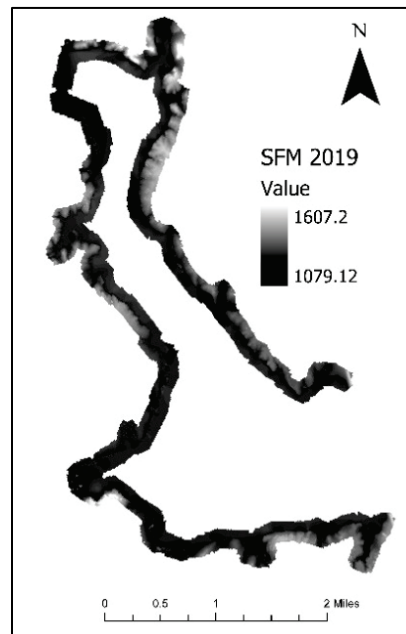
The 2019 SfM survey was conducted by the Kansas Geological Survey from 23 August 2019 to 28 August 2019 using a remotely operated UAS\* (Shelley 2019.) Over the course of the survey, significant inflows caused the pool to fluctuate from 1469.6 ft to 1476.4 ft. The data were adjusted to established ground points set around the lake. The SfM survey yielded a DEM with 6 cm cell size. The 2019 data set was resampled to the same 2 m cell density as the 2009 data to allow comparisons (Figure 6).

Figure 6. DEM surface from 2019 structure from motion.
