# Evaluation of Reentry Effects of Delta II Second Stage Propellant Tanks

March 21, 2018

Gary L. Steckel<sup>1</sup> and Paul M. Adams<sup>2</sup>

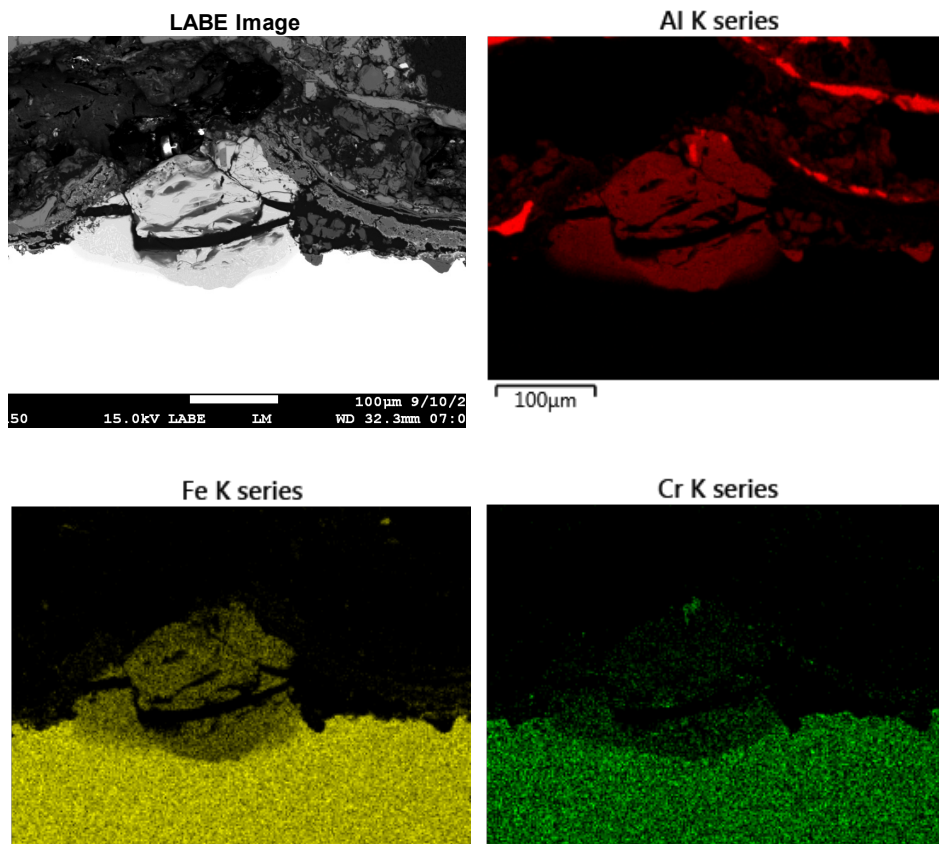
Polished cross-sections of the four samples were examined by optical microscopy to identify areas with possible alloying between the aluminum splatters and stainless steel tank surface. An example of an area selected for analysis is shown in the optical micrograph in Figure 13. This area appeared to have resolidified aluminum splatters on the tank surface and a resolidified area that appeared to be bonded to the tank surface—an indication of alloying between the aluminum and stainless steel. Figure 14 presents a SEM image of the same area, along with EDS elemental maps showing the locations of Al, Fe, and Cr (red, yellow, and green, respectively). The Al map verified the presence of Al splatters on the tank surface. The Fe and Cr maps clearly highlight the stainless steel tank wall. Most importantly, the maps verified the presence of Al, Fe, and Cr within the resolidified material that appeared to have a continuous bond with the tank wall. Thus, the mapping verified alloying between the Al splatters and stainless steel wall, making this a suitable area for more detailed SEM/EDS analyses to determine the peak reentry temperature at this location on the propellant tank.

Figure 14. Electron image and elemental maps of area in Figure 13.

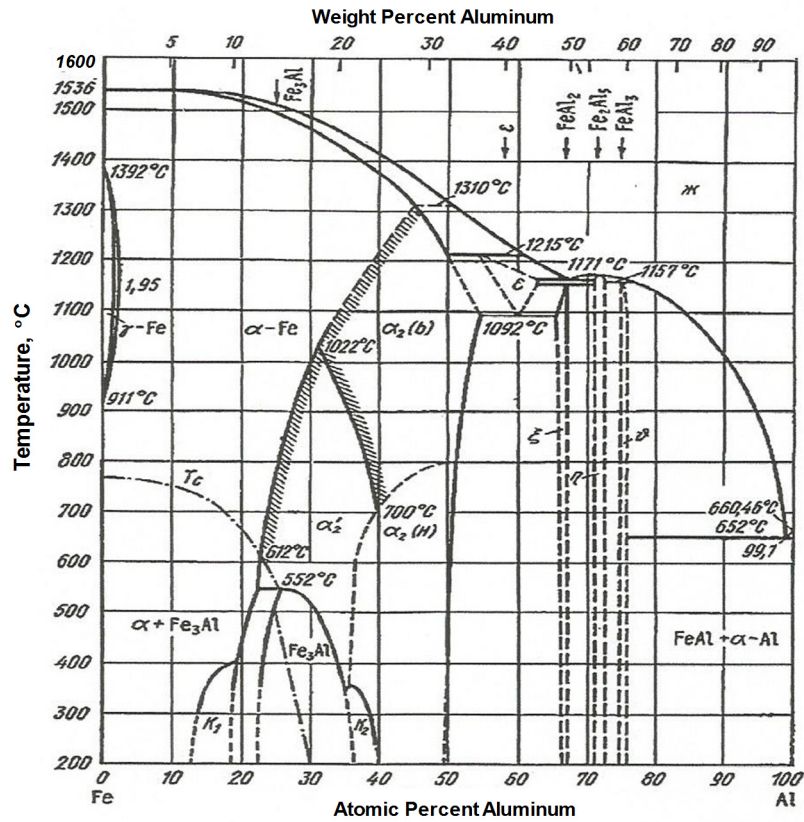
Following the procedure used by Wan [3], peak reentry heating was estimated by measuring the compositions of the phases that did and did not melt during reentry and determining their melting temperatures from the Fe–Al phase diagram. The Fe–Al phase diagram was recently updated by Matysik, et al. [10] and is shown in Figure 16. It will be shown below that the area of interest for our analysis is between 50 and 75 at. % Al. This region on the phase diagram is quite complicated near the melting point and is magnified in Figure 17. Depending on the Al concentration, several different intermediate phases ( $\alpha_2$ ,  $\epsilon$ ,  $\xi$ ,  $\eta$ , and  $\upsilon$ ) can form during cooling between 1200° and 1150°C. All these phases remain stable at room temperature, except for the  $\epsilon$  phase that decomposes into the  $\alpha_2$  and  $\xi$  by the eutectoid reaction at 1092°C.

Figure 16. Iron–aluminum phase diagram.

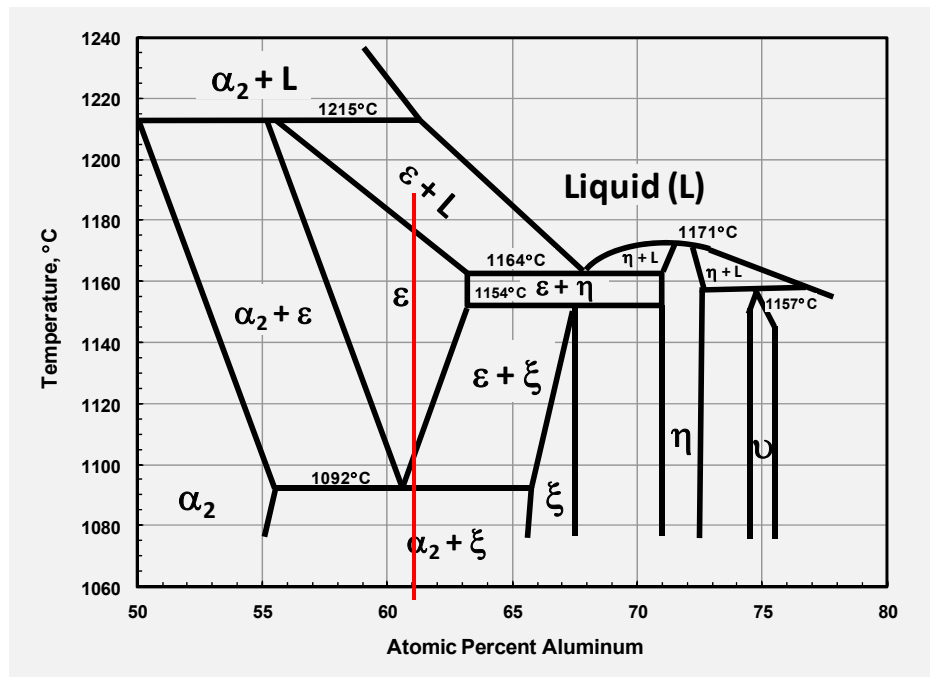
Figure 17. Magnified view of iron–aluminum phase diagram between 50 and 80 at. % Al.

large area EDS scan of the two-phase resolidified region gave an Al content of 61 at. %, the weighted average for the two phases. From the phase diagram, at temperatures below 1092°C, an alloy with 61 at. % Al (as indicated by the red line) has a microstructure consisting of  $\alpha_2$  with an Al content of approximately 55 at. % (light phase in Figure 18) and  $\xi$  with an Al content around 66 at. % (dark phase). For 61 at. % Al, melting initiates at 1075°C. Thus, the peak reentry temperature at this location on the tank was at least 1075°C, but did not exceed 1215°C.

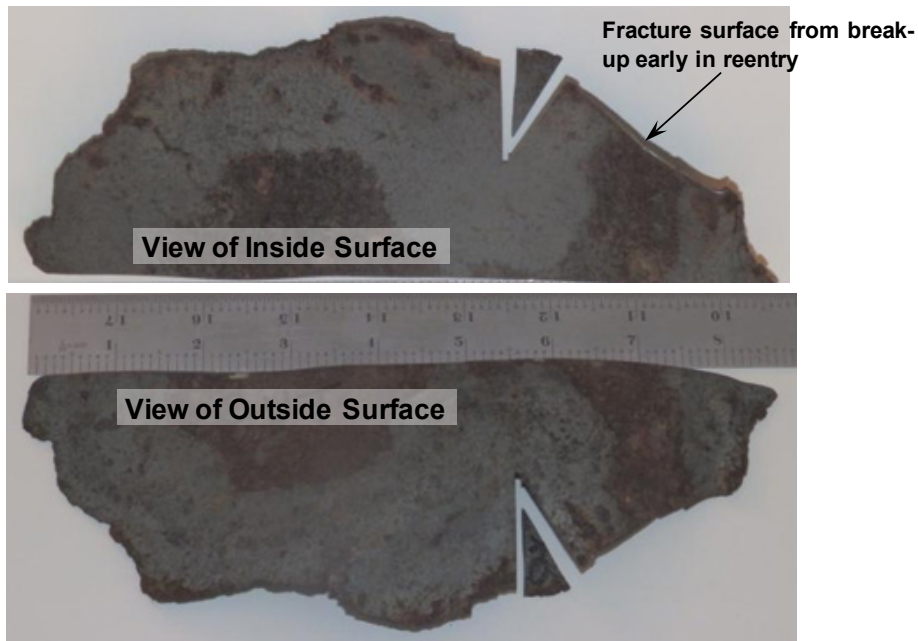
Sample A1, shown in Figure 19, was cut from the aft dome of the propellant tank along the path where the dome fractured during breakup. It was originally cut from the tank for evaluation because the light gray pattern on the outside surface suggested that a thick layer of molten aluminum had splattered along the fracture path during reentry. However, once the sample was removed, it was discovered that a matching gray pattern was also present on the inside surface (Figure 20). SEM/EDS spectra were taken on the surfaces of the gray area as well as the reddish area. No aluminum was detected on the gray area, and

Figure 20. Photographs of outside and inside surfaces of Sample A1.

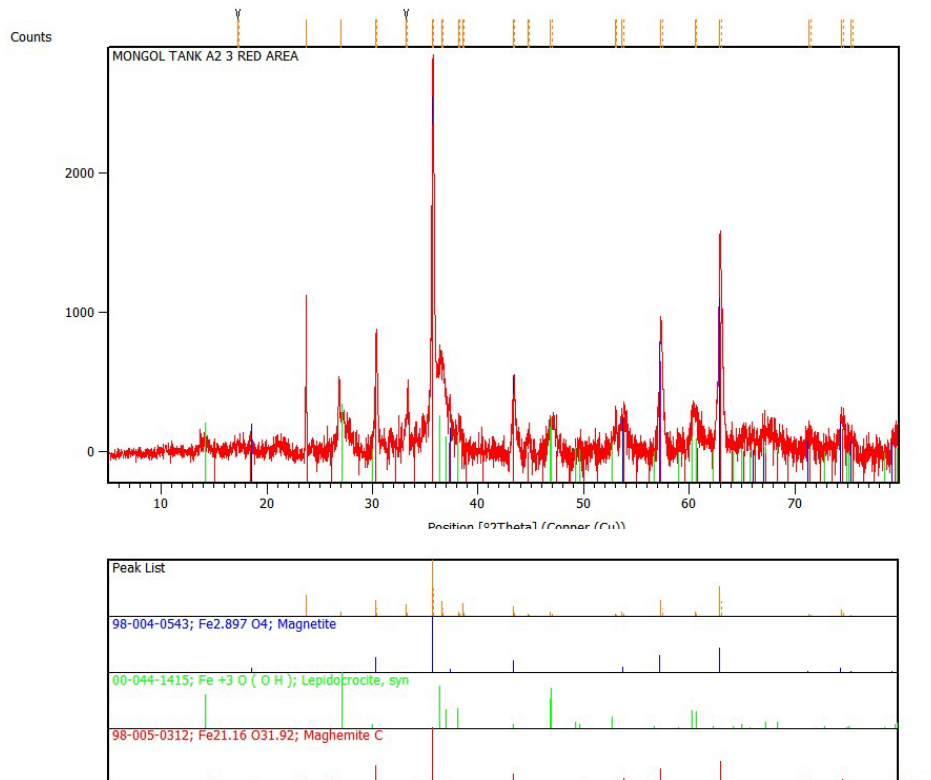
X-ray diffraction spectra were taken for the gray and reddish areas to further characterize the oxide layers. Magnetite ( $\text{Fe}_3\text{O}_4$ ) or maghemite ( $\gamma\text{-Fe}_2\text{O}_3$ ) and lepidocrocite ( $\text{FeO}(\text{OH})$ ) matched the spectra for the reddish area (Figure 21). Magnetite and maghemite have the same diffraction peaks, so either or both oxides may have been present. However, maghemite is normally not stable at room temperature, so the reddish oxide is likely magnetite [11].

Figure 21. X-ray diffraction spectrum obtained from reddish oxide on Sample A1.
