# **NAVAL POSTGRADUATE SCHOOL**

## **THESIS**

**A SYSTEMATIC APPROACH TO IDENTIFYING  
OPPORTUNITIES FOR MAKING SYSTEMS CONTEXT  
AWARE TO ADDRESS SAFETY HAZARDS**

September 2020

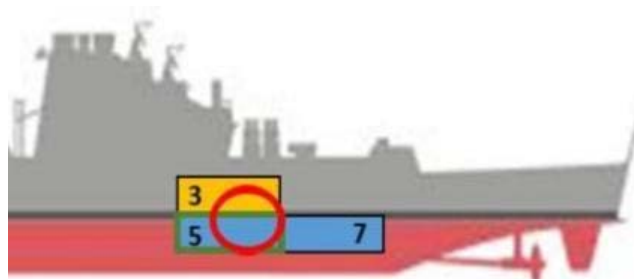
Figure 11 - Relative Positions of Berthings 3, 5 (in green), and 7, and point of impact

Berthing 5 is located aft (near the back of the ship) on the port side. See Figure 10. It is approximately 25 feet by 15 feet and has 18 racks, stacked as bunk beds three-high. Each row of racks has a locker for Sailors' belongings. There is a lounge with seats, a small table, and a wall-mounted television. There is a head with one toilet, one shower stall, and one sink.
