Lock Operation Improvements

Stuart D. Foltz and Daniel E. Hooks

April 2021

Final Technical Report

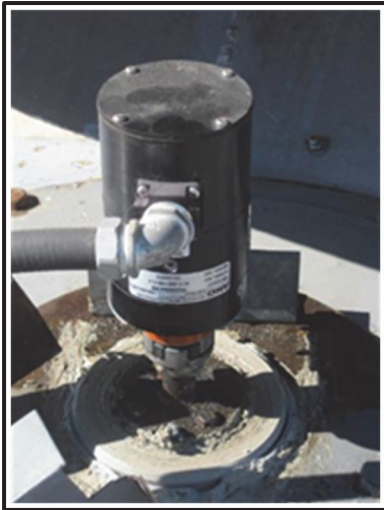
Figure 1. Resolver at Lockport Lock.

In 2005, single-turn, stainless steel resolvers were installed at the Marseilles Dam (Figure 2) in place of optical encoders. These units proved to be very reliable; so far there have been no failures. Resolvers also installed at the Lockport Lock in 2005 have demonstrated much higher reliability than the encoders used before the switch. This field experience helps confirm the

observation that resolvers are more reliable and better suited to this purpose than optical encoders. Reason for the excellent resolver reliability, is because resolvers do not have optics that can become contaminated like optical encoders do. Encoders are not recommended in humid environments.

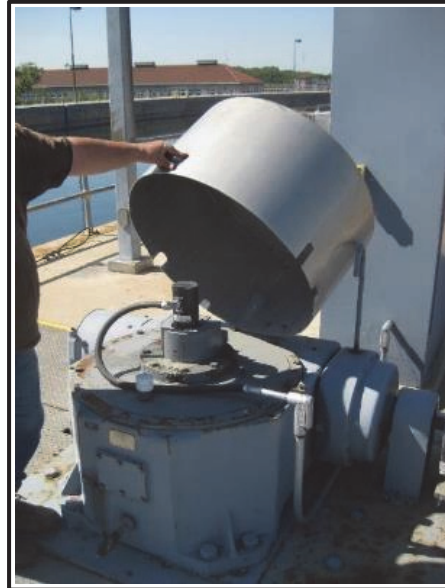
Figure 3. Gearbox cover at Lockport Lock.

Gear box covers are essential to keep water and snow out of the gear box. Since the upper shaft seal of the gear box does not provide a perfect seal, water will inevitably end up in the machinery if the gear box is not provided with a cover. Gear box covers also protect gear oil against contamination. Although some lock locations filter their gear oil to remove water, this additional step could be avoided entirely by simply installing a gear box cover. Gear box covers are simple and reliable; in over 20 years of service, the gear box cover at Lockport Lock (Figure 3) has only blown off one time due to a microburst in a bad wind storm.

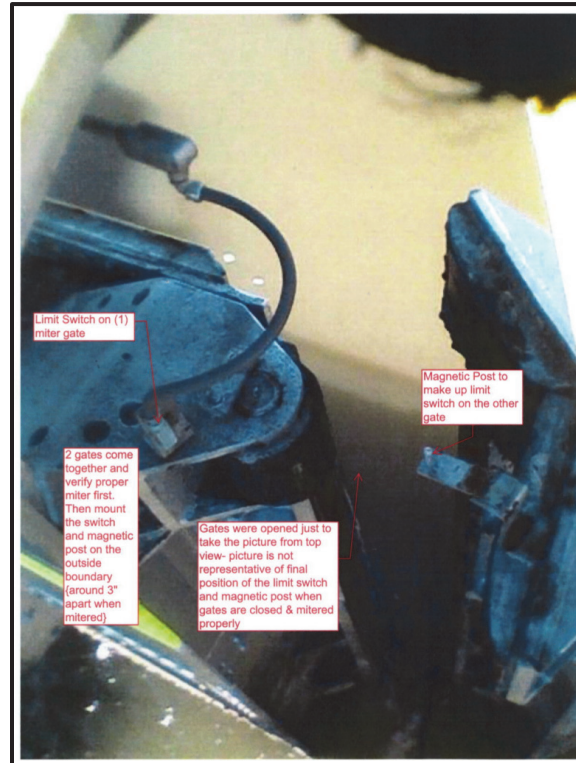
Figure 5. Magnetic proximity switch location in Nashville District.

It has been noted that the proximity switch location on the lower miter gates downstream would not work on any upper miter gates, as the proximity switch and magnet would be exposed to damage from barge impact when the upper miter gates are open. Switches have been damaged in the past at Mobile District, because of this reason. Figure 6 shows the proximity switch location used at New Orleans District. This location may be more suitable for low-lift locks because the proximity switch is not placed on the downstream side of the miter gates. In other words, when the chamber is empty and the upper or lower gates are open, the proximity switch is recessed and high enough, so that it cannot be damaged by barge impact as the barge enters and exits the lock chamber. As a practice, it is best to locate the mitering proximity switch and magnet at top/midpoint

like Nashville District and New Orleans District do. Damage can be prevented.

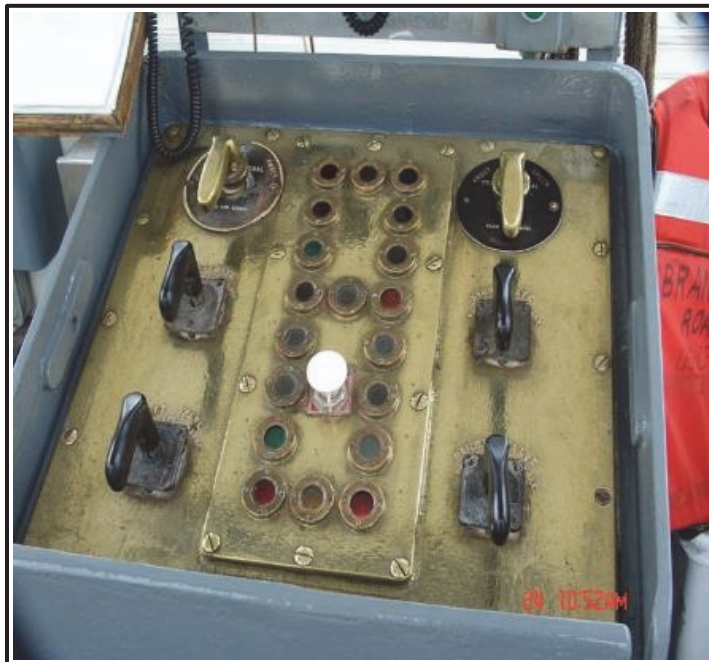
Figure 14. Brandon Road control panels.

Brandon Road Lock still has its original 1930s vintage control panels (Figure 14). The old obsolete mechanical gate position controls still remain. Modernized control panels may be able to fit small PLC Input/Output (I/O) racks into the new control panels when the lock gets PLC/resolver upgrades. Proximity switches and extended-range magnets can be installed before that. Proximity switches will prevent damage resulting from mechanical gate positions controls failure and operator not checking mitering.

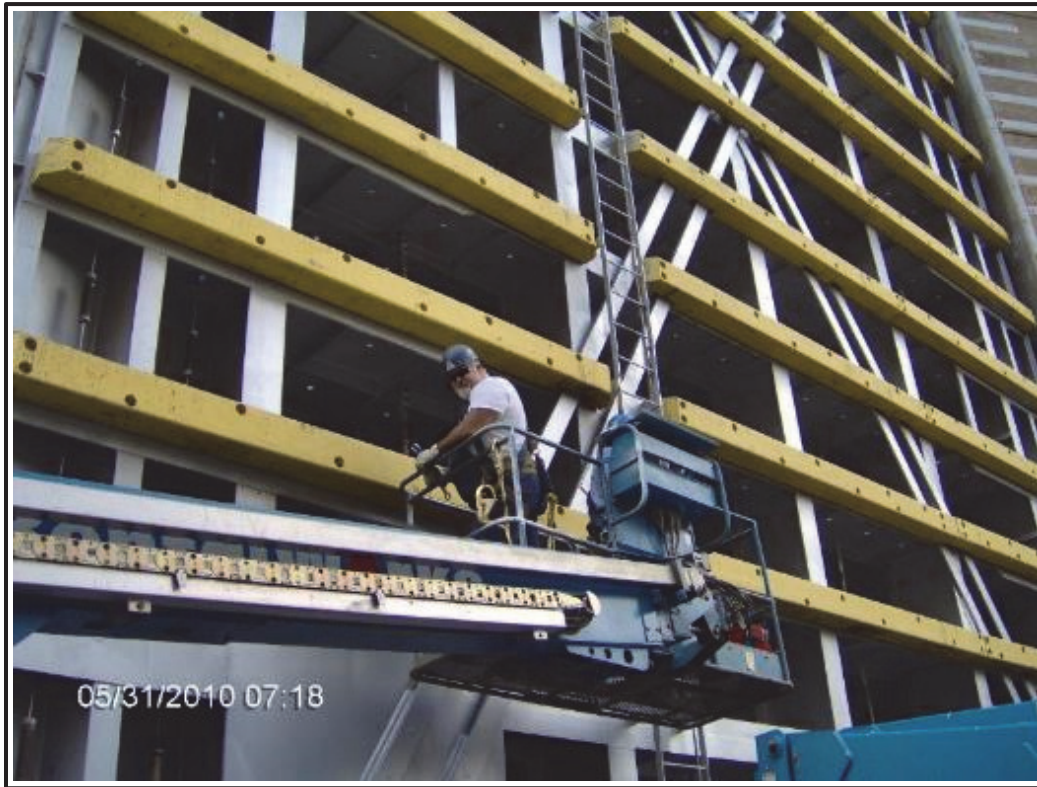
Figure 20. Plastic bumpers attached to miter gate.

For example, plastic lumber (Figure 20) is more durable and far more abrasion resistant than wood. One drawback to the use of plastic lumber is that it sometimes gets pulled off by the bolts. The center cores of the timbers are softer, making it more prone to pulling off. This is especially the case if the bolt holes are slotted for differential thermal expansion.

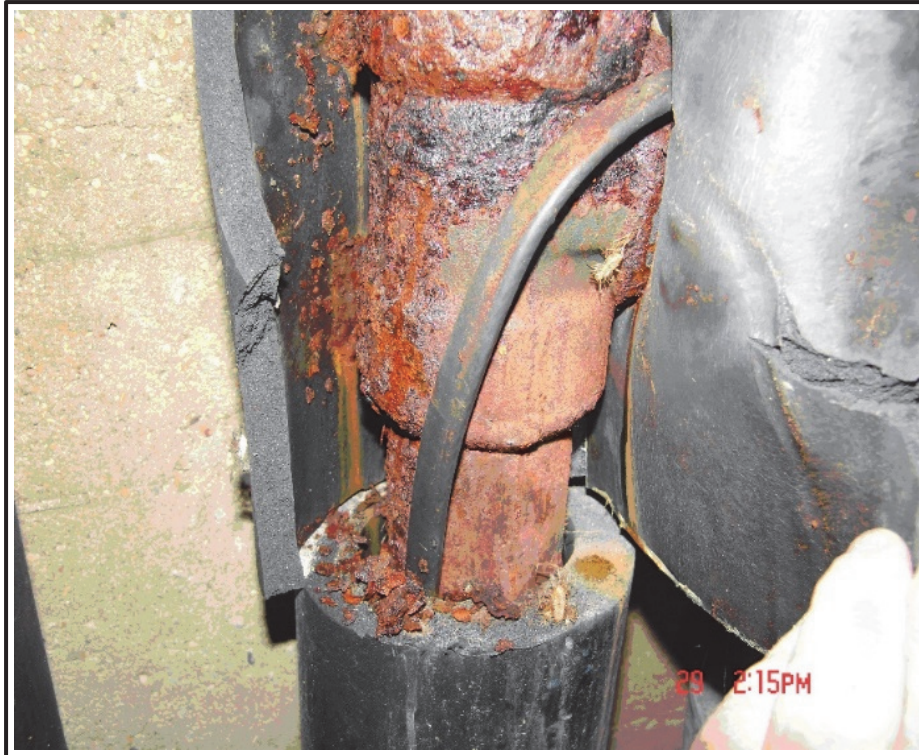
Figure 23. Hydraulic system on emergency gate.

Corrosion is an issue that may occur on many different components or parts at lock sites. Any part that is exposed to humidity or water may become corroded. If not addressed, corrosion can become a very costly problem. The emergency gate at Lockport Lock shows significantly more corrosion than does the service gate, as the service gate was converted to S/S pipes. Figure 23 shows the emergency gate piping, which was in critical condition due to the large amount of corrosion. This has now been converted to S/S also.

It is better to use S/S pipe in original installations in locations close to water.

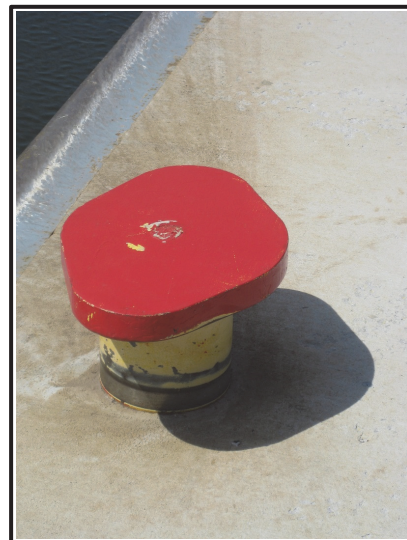
Figure 26. New mooring bit.

In the past, lines would occasionally slip off the pin (especially lines from empty barges, which sit much higher in the water than loaded barges). Figure 25 shows the old mooring bit design. Figure 26 shows a new type of mooring bit that fixes these problems, but sharp edges were cutting lines. A key consideration when installing mooring bits is to specify contracts requiring manufacturer to grind-down sharp edges.

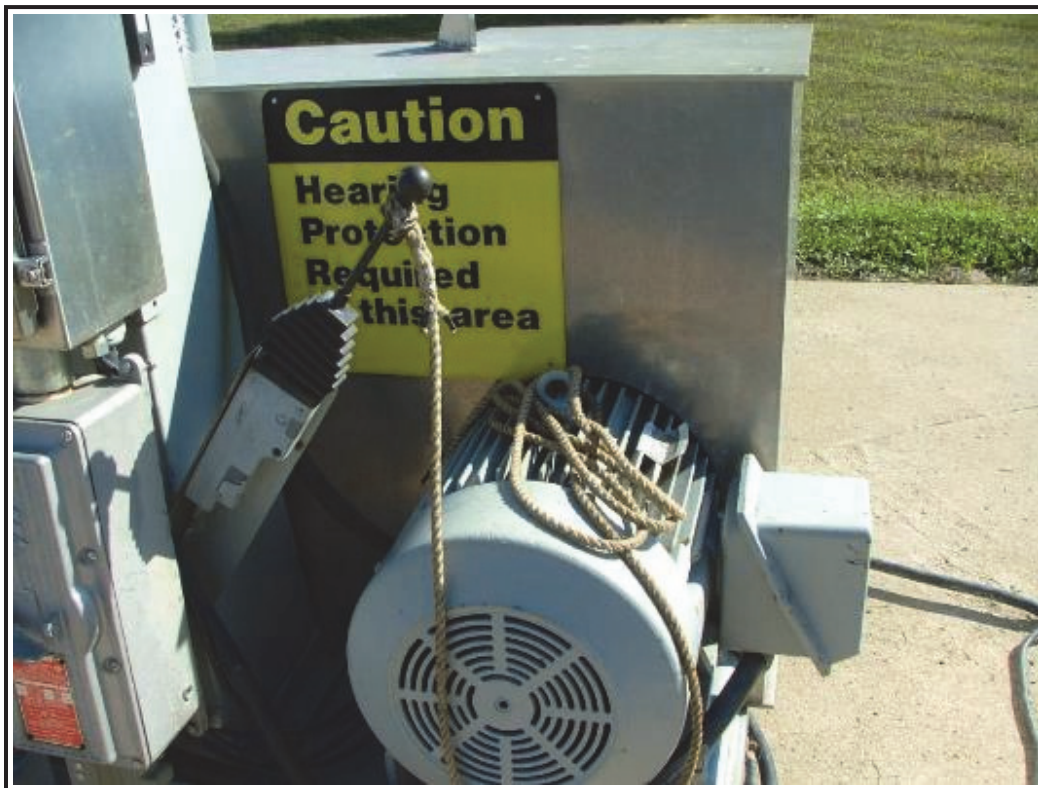
Figure 35. Hydraulic tow haulage unit at Peoria Lock.

The old electronic tow haulage units had a problematic design flaw, which allowed operators to walk-away from the controls while the cable drum was still turning. This was the cause of many accidents, including an operator losing his thumb. The IWW decided to go with hydraulic tow haulage units (Figures 35 and 36), which have a spring-return “dead-man” safety feature. There have been multiple costly accidents due to operators leaving

controls unattended. A possible risk mitigation method would be to incorporate a motion switch that would time out if an operator walked away. Unsupervised operators have sometimes adopted this unsafe practice (Figure 36) that could also damage equipment (rope is used for bypassing spring-return “dead-man” safety feature).

Lock supervisors should not allow “dead-man” safety feature to be bypassed.

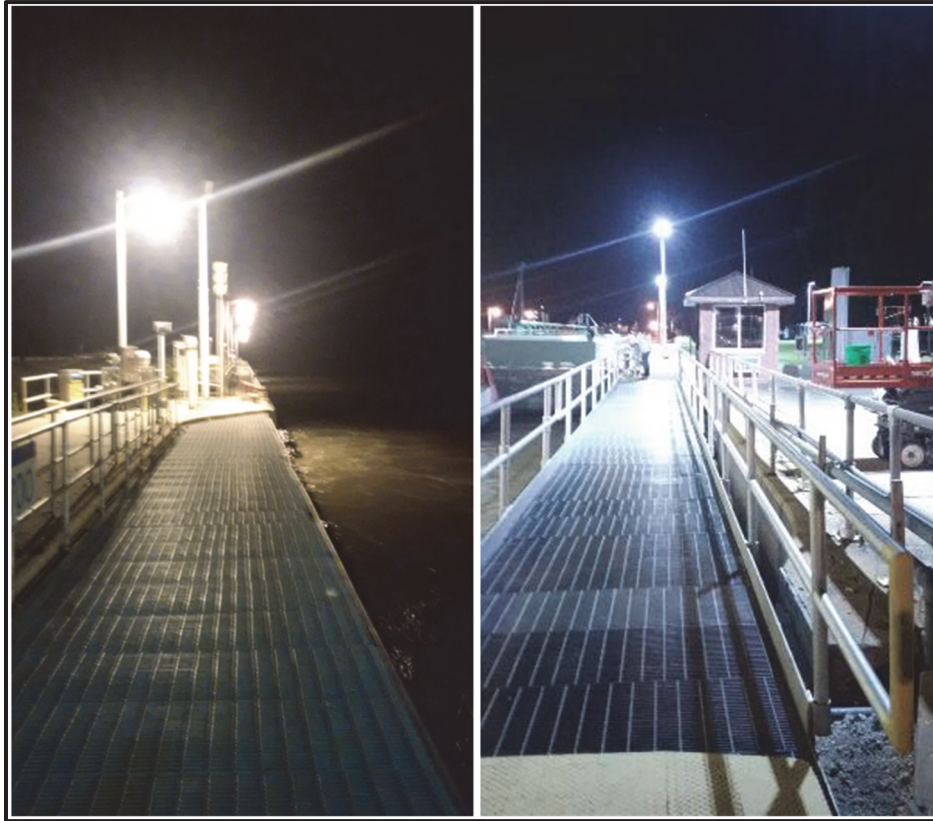
Figure 40. Before (left) and after (right) LED replacement at Starved Rock.

Starved Rock Lock converted its light pole lighting to LED with impressive results. Light readings from the new LED lighting were 4-5 times higher than readings from the old light pole lighting. Six LEDtronics wall packs were installed on the Lockport Lock pump houses and cable buildings. They are friendly to navigation, as it is not too bright to look at. Figure 40 shows lighting at Starved Rock Lock before and after LED replacement.

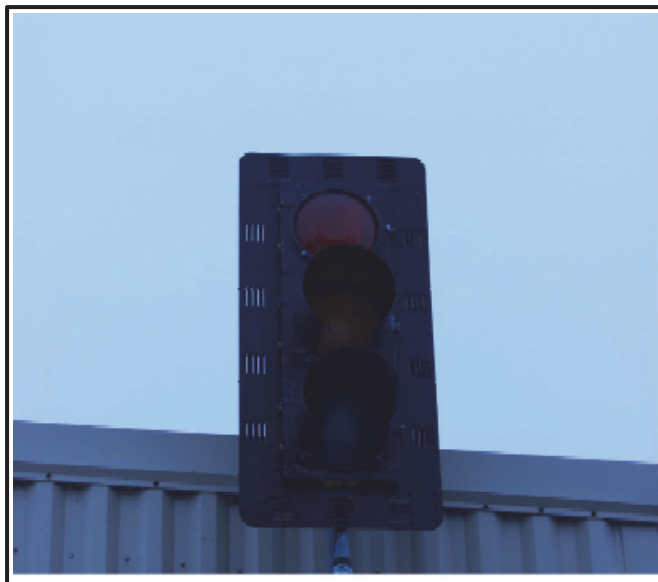
Figure 48. Traditional signal at upstream lock gate.

Replacement LED traffic signals are brighter than the old incandescent signals. The conversion from incandescent to LED fixtures is easy and (so far) has caused no problems. The new LED fixtures are easy to install since they are designed to fit in the old light socket. Figures 48 and 49 show the traditional incandescent signals and the new LED lighting fixtures, respectively.

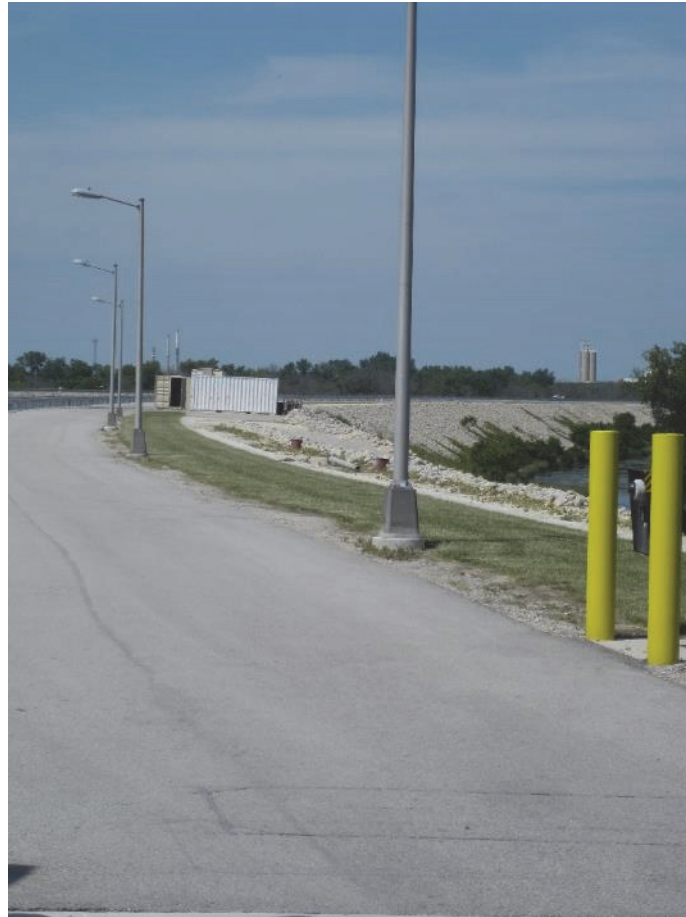
Figure 50. Light pole at Lockport Lock.

At Lockport Lock, poles upgraded to LED (Figure 50) cannot be accessed for maintenance, except for one tip-down pole. Another issue that surfaced after the upgrade was that the 8-in. curb that previously protected the poles was not reinstalled as part of the levee rebuild. Since the pole was no longer well-protected, a visitor backed into the pole, knocked it down, and damaged the new LED light. As a result, the light pole, the light pole base, and the LED light had to be replaced.

Note that Lockport Lock engaged Holophane to perform a lighting study based on the height and spacing of the light poles to calculate the amount of light needed and to then choose an appropriate model for the situation. It is recommended that such studies be performed before installing LED fixtures.
