Geotechnical Inspection and Technical Review of Santa Margarita River Marine Corps Air Station Levee, U.S. Marine Corps, Camp Pendleton, CA, 19-20 November 2019

Lucas A. Walshire and Joseph B. Dunbar

August 2021

Final report

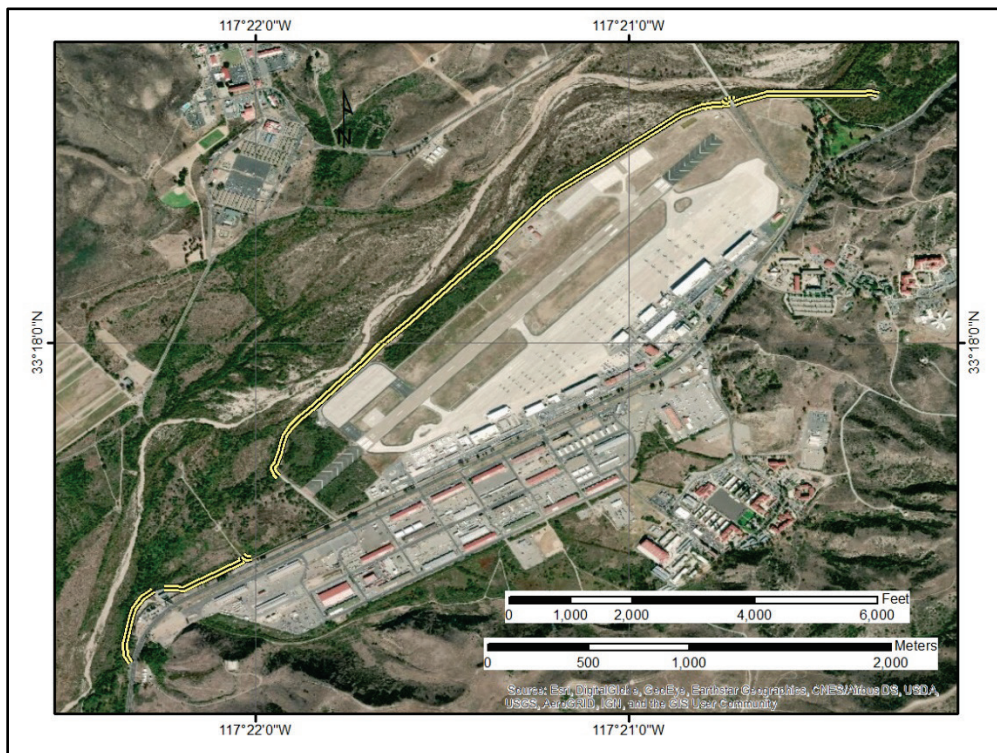
Figure 11. Areas identified for launchable riprap (yellow double line) in BergerABAM (2019a).

Installation of the launchable riprap will address issues associated with scour and the observed depressions in the current riprap revetment. Locations identified where launchable riprap are to be installed are shown in Figure 12. Figures 13 and 14 show the design of the launchable riprap as well as the access path for the levee and floodwall sections (BergerABAM 2019a). The proposed design will remediate the existing riprap with the launchable riprap design.

As scour occurs, the riprap is designed such that gravity will force the riprap at higher elevations to flow into the potential scour hole, arresting further progression. This remediation addresses two deficiencies: it will protect the riverside slope from direct contact by weathering and erosion, which is slowly degrading the embankment, and it will also provide a dynamic response to possible scour induced by high flow events.
