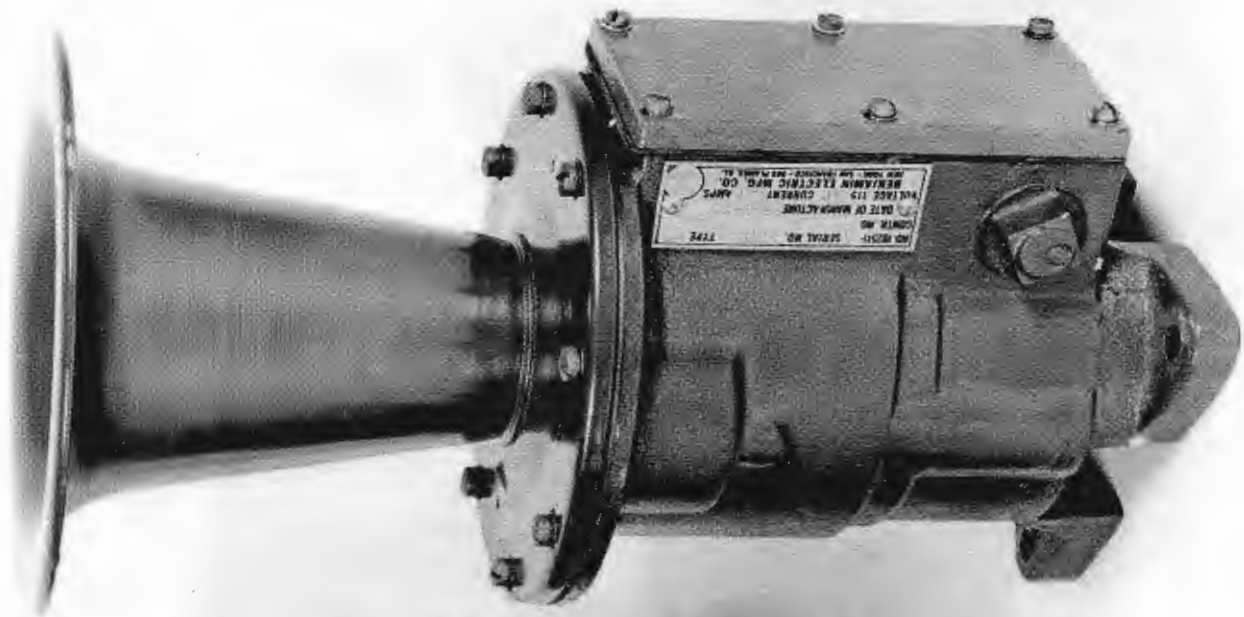
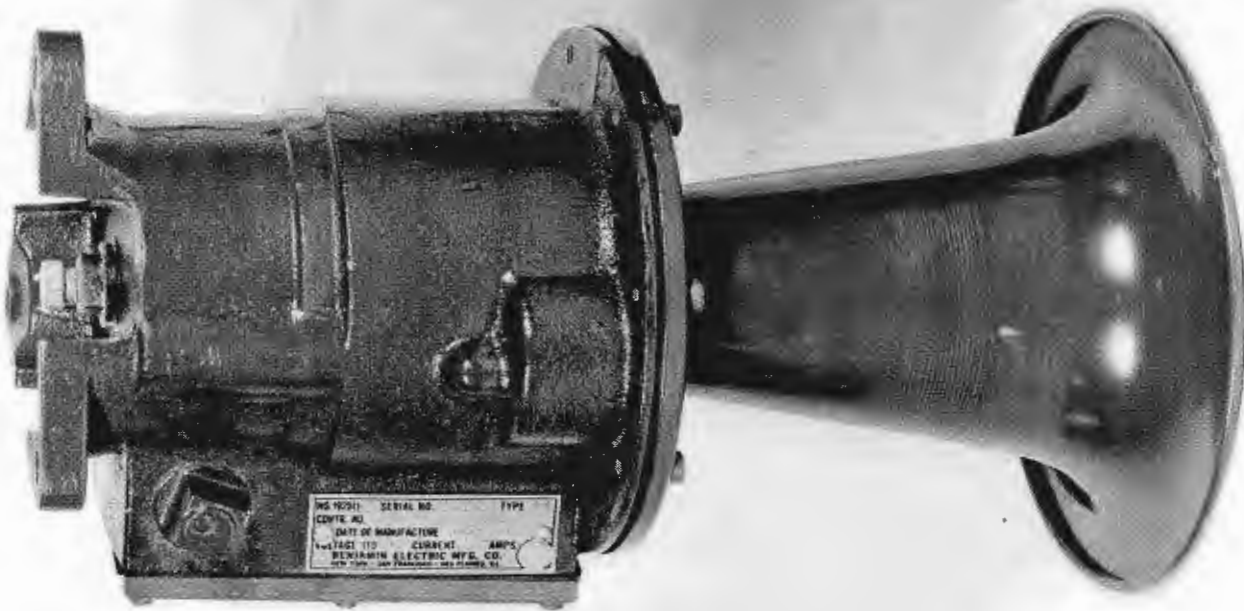
PLATE 2

<u>Requirements</u>	<u>Test Values</u>	
	<u>Type H-8</u>	<u>Type H-9</u>
Pitch of note: 100 to 600 C.P.S.	Complied. (See Plate 1)	Complied. (See Plate 2)
Inclination: Shall operate in any position when supplied with rated voltage and frequency \pm 10 per cent.	Complied.	Complied.
Endurance test: Shall operate 1500 cycles of "one minute on" and "one minute off", the first 750 cycles at 60°C. and the second at 0°C. ambient temperatures.	Complied following 3 diaphragm replacements due to fractures. (See Conclusions)	Complied following 1 diaphragm replacement due to fracture. (See Conclusions)
Temperature rise: Maximum temperature shall not exceed 115°C. during the endurance test. (55°C. rise at 60°C.)	Complied, 30.9°C. above 60°C. ambient.	Complied, 26.5°C. above 60°C. ambient.
Shock integrity: Shall withstand 20 shocks of 250 foot pounds each as specified in paragraph F-2g.	Complied.	Complied.
Vibration test: Shall be mounted on a standard Navy 3 foot pound vibration machine and subjected to six tests of 30 minutes each at 100, 150, 200, 250, 300, and 350 shocks per minute.	Complied.	Complied.
