NRL Report No. B-1645

Report of Test

Horns, Types H-8 and H-9

Submitted by Clark Cooper Company,

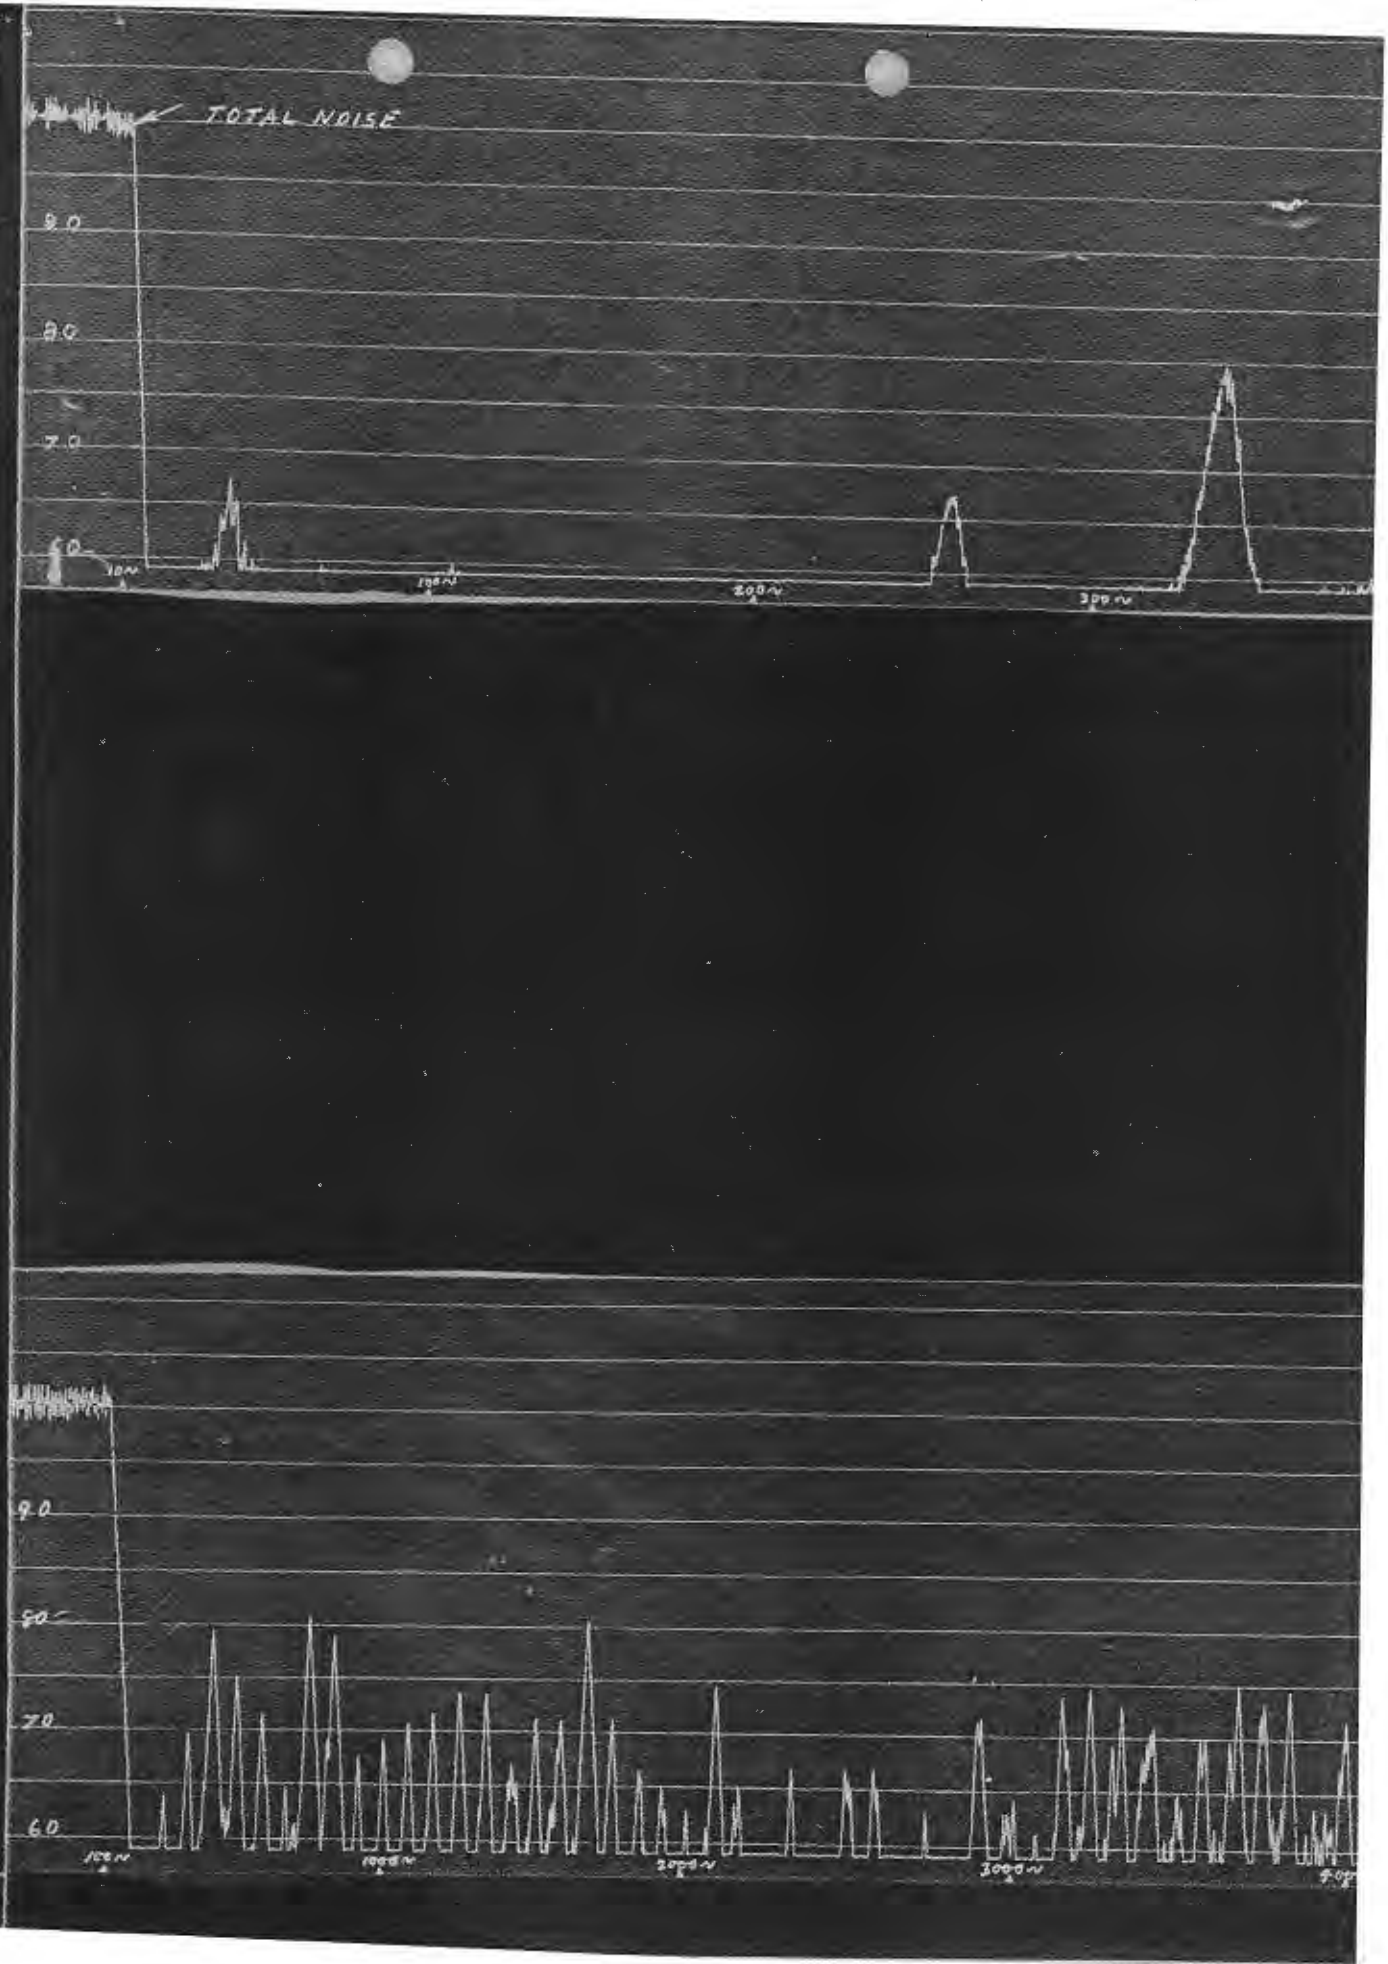
TYPE H-8 115 V. 1T, D.C. HORN

<u>Requirements</u>	<u>Test Values</u>	
	<u>Type H-8</u>	<u>Type H-9</u>
Voltage: 115 volts	115 volts	115 volts
Current:	Direct	Alternating
Amperes: Not specified	0.74 amperes	0.72 amperes.
Watts: Shall not exceed 75	*81.1 watts	60 watts
Power factor: Not specified	- -	72.4%
Weight: Shall not exceed 15 pounds	Complied 10 pounds, 13 ounces	Complied 10 pounds, 13 ounces.
Sound pressure output: Shall be not less than 90 decibels at 18 feet in a soundproof room under the following conditions:		
At rated voltage and frequency:	100 db (total noise)	102 db (total noise)
After endurance test	Could not be tested due to failure during the endurance test.	
Pitch of note: 100 to 600 CPS.	Complied (See Plate 1)	Complied. (See Plate 2.)
