Report on Evaluation of Apartment Towers 1–4 and Parking Garages 1–4 at Camp Walker, Daegu, South Korea

April 2022

Final report

Prepared for Far East District, Pacific Ocean Division
U.S. Army Corps of Engineers
573 Bonney Loop, Building 525, Suite A300
Fort Shafter, HI 96858

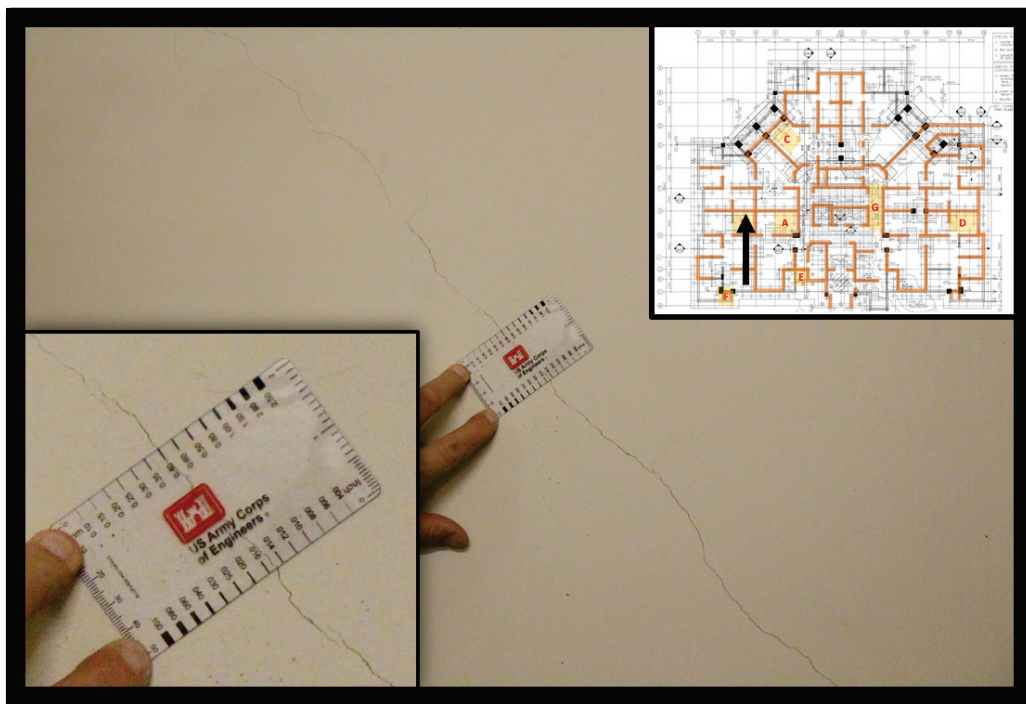
Diagonal cracks were observed in multiple locations in the walls of the Tower 1 basement. These cracks were usually oriented sloping away from the bottom corners created when two walls and the floor intersected.

Figure 1 shows a typical diagonal crack seen in the basement of Tower 1. From the view in this figure, the corner would be down and to the left.

Figure 1. Diagonal crack within the Tower 1 basement storage area (Section B of the floorplan insert). The widest section of the observed crack was 0.40 mm (crack gauge insert); however, the crack width narrows at the extents and does not intersect with the floor slab.

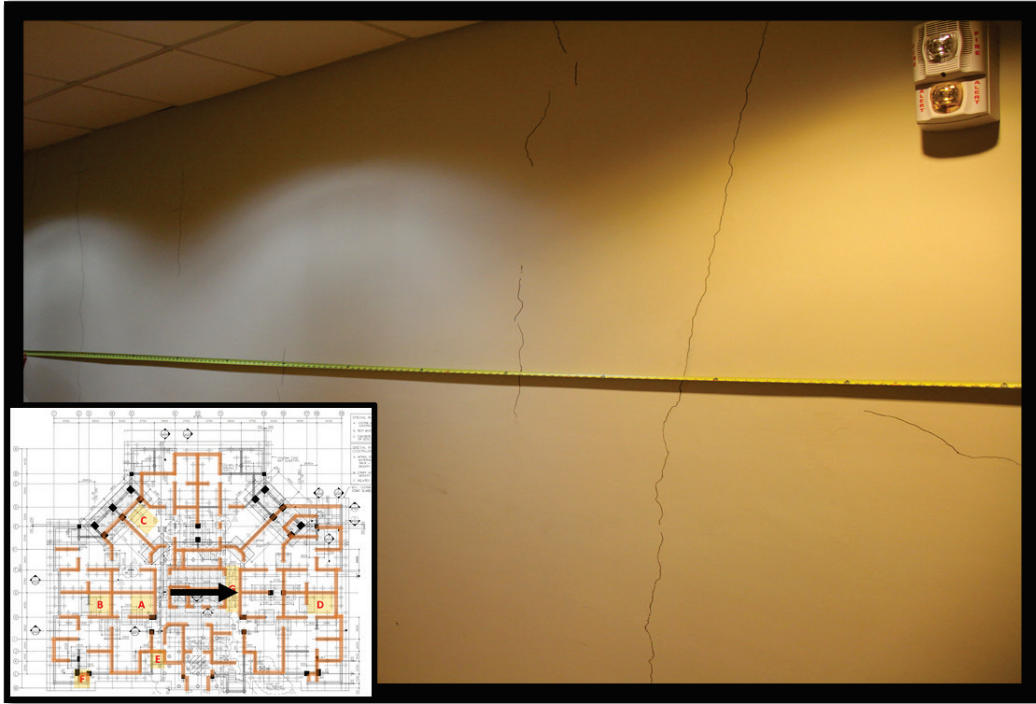
Figure 3. Wall cracks within the Tower 1 basement storage area (Section G of the floorplan insert). The widest observed crack width was less than 0.40 mm. The shown cracks were traced with a permanent marker to highlight typical locations, lengths, and spacing and are not representative of crack width.

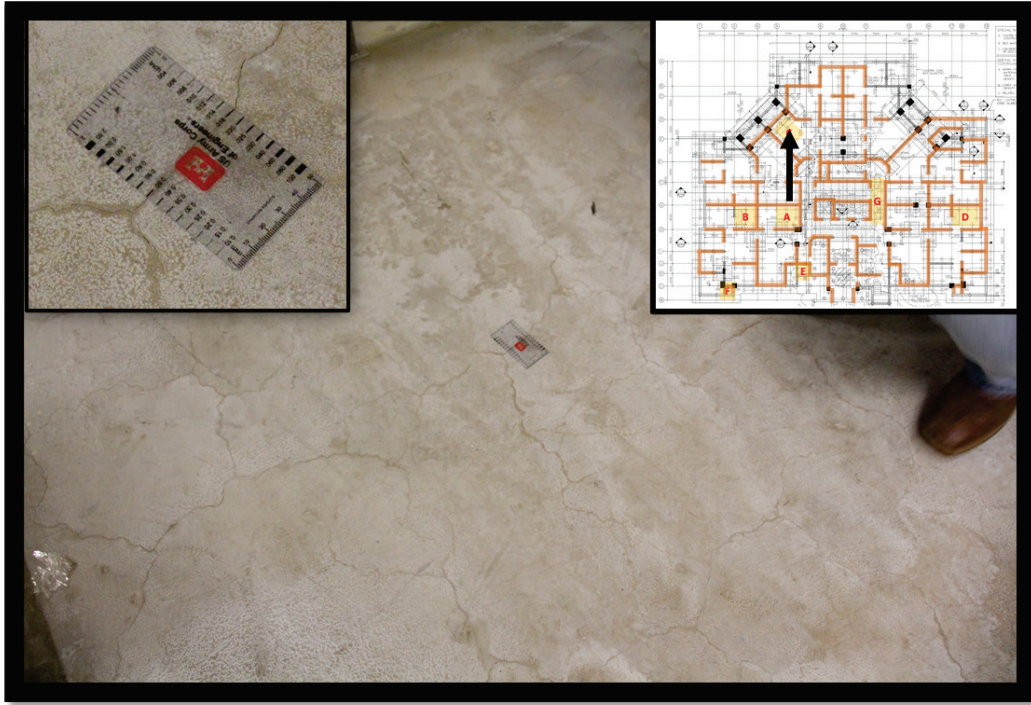
The basement of Tower 1 was one of the only areas where the bare concrete floor was visible. Figure 4 shows typical crack patterns and widths. This type of multidirectional cracking is often an indicator of poor concrete finishing practices or early-age plastic shrinkage. On a slab, this is often a sign of poor finishing or curing practices. Poor finishing can cause a thin surface layer that has a very high water to cement (w/c) ratio. In this case or in poor curing, as water is lost to evaporation, this surface layer shrinks causing cracking. Figure 5 shows additional views of similar cracking in the same area of the Tower 1 basement.

Figure 4. Slab floor cracks within the Tower 1 basement storage area (Section C of the floorplan insert). The widest observed crack width was between 0.40 and 0.50 mm (crack gauge insert) with most observed cracks being hairline cracks of less than 0.25 mm.

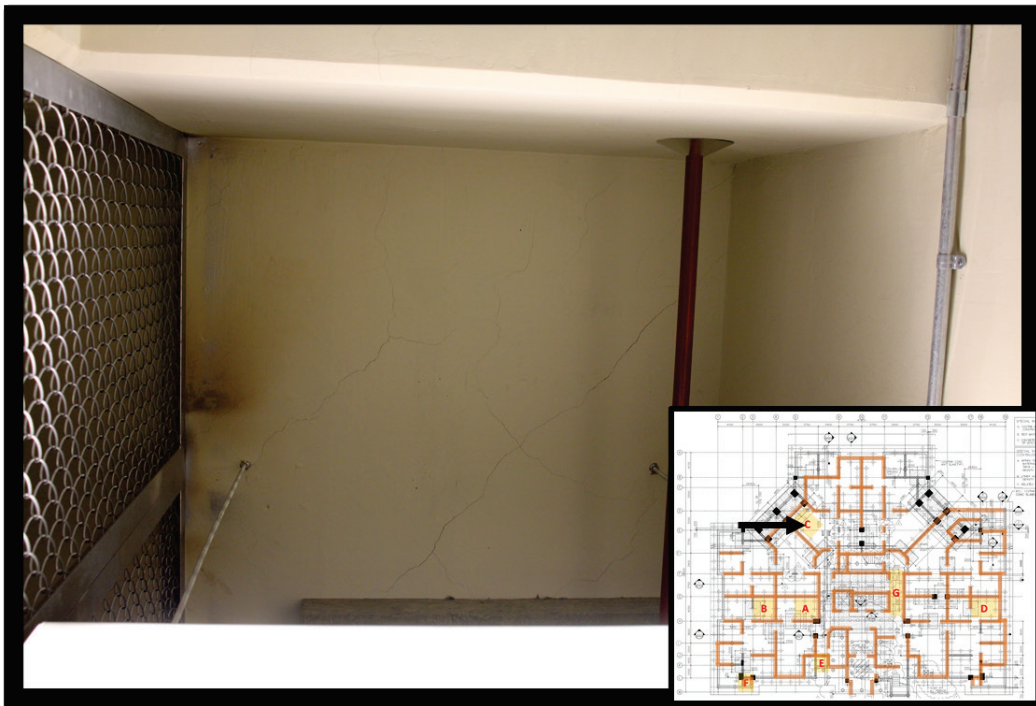
In several areas of the basement cracking was observed in the overhead slab (ceiling). These cracks were random in orientation and often initiated/terminated at intrusions such as where electrical conduits, water lines, or other building systems came through the slab. Figure 6 shows a typical example of these cracks in the basement ceiling.

Figure 6. Overhead (ceiling) slab cracks within the Tower 1 basement storage area (Section C of the floorplan insert). Widths of these cracks were not measured but approximate the size, patterns, and widths as other observed cracks in the floor slabs.

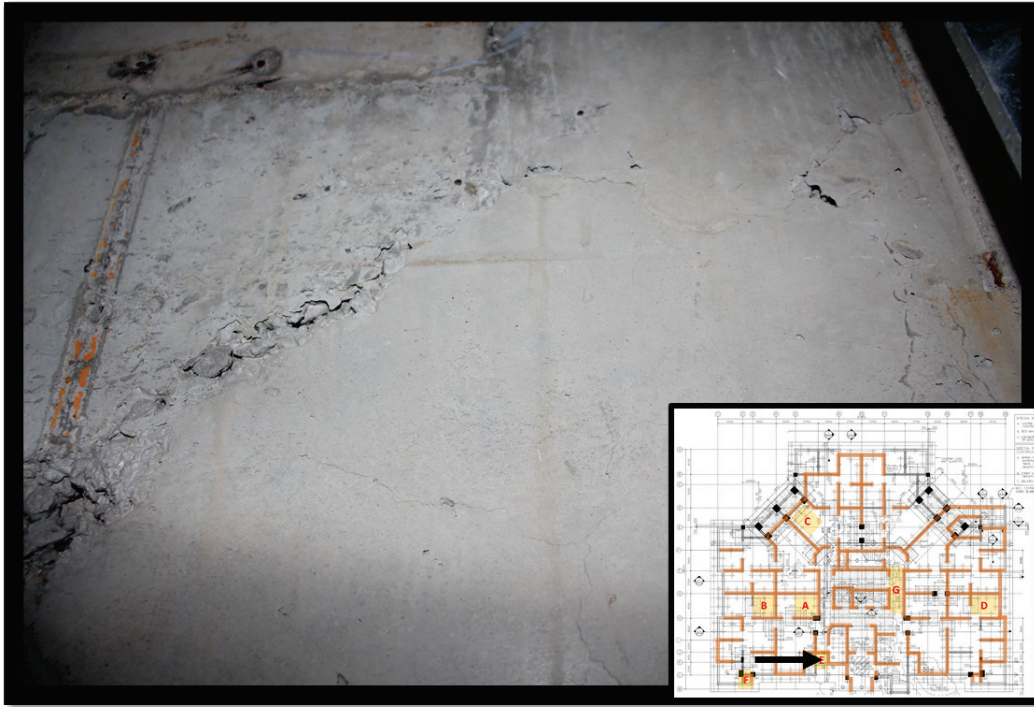
The only bare concrete that was accessible to inspection in Tower 1 was in the mechanical and electrical shafts. These locations demonstrated cracking similar to that observed elsewhere, but also showed the construction cold joints that existed throughout the building as seen in Figure 7.

Figure 7. Cold joints within the Tower 1 basement shaft area (Section E of the floorplan insert). These cold joints were observed on bare concrete and were typical in the mechanical and electrical shaft areas in the upper floors.

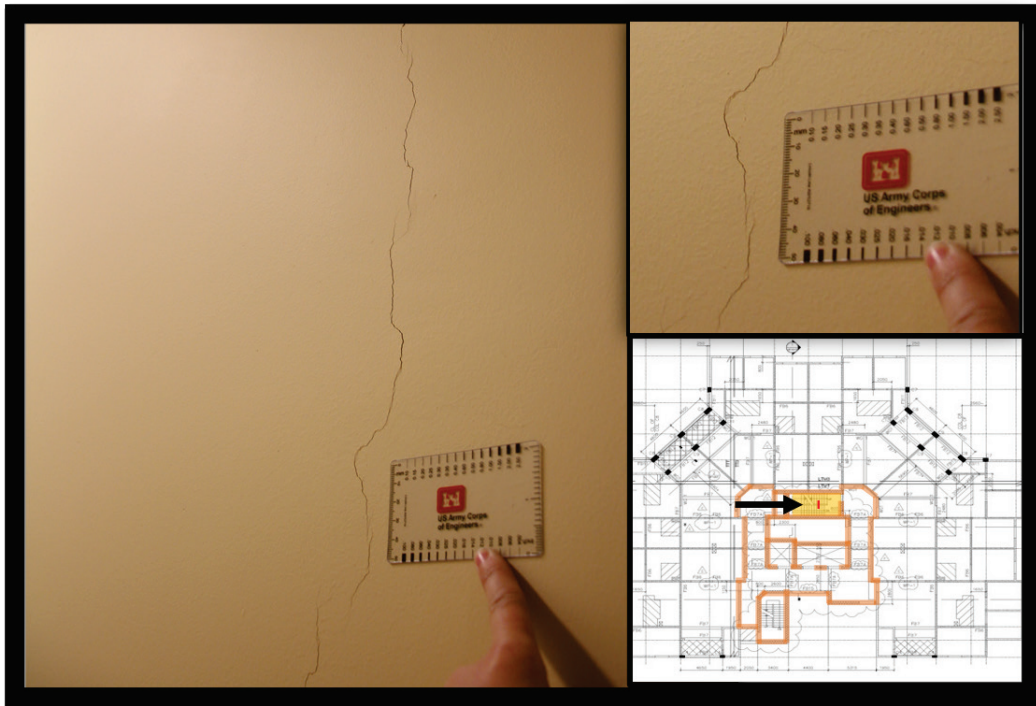
In the upper floors, cracking was observed in the public hallway areas. These areas were mudded and painted and generally did not display a significant number of cracks. Where they did appear, they were generally vertical and were most often directly over reinforcing bars (see Figure 8). In a few areas, diagonal cracks were observed in walls near stairwells.

Figure 8. Cracking over mudded walls (typical) within the nonbasement floors of Tower 1 (Section I of the floorplan insert).

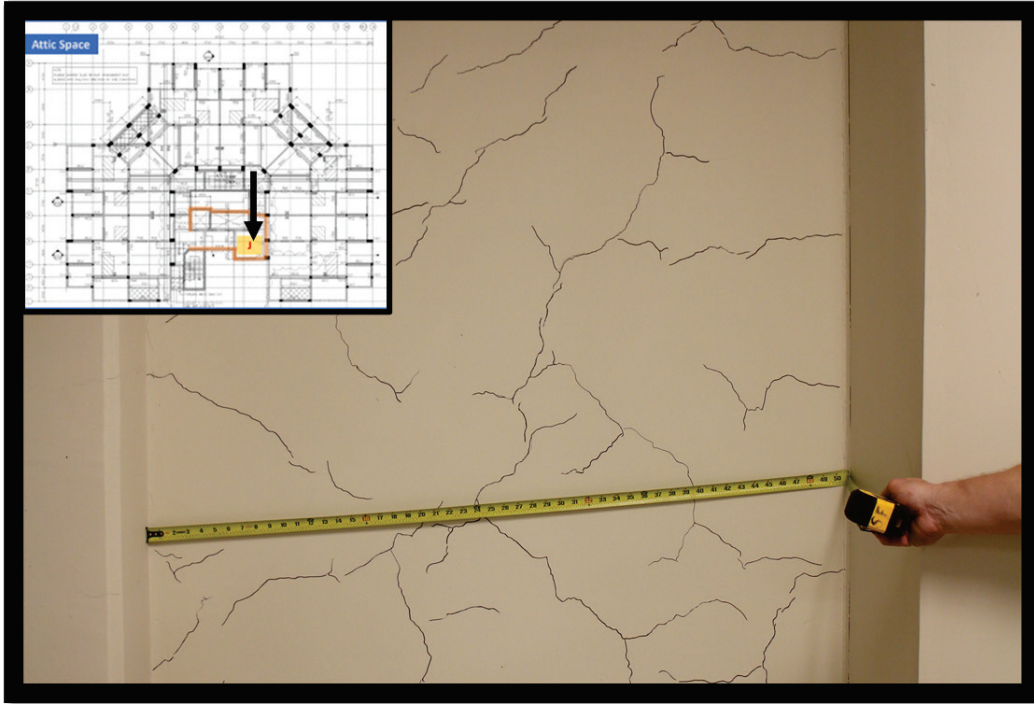
The attic area of Tower 1 houses the mechanical and electrical systems that operate the tower's three elevators. This area is not accessible to the public under normal circumstances. Multidirectional cracking was seen in the mudded walls throughout this area as seen in Figure 9 (note that these cracks are traced for visibility). The size of the cracks was not noticeably different from elsewhere in the structure, but there appeared to be a greater number of cracks. This may be due to a lessened emphasis on aesthetics, which meant apparent cracks were not remudded or repainted as they might have been in other areas.

Figure 9. Wall cracks within the Tower 1 attic elevator mechanical area (Section J of the floorplan insert). The widest observed crack width was less than 0.40 mm. The shown cracks were traced with a permanent marker to highlight typical locations, lengths, and spacing and are not representative of crack width.

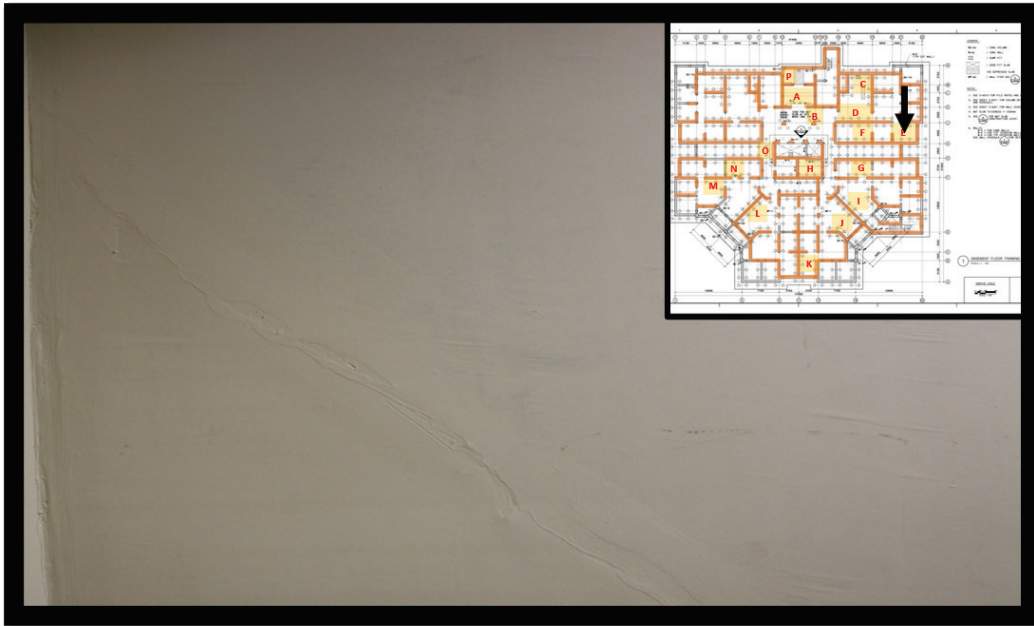
Figure 11. Typical observed diagonal cracking within the Tower 2 basement storage area (Section E of the floorplan insert). The widest area of the typical observed crack was less than 0.40 mm and did not intersect the floor slab. The crack shown here has been repaired; however, it is typical of orientation, location, and size of the Tower 2 diagonal cracking.

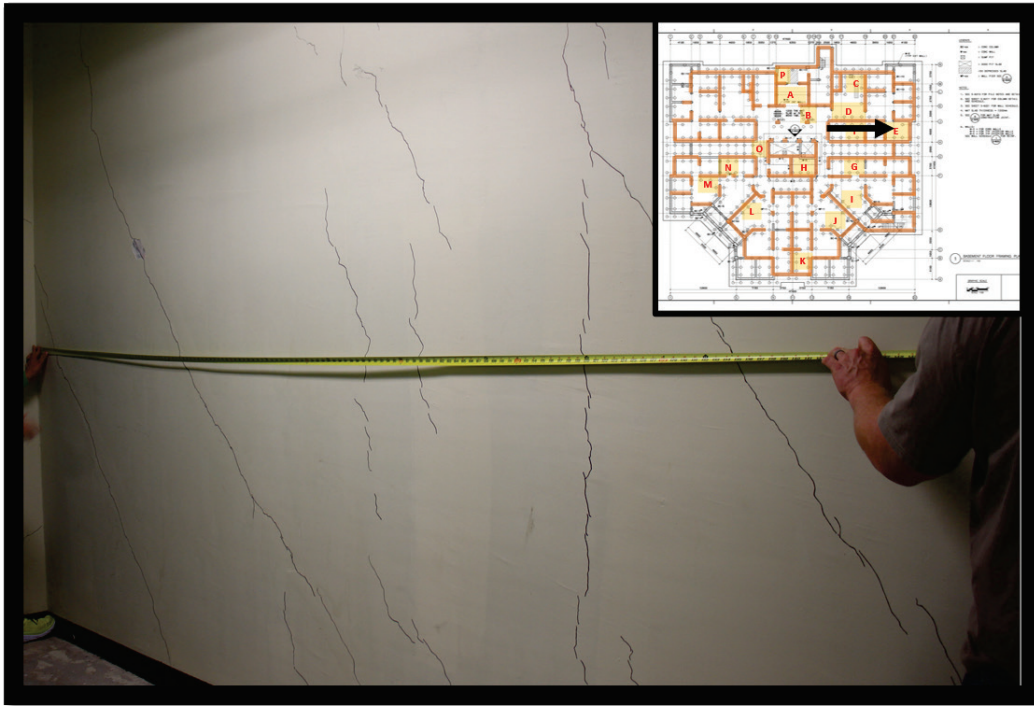
Figure 12 shows the crack pattern on a section of wall in the basement of Tower 2. This picture captures the mixture of diagonal and vertical cracking often present in this basement. It also demonstrates the relative spacings of these cracks. It should be noted that most of the cracks seen in this picture are hairline (<0.2 mm in width). The cracks have been traced for visibility, but the lines are not representative of crack widths.

Figure 12. Wall cracks within the Tower 2 basement storage area (Section E of the floorplan insert). The widest observed crack width was less than 0.40 mm. The shown cracks were traced with a permanent marker to highlight typical locations, lengths, and spacing and are not representative of crack width.

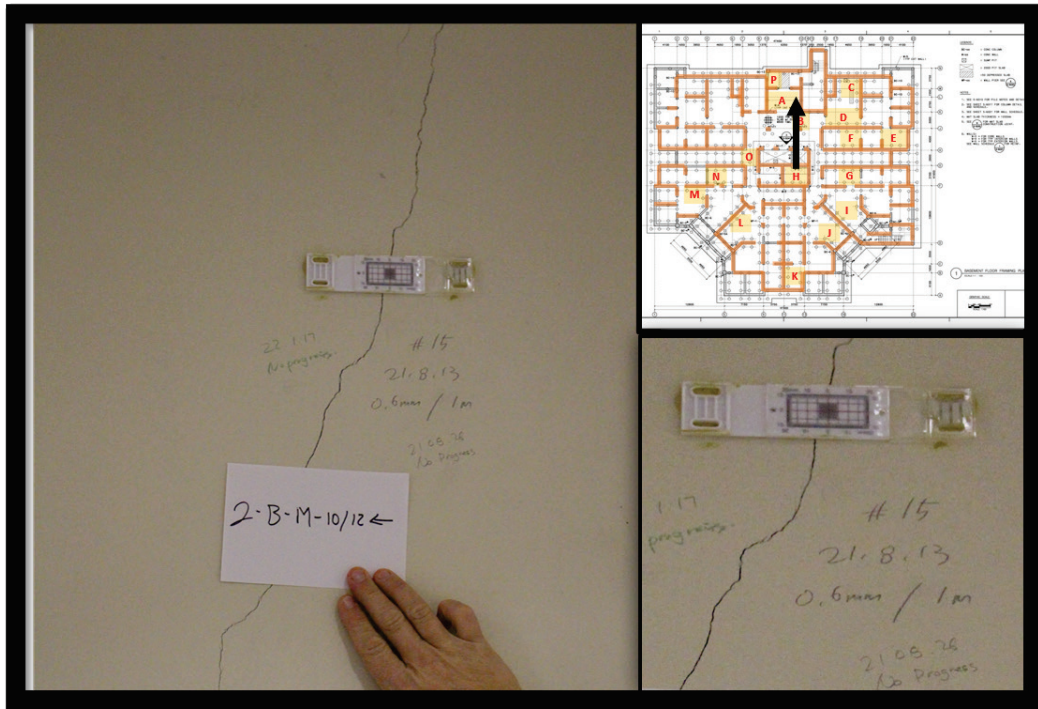
Vertical cracks were observed throughout the basement of Tower 2. As in Tower 1, these cracks occurred most often over vertical rebar. The size and number of these cracks were greater than in Tower 1. Figure 13 and Figure 14 show the most severe observed vertical crack and a typical vertical crack, respectively. Figure 15 shows the relative spacings and lengths of these cracks on a basement wall. All cracks are traced for visibility, and, thus, the figure should not be seen as indicative of crack widths.

Figure 13. Most severe observed vertical crack within the Tower 2 basement storage area (Section A of the floorplan insert). The widest section of the observed crack was 0.6 mm (crack gauge insert).

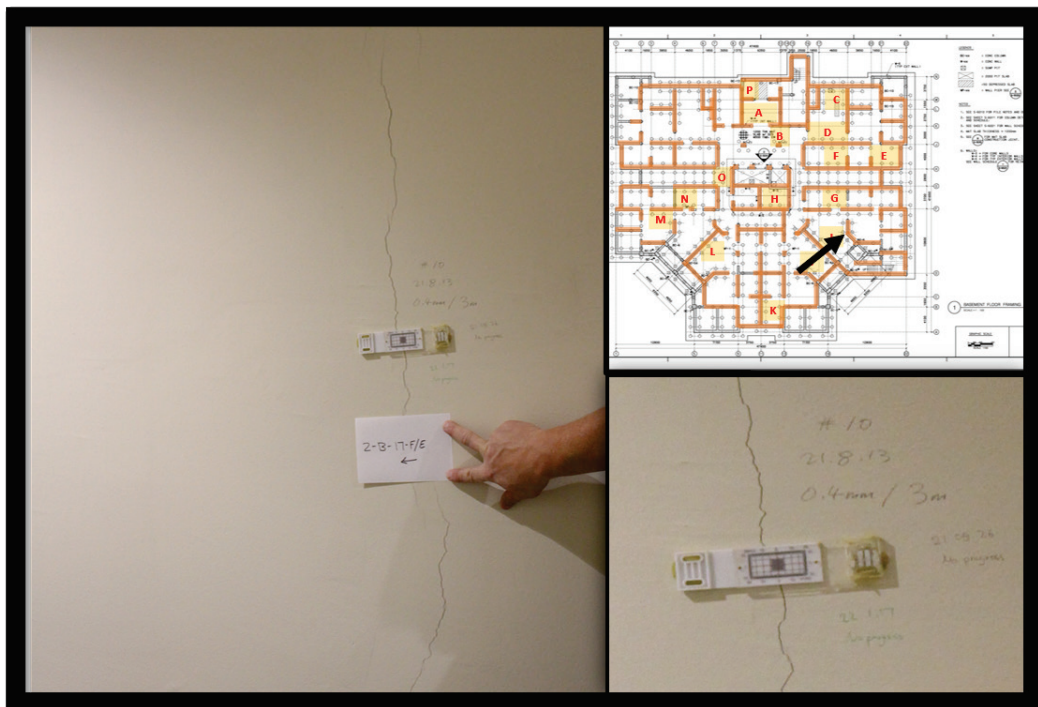
Figure 14. Typical observed vertical cracking within the Tower 2 basement storage area (Section I of the floorplan insert). The widest area of the observed crack was less than 0.40 mm and did not intersect the floor slab (crack gauge insert).

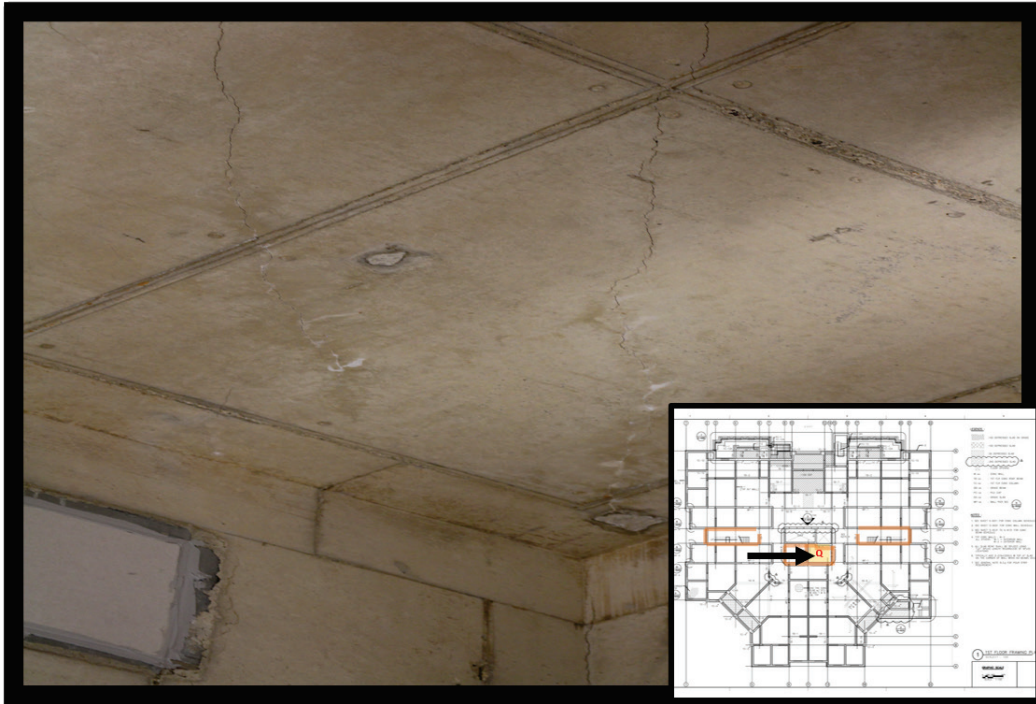
In Tower 2, the majority of the bare concrete observed was in a large access shaft that was behind the elevator shafts on each floor. These small rooms had exposed concrete walls, floors, and ceilings. Figure 17 shows cracking on the ceiling of one of these rooms. In this location, white exudate staining can be seen around some of the cracks. This exudate was dry and did not appear recent. It was likely formed shortly after the concrete was cast prior to the building envelope being sealed against weather. If this is the case, it indicates that these cracks were present very early in the structure's life.

Figure 17. Typical observed overhead (ceiling) slab cracks within the Tower 2 (Section Q of the 1st Floor floorplan insert).

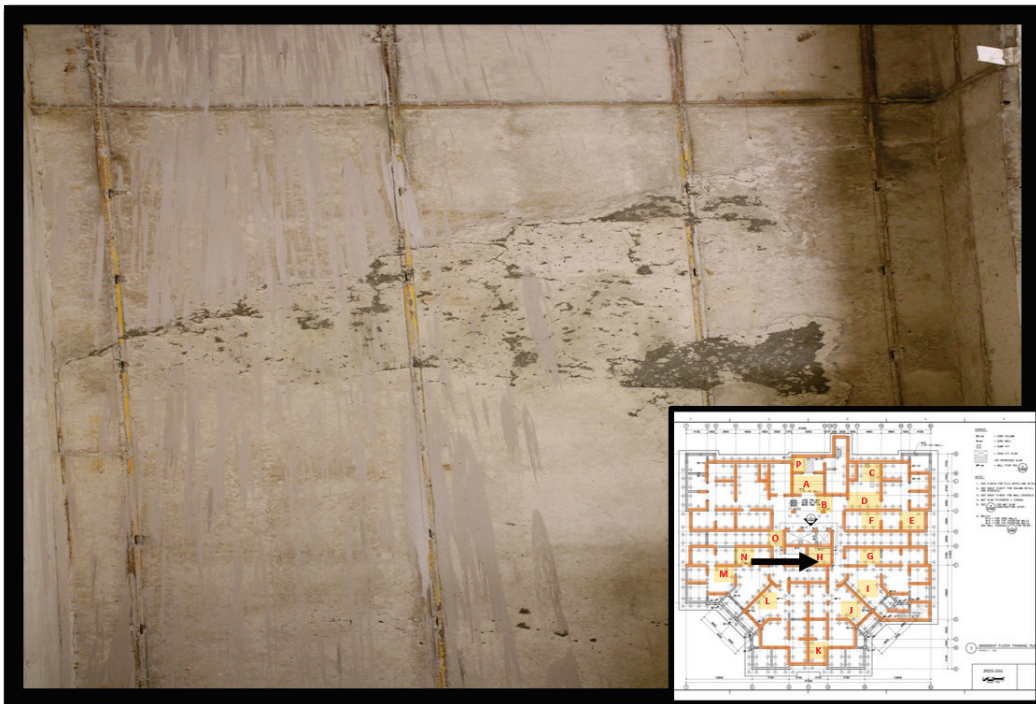
Figure 18 shows a cold joint observed in one of these access shafts. The concrete consistency is visibly different above and below this cold joint, which was typical of many cold joints observed in the towers. Figure 19 shows typical vertical cracking observed in the bare concrete. The extents and size of the cracking in bare concrete was comparable to that observed in mudded and painted concrete.

Figure 18. Observed cold joints within the Tower 2 elevator shaft area (Section H of the floorplan insert). These cold joints were observed on bare concrete and were typical in the elevator shaft areas in the upper floors.

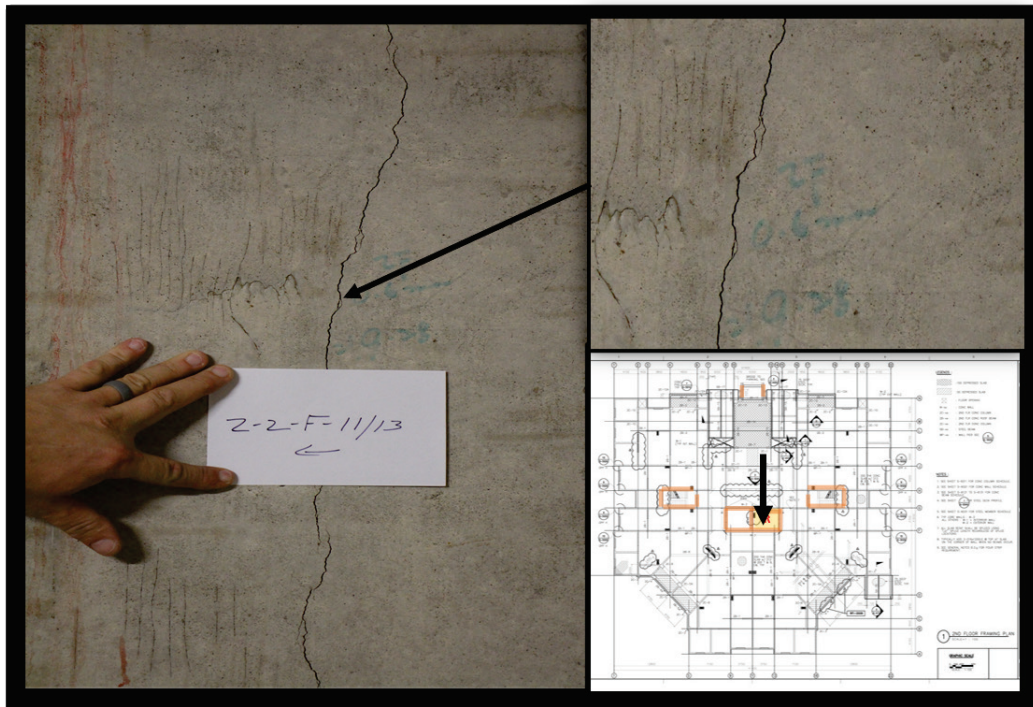
Figure 19. Cracking on bare concrete walls (typical) within the nonbasement floors of Tower 2 (Section R of the 2nd Floor floorplan insert). Majority of observed crack widths were less than 0.4 mm (insert depicts the largest observed of these cracks at a width of 0.6 mm).

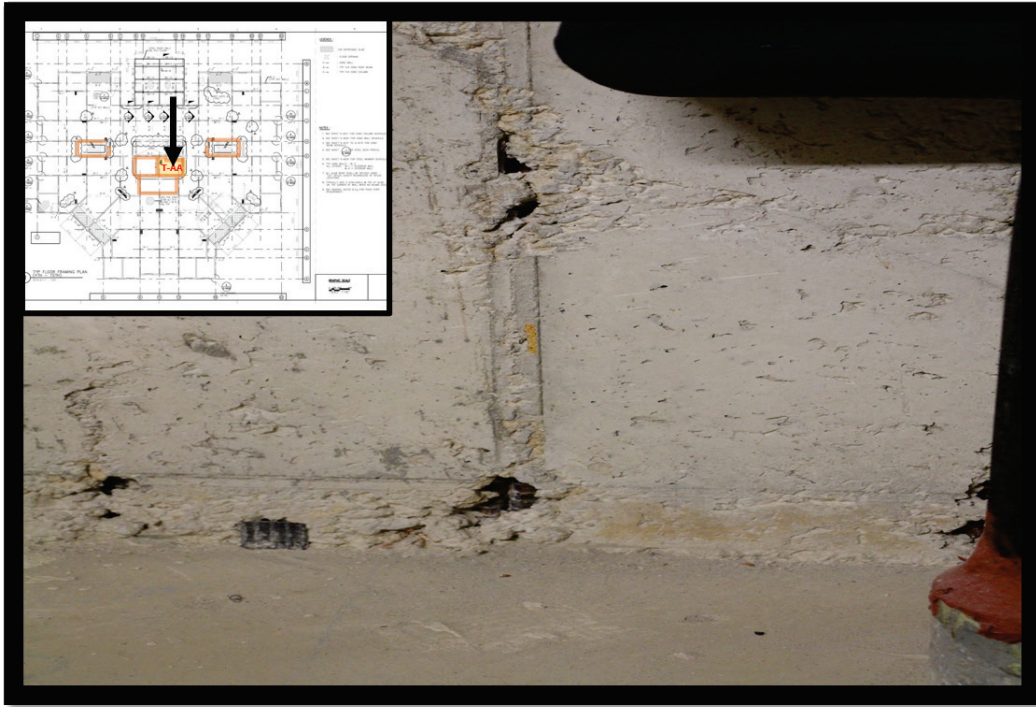
Figure 20 shows some of the worst honeycombing observed in the towers. There were several areas of bare concrete where concrete patching had been performed, but this area was unrepaired and unpatched. When honeycombing was observed, it was often near the bottom of walls and near areas of high rebar congestion. This is likely due to the difficulty of providing adequate concrete vibration in these areas, resulting in poor consolidation. These areas were also often near cold joints.

Figure 20. Honeycombing within Tower 2 (Section TAA of the 12th Floor floorplan insert). The honeycombing varied in severity but was typically located in areas of high rebar congestion and was often near cold joints.

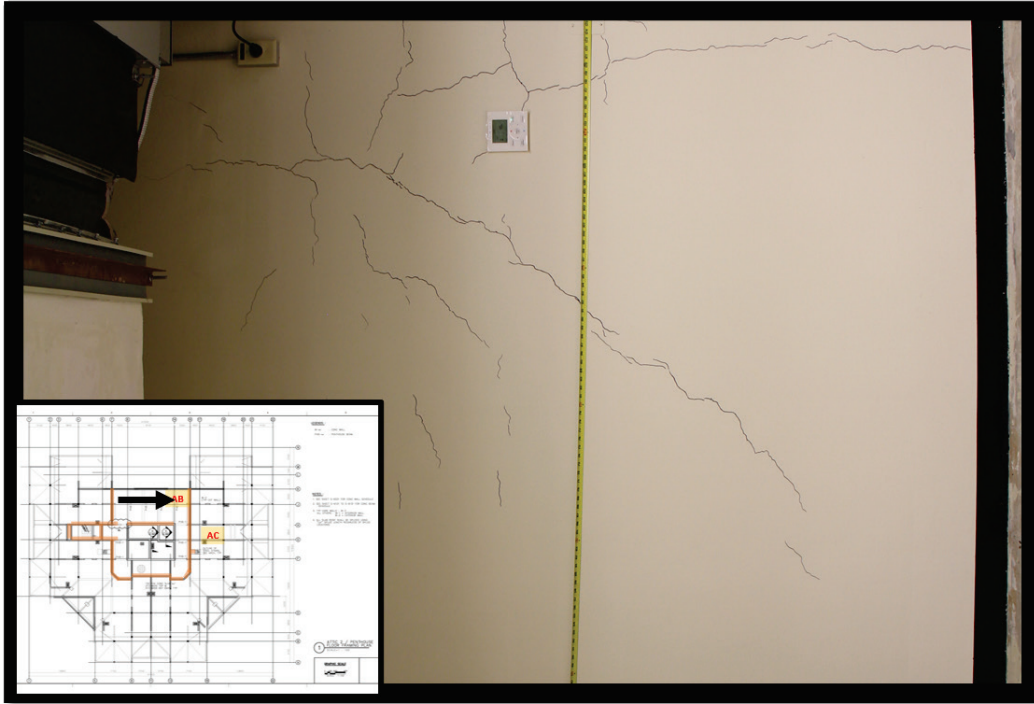
As in Tower 1, the attic area of Tower 2 was observed to have multidirectional cracking as shown in Figure 21. These cracks were more obvious than many other areas of the structure, but this may be attributable to less aesthetic concerns in areas not accessible to the public.

Figure 21. Cracks within the Tower 2 attic elevator mechanical area (Section AB of the floorplan insert). The widest observed crack width was less than 0.40 mm. The shown cracks were traced with a permanent marker to highlight typical locations, lengths, and spacing and are not representative of crack width.

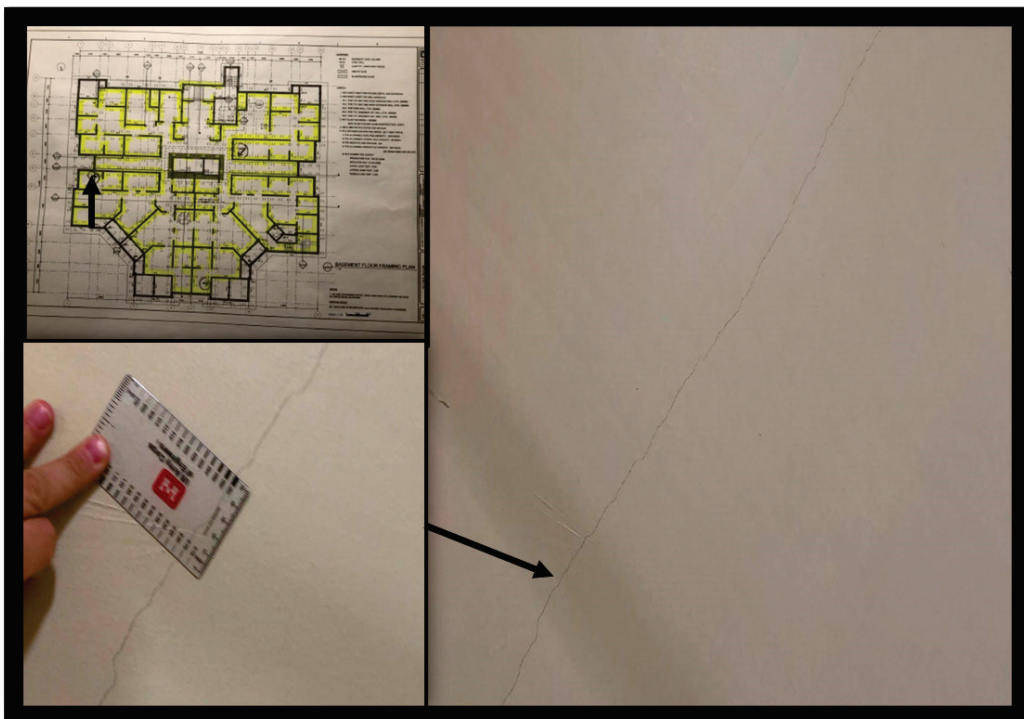
As with Towers 1 and 2, the basement of Tower 3 was where the most concrete surfaces were accessible for inspection. The types of cracks (i.e., diagonal and vertical wall cracks, randomly oriented ceiling and floor cracks, etc.) were the same as seen in the previous two towers. The number and dimensions (both length and width) of cracks were significantly smaller than in either Tower 1 or 2. Figure 22 shows a representative diagonal crack from Tower 3. While representative cracks from Tower 1 and Tower 2 (Figure 1 and Figure 11) were measured at around 0.4 mm, the representative crack from Tower 3 in Figure 22 is only 0.15 mm.

Figure 22. Representative diagonal crack within the basement area of Tower 3 (Indicated on floorplan insert). The widest section of the observed crack was 0.15 mm (crack gauge insert).

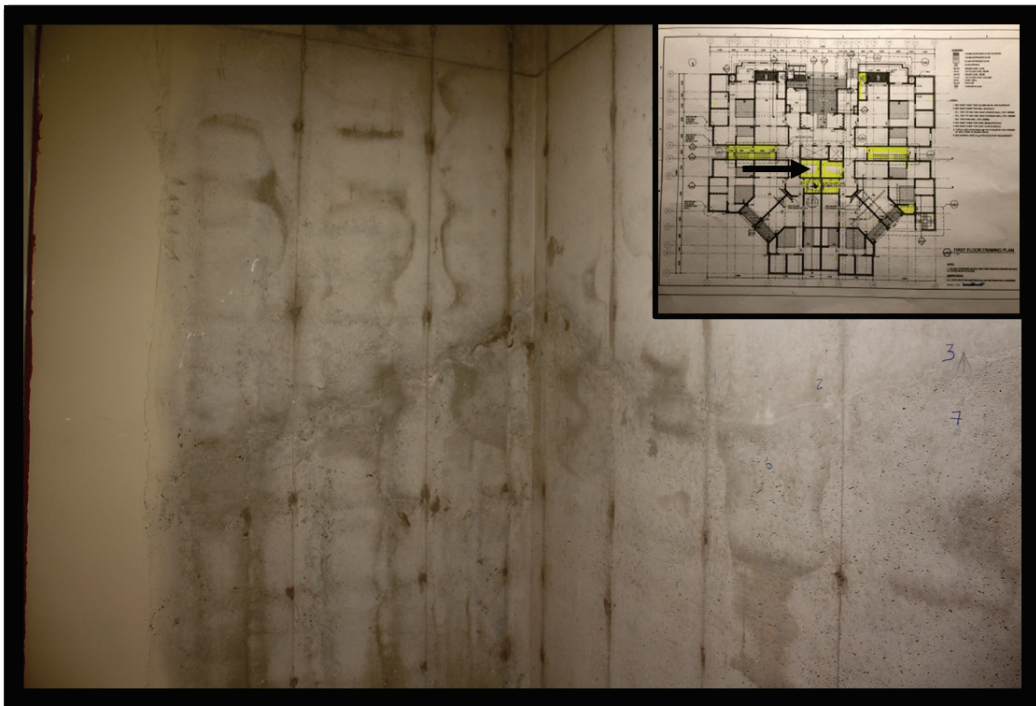
Bare, unmudded concrete was only accessible in a few locations, mostly in the rooms behind the central elevator shafts. Figure 23 shows a typical cold joint in one of these locations. These cold joints were similar to those observed in Towers 1 and 2. Figure 24 shows a vertical crack on bare concrete observed in one of these areas. This crack measured 0.35 mm and was one of the larger cracks observed in Tower 3.

Figure 23. Typical observed cold joints within Tower 3 elevator shaft area (floorplan insert).

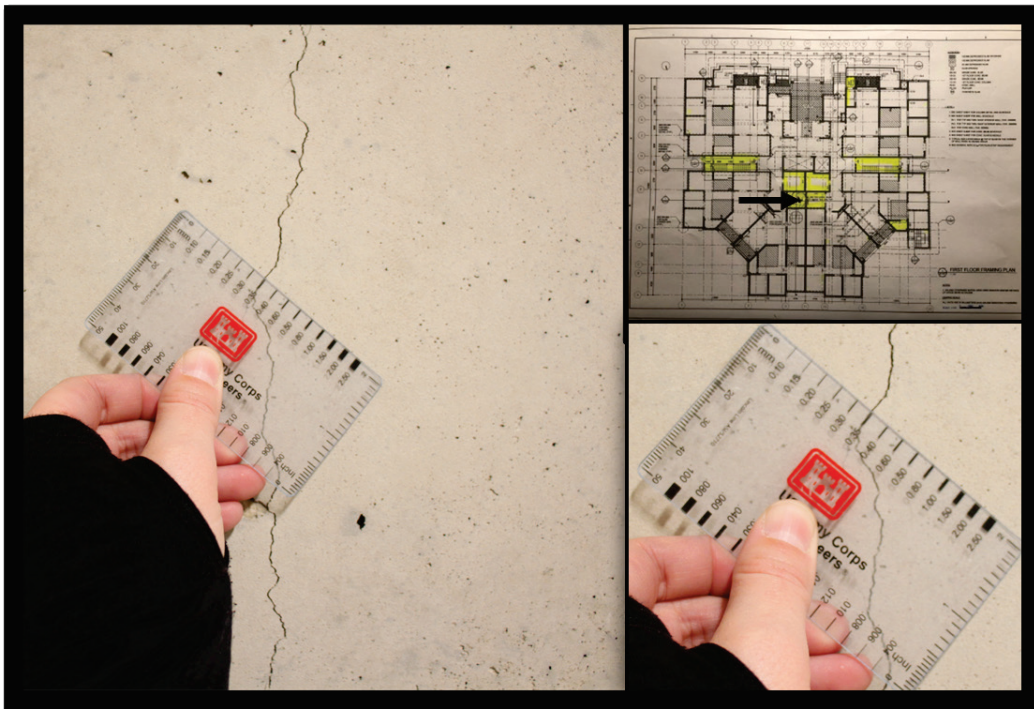
Figure 24. Vertical crack in Tower 3 observed on bare concrete (Section A of the floorplan insert). The widest section of the crack was 0.35 mm (crack gauge insert).

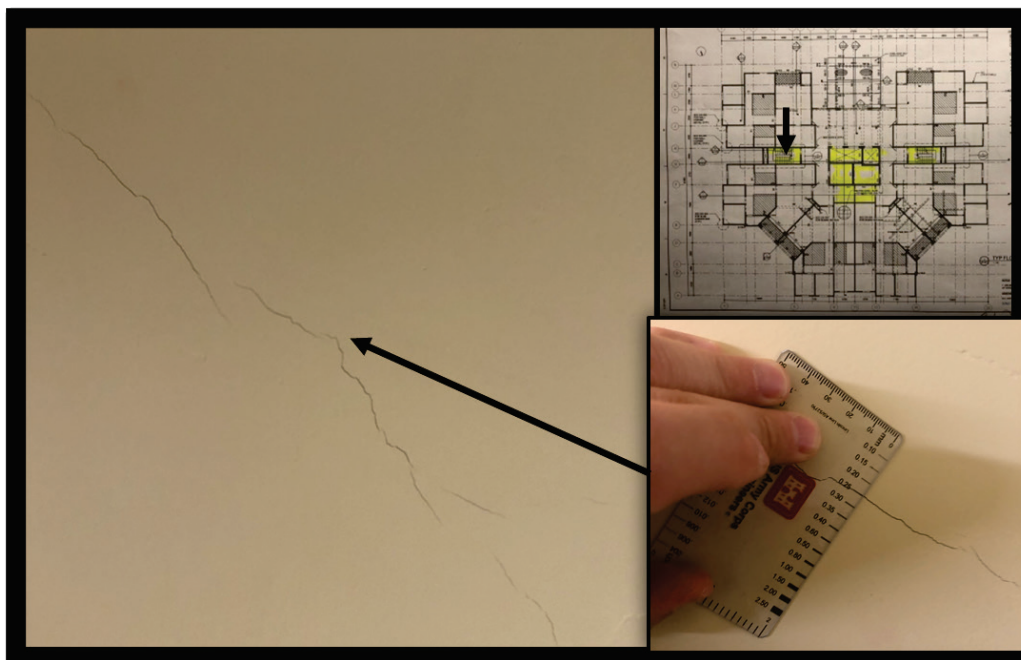
Figure 26. Observed cracking within Tower 3, 14th Floor stairwell (Stairway #2 of the floorplan insert). The widest area of the observed crack less than 0.25 mm. The crack did not intersect the ceilings, floors, or wall edges.

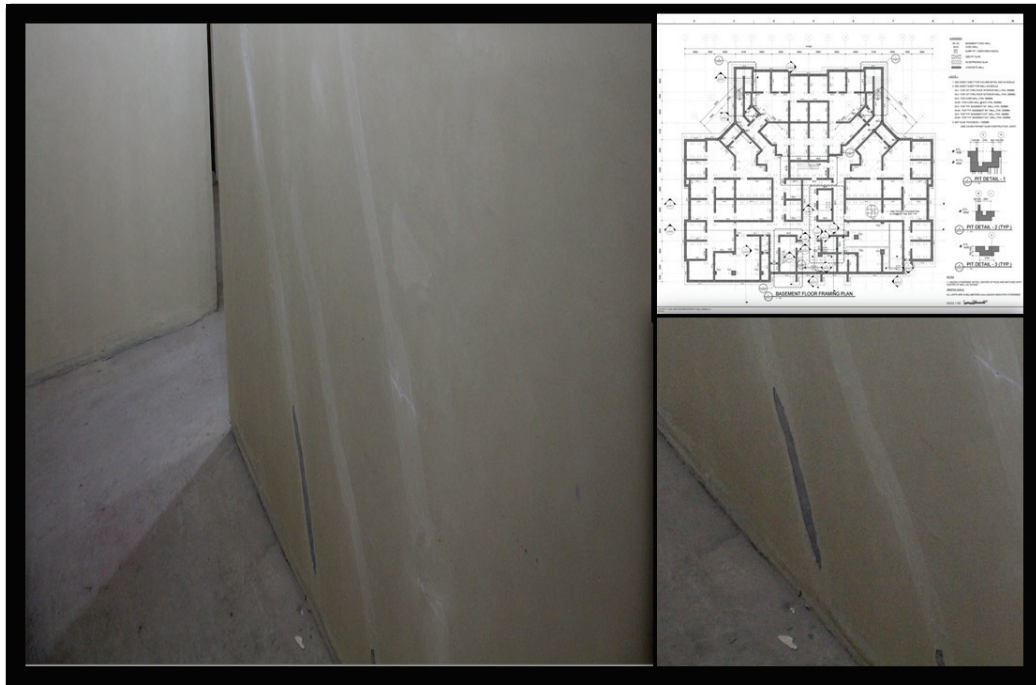
Diagonal cracks were observed in the basement walls and were consistent with those observed in the basements of Towers 1, 2, and 3. Figure 27 shows diagonal cracks typical of those found in Tower 4. This type of cracking was not observed in the walls on floors above the basement. All of the diagonal cracks were isolated to the walls and did not propagate to the ceiling or floor slabs.

Figure 27. Typical diagonal cracking observed in the basement of Tower 4 (floorplan insert). The cracking was covered post placement but before visual inspections (insert shows the inspected crack on bare concrete without patch).

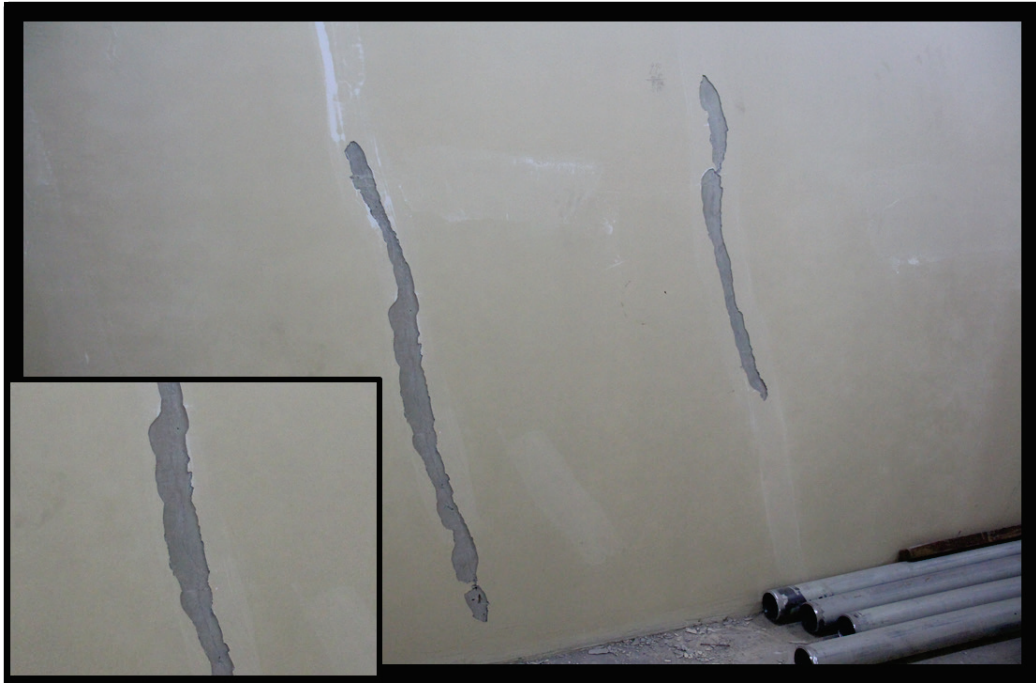
Vertical cracks were observed in basement walls and walls throughout the remaining floors and were consistent with those observed in the other towers. Crack widths ranged from hairline to approximately 0.25 mm. In the basement and other areas where the walls were thinly coated, many of the concrete cracks were manifest in the coating layer. Figure 28 shows an example of concrete cracking and the subsequent cracking of the surface coating in a basement wall. Figure 29 shows another vertical wall crack in a painted wall on an upper floor.

Figure 28. Vertical cracking observed in the basement of Tower 4 (floorplan insert). The cracking was covered post placement but before visual inspections (insert shows observable crack after patch/paint removed).

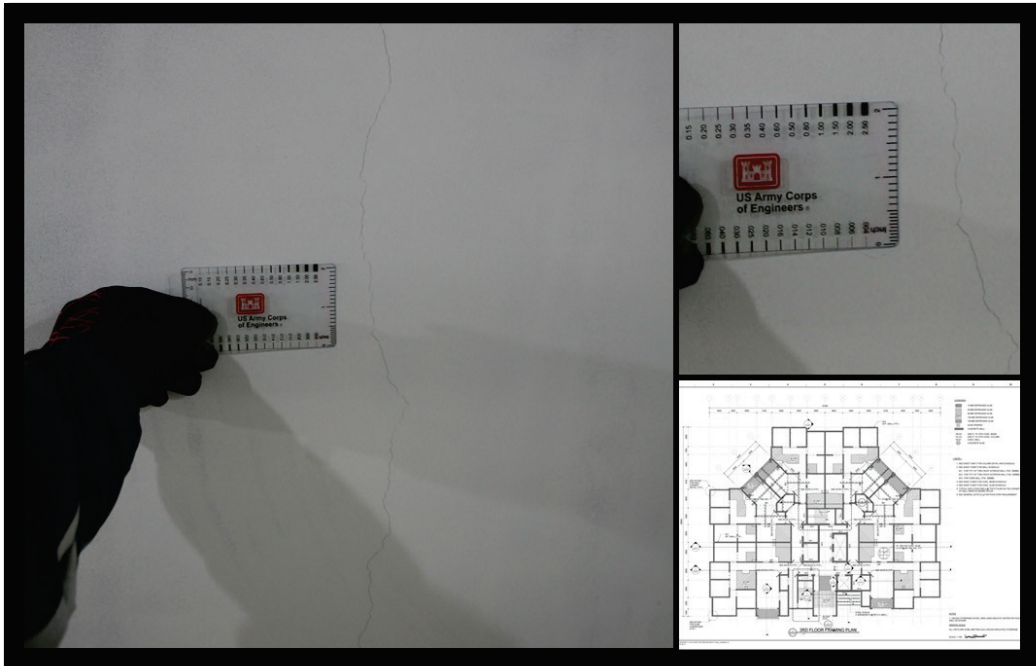
Figure 29. Observed vertical crack in Tower 4 (3rd Floor floorplan insert). The crack width was less than 0.20 mm (crack gauge insert).

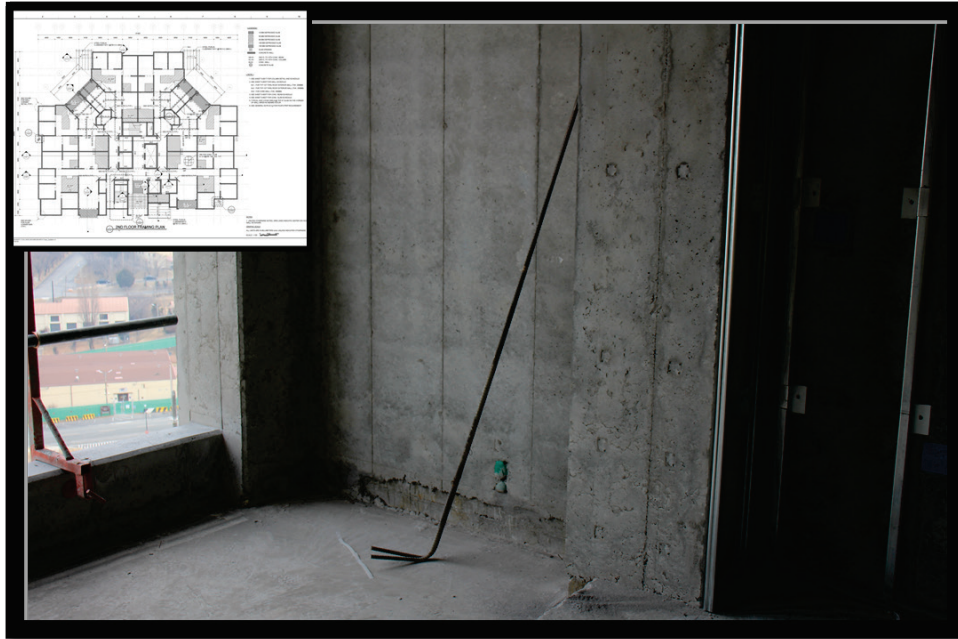
Some instances of poor consolidation and nonuniform concrete were observed throughout the tower. Poor consolidation and mortar patches were noted along the bottom of the walls of several balconies. Figure 32 shows one of these locations with additional consolidation issues in the adjacent columns.

Figure 32. Poor consolidation along bottom wall of Tower 4 balcony and adjacent columns (floorplan insert).

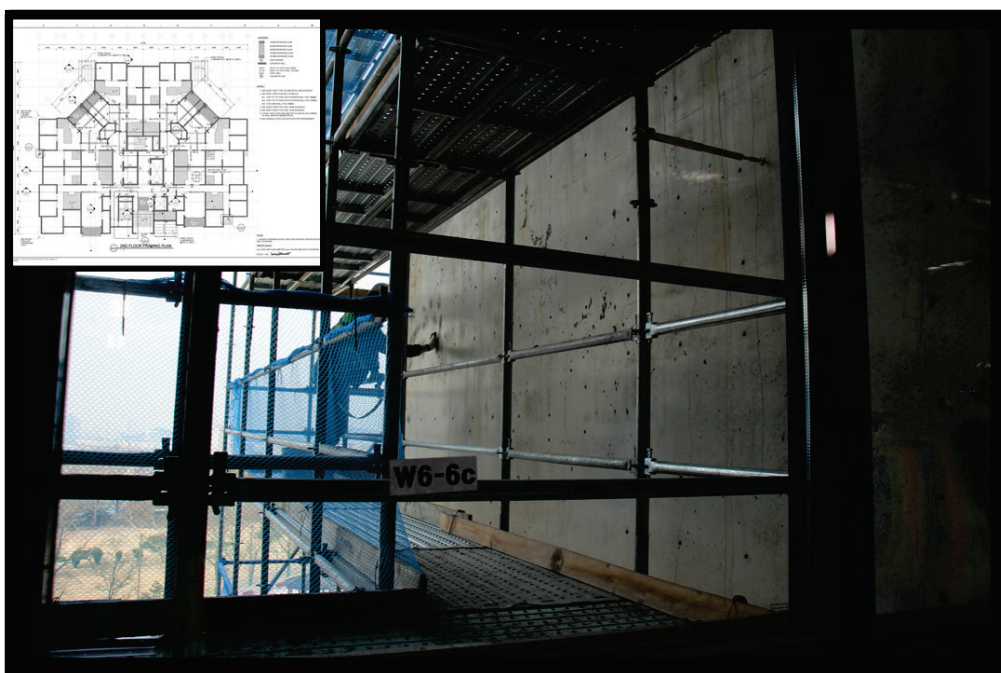
Surface voids, often referred to as bugholes, are another manifestation of poor concrete consolidation and were observed in some walls in Tower 4. Figure 33 shows a construction worker patching surface voids with mortar in an exterior concrete wall of Tower 4.

Figure 33. Patching of voids in exterior concrete of Tower 4 (floorplan insert).

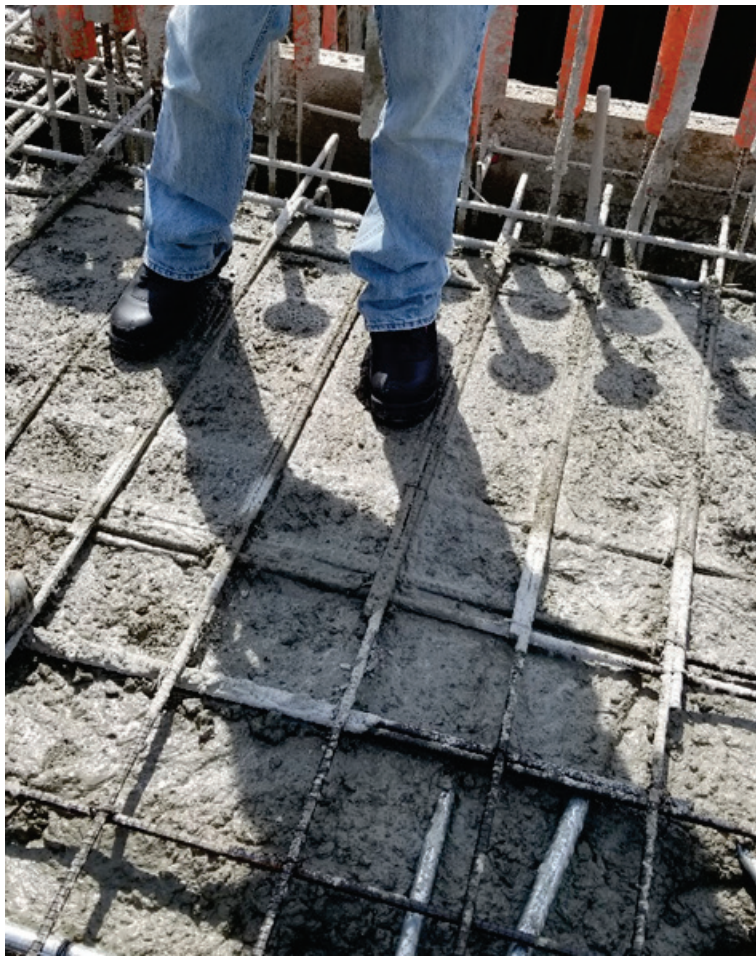
Specification section 03 30 00 provides specific requirements regarding joint placement and concrete placement and consolidation methods. In many cases, these do not appear to have been adhered to. Pictures provided by USACE-POF during construction included cold/construction joints located randomly within slabs and walls where concrete placements were terminated. Pictures reviewed along with field observations by the ERDC team indicated that this concrete had hardened prior to additional concrete being placed (see Figure 35 below). These do not conform with requirements in the specification 03 30 00 section 3.5 regarding the required position of construction joints during concrete placements.

Figure 35. Concrete placement terminated within a slab. The person standing on the concrete indicates that this concrete has hardened.
