Report on Evaluation of Apartment Towers 1–4 and Parking Garages 1–4 at Camp Walker, Daegu, South Korea

April 2022

Final report

Prepared for Far East District, Pacific Ocean Division
U.S. Army Corps of Engineers
573 Bonney Loop, Building 525, Suite A300
Fort Shafter, HI 96858

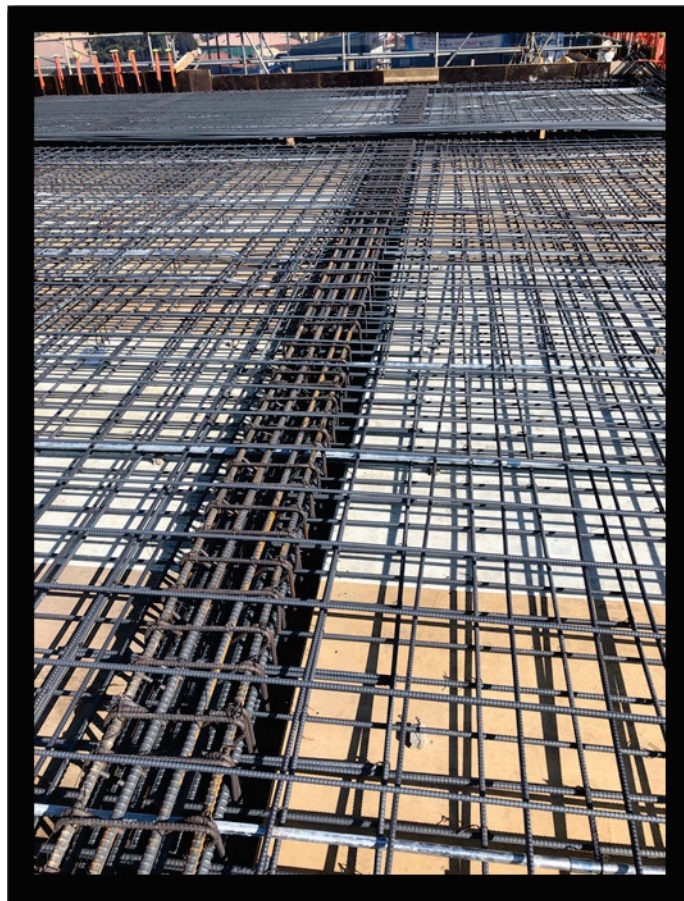
The rebar construction practices showed highly uniform rebar placement and good quality installation as seen in Figure 36 and Figure 37.

Figure 36. Reinforcement in Parking Garage 4 roof. The rebar placement was very precise in all areas observed.

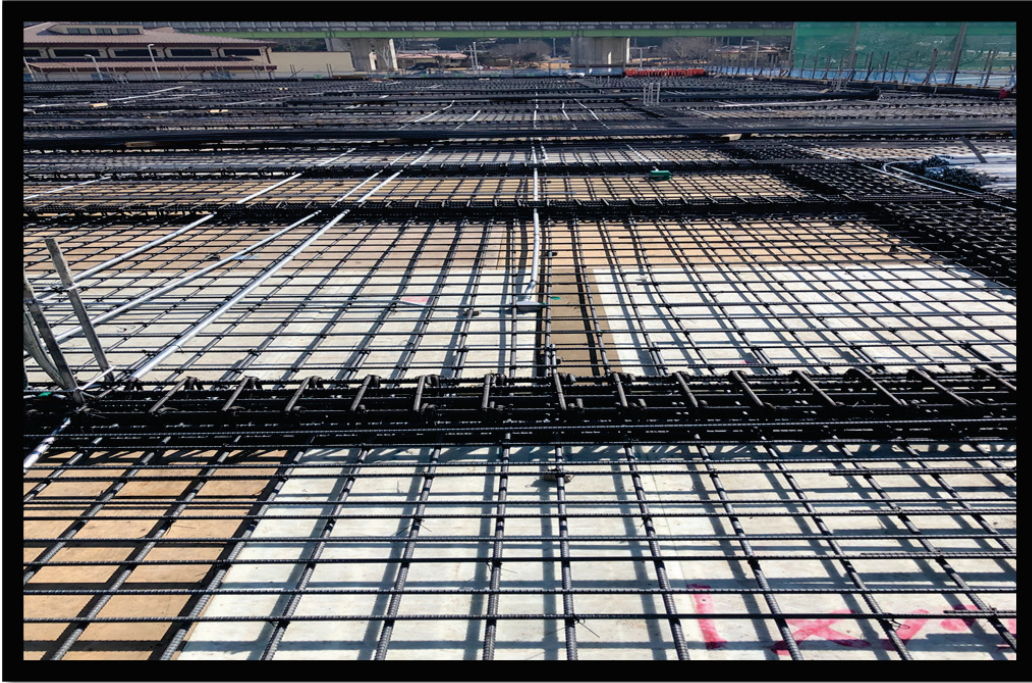
Figure 37. Typical rebar placement showing intersection between slab and beam (Parking Garage 4).

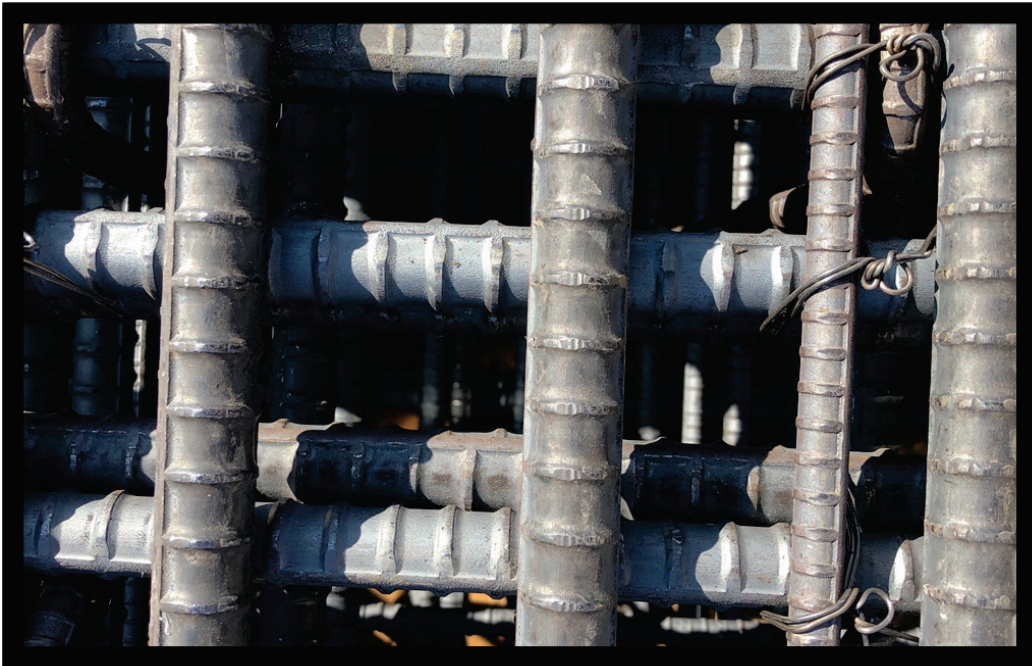
However, the observed rebar spacing was extremely congested. Figure 38 shows the congestion where a slab and beam come together. The congestion was even more severe where beams and columns intersected as seen in Figure 39. Examples from the parking garage are used here due to having more access to placed rebar; however, significant congestion was seen in the towers as well. Figure 40 shows the tight rebar spacing around an HVAC duct passthrough. This congestion created problems, noted in the QA/QC reports and in conversations with the Far East District inspectors, with the post-placement vibration wherein standard vibrational techniques were not practical or feasible. Importantly, this degree of rebar congestion would contribute to the poor consolidation and nonuniformity observed in the bare concrete.

Figure 38. Rebar congestion in slab-beam intersection in Parking Garage 4.

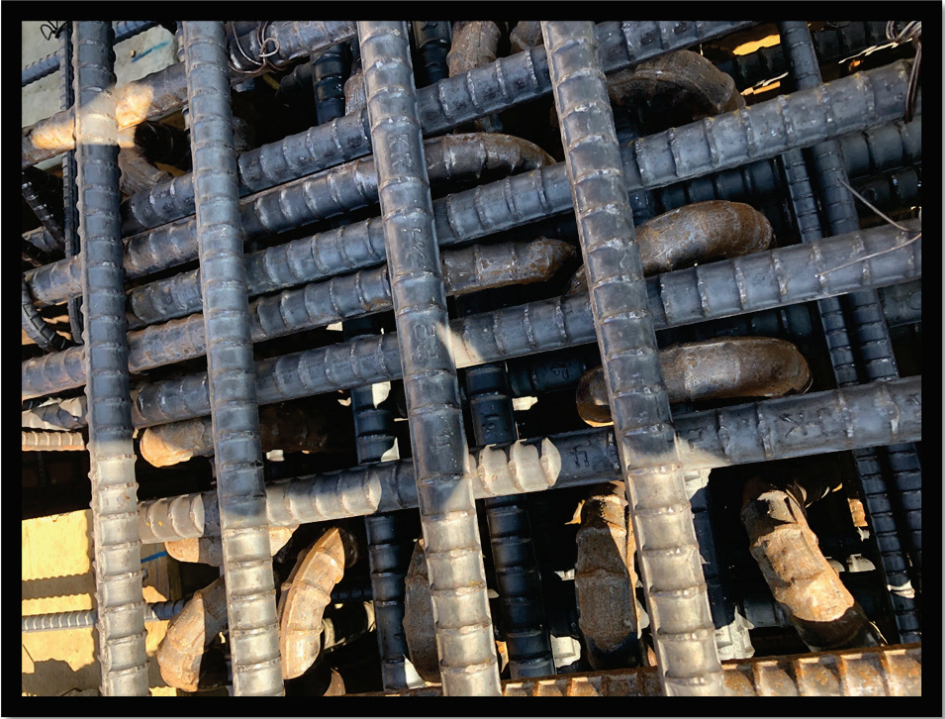
Figure 39. Rebar congestion at intersection between beams and column in Parking Garage 4.

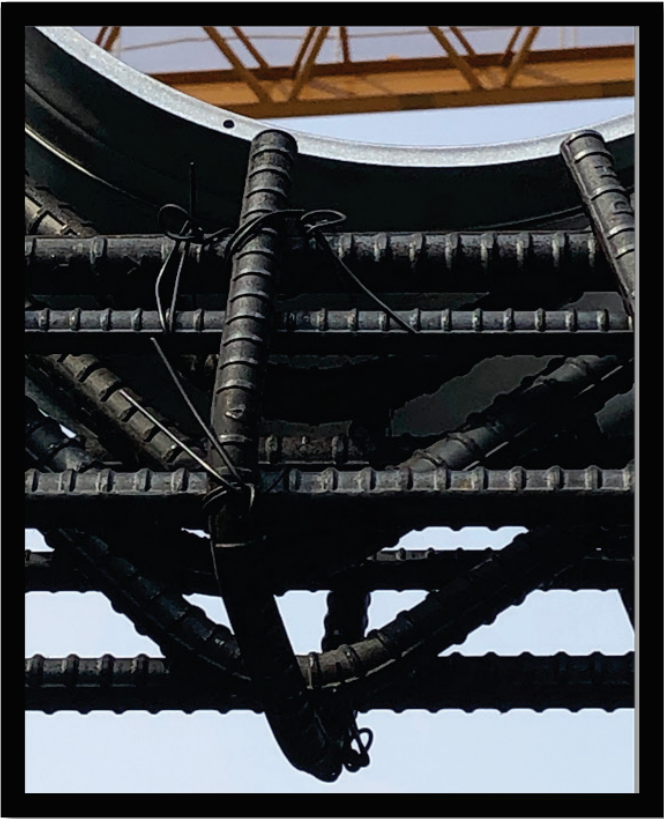
Figure 40. Congested rebar around HVAC duct passthrough in Tower 4.

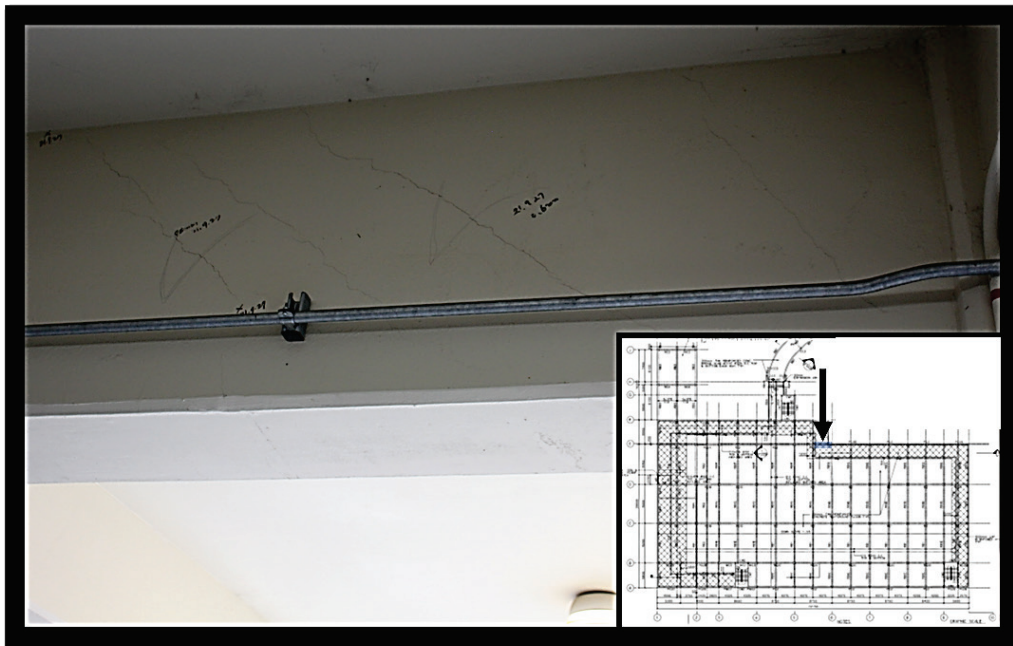
The types of cracking observed in Parking Garages 1–3 were similar across all three structures with only the prevalence and extents of cracking varying. Most of the cracking observed was vertical and diagonal cracking in the beams and girders of the garages. The diagonal cracks were oriented at approximately 45 deg and did not usually change orientation depending on where they were in the beam. In other words, the cracks near the centers of the beams were often at the same 45-deg angle as those cracks near the ends of the beams. Figure 43 shows this type of cracking in a beam in Garage 1.

Figure 43. Parallel diagonal cracks in beam on Column Line E between Column Lines 5 and 6 of upper floor of Garage 1.

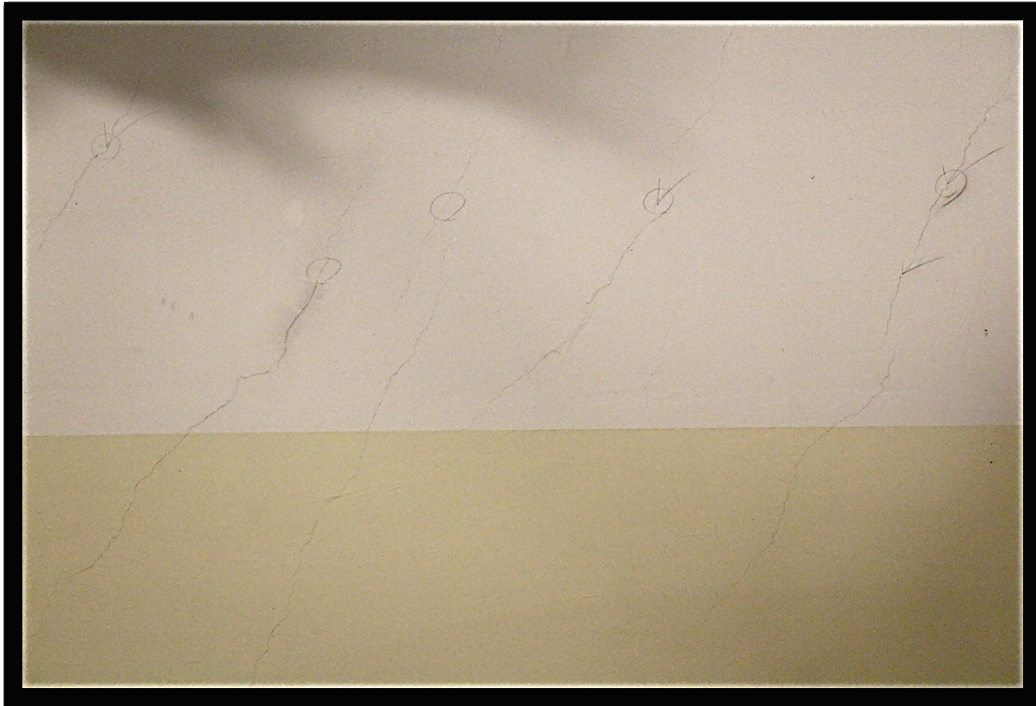
The lower, below-ground floor showed significantly less cracking in beams and girders but did display cracking in the walls. The cracks in the walls tended to be primarily diagonal in orientation with some of the cracks being vertical. The angle on the diagonal cracks tended to be much steeper (closer to vertical) than cracking observed in the garage beams or tower walls (see Figure 47). The largest cracks observed in walls were approximately 0.5 mm with most of the cracks being less than 0.2 mm.

Figure 47. Diagonal cracks in first floor (basement) of Parking Garage 1.

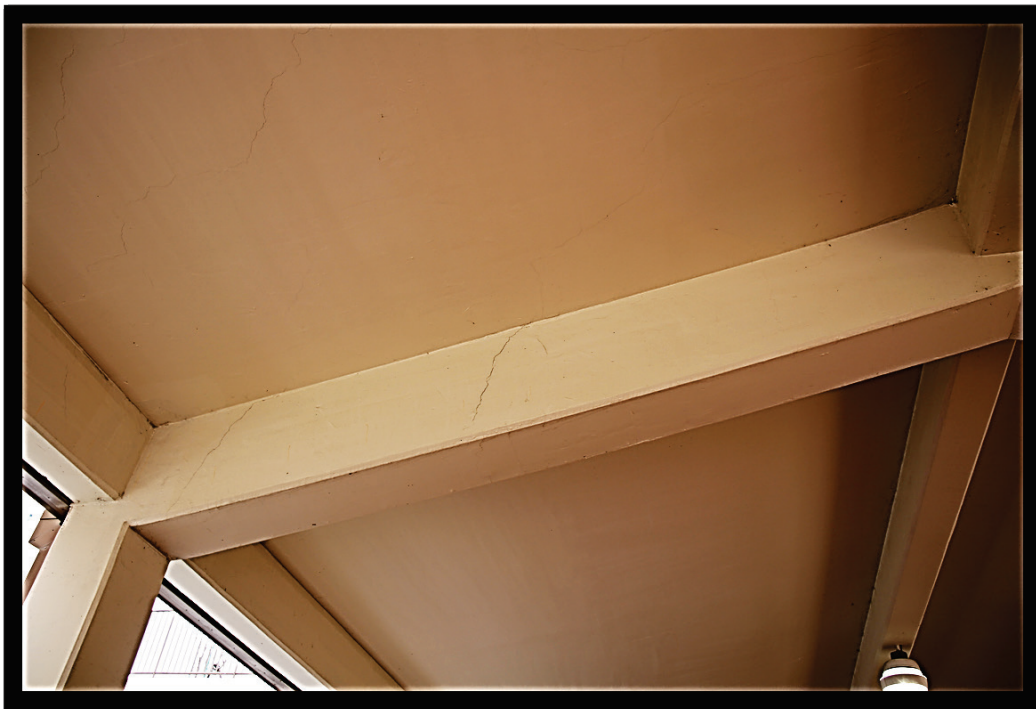
The largest crack observed was found in the roof beam of the ramp going down to the basement of Garage 1 and is shown in Figure 48. This crack was approximated to have a maximum width of 1.2 mm, although the bottom of the crack was significantly narrower at the location of the longitudinal reinforcing steel and the crack did not show any differential movement along its length. The crack also had a relatively steep angle, which reduces the effectiveness of any shear stirrups present. This beam was under very minimal loading due to it only supporting a thin sheet of metal roofing. At the time of this visual inspection, USACE-POF had already let a contract to repair this particular beam.

Figure 48. Crack in roof beam over Parking Garage 1 ramp. Crack width was approximately 1.2 mm.

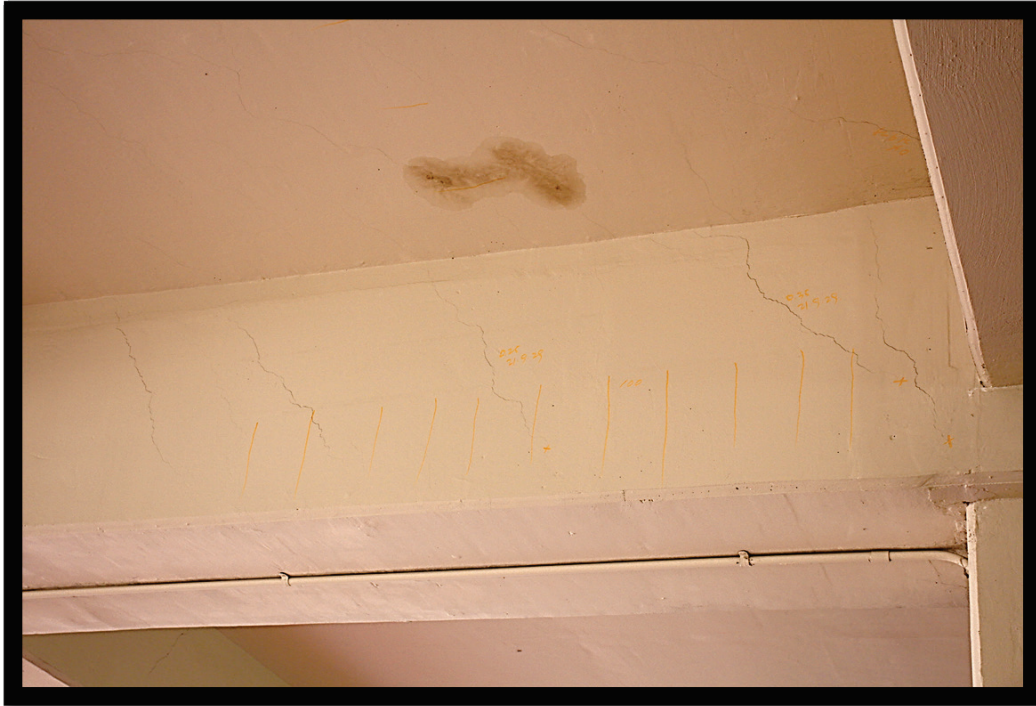
Figure 49 shows typical diagonal cracking in a girder of Parking Garage 2. Like in Parking Garage 1, these cracks did not change angle depending on their location on the beam. This would not be typical of cracks induced by shear loads. This figure also shows some slab cracking in the ceiling with staining indicating that water is ingressing. This can be a concern for long-term durability of the structure. There were very few areas where this kind of water ingress was seen, but none would be expected in such a new structure. Figure 50 shows the largest crack observed during visual inspection of Parking Garage 2. This crack

Figure 49. Typical diagonal cracking in girder of Parking Garage 2. Note the staining near a crack on the ceiling indicating water coming through from the upper floor.

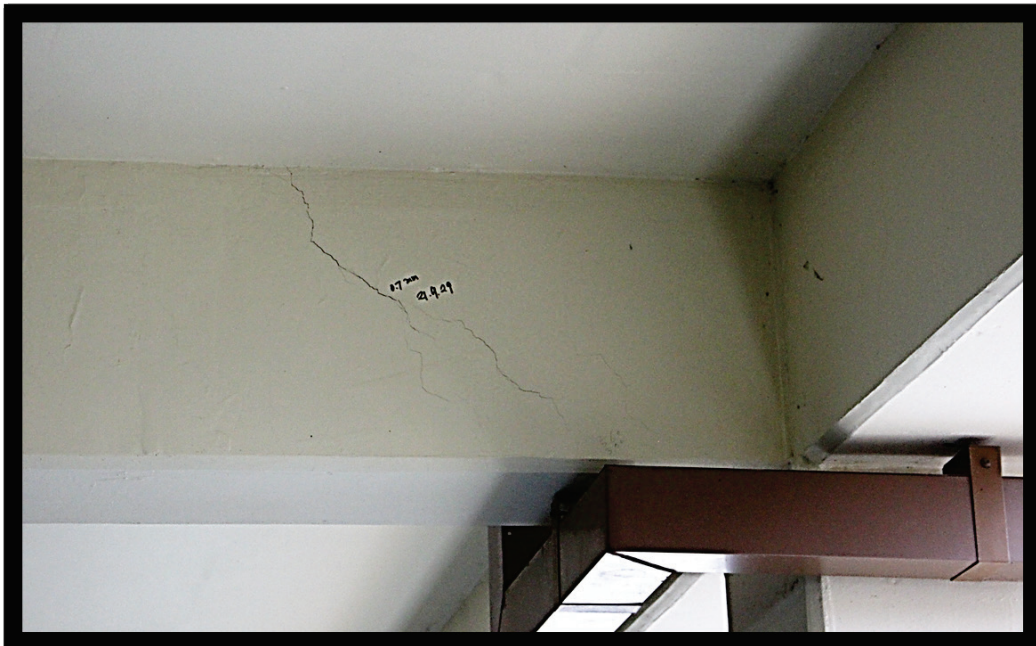
was 0.7 mm in width at its widest but was closed near the bottom of the beam and much narrower at the top of the beam.

Figure 50. Most severe diagonal crack noted in Parking Garage 2 (0.7 mm).

Parking Garage 2 did not exhibit any cracking or other distress that was significantly different from Parking Garage 1. The report by USACE-POF provides recommendations for remediation of the larger cracks in this structure. The visual inspection by the ERDC supports this course of action. For both Parking Garages 1 and 2, it is recommended that cracks over 0.2 mm be monitored for growth every 6 months until final AE report is provided.

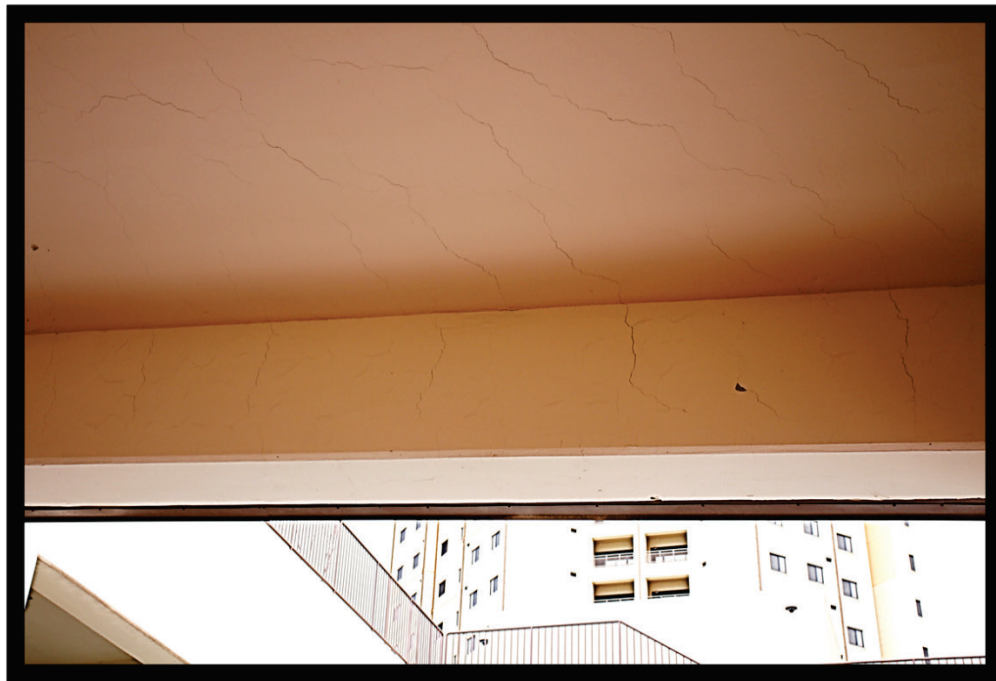
Figure 51 shows multidirectional cracking in the beams and ceiling of the roof over the ramp into the upper floor of Parking Garage 2. This was unusual, because this portion of the structure only serves to cover the rampway and holds no significant loads. In this way, it is similar to the largest crack found in Parking Garage 1. It is unclear why these two areas of the structures exhibited some of the most severe cracking observed in Parking Garages 1 or 2.

Figure 51. Multidirectional cracking extending from beams into ceiling slab of roof over ramp to floor 2.

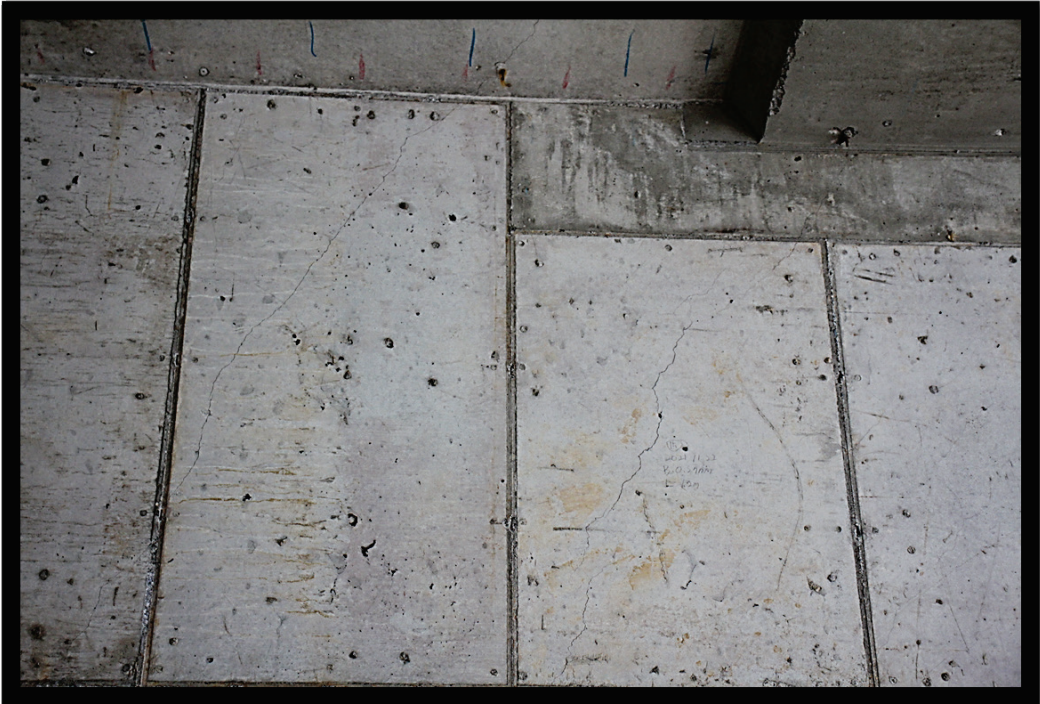
Figure 54. Vertical cracking in stairwell wall of Parking Garage 4.

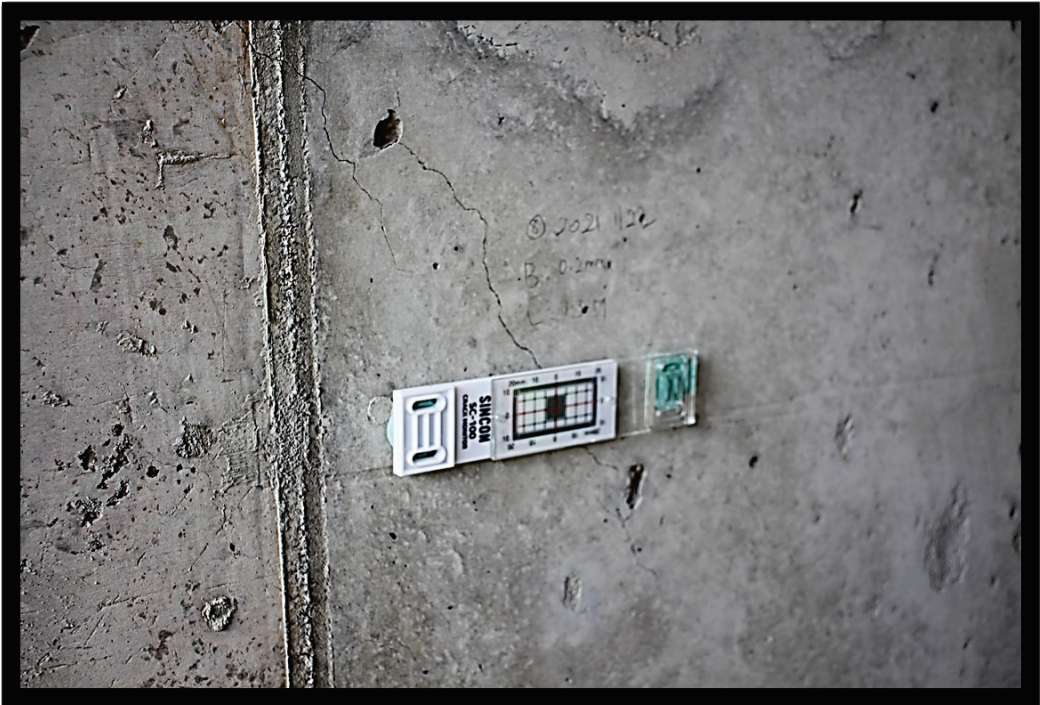
Figure 55. Crack monitoring in Parking Garage 4.

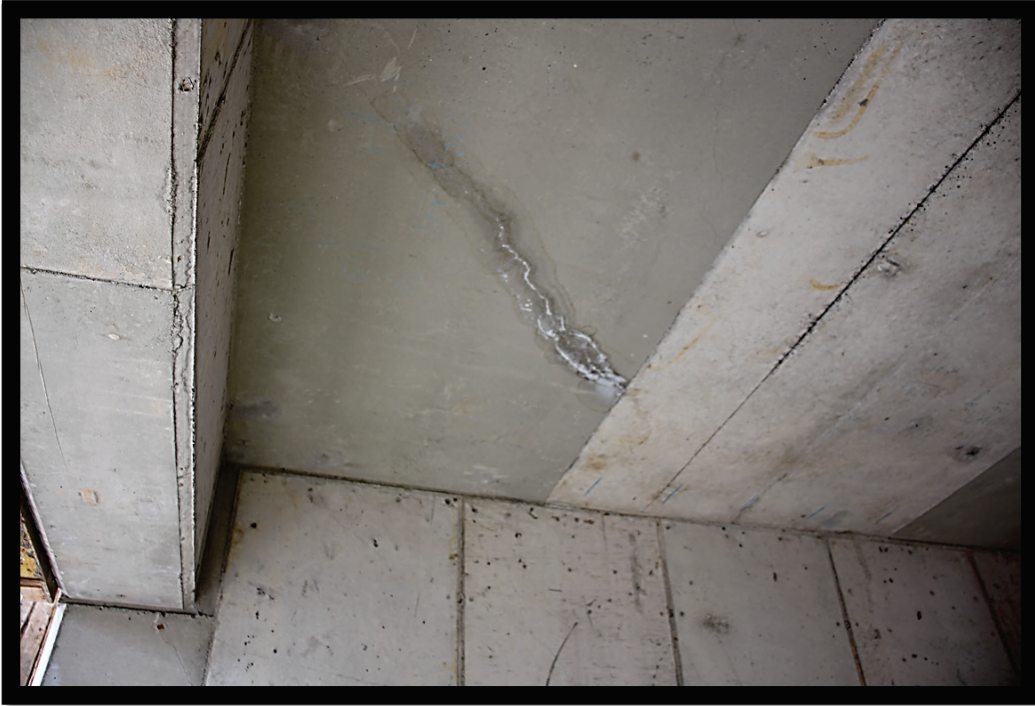
Due to Parking Garage 4 still being under construction, observations should not be directly compared with Garages 1–3. Features noted in Garage 4 may also have been present in Garages 1–3 in their unfinished states. Observations from Parking Garage 4 do indicate that many types of cracking were manifest at a very early age. Figure 54 shows vertical cracking in the wall of a stairwell in Parking Garage 4. These cracks have occurred very early and prior to any significant load being applied to the structure. Figure 55 shows ongoing crack monitoring that was initiated more than a month prior to the photograph being taken. This is further evidence of the early-age nature of these cracks. Figure 56 depicts a crack in the ceiling slab of the first floor of the parking garage. The white staining suggests that water was able to penetrate through the slab and that the crack is through the entire depth of the slab.

Figure 56. Crack in slab of Parking Garage 4 showing staining at location of water ingress.

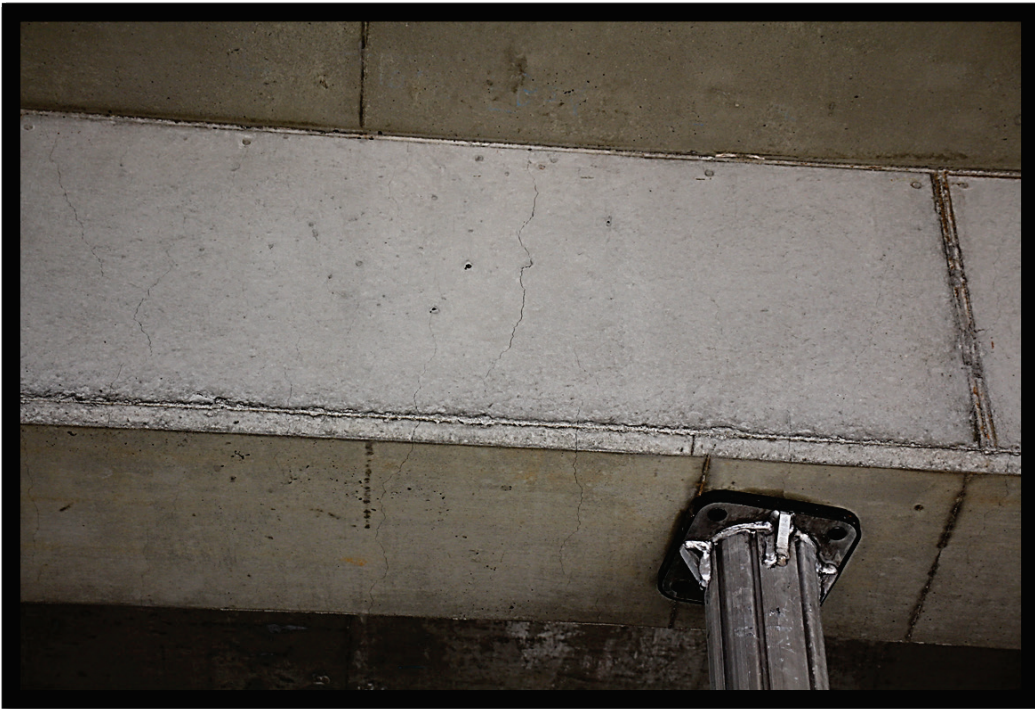
Figure 57 shows vertical cracking in a beam within the first floor of Parking Garage 4. This cracking is of particular interest, because it is immediately adjacent to a piece of shoring that has been in place since the concrete was cast. Since this is the case, it is very unlikely that the crack was caused by external loading. Rather, the location, orientation, and age of the crack all suggest plastic shrinkage.

Figure 57. Vertical crack in beam immediately adjacent to shoring. This shoring was in place continuously since concrete was cast.

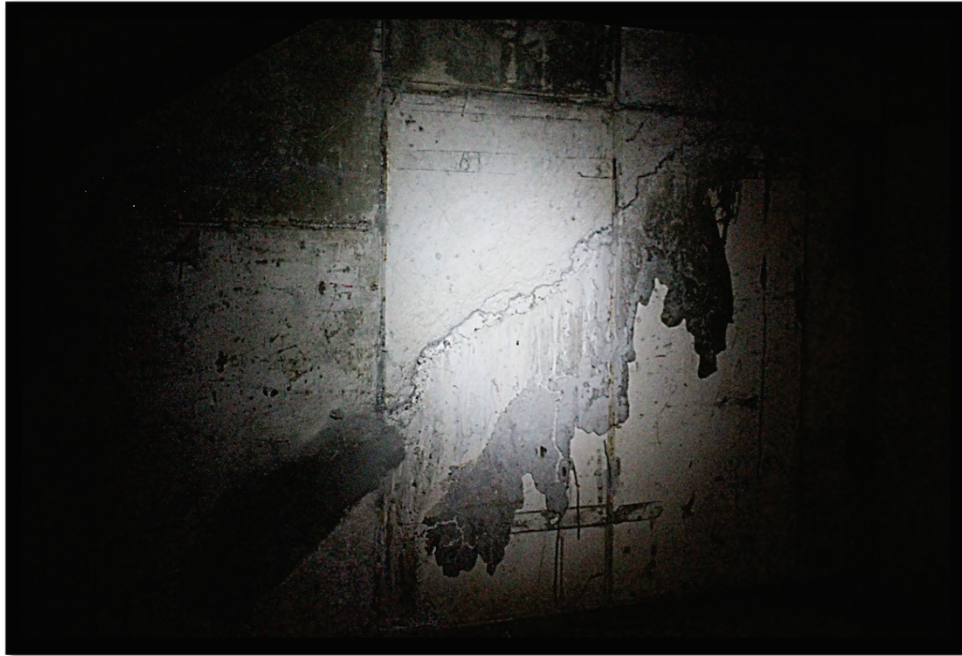
In addition to cracking, the same types of cold joints were observed in Parking Garage 4 that were observed in the other structures. Figure 58 shows one of these cold joints beneath a staircase.

Figure 58. Diagonal cold joint under staircase in Parking Garage 4.

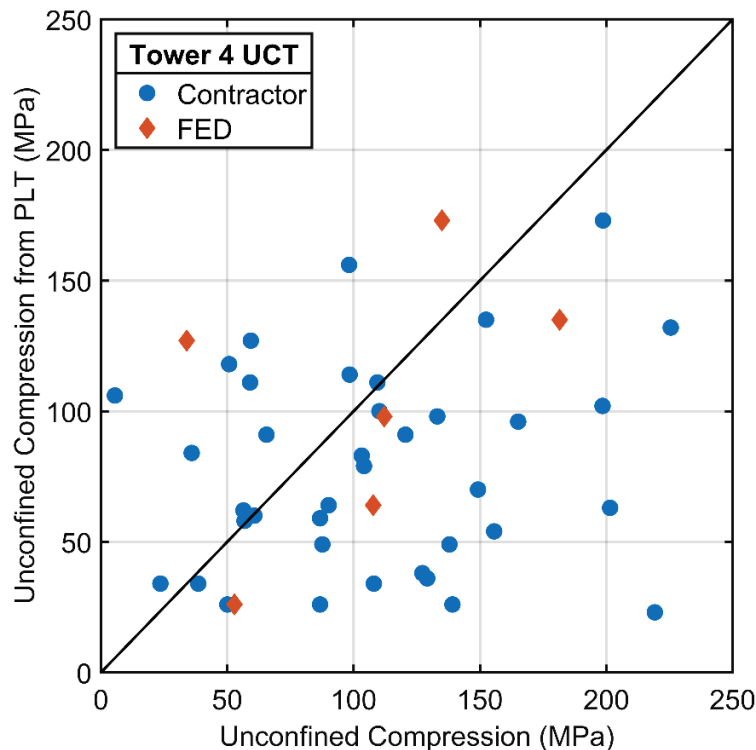
Laboratory testing of bedrock samples from Tower 4 included unconfined compression testing (UCT) performed by the Far East District (FED) geotechnical laboratory as well as a commercial laboratory. The UCT results allow for a direct comparison of the PLT correlation directly to UCT results. Figure A4 shows this comparison. Most of the tests were conducted on samples with a UC strength greater than 50 MPa. Figure A4 shows that, typically, the directly measured UC strengths are greater than the PLT derived strengths. Therefore, the PLT results are considered conservative with the caveat that the comparison was performed on samples with strengths much greater than those assumed for design.

Figure A4. Tower 4 laboratory testing results comparing unconfined compression test results to PLT derived unconfined compression.

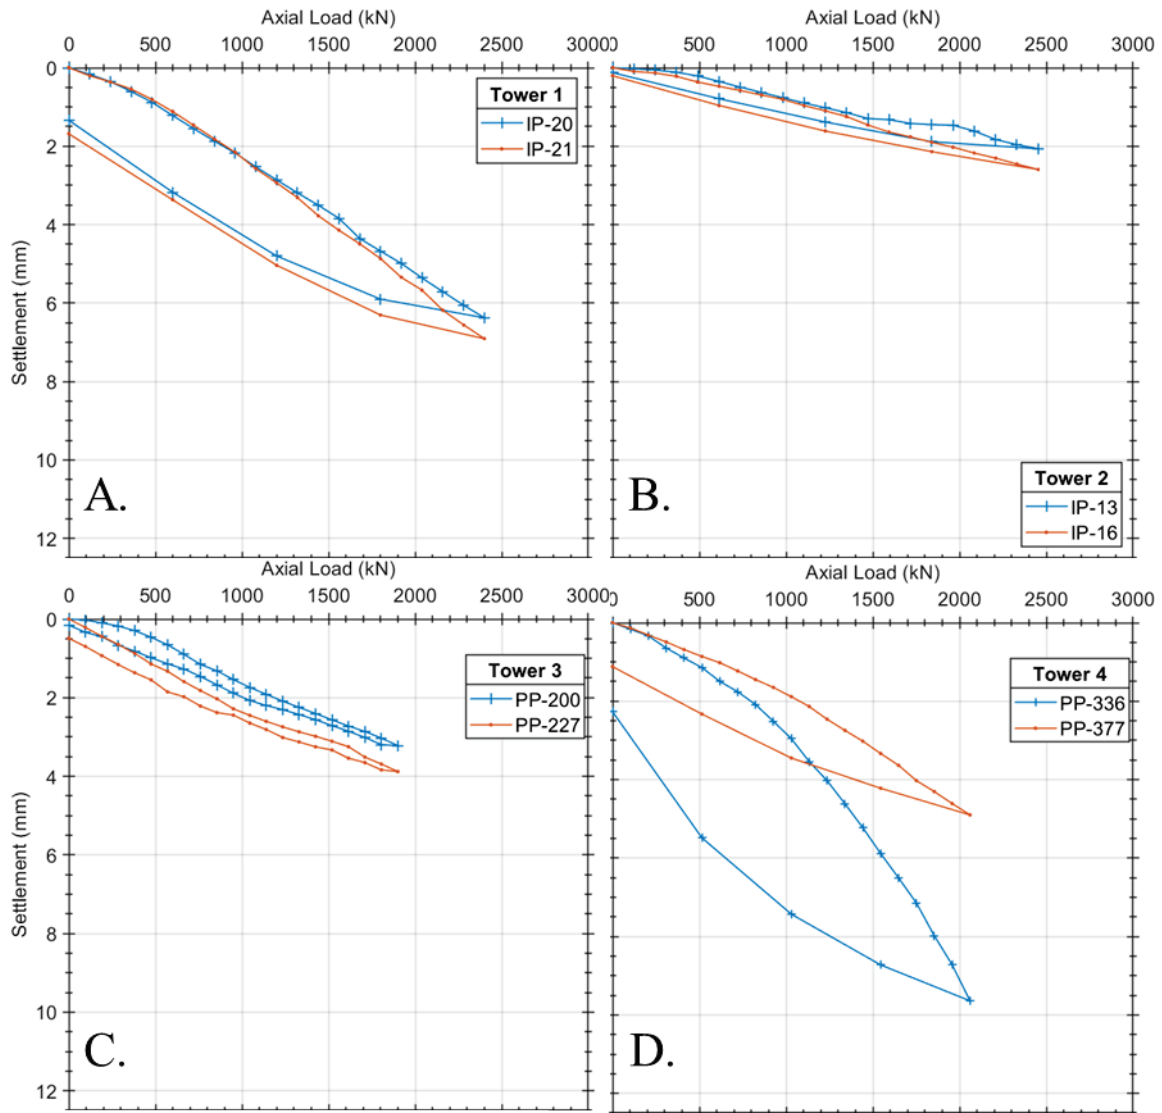
Two static load tests were performed for each of the towers. The maximum applied axial loads were 2400 kN, 2452.6 kN, 1900 kN, and 2060.1 kN for Towers 1–4 respectively, and were more than the design loads. The static load tests were performed to meet ASTM 1143 (2020) using Procedure A: Quick Test. Results are shown in Figure A5 in the form of load-settlement curves. Pile failure load was found using Davisson's method and the allowable load was found using a factor of safety of 2.0. The tabular results of the static load tests for Towers 1–4 are shown in Table A7. The stated allowable structural settlements from the foundation reports (Table A1, Ref #1–4) were stated to be 25 mm total and 12.5 mm differential settlement. The results shown in Table A7 and Figure A5 show that the settlements at the maximum loads are well below the differential settlement threshold, which indicates that the pile foundations have sufficient capacity to carry the design structural loads without excessive foundation settlement.

Figure A5. Load settlement curves from static load tests: A. Tower 1, B. Tower 2, C. Tower 3, and D. Tower 4.

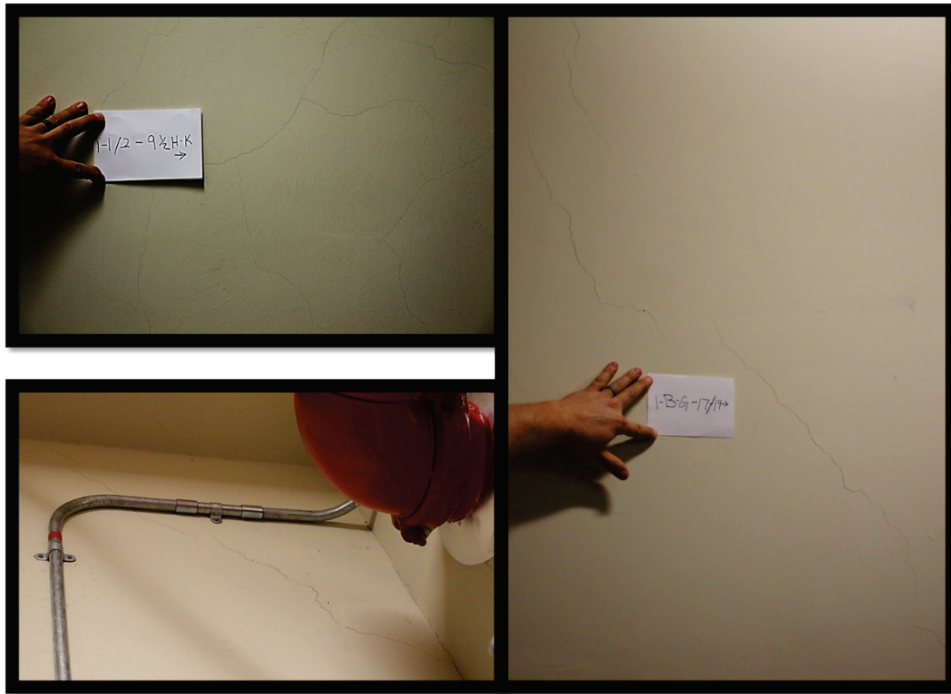
Figure B1. Cracking in walls of Tower 1.

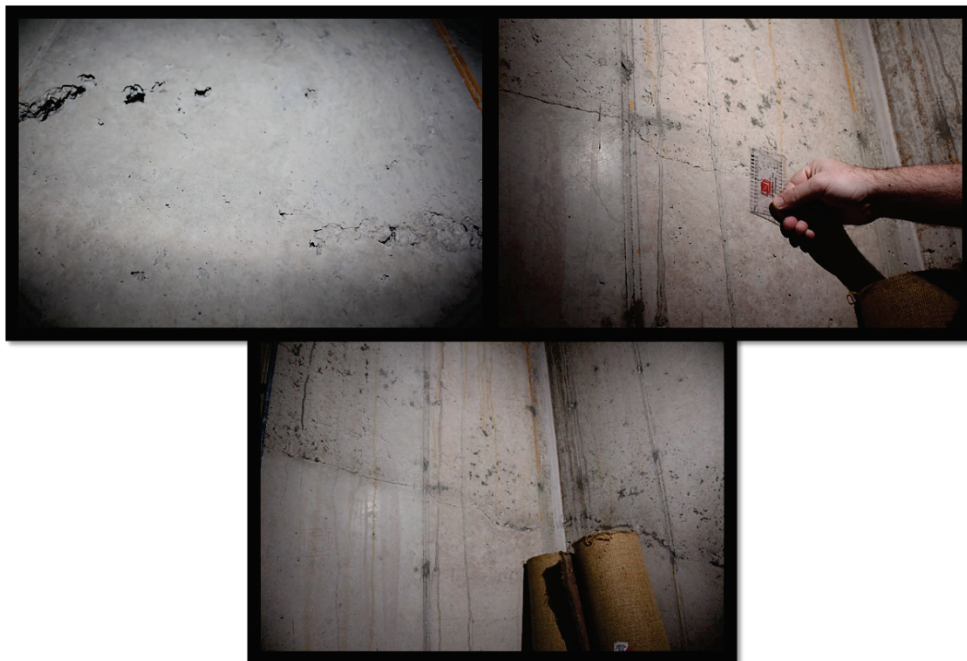
Figure B2. Honeycombing and cold joint in cored shaft of Tower 1.

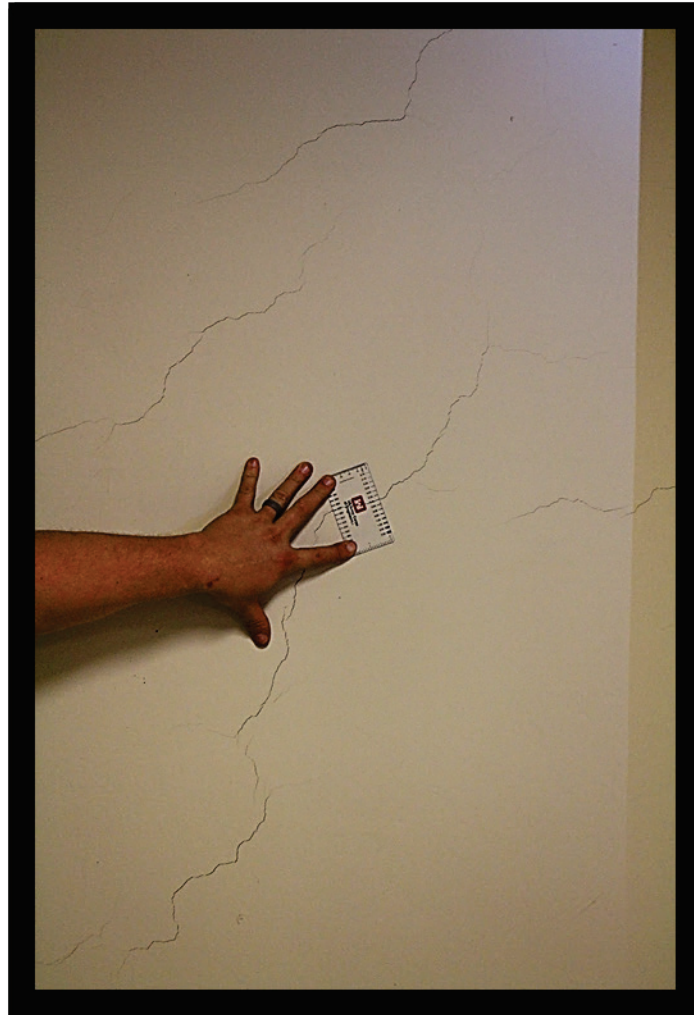
Figure B3. Cracking in mapped wall of elevator mechanical room in Tower 1.

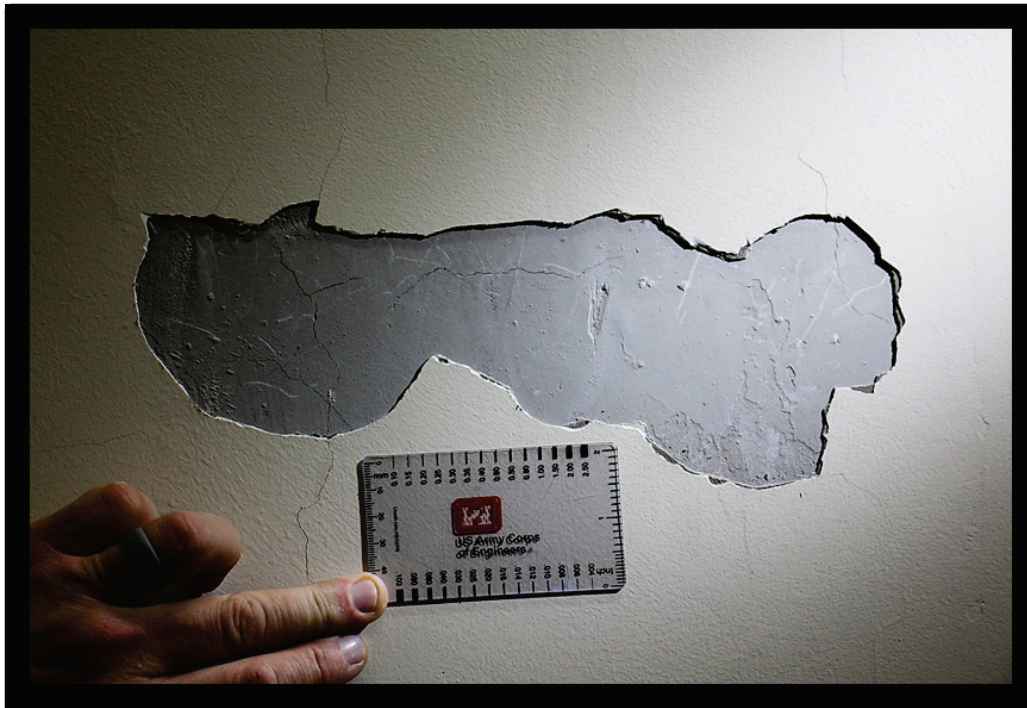
Figure B4. Cracking in concrete and cementitious coating in wall of Tower 1.

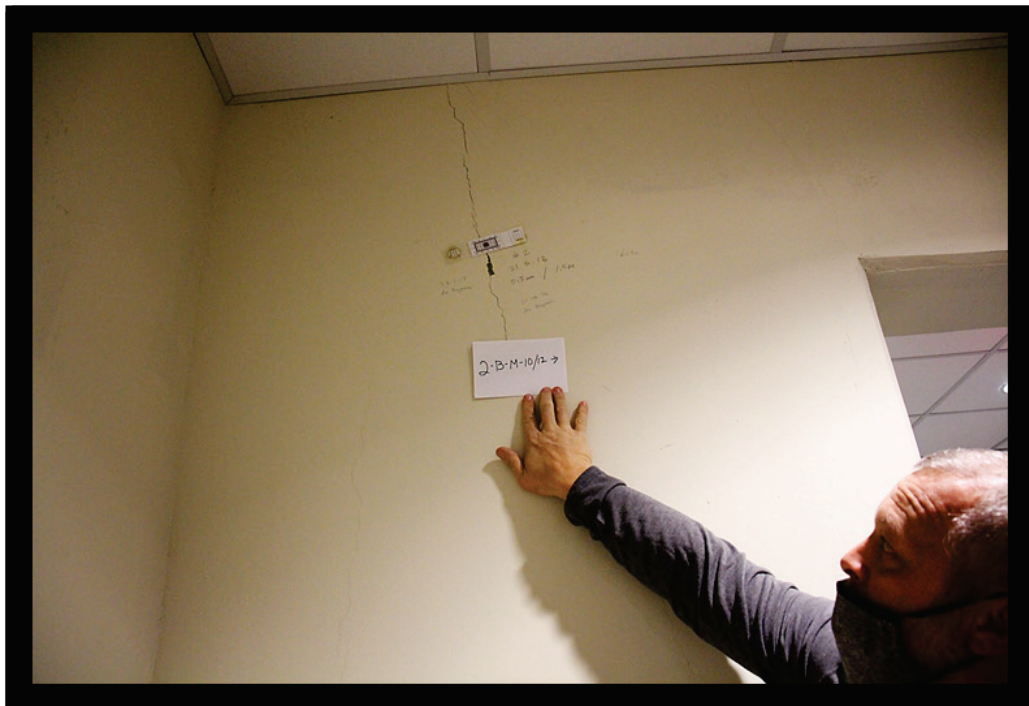
Figure B13. Wall crack with gauge in Tower 2 basement.

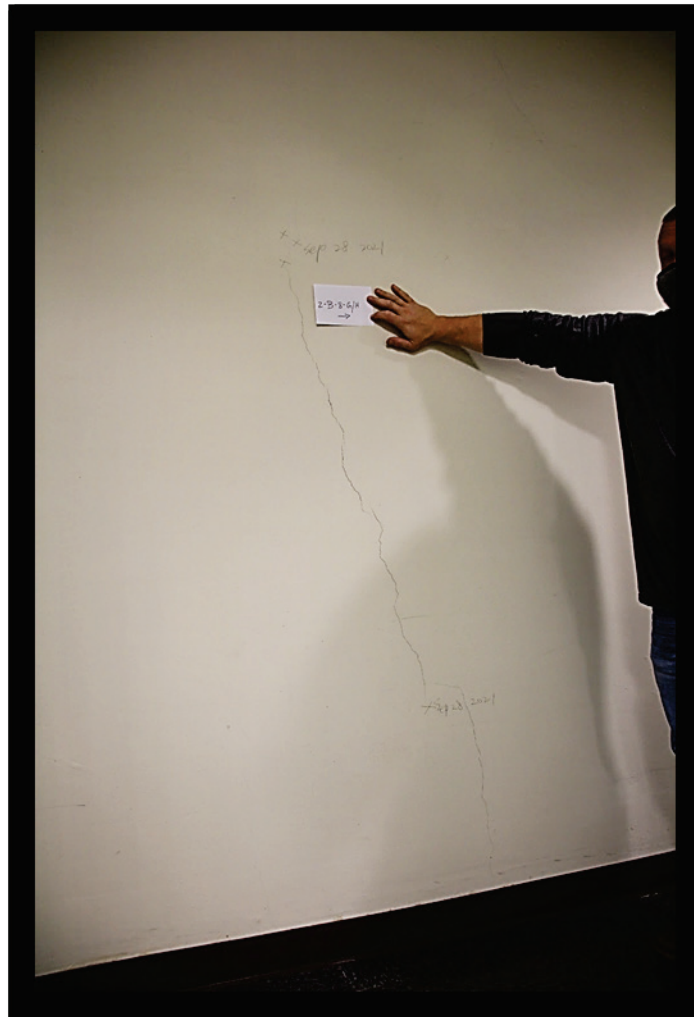
Figure B17. Wall crack with gauge in Tower 2 basement.

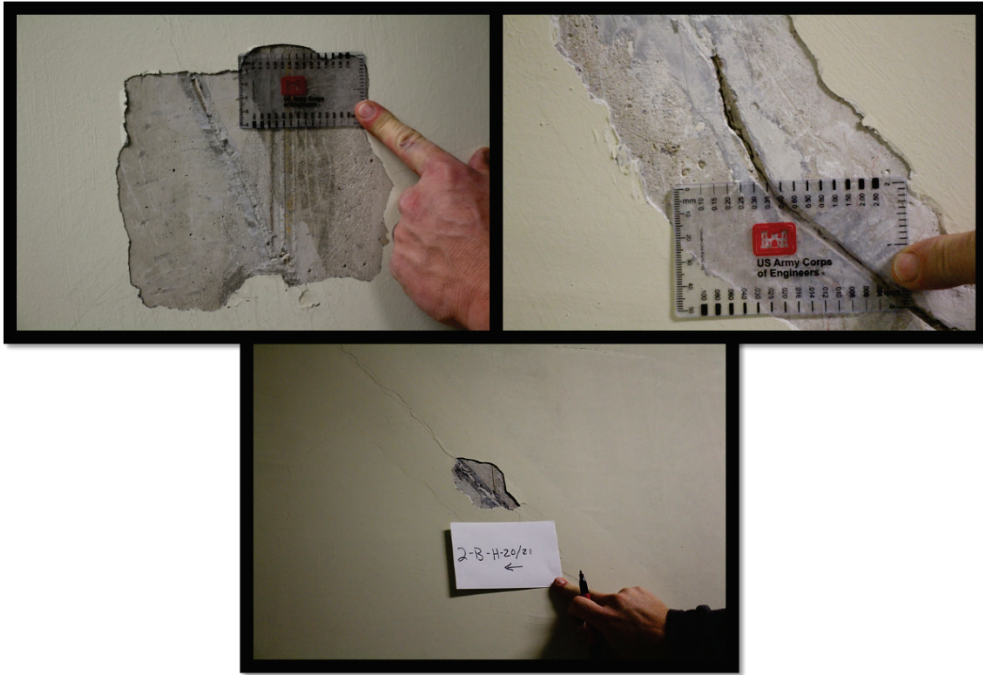
Figure B18. Sealed cracks in Tower 2 basement.

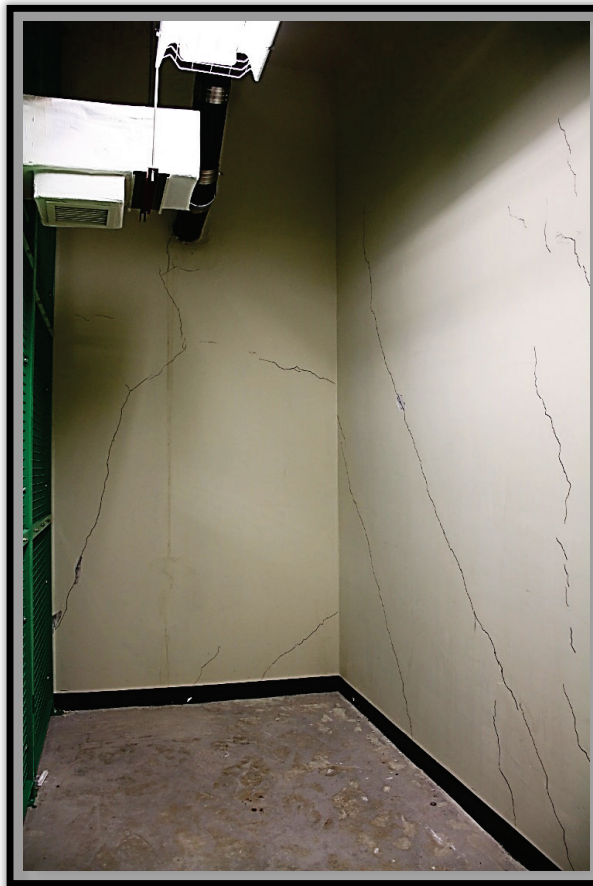
Figure B19. Mapped diagonal cracks in basement storage area of Tower 2.

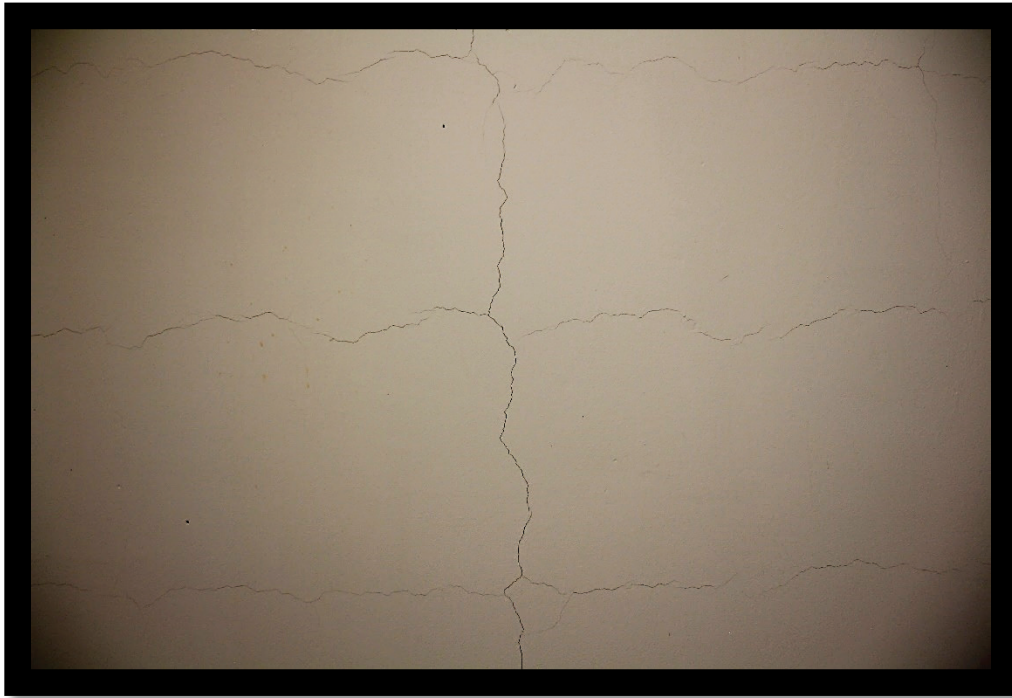
Figure B20. Vertical and horizontal cracks in stairwell wall of Tower 2.

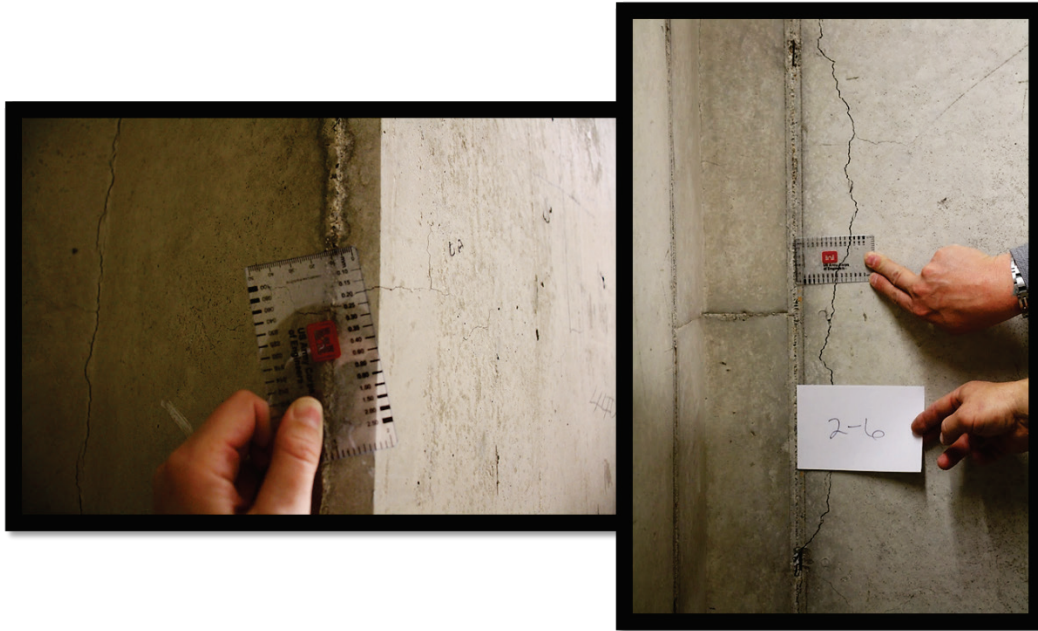
Figure B22. Wall cracks in shaft behind elevators in Tower 2.
