Report on Evaluation of Apartment Towers 1–4 and Parking Garages 1–4 at Camp Walker, Daegu, South Korea

April 2022

Final report

Prepared for Far East District, Pacific Ocean Division
U.S. Army Corps of Engineers
573 Bonney Loop, Building 525, Suite A300
Fort Shafter, HI 96858

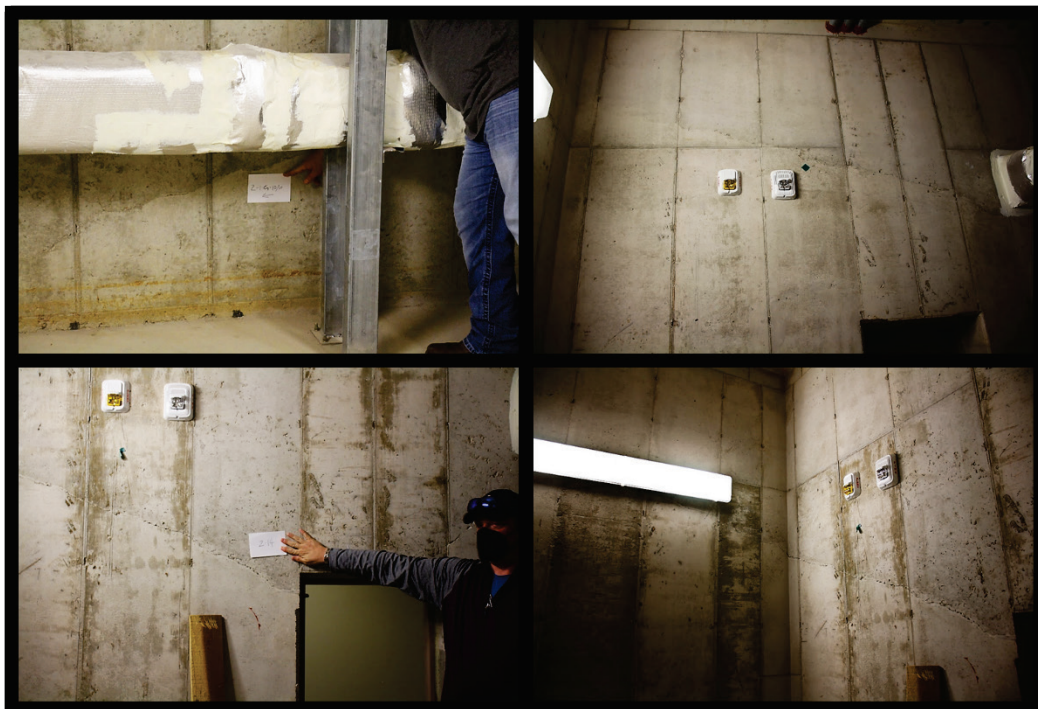
Figure B23. Cold joints in shafts behind elevators in Tower 2.

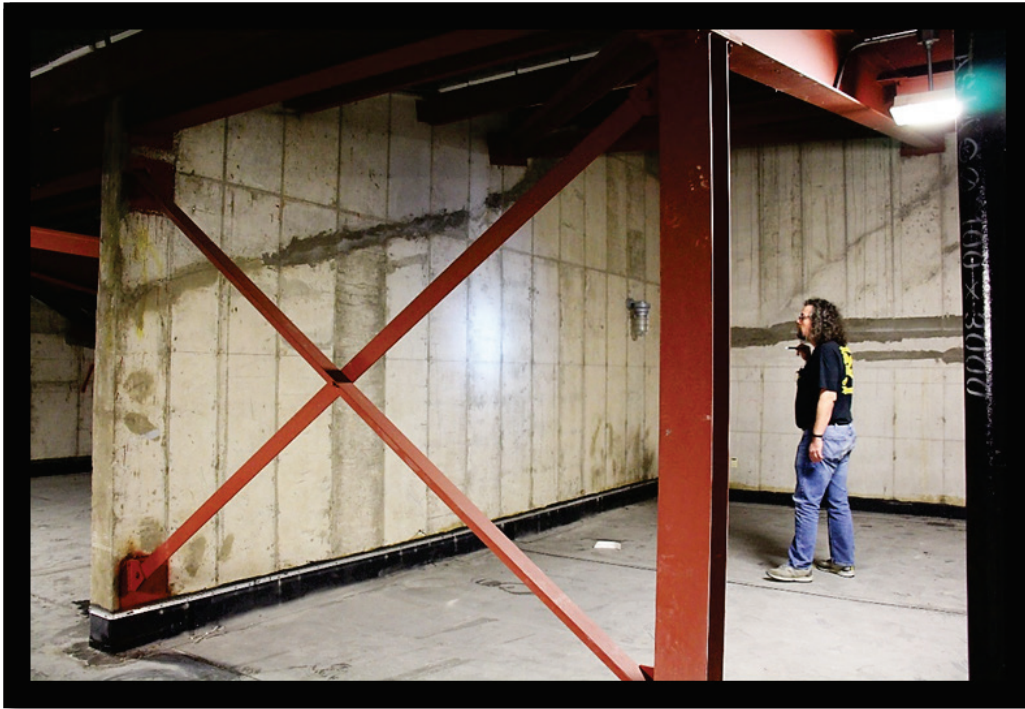
Figure B26. Diagonal cold joint in wall of attic in Tower 2.

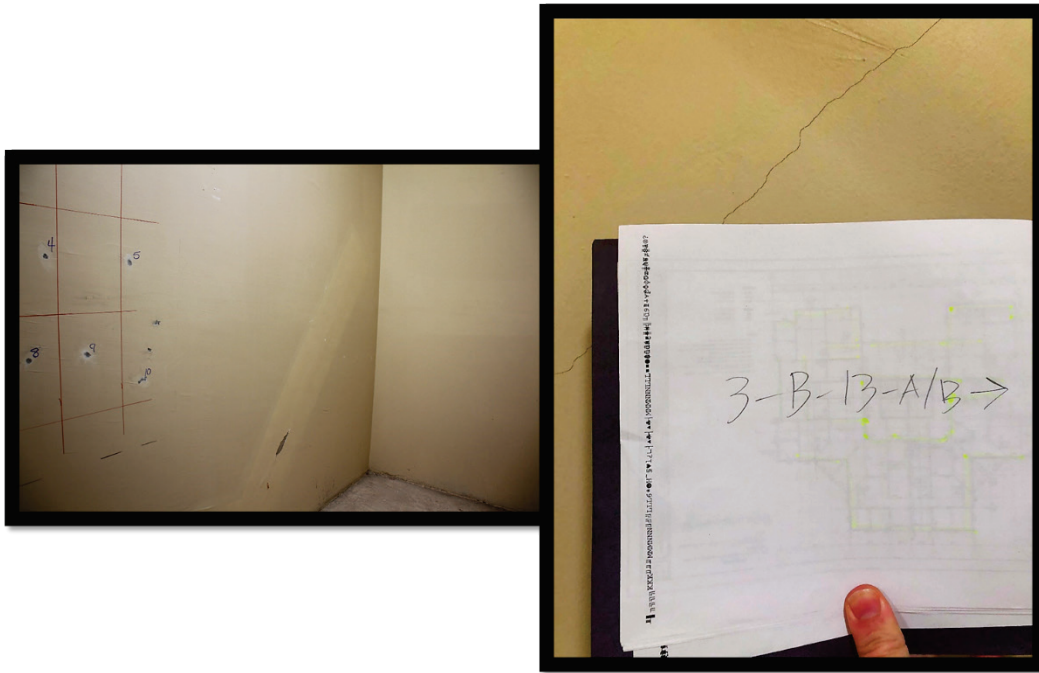
Figure B32. Diagonal cracks in basement walls of Tower 3.

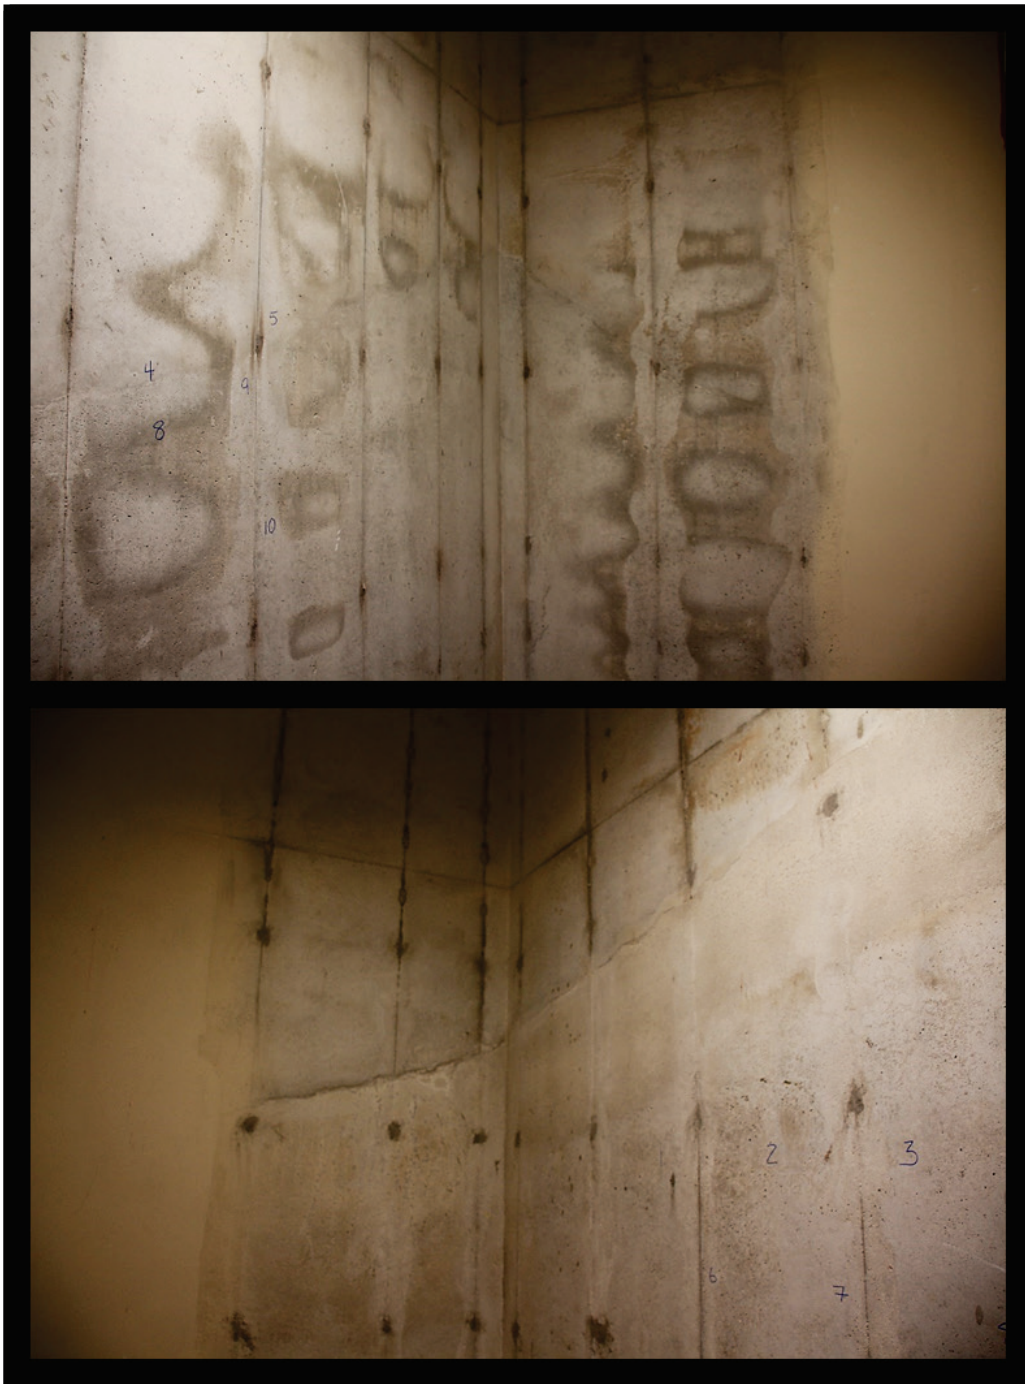
Figure B33. Cold joints in walls of shaft behind the elevators in Tower 3.

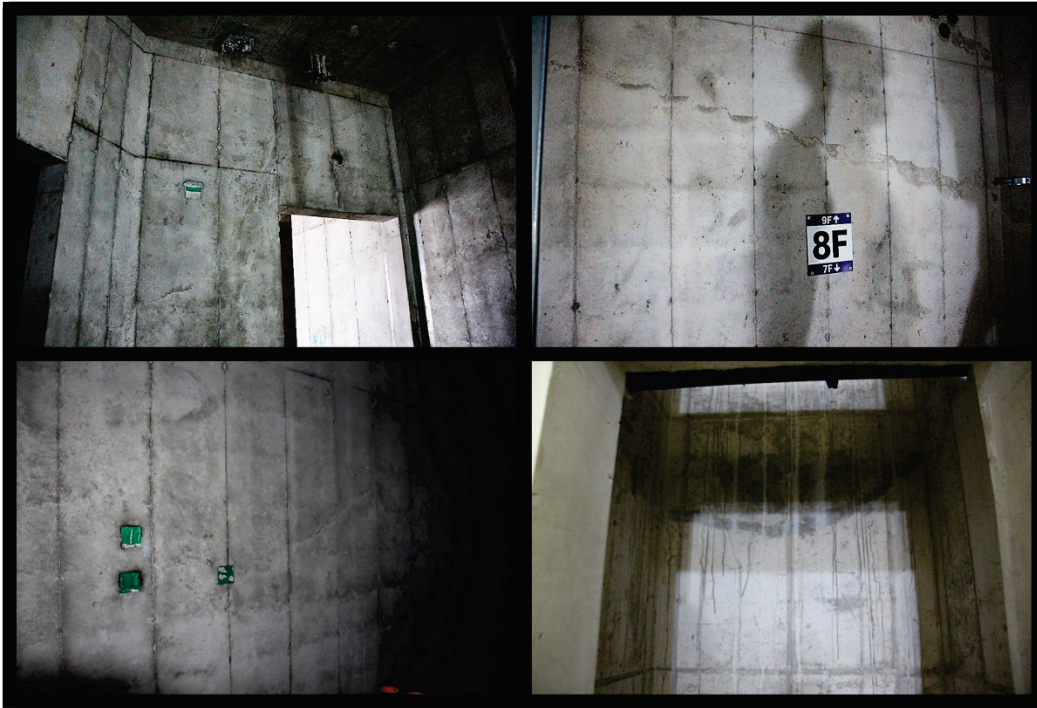
Figure B42. Cold joints in walls of Tower 4.

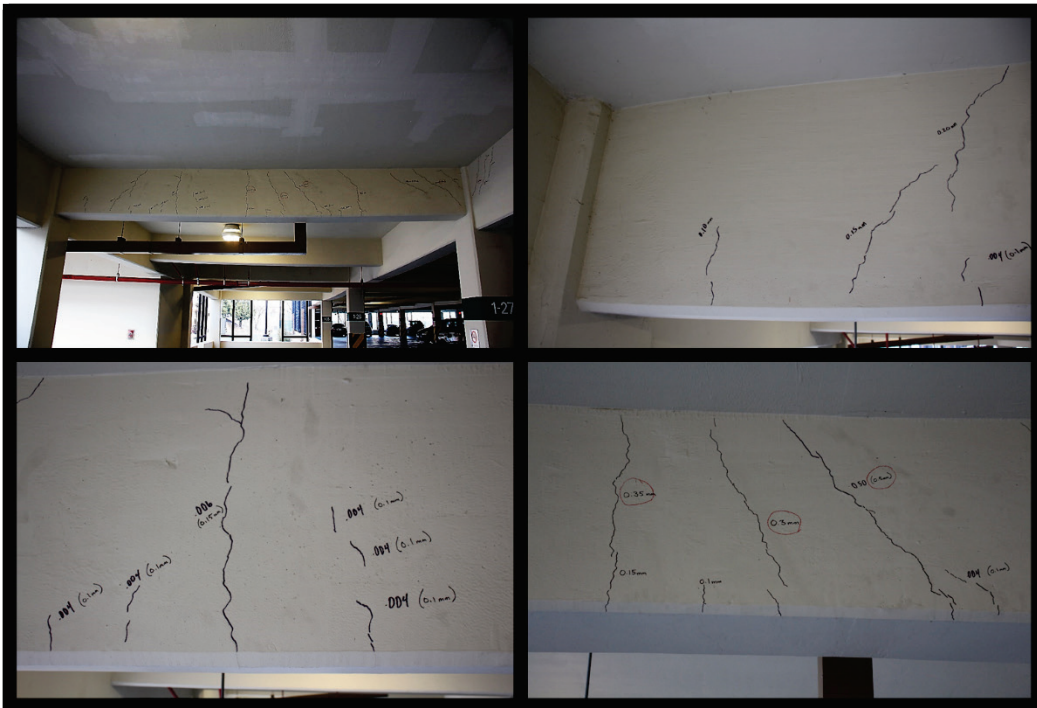
Figure B55. Mapped cracks in beam along column line 4 in Parking Garage 1.

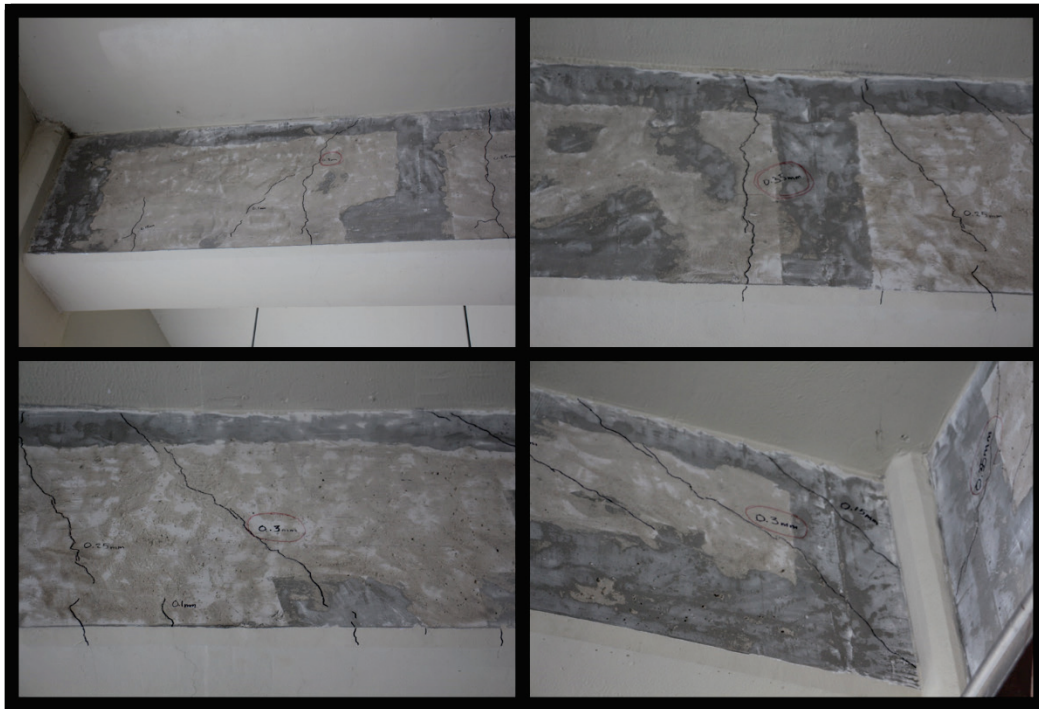
Figure B61. Mapped cracks in bare concrete of girder along column line E in Parking Garage 1.

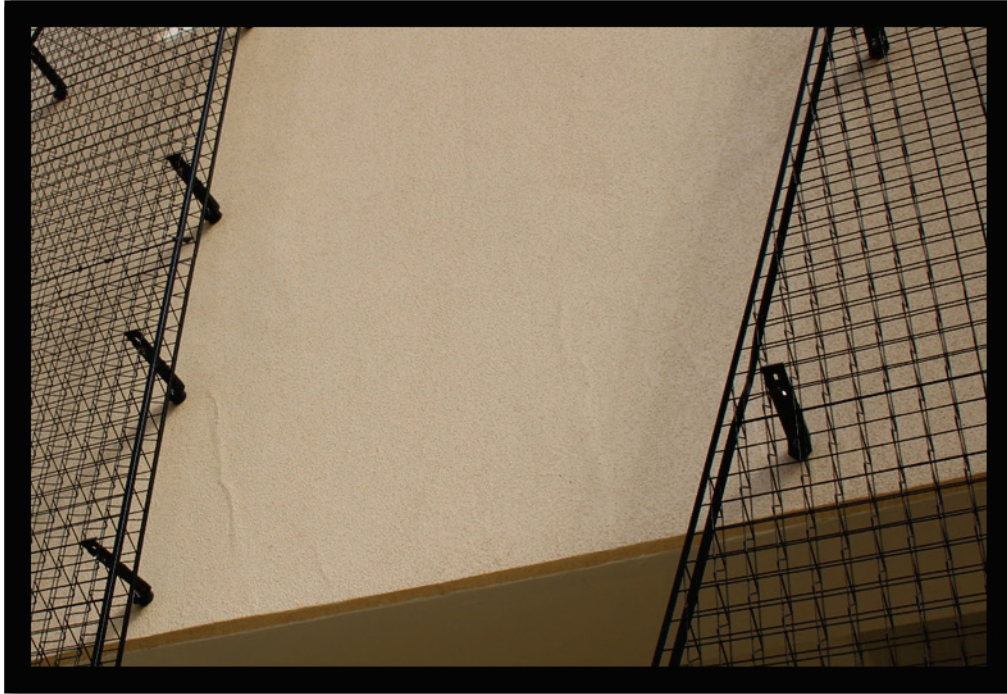
Figure B66. Diagonal crack in wall of stairwell in Parking Garage 3.

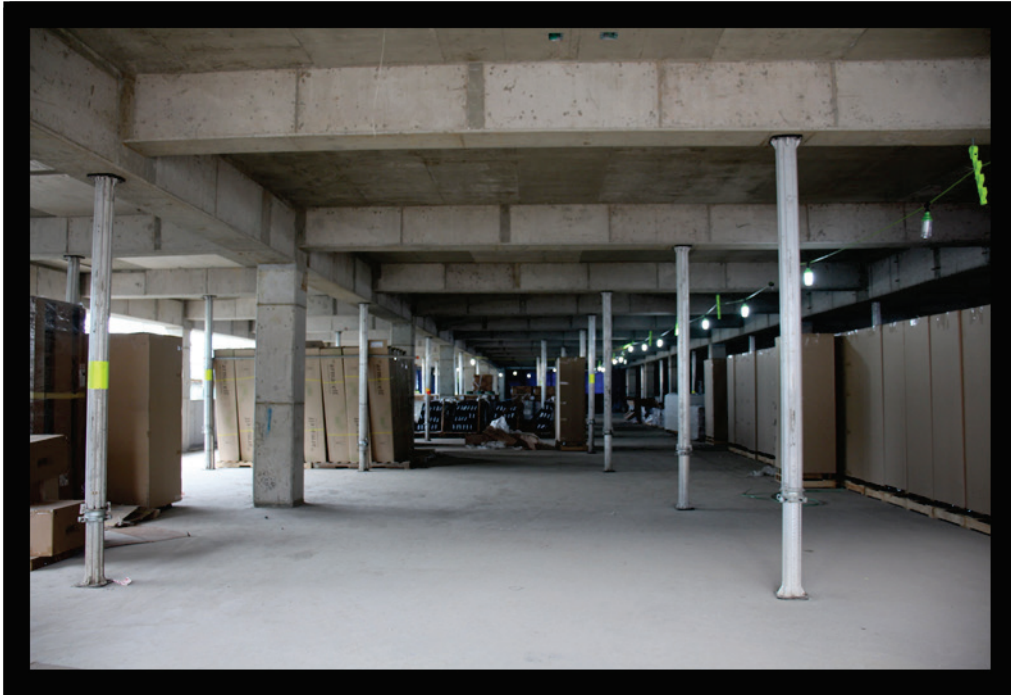
Figure B68. Cold joints in walls in Parking Garage 4.

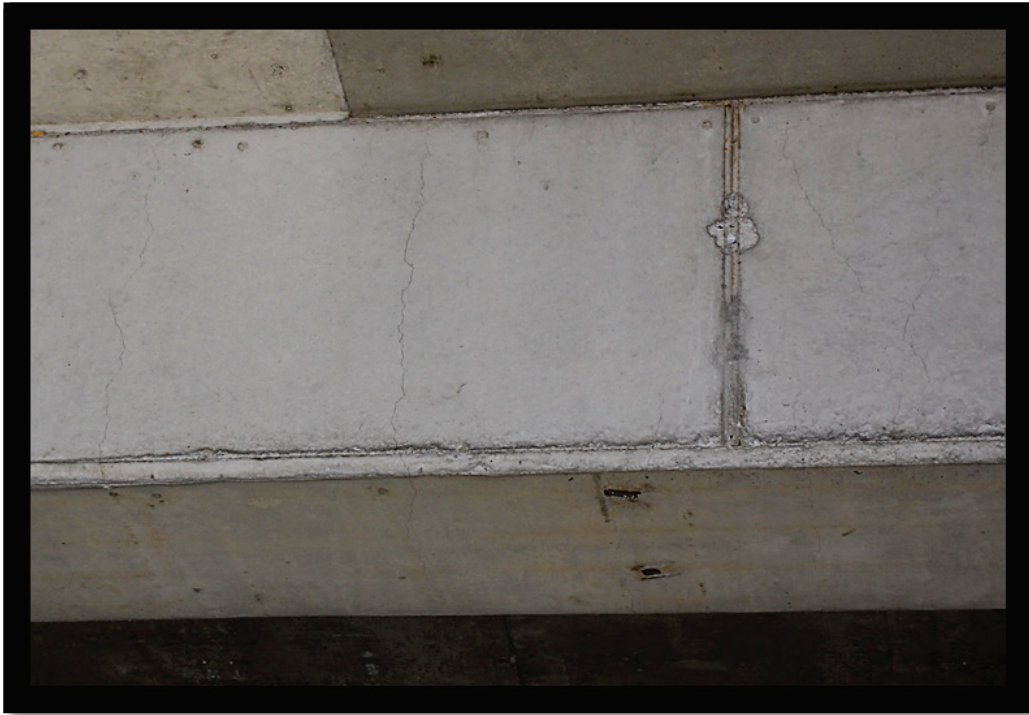
Figure B71. Vertical crack in wall in Parking Garage 4.

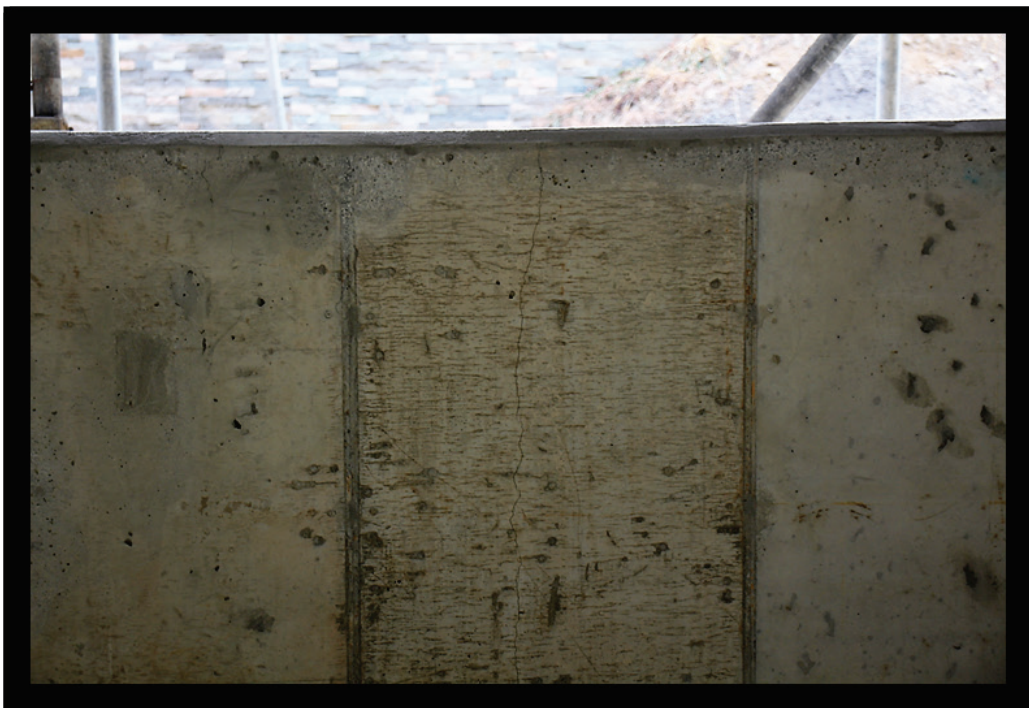
Figure B72. Cracks in exterior column and connected girder in Parking Garage 4.

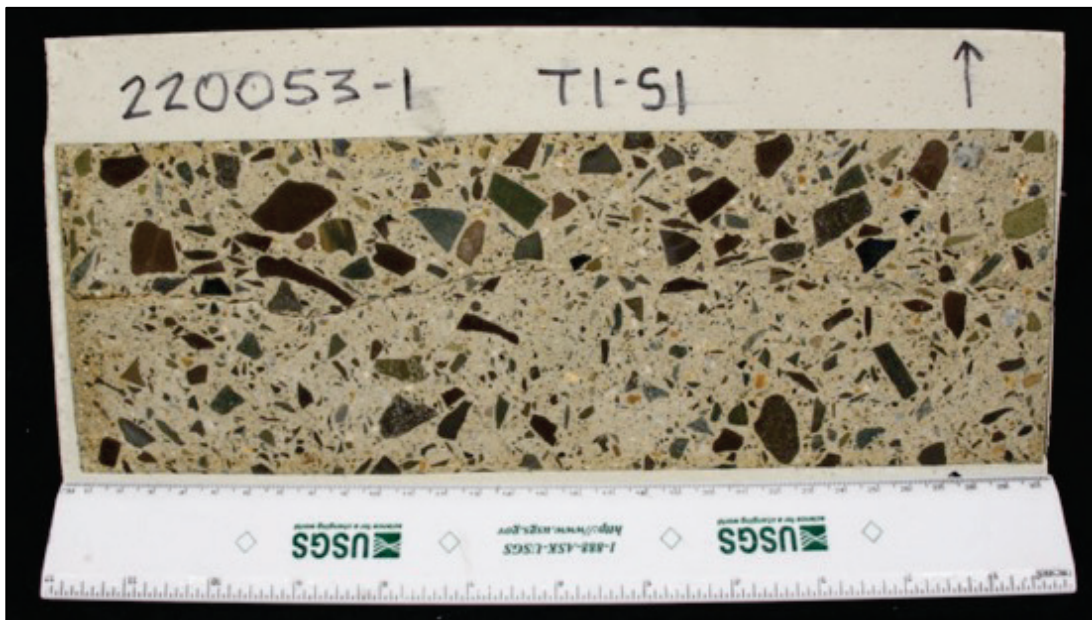
Figure C2. Photo of bisected core T1-S1.

Examination of the core presented one crack on the core surface that extended with depth over the entire length of the core (Figure C5). The crack varied in width from 0.25 to 2.50 mm and represented the only macrocracking present in the sample. The coarse aggregate was a crushed stone and had a maximum nominal size of 1.0 in. It consisted primarily of granitic mineralogies with some sandstone particles present. The fine aggregate was a crushed stone and a quartz sand. The coarse aggregate was not uniformly dispersed, with some areas having a low concentration of coarse aggregate. These regions were concentrated on one side of the crack. Darkened rims were observed on some coarse aggregates, indicative of a reaction between the particles and paste; however, no disruption to the concrete was associated with this feature. Internal microfractures were observed in some coarse aggregates but are likely pre-existing features. No indicators of deleterious reactions, such as alkali-silica reaction (ASR), were observed within the sample. The paste was Yellowish Gray (5Y 8/1) in color and was air entrained. Entrapped air voids up to 0.5 in. in diameter were observed, but rare.

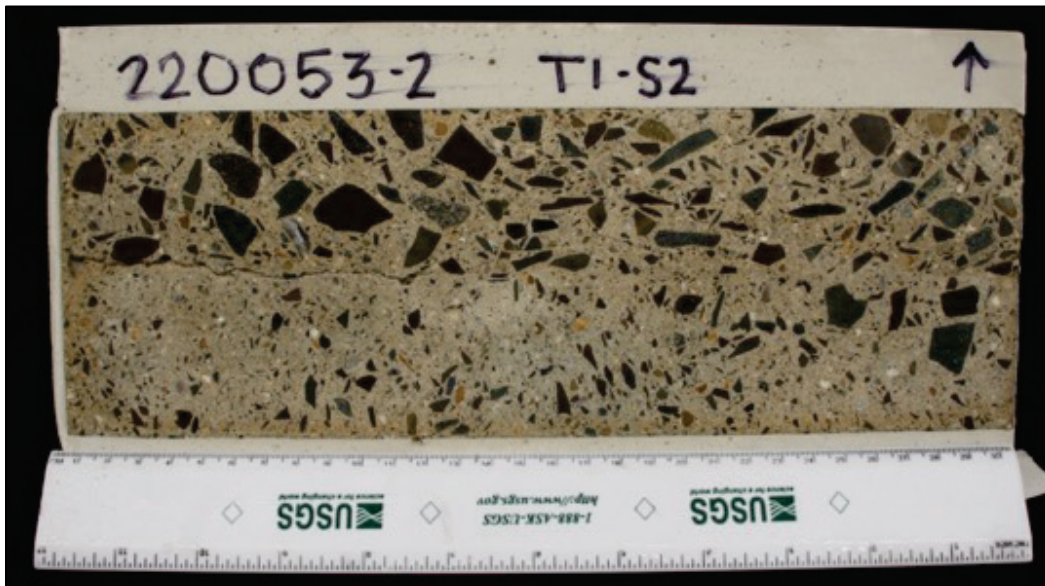
Figure C9. Photo of bisected core T1-S2.

Examination of the core presented one extensive crack on the core surface that extended with depth up to 8 in. (Figure C12). The crack varied in width from 0.10 to 2.0 mm and represented the only cracking present in the sample. The coarse aggregate was a crushed stone and had a maximum nominal size of 1.0 in. It consisted primarily of granitic mineralogies with some sandstone particles present. The fine aggregate was a crushed stone and a quartz sand. The coarse aggregate was not uniformly dispersed, with some areas having a low concentration of coarse aggregate. These regions were concentrated on one side of the crack. Darkened rims were observed on some coarse aggregates, indicative of a reaction between the particles and paste; however, no disruption to the concrete was associated with this feature. Internal microfractures were observed in some coarse aggregates but are likely pre-existing features. No indicators of deleterious reactions, such as alkali-silica reaction (ASR), were observed within the sample. The paste was Yellowish Gray (5Y 8/1) in color and was air entrained. Entrapped air voids up to 0.2 in. in diameter were observed, but rare.

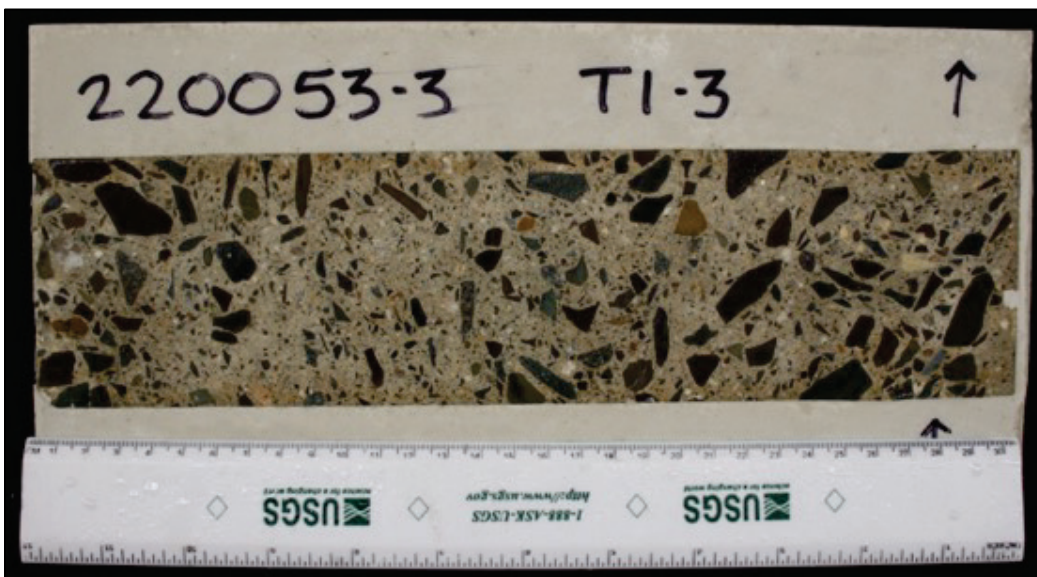
Figure C16. Photo of bisected core T1-3.

Examination of the core presented some hairline cracks on the surface, but none were observed with depth. The coarse aggregate was a crushed stone had a maximum nominal size of 1.25 in. It consisted primarily of granitic mineralogies with some sandstone particles present. The fine aggregate was a crushed stone and a quartz sand. The coarse aggregate was not uniformly dispersed, with some areas having a low concentration of coarse aggregate. Darkened rims were observed on some coarse aggregates, indicative of a reaction between the particles and paste; however, no disruption to the concrete was associated with this feature. Internal microfractures were observed in some coarse aggregates but are likely pre-existing features. No indicators of deleterious reactions, such as alkali-silica reaction (ASR), were observed within the sample. The paste was Yellowish Gray (5Y 8/1) in color and was air entrained. Entrapped air voids up to 0.5 in. in diameter were observed, but rare.

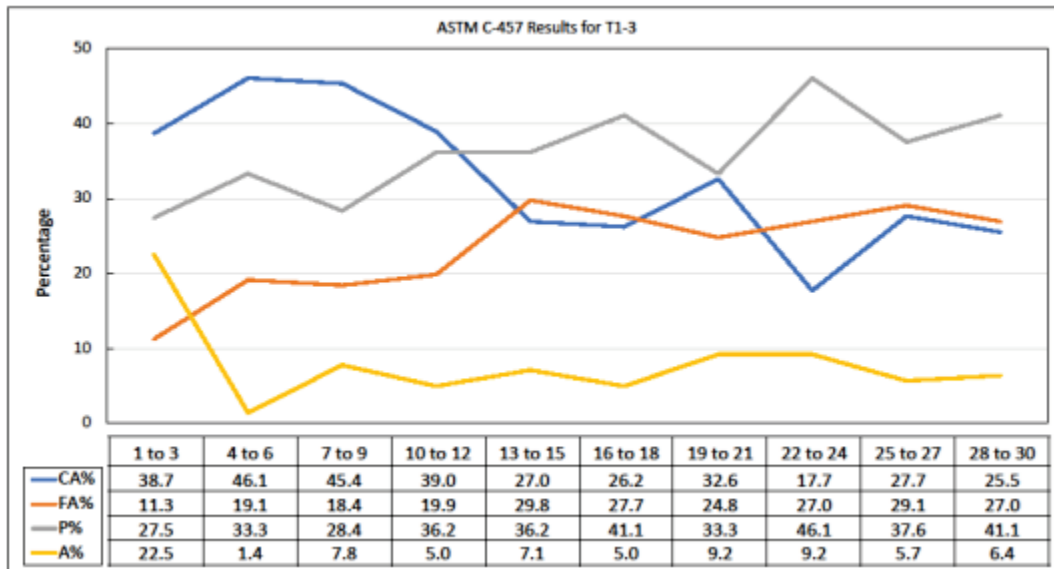
Figure C21 shows a comparison of the concrete constituents for every 1 cm, or 3 traverses into the sample. The phases do not have any discernible trend with depth. Entrained air voids were often concentrated in clusters while entrapped air voids were consistently found along aggregate boundaries. The largest entrapped air voids were found in the top several centimeters.

Figure C21. Comparison of concrete phases in sample T1-3 with depth acquired during ASTM C-457 analysis. The x-axis represents traverse lines across the core, 3 of which equal approximately a centimeter.

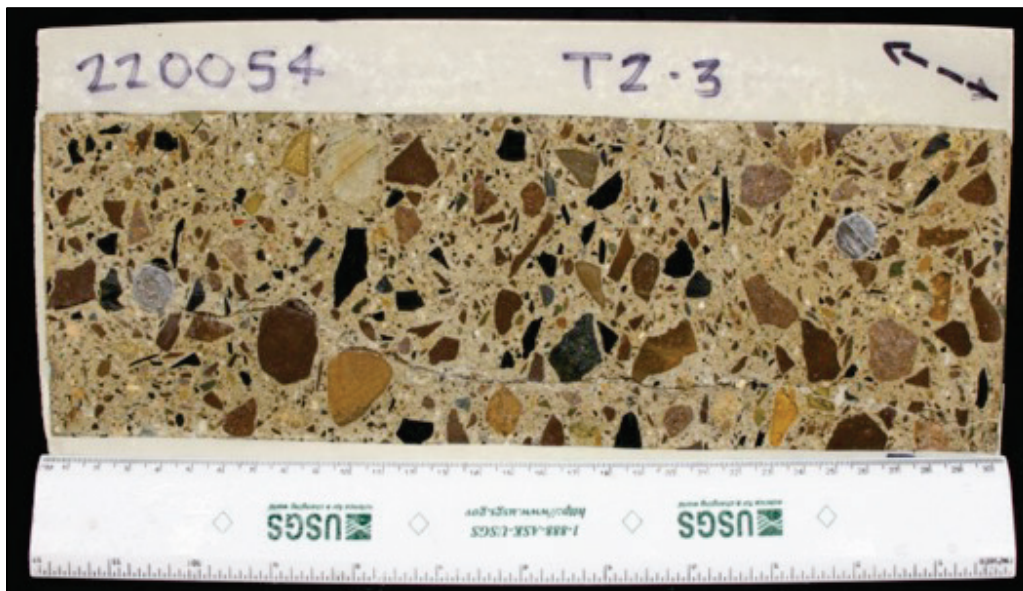
Figure C23. Photo of bisected core T2-3.

Examination of the core presented one extensive crack on the core surface that extended with depth over the entire length of the core (Figure C26). The crack varied in width from 0.25 to 2.50 mm and represented the only cracking present in the sample. The white material infilled throughout the crack is hydrostone and not a product of ASR. The coarse aggregate was a crushed stone had a maximum nominal size of 1.0 in. It consisted primarily of granitic mineralogies with some sandstone particles present. The fine aggregate was a crushed stone and a quartz sand. The coarse aggregate was not uniformly dispersed, with some areas having a low concentration of coarse aggregate. These regions were concentrated on one side of the crack. Darkened rims were observed on some coarse aggregates, indicative of a reaction between the particles and paste; however, no disruption to the concrete was associated with this feature. Internal microfractures were observed in some coarse aggregates but are likely pre-existing features. Reinforcing bar was present within the sample. No indicators of deleterious reactions, such as alkali-silica reaction (ASR), were observed within the sample. The paste was air entrained. Entrapped air voids up to 0.5 in. in diameter were observed, but rare.

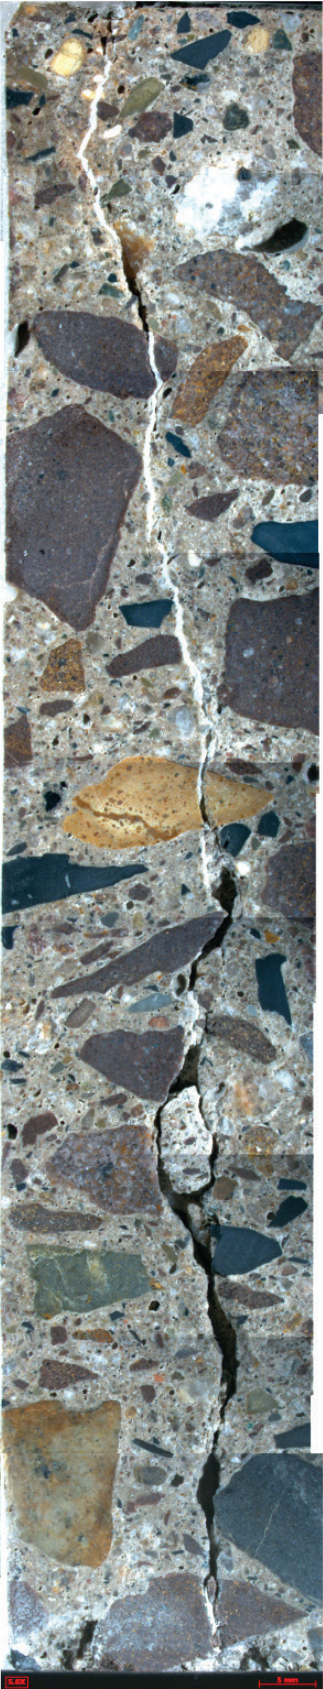
Figure C26. Map of crack observed in core T2-3.

- Sample T2-3 contained a coarse aggregate with primarily silicate-based mineralogy with a maximum nominal size of 1.0 in. The fine aggregate was a crushed stone and quartz sand. An extensive crack was observed that extended with depth throughout the entire length of the core and varied in thickness from 0.25 to 2.50 mm. Discoloration of the paste was observed near the surface, likely due to carbonation. The concrete was air entrained, although at a low level, and entrapped air voids were observed, but rare.

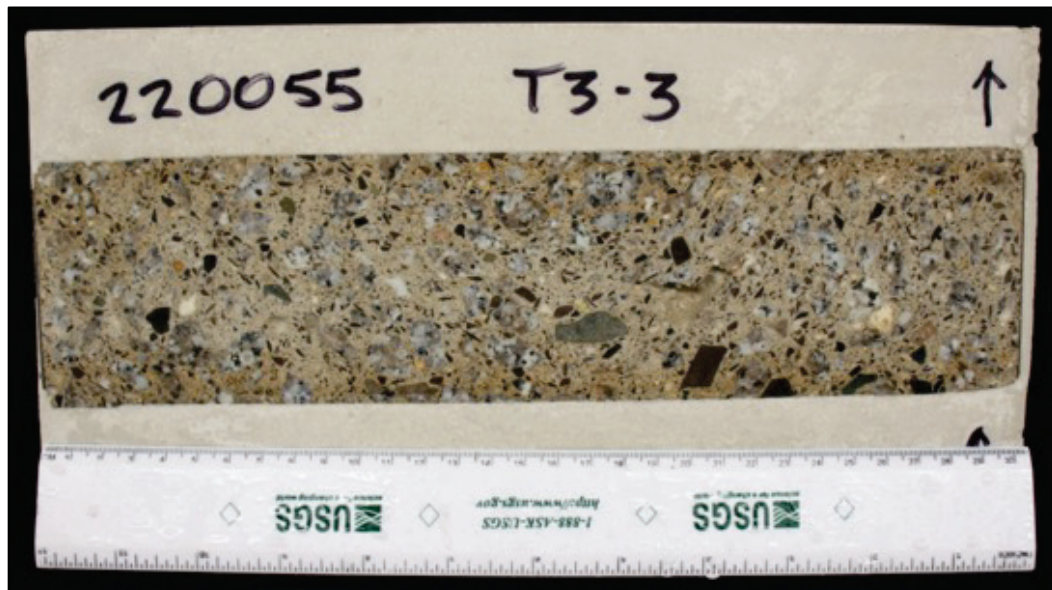
Figure C31. Photo of bisected core T3-3.

Examination of the core presented one extensive crack on the core surface that extended with depth over the entire length of the core. The crack varied in width from 0.25 to 2.50 mm and represented the only cracking present in the sample. The coarse aggregate was a crushed stone that had a maximum nominal size of 0.75 in. It consisted primarily of granitic mineralogies. The fine aggregate was a crushed stone and a quartz sand. The coarse aggregate was not uniformly dispersed, with some areas having a low concentration of coarse aggregate. These regions were concentrated on one side of the crack. Darkened rims were observed on some coarse aggregates, indicative of a reaction between the particles and paste; however, no disruption to the concrete was associated with this feature. Internal microfractures were observed in some coarse aggregates but are likely pre-existing features. No indicators of deleterious reactions, such as alkali-silica reaction (ASR), were observed within the sample. The paste was Yellowish Gray (5Y 8/1) in color and was air entrained. Entrapped air voids up to 0.5 in. in diameter were observed, but rare.

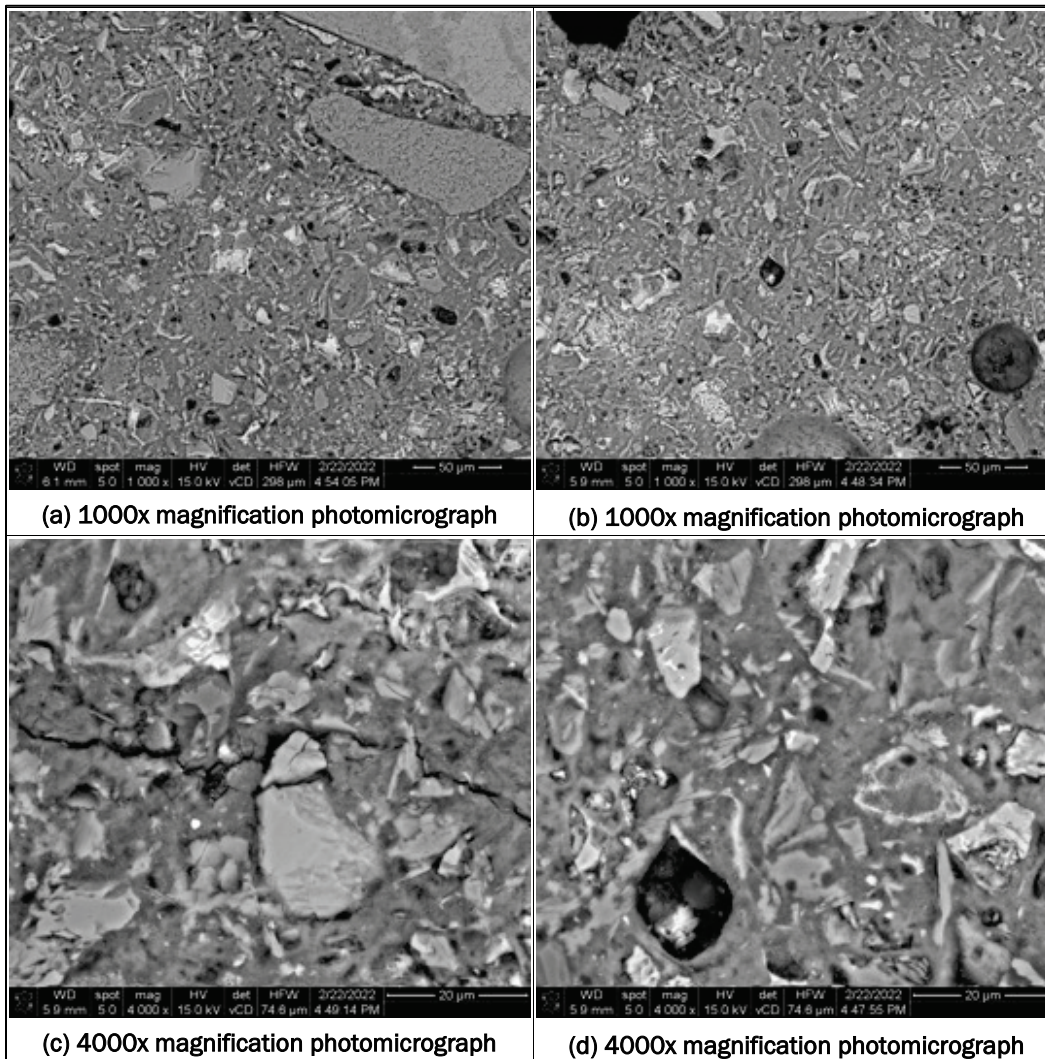
Figure C35. Electron photomicrographs of T3-3; (a) 1000x photomicrograph of paste microstructure; (b) 1000x photomicrograph of paste; (c) 4000x photomicrograph of paste; (d) 4000x photomicrograph of paste.

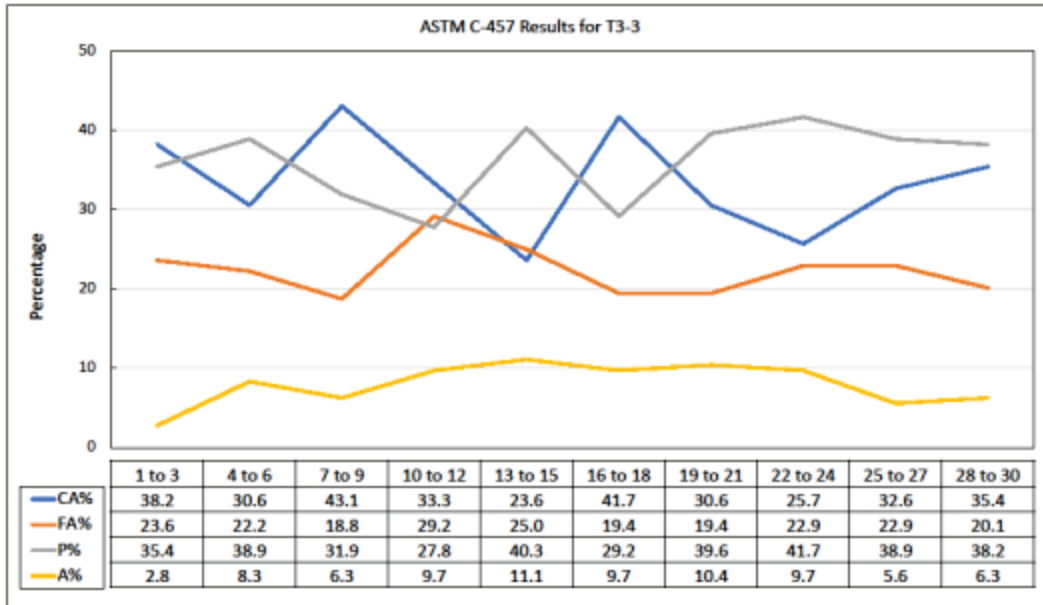
Figure C36. Comparison of concrete phases in sample T3-3 with depth acquired during ASTM C-457 analysis. The x-axis represents traverse lines across the core, 3 of which equal approximately a centimeter.

Figure C36 shows a comparison of the concrete constituents for every 1 cm, or 3 traverses into the sample. Air content was relatively high from 4 to 8 cm. Entrained air voids were often in clusters and some appeared infilled. The other phases did not have any discernible trend with depth.

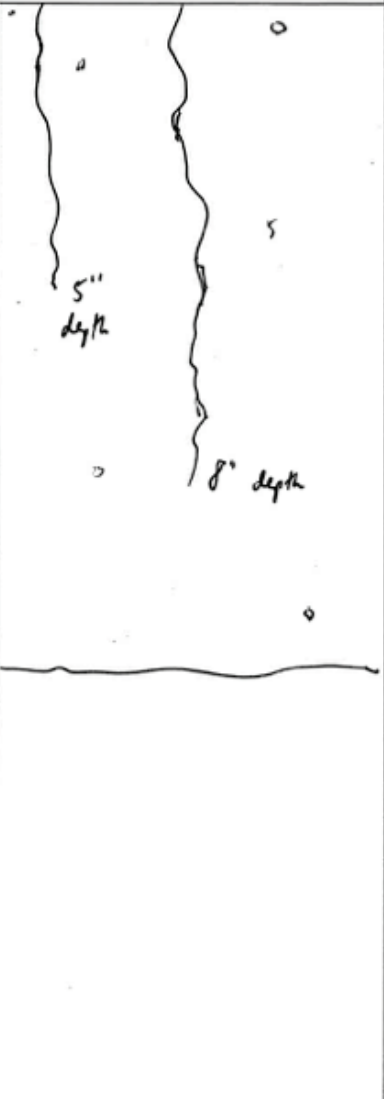
Location: Korea Core Name: T1-5-2, 220053-2 Investigator: CMG Date: 2-15-22		CORE SURFACE - bisected by thin crack (.2mm - 1.5mm)

Max. aggregate size - 1" Aggregate type - Max. entrapped air size - 0.2" Cracks visible? - Yes, crack extends from the surface into depth up to 8" - Varied in thickness from (0.1 mm - 2.0 mm) - Large discrepancy in volume percentages of agg vs paste separated by the crack A side = coarse agg visible & well dispersed B side = little CA. in size & volume	
		- minimal entrapped air - agg - paste had appeared along

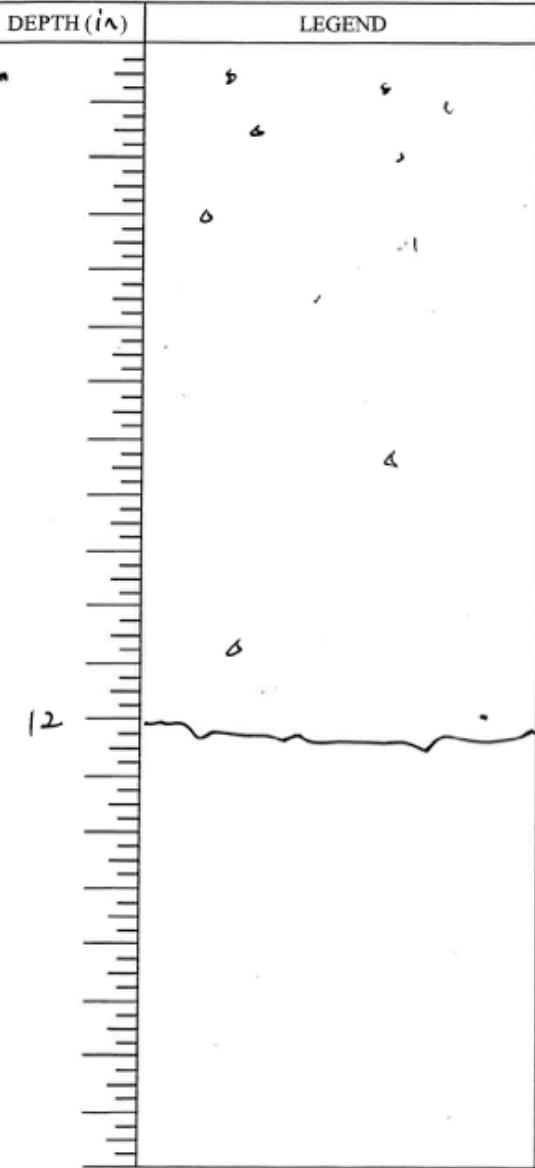
Location: Korea
 Core Name: T1-3, 220053-3
 Investigator: CMC
 Date: 2-15-22

- few large entrapped air voids (2.5mm)
- hairline cracks

Cracks visible? - No cracks observed

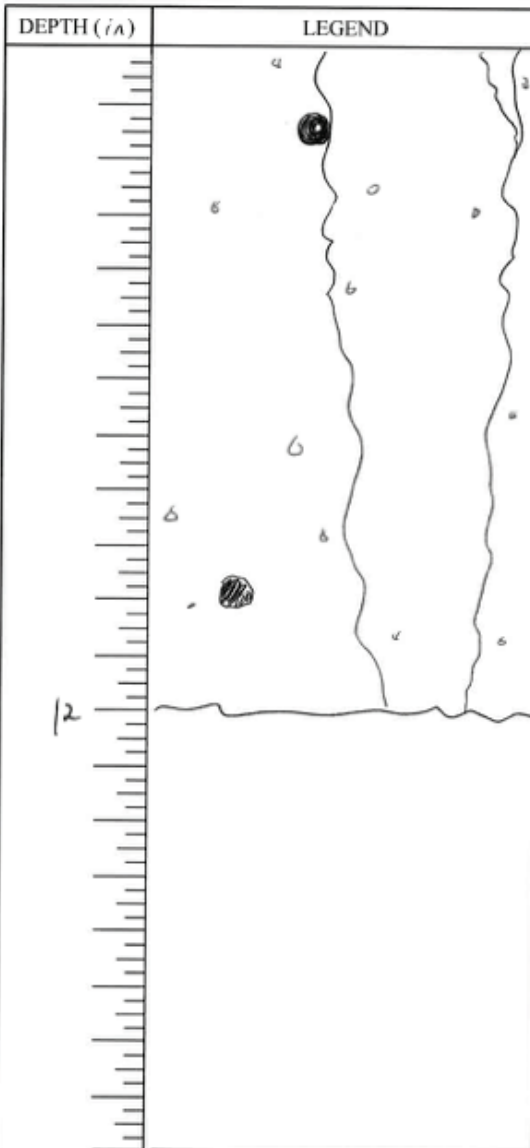
- large crack bisects surface (.4 - 1.5 mm)
- entrapped air voids

- Max. aggregate size - 1 1/4"
- Aggregate type -
- Max. entrapped air size - 0.5 cm
- Cracks visible? - yes, surface crack extends w/ depth & bisects the core.
- width is 0.5 mm - 2.5 mm
- rebar present
- crack bisects some CA
- relatively high percentage of elongated CA

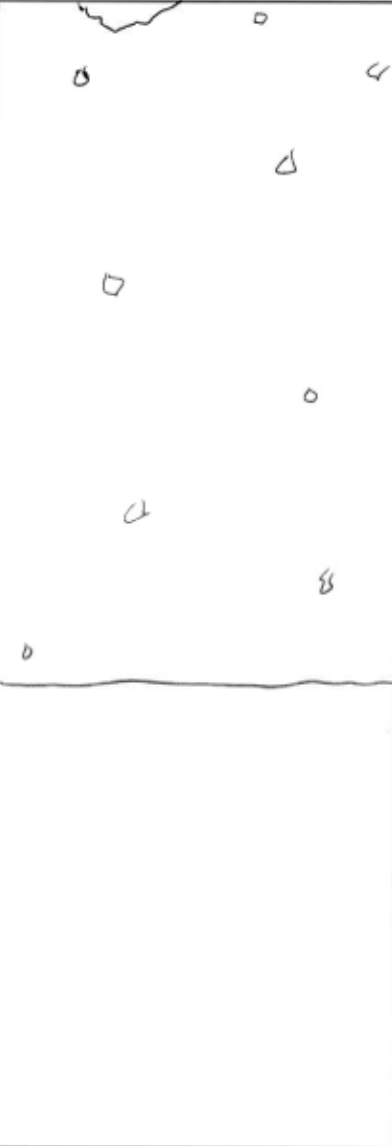
Max. aggregate size - <i>1"</i> Aggregate type - Max. entrapped air size - <i>0.5 cm²</i> Cracks visible? <i>None</i> - CA phase percentage is very low, potential segregation or mix design issues
		TESTS

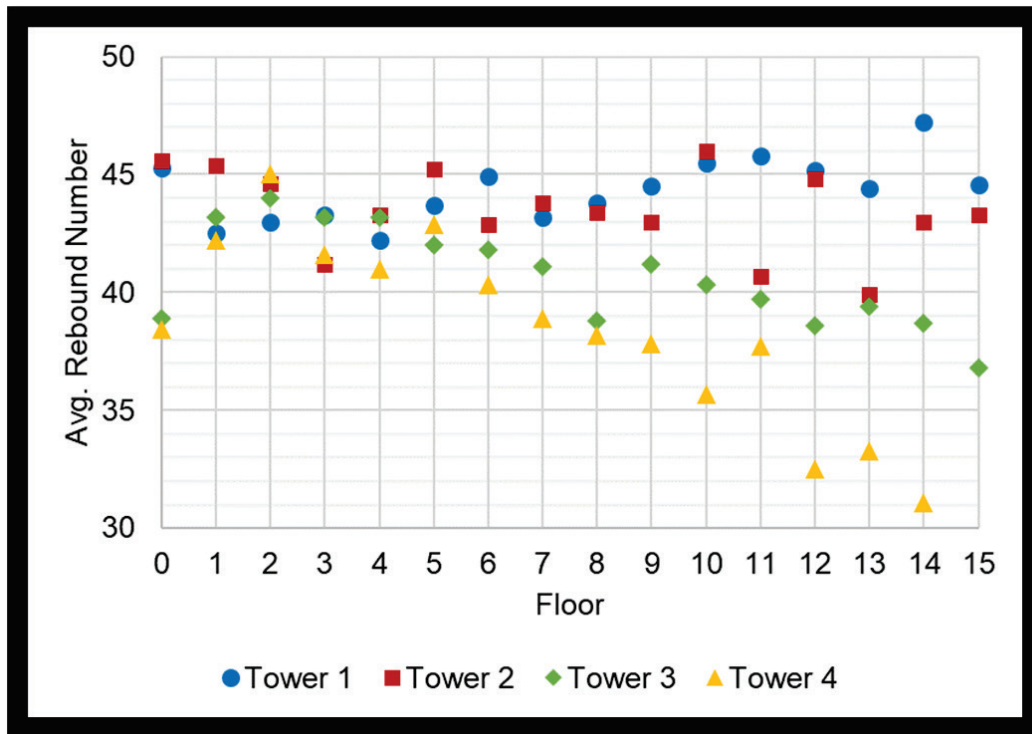
Figure D1. Average rebound numbers obtained on each floor for each tower.

generally decreased as the floor level increased. Both of these trends can be attributed to the respective ages of the concretes.

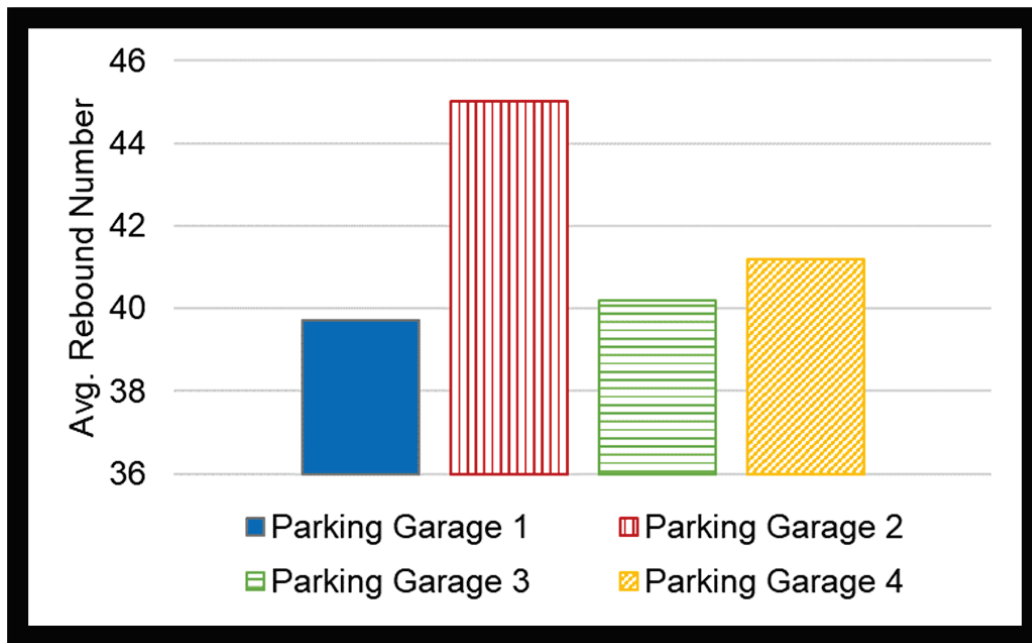
Figure D2. Average rebound numbers obtained in each parking garage.

Rebound hammer tests were performed on bare concrete in beams, girders, and columns in the parking garages. The average rebound numbers obtained are shown in Figure D2. All values ranged between 38 and 47, and there appeared to be no trend regarding the age of the concretes. Overall, rebound numbers in Parking Garage 2 were higher than in the other parking garages.

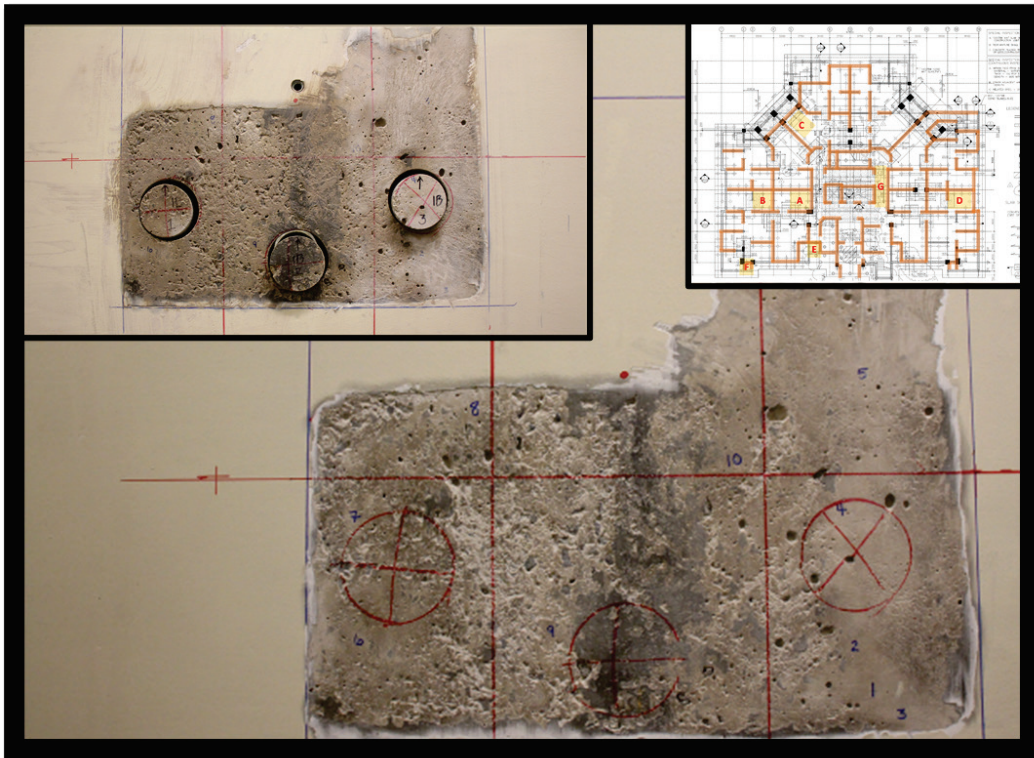
Two areas in the basement of Tower 1 were cored—one area deemed to be representative of the concrete quality throughout the structure and one area containing a cold joint within a shaft. Three 3-in.-diam cores were taken from the representative area of Tower 1. Figure D3 shows the prepared and cored area.

Figure D3. Prepared and cored (upper left insert) area of representative concrete in Tower 1. Red lines indicate locations of internal reinforcement.

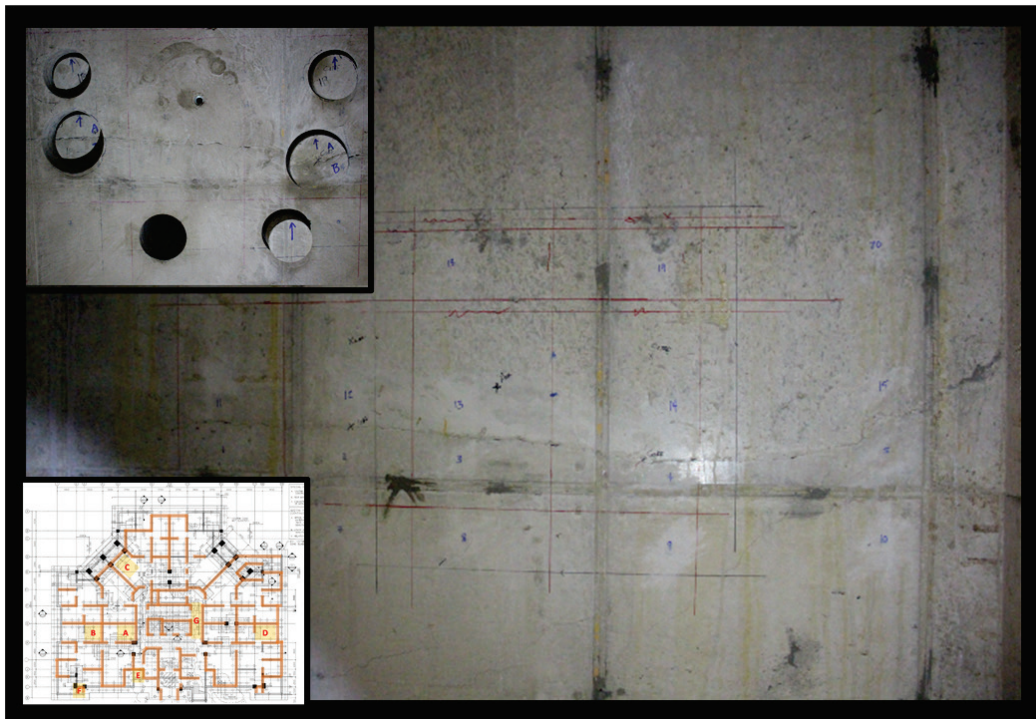
Figure D4 shows the prepared and cored cold joint in Tower 1. Two 3-in.-diam compressive strength cores were taken both above and below the cold joint for compressive strength testing, and two 4-in.-diam cores were taken over the cold joint for petrographic analysis.

Figure D4. Prepared and cored (upper left insert) area of wall containing a cold joint in Tower 1. Red lines indicate locations of internal reinforcement.
