Report on Evaluation of Apartment Towers 1–4 and Parking Garages 1–4 at Camp Walker, Daegu, South Korea

April 2022

Final report

Prepared for Far East District, Pacific Ocean Division
U.S. Army Corps of Engineers
573 Bonney Loop, Building 525, Suite A300
Fort Shafter, HI 96858

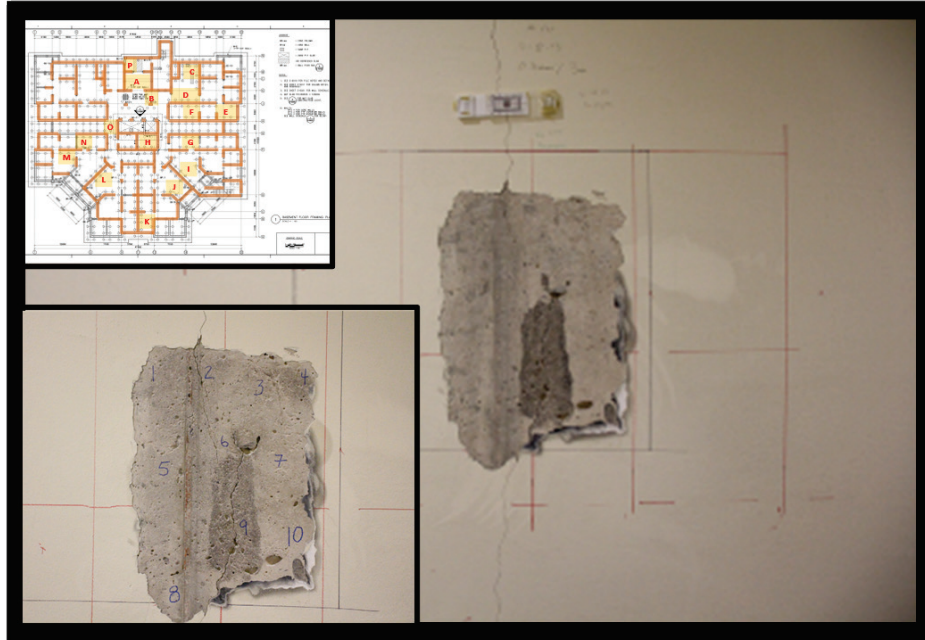
One area in the basement of Tower 2 was cored to provide two 3-in.-diam cores for compressive strength testing and one 4-in.-diam core taken over a crack for petrographic analysis. The crack was 0.4 mm wide and was selected for coring primarily to determine whether or not cracks of this magnitude penetrated the full depths of the walls. Another crack was visible in approximately the same location on the opposite side of the selected wall. Vertical reinforcement was located behind the crack by the GPR device. After coring, it was confirmed that the crack did in fact penetrate the full depth of the wall, and the assumption was made that the other cracks of this magnitude did as well. The cored area of Tower 2 is presented in Figure D5.

Figure D5. Prepared area for concrete coring in Tower 2. One core was taken over the crack, and two cores were taken to the sides of the crack to be representative concrete samples. Red lines indicate locations of internal reinforcement. Insert shows Schmidt hammer locations.

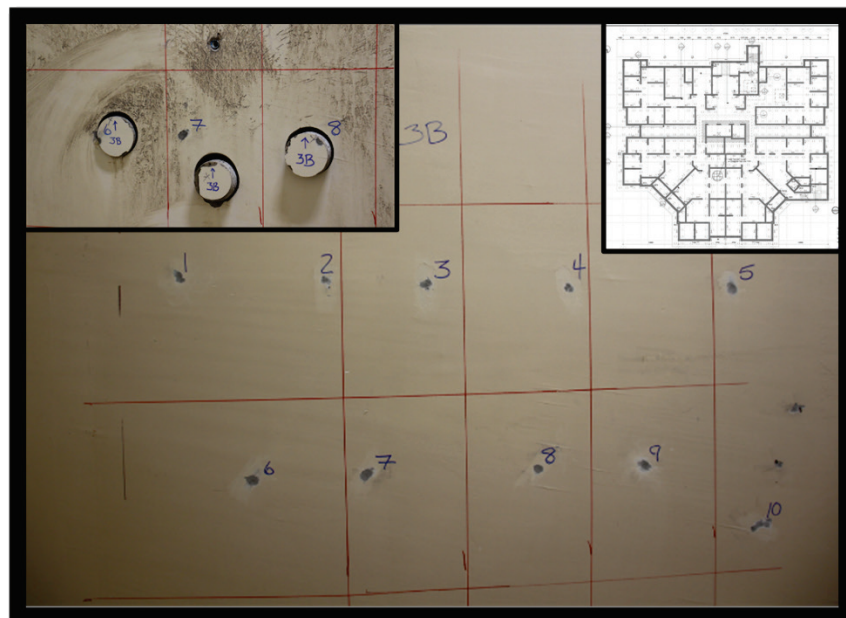
One representative area of Tower 3 was cored to provide two 3-in.-diam cores for compressive strength testing and one 3-in.-diam core for petrographic analysis. Figure D6 shows the prepared and cored area of Tower 3.

Figure D6. Prepared and cored (insert) area of representative concrete in Tower 3. Red lines indicate locations of internal reinforcement and numbers represent locations of Schmidt hammer testing.
