FINAL REPORT:

Kauai Source Restart 2021

APL-UW 2021 Kauai Cable Repair Support Trip Report

16 June - 30 June 2021

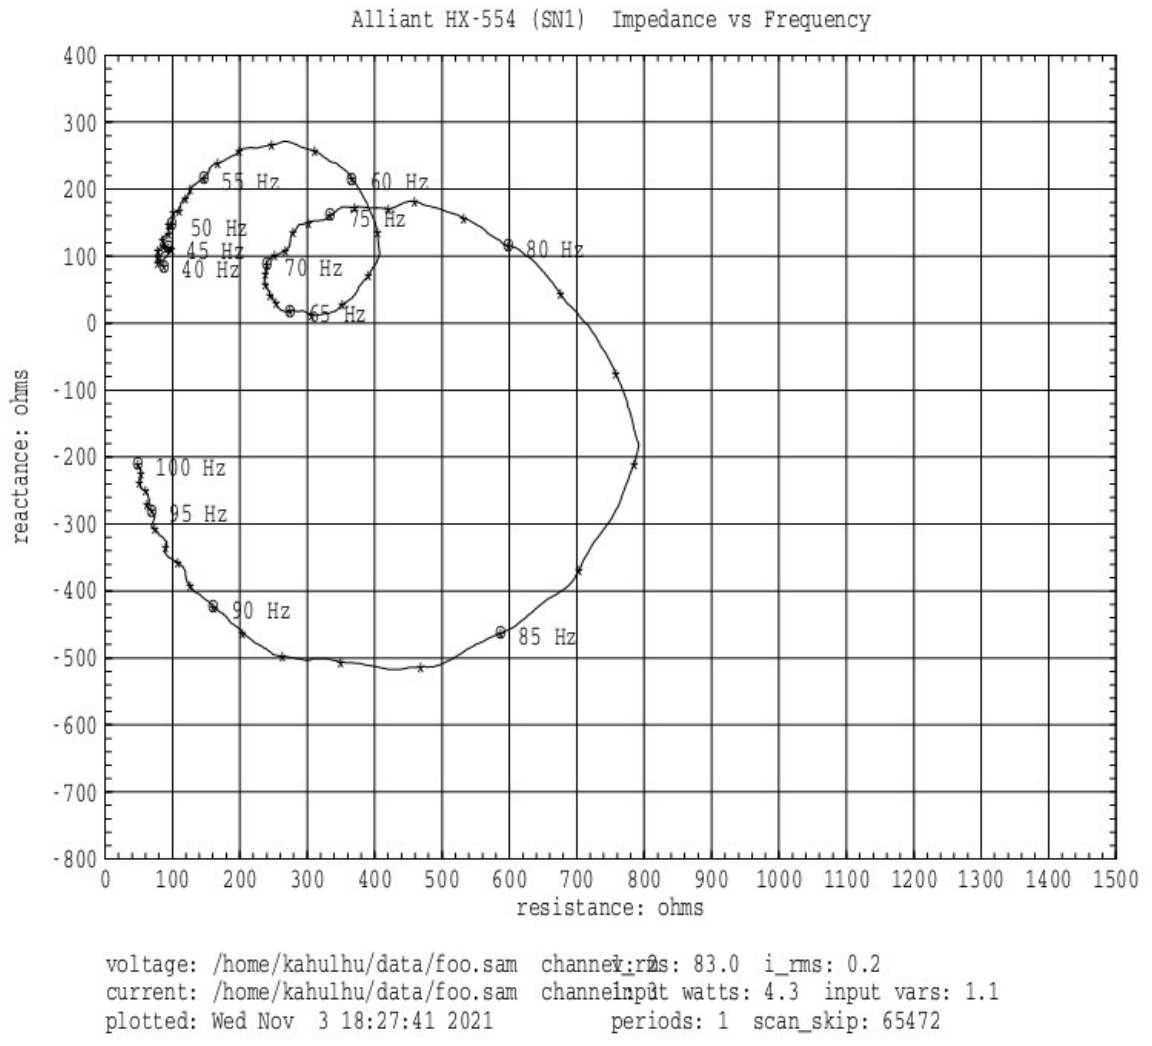
and admittance measurements made after final testing are shown in Figs. 1 and 2, respectively.

Figure 1: Capture cth1635963931 impedance loop.

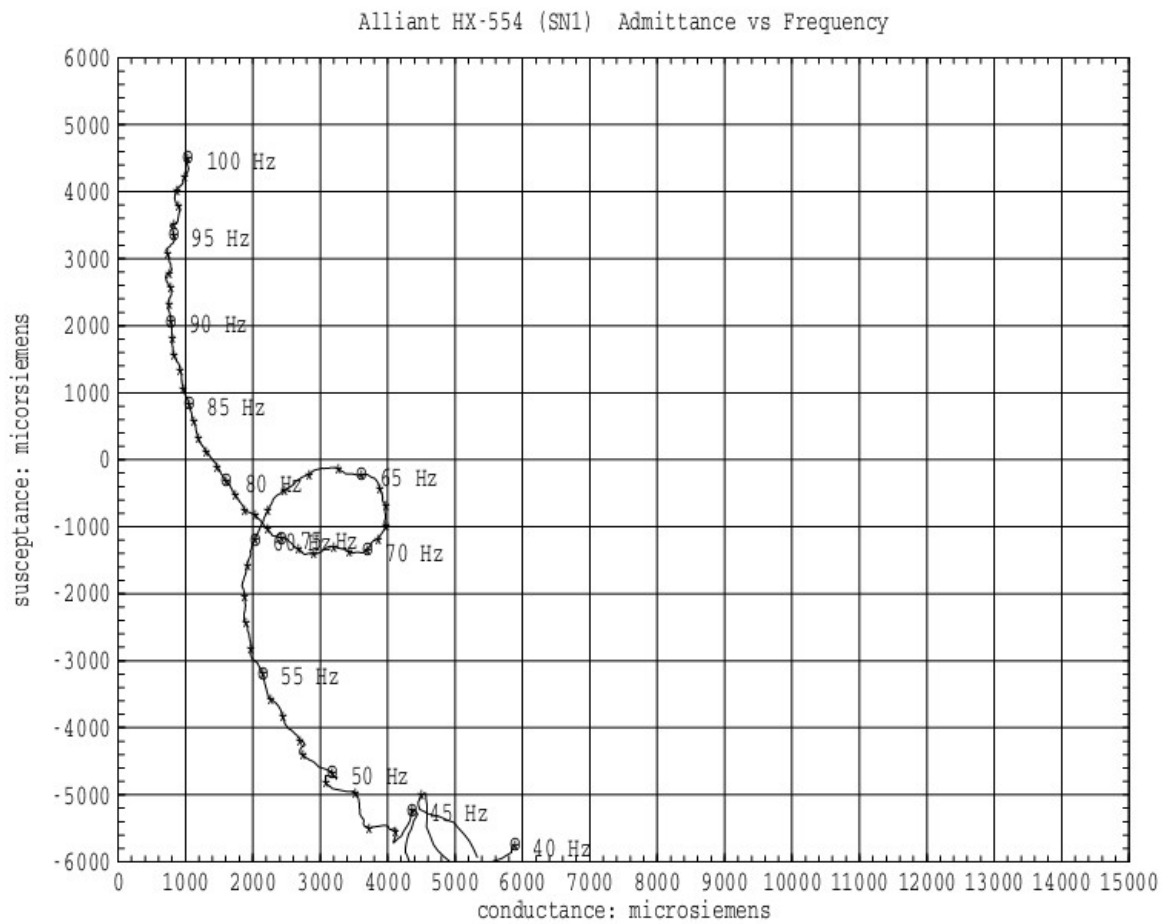
Figure 2: Capture cth1635963931 admittance loop.

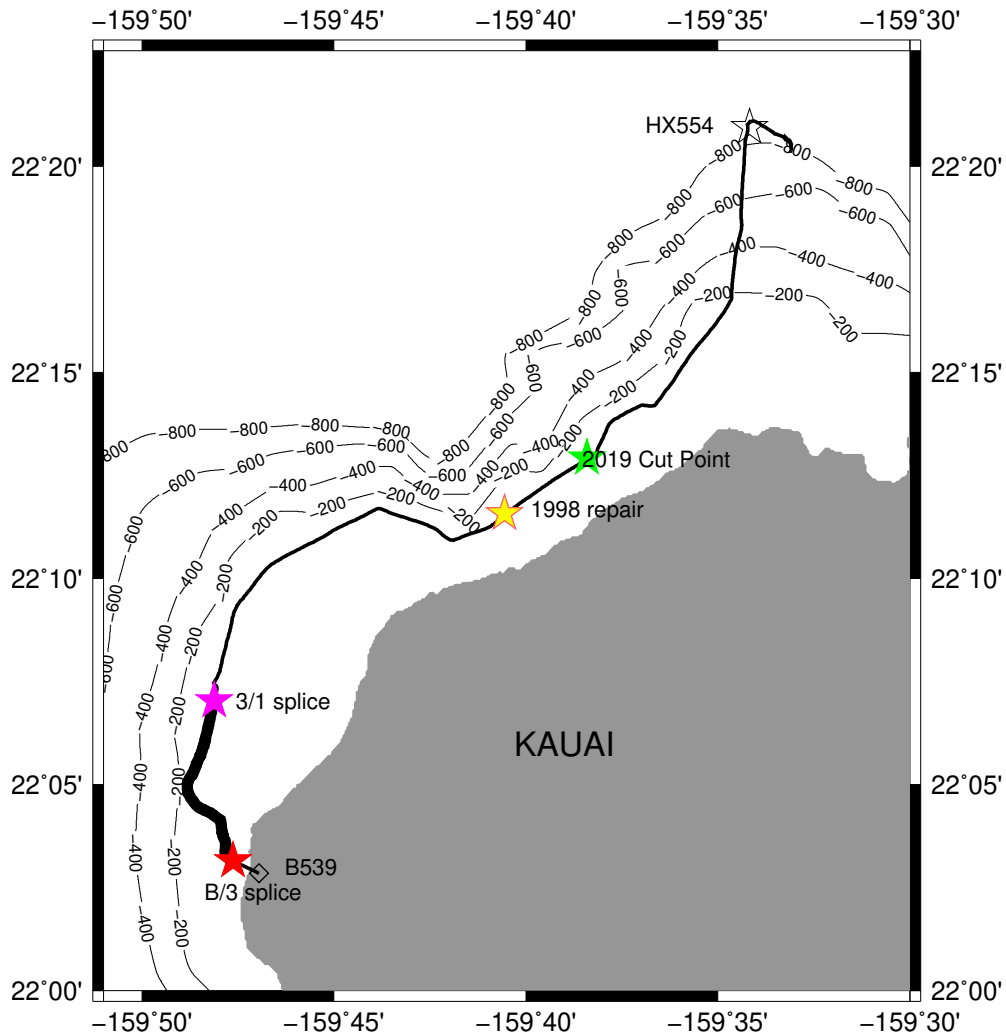
The entire cable (Fig. 1) consists of multiple segments; nomenclature for these segments is shown in Table 1. Measurements from the Cal Lab in 2016 indicated a shorted fault several hundred meters seaward from the BSUREB77/SDL3 splice. At the start of this effort, the fault had migrated shoreward to the splice.

Figure 1: Entire in-water cable route. The armored SD list 3 cable section is shown with a heavy black line. The unarmored SD list 1 cable shown with a normal black line. The magenta star indicates the SD3/SD1 splice. The yellow star is the site of the 1998 fault. The green star is the site of the 2019 test. The very short segment from hut 539 to the SDL3 armored cable is the “BSUREB77 string”. The red star is the splice from the BSUREB77 cable to the SDL3 cable.

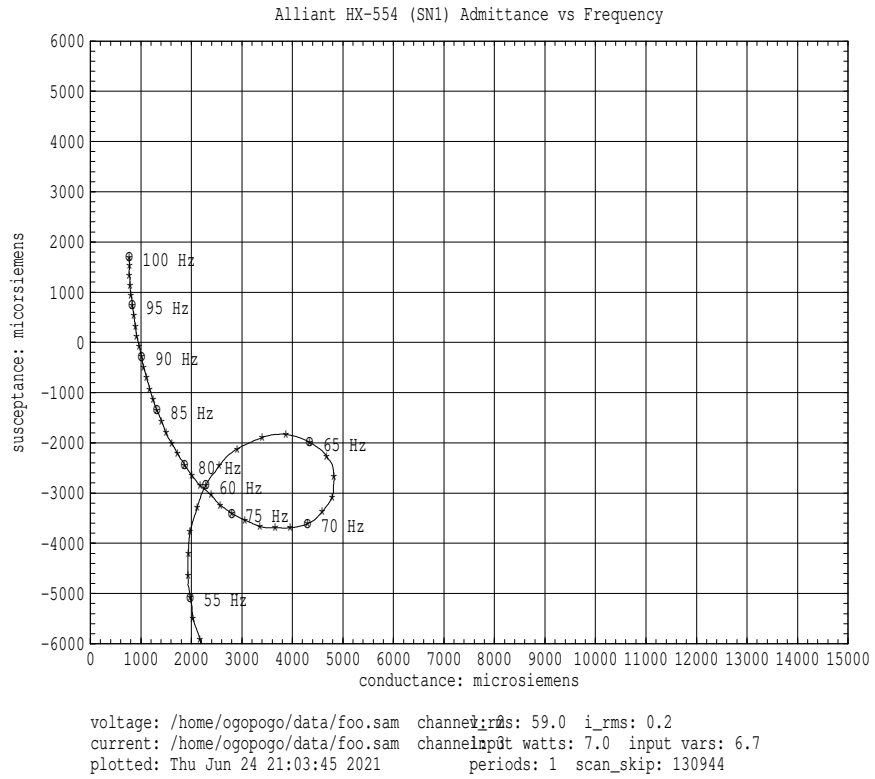
Admittance and impedance loops were captured for each transmission. In all cases, the loops resembled each other. Example admittance and impedance loops are shown in Fig. 3 and Fig. 4, respectively.

Figure 3: Measured admittance loop captured aboard the C/S DECISIVE.

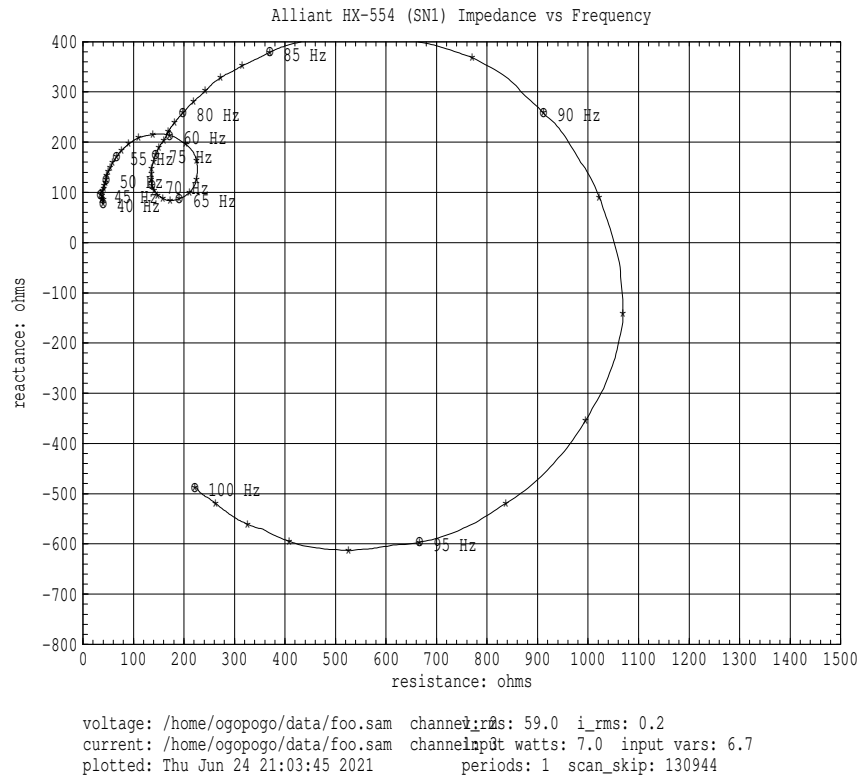
Figure 4: Measured impedance loop captured aboard the C/S DECISIVE.

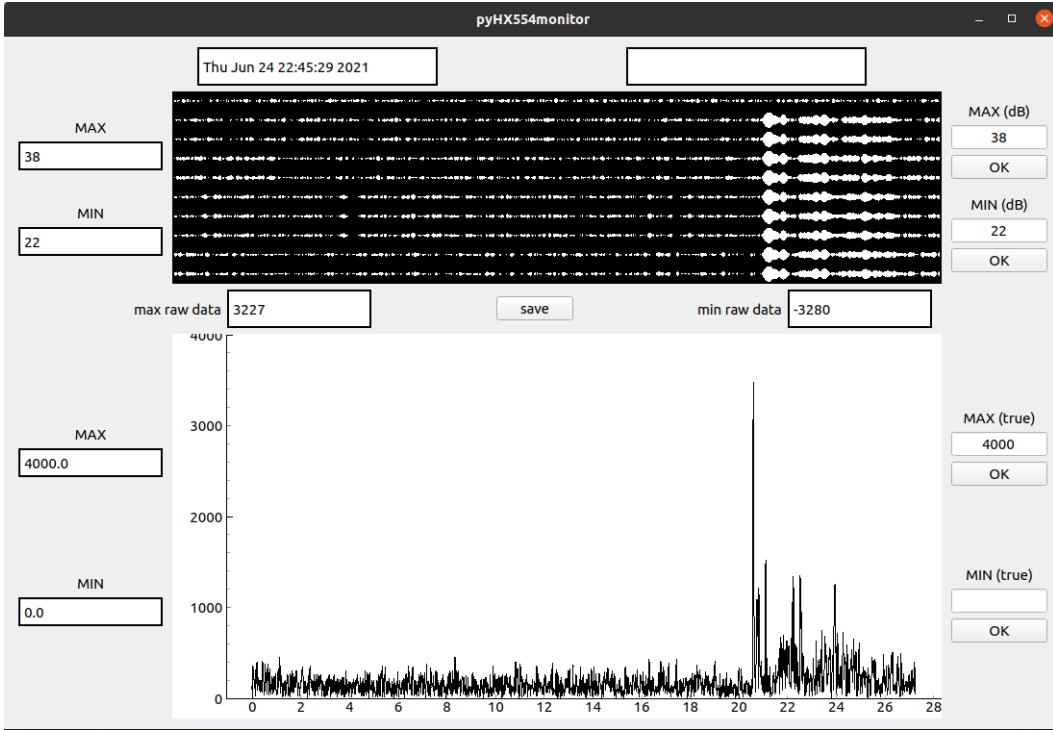
Figure 5: Screen capture of the presentation of code `hxmonitor.py` during a 185.4 dB transmission. The bottom panel shows the pulse-compressed signature of a single m -sequence. The top panel shows a scrolling, “lofargram-like” series of pulse-compressed data capture strips, with intensity rendered as white dot radius. The most recent arrival strip is the lowest strip, those above are older. One new strip every m -sequence period. The primary arrival occurs at roughly 20.5 s (arbitrary reference) in the bottom panel. If the “noise level” is eyeballed from the early part of the record to be 100, and the highest peak to be 3500, then the SNR is roughly $10\log_{10}(35) \approx 15$ dB.

The acoustic transmissions were clearly observed at the selected hydrophone; even the transmission at 177.4 dB was seen. A snapshot of the visualization output during one of the stronger transmissions is shown in Fig. 5.

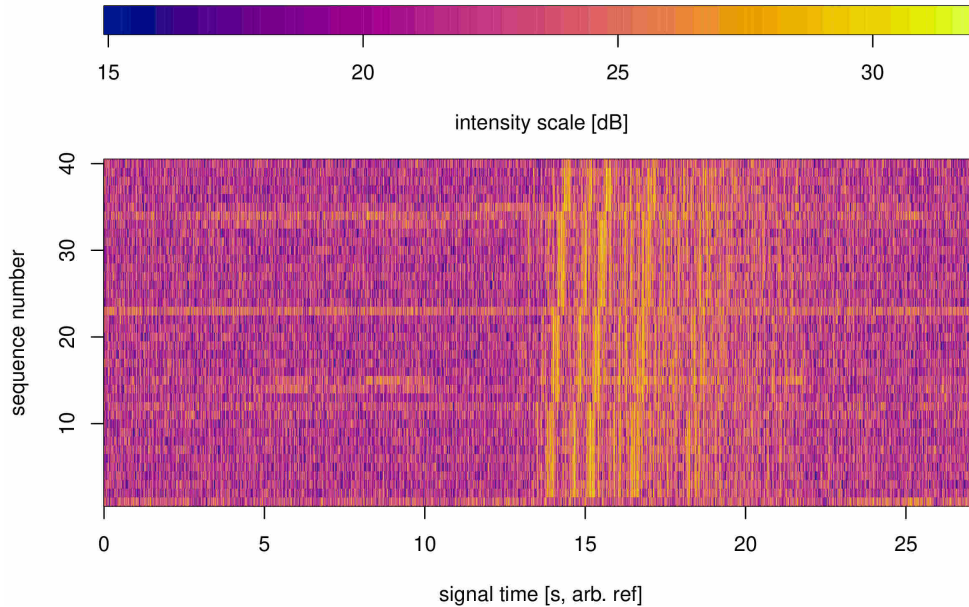
The acoustic transmissions were also monitored at the Aloha Cabled Observatory (ACO) (<http://aco-ssds.soest.hawaii.edu>) at $22^{\circ} 45'N$, $158^{\circ} 00'W$, at 4728m depth. ACO is roughly 176 km ENE of the HX554. The transmissions for 185.4 dB at 22:00:44 are shown in Fig. 6.

Figure 6: Transmission at 22:00:44 (185.4 dB) as captured on the deep hydrophone at ACO. The arrivals have about 9 dB SNR. Data courtesy Prof. Bruce Howe, UH.

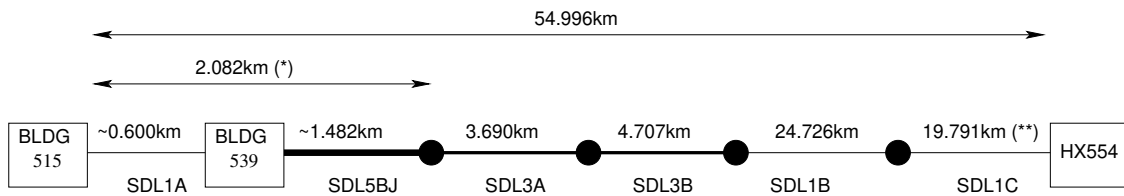
A diagram of the final cable configuration is shown in Fig. 9. This has been reproduced from Ref. 4. Notation in Fig. 9 is explained in Table 4.

Figure 9: Straight line diagram of the system after repair. Taken from Ref. 4. Black dots are splices made on the C/S DECISIVE. Notes: (*) Distance from BLDG 515 to the cable hut BLDG 539 is unknown. Total distance from BLDG 515 to the SDL5/SDL3 splice is 2.082 km (deduced from reflectometry.) (**) Distance from the last splice to the HX554 deduced from reflectometry.

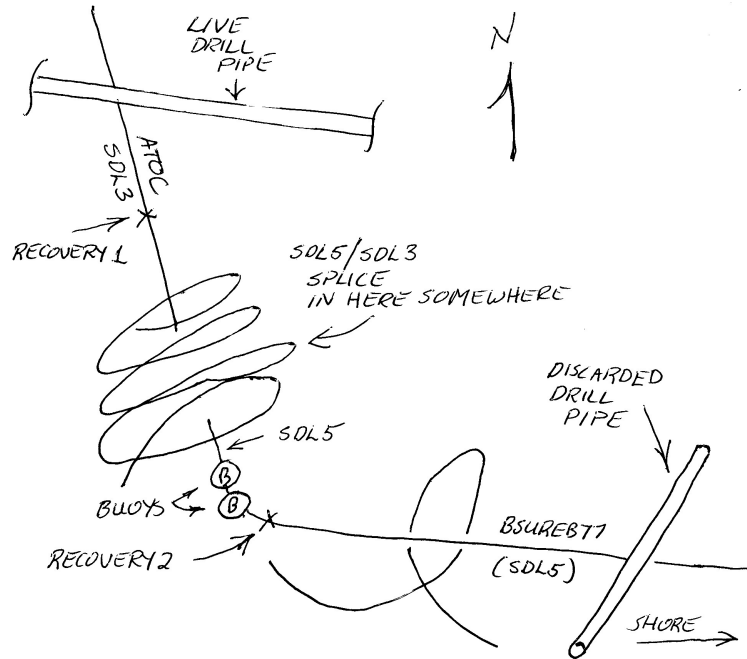
Transit to the seaward end of the BSUREB77 cable. ROV survey locates the two buoys marking the cable, but the buoys were adjacent to a big tangled mess of cables. Fig. 15 and Fig. 16. Concern over operating near the tangle persuades the crew to try to recover

Figure 15: Map of the BSUREB77/SDL3 splice area.

the fault from the seaward side of the tangle. (“RECOVERY1” in Fig. 15.) This turns out to be SDL3 cable; as expected, it was severely abraded in multiple areas. (Fig. 17.) Quite unexpected, a bitter end of the SDL3 is recovered; inspection suggests the cable had been cut. (Fig. 18.)

The C/S DECISIVE repositions to the two buoys and redeploys the ROV, cuts away the two buoys, and cuts the cable about a meter shoreward of the buoys. (“RECOVERY2” in Fig. 15.) The APL-UW shoreteam interrogates the cable seaward from the Cal Lab, and immediately detects a noticeable change; the distance to the first (and only) observable fault is shorter (by about 88.5 m, i.e., $0.89 \mu\text{s}$.) (See Fig. 7.) The largest gripper is deployed on the ROV, and is able to get a secure bite onto the cable. The cable is recovered to the deck. (Fig. 19.) Upon inspection, this cable is determined to be SDL5BJ. (Fig. 20), i.e., the BSUREB77 shorecable. This cable is interrogated shoreward, and is found to (still) be viable.

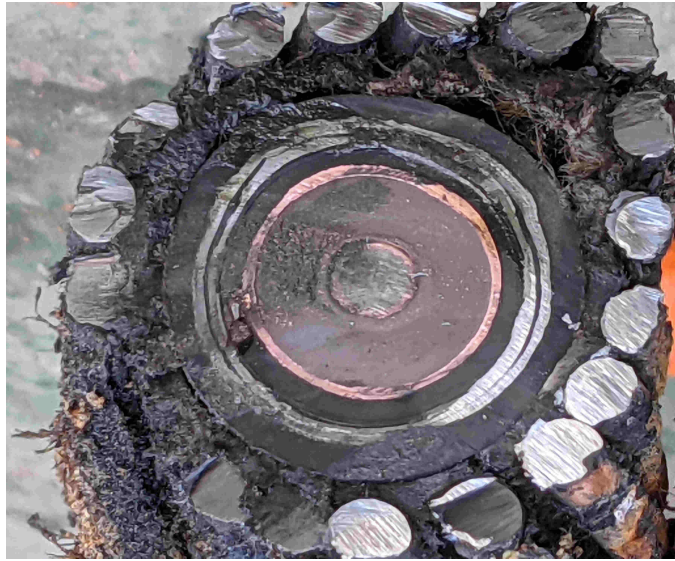
Figure 20: Cross-sectional view of the BSUREB77 shore cable.
