Regional Sediment Management (RSM) Program

Two Years of Post-Project Monitoring of a Navigation Solution in a Dynamic Coastal Environment, Smith Island, Maryland

June 2022

Final report

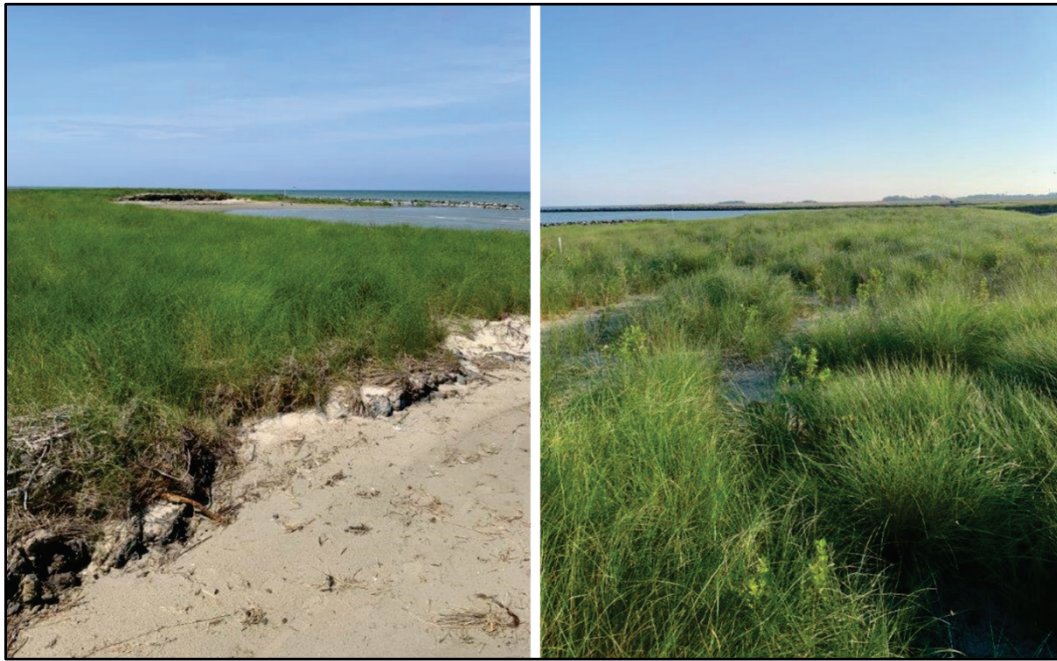
The placed dredged material included elevation zones designed and graded to support planted vegetation assemblages, including low marsh, high marsh, and hummock. Post-construction site visits noted that elevation zones were higher than nearby natural elevations for those plant assemblages and especially for the high marsh, which could lead to the establishment of invasive *Phragmites*. Site visits in October 2019 and June 2020 (Figures 13, 14, and 15) found that plants in place were generally healthy and establishing well. There was some loss of plants along the waterline in the intertidal zone, and an erosive scarp formed along a section of the placement area, behind the breakwaters.

Figure 14. Left: At south jetty looking south across placement site toward sill (June 2020). Right: South placement site looking north toward jetties (June 2020).

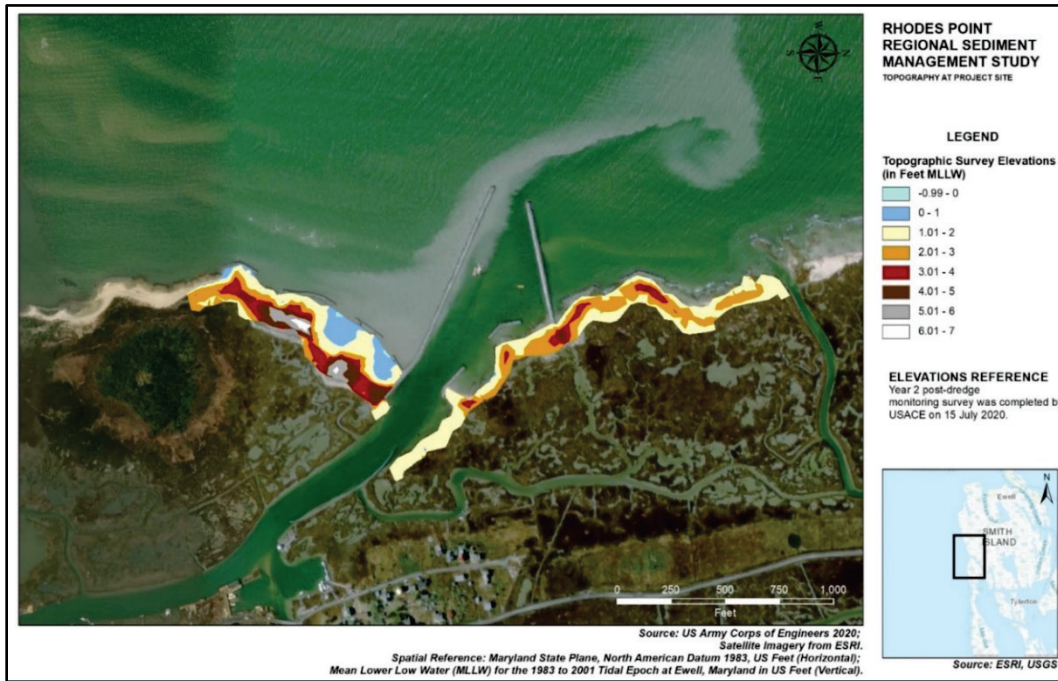
Figure 16. Topographic survey elevations from July 2020. Note the sediment plume coming off the placement site as the base image was taken prior to planting of the placement site in June 2019.

The current site topography is shown in Figure 16 and still largely reflects the as-built elevation ranges for the fill that was placed behind the sill south of the south jetty and on landward side of the north jetty. Post-placement changes in site elevation between July 2019 and July 2020 are shown in Figure 17. The placement area, especially landward, appears to be gaining elevation, mostly in the 0 to 1 ft range, but up to 3 ft in some locations. Overwash deposits were observed during site visits and presumably provided material to increase elevation in lower areas. It is possible that wind action could have acted to deposit sand at higher elevations, analogous to natural sand dunes. However, the gaps in the breakwater continue to allow for erosion of the south placement site through the gaps and behind the breakwaters (Figure 18). The scarped area also continues to erode and is labeled in Figure 18.

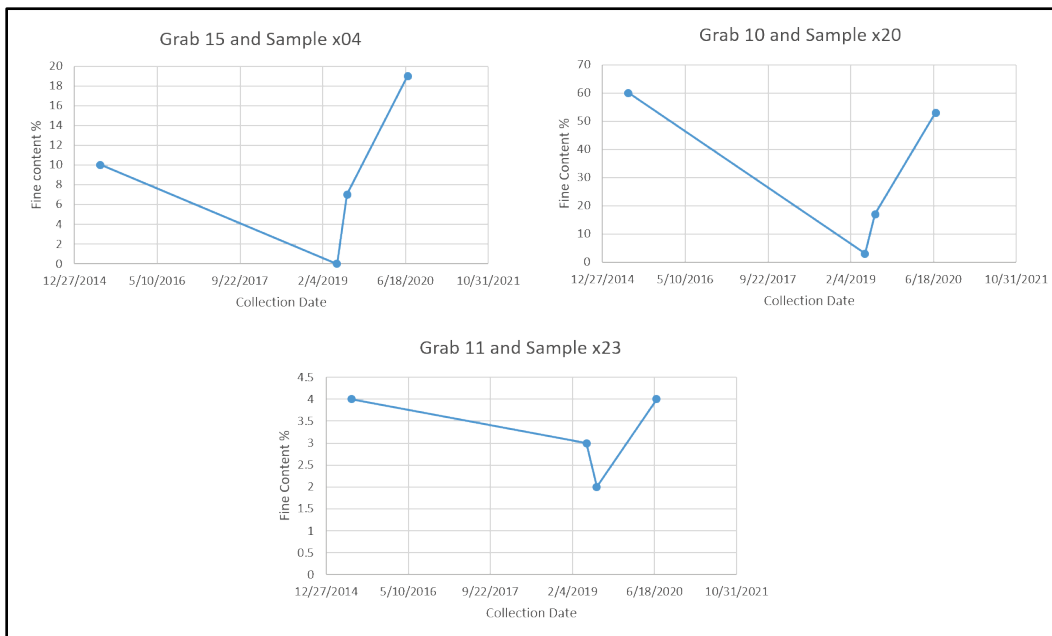
- Relatively high percentages of fine material composed the pre-construction samples that were taken in 2015. The percentages of fine material (Unified Soil Classification System, grain size less than 0.075 mm) decreased significantly in the FY 2019 samples (first set of post-construction samples) as shown from example graphs in Figure 19. This is likely a result from the dredging that occurred in 2018. Fine sediments are more likely to be agitated and removed/disturbed during dredging versus sediments that are more compact or larger grained.

Figure 19. Graphs showing grain size changes over time for grab samples taken in 2015 (Grab 15, 10, and 11) and samples taken in May 2019 (Samples 104, 120, and 123), July 2019 (Samples 120, 220, and 320), and July 2020 (Samples 123, 223, and 323) at the same location.

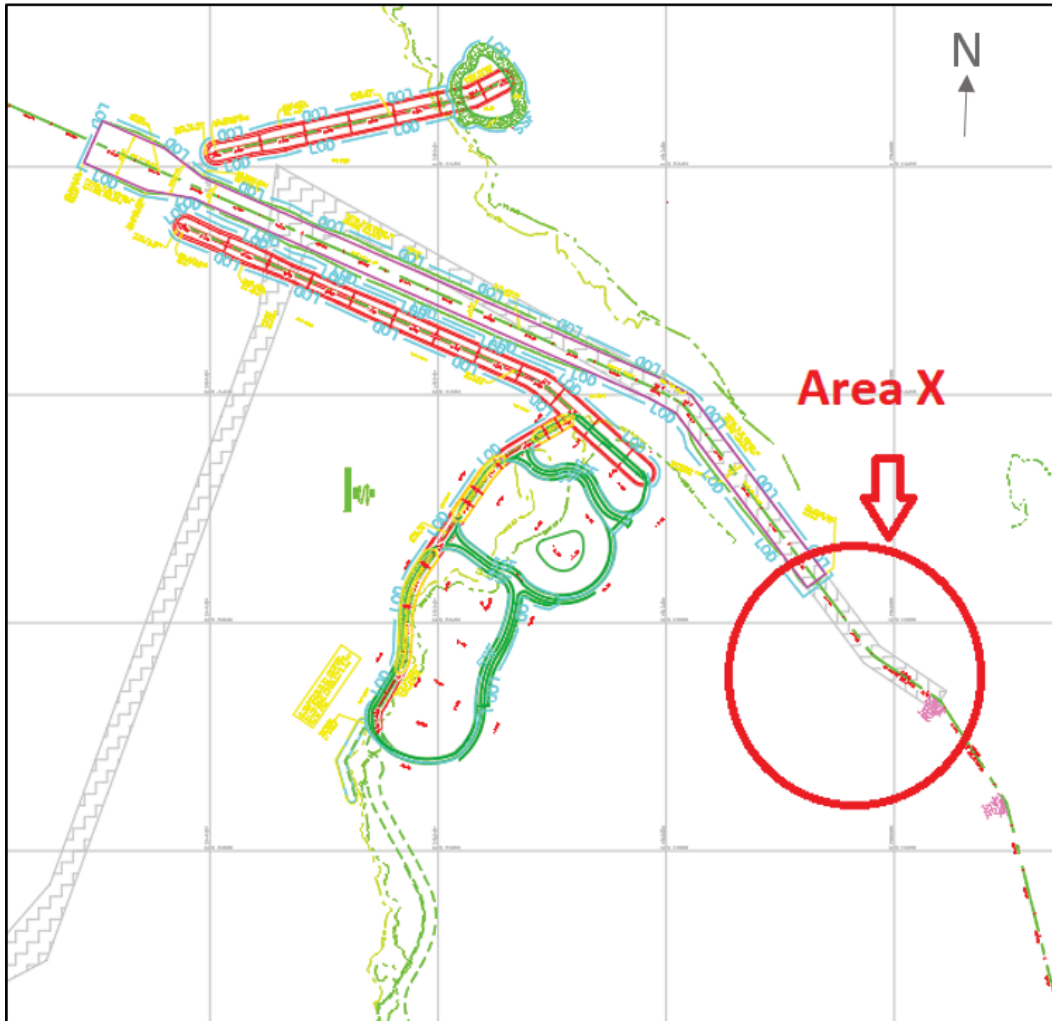
Figure 21. Location of Area X described in the text.

- From February 2019 to July 2020, fine contents remained stable, or where there is a trend have generally increased (Figure 20). Increased deposition of fine material generally represents locations of reduced wave energy.
- For samples x20 (e.g., 120, 220, 320) and x21, shown as Area X (Figure 21) inside the southeast extent of the channel, grain size shifted from silt (grain size less than 0.075 mm) to coarse sand (grain size less than 4.75 mm; 2% fine content) immediately following dredging and has since become siltier (53% and 70% fine content, respectively), possibly representing re-sedimentation within the channel and/or reduced wave energy.

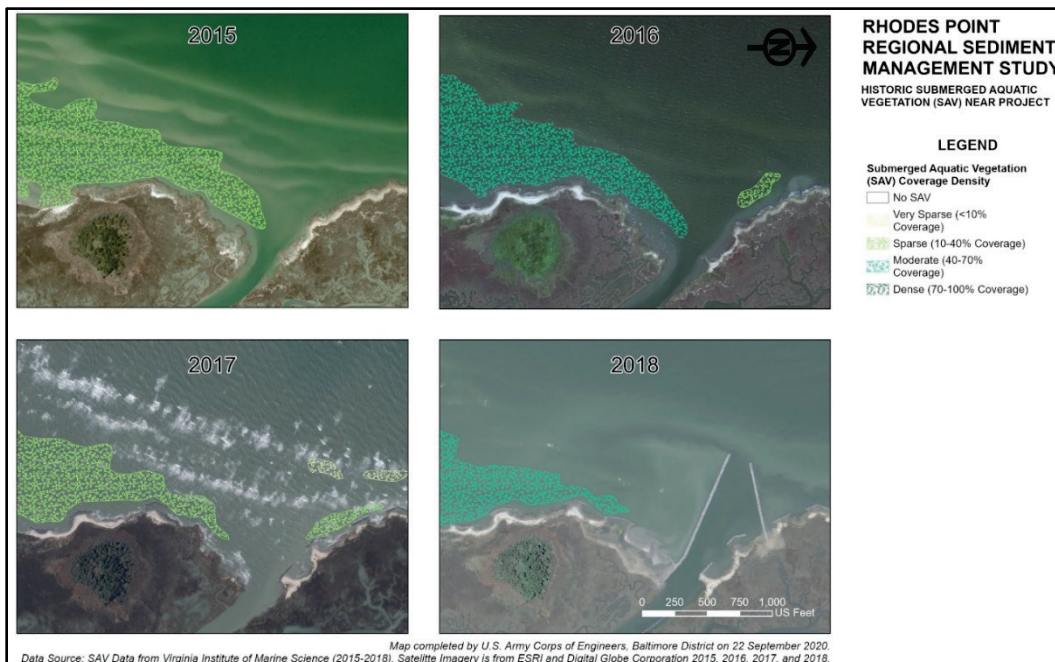
Figure 23. 2015–2018 occurrence of SAV as documented by VIMS (VIMS 2020).

A total of 13 transects (numbered 1–10 in the project footprint; 11–13 in the reference area) was surveyed in June and August 2020. Figure 22 shows SAV monitoring transects and results. No SAV was found in the project area during the June and August 2020 surveys while both *Ruppia maritima* and *Zostera marina* were found during both surveys in the reference area. For comparison with 2020 monitoring data, Figure 23 shows SAV presence as determined by VIMS (VIMS 2020) for 2015 to 2018, prior to project construction. Both SAV species were documented along the southernmost transects within the project area (transect 9 and 10) during the June 2019 survey but were absent in 2020. Because transects 9 and 10 had SAV during the first growing season following the channel realignment, it is assumed there was not physical disturbance along those transects, and current SAV absence is not due to the realignment project. Absence of SAV in transects 9 and 10 may be representative of ongoing local changes in SAV distribution. The VIMS aerial surveys (VIMS 2020) report SAV coverage receding in a southerly

direction from the channel since 2016/2017, prior to the channel realignment (Figure 23).
