Baseline Data for a Cedar Tree Revetment Monitoring Site near Wichita, Kansas

PURPOSE: This US Army Corps of Engineers (USACE) National Regional Sediment Management technical note (RSM-TN) documents baseline data collected at a cedar tree revetment installation on a small creek near Wichita, KS. These data can be used in subsequent years to add to the understanding of the longevity, effectiveness, and failure modes of cedar tree revetments as bank stabilization.

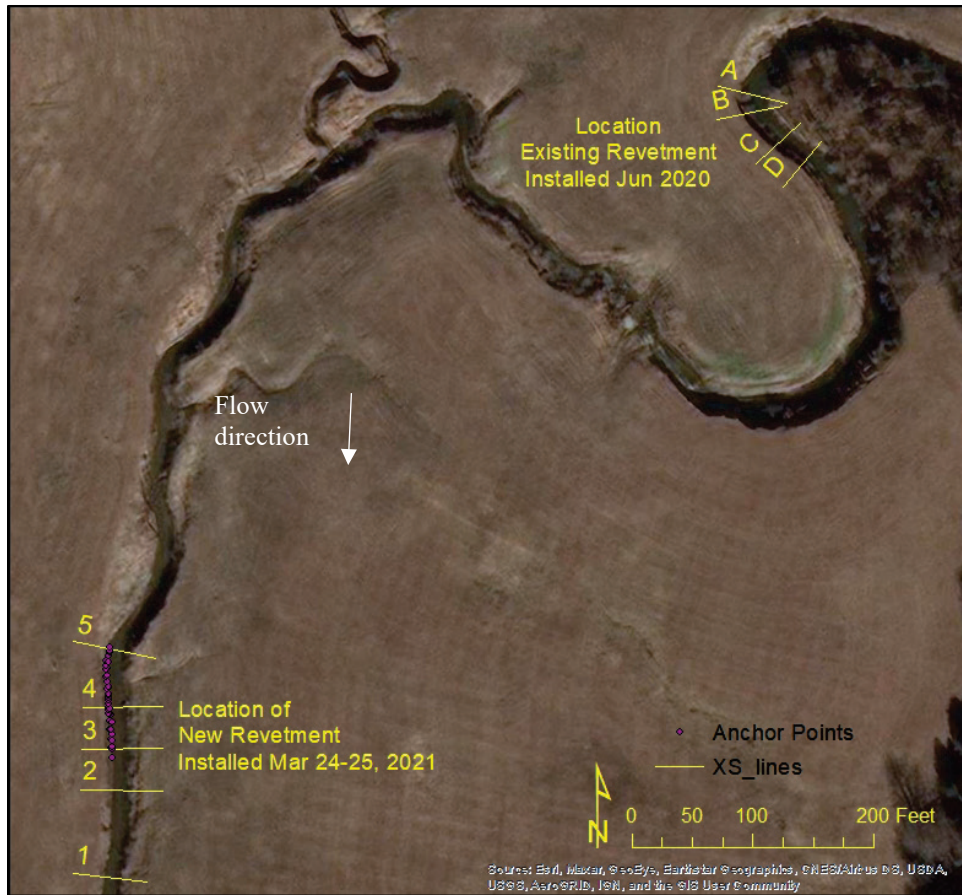
Cross-Sectional Measurements. Five cross sections were collected at the site of the new revetment to monitor streambank erosion and geomorphic changes that might contribute to revetment failure (see the lower left corner of Figure 6.) Table 1 provides the data, with the point name indicating the cross-section number (1–5) from downstream to upstream. Cross section 1 is approximately 100 ft (30 m) downstream from the revetment. Cross section 2 is just barely downstream of the revetment. Cross section 3 crosses Tree #2 (the second from the downstream). Cross section 4 crosses in the middle of the revetment, which also coincides with bank erosion pins installed by Dr. Charles Barden during revetment installation. Cross section 5 crosses near the upstream end of the revetment.

Figure 6. The locations of the cross sections collected at McConnell Creek. Five cross sections were collected at the downstream site, and four were collected at the upstream site. Upstream cross sections are labeled A through D while downstream cross sections are labeled 1 through 5.
