2021 Guided Wave Inspection of California Department of Water Resources Tainter Gate Post-Tensioned Trunnion Anchor Rods

Oroville Dam

December 2022

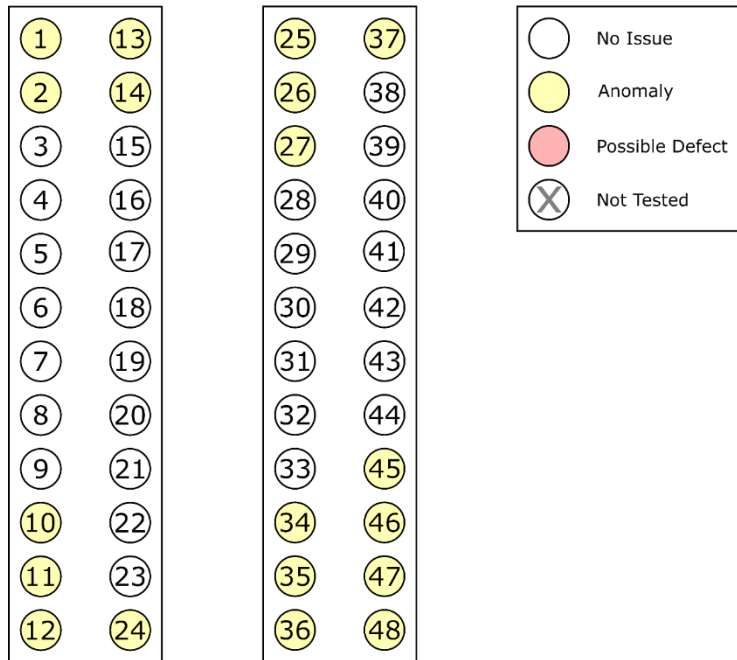
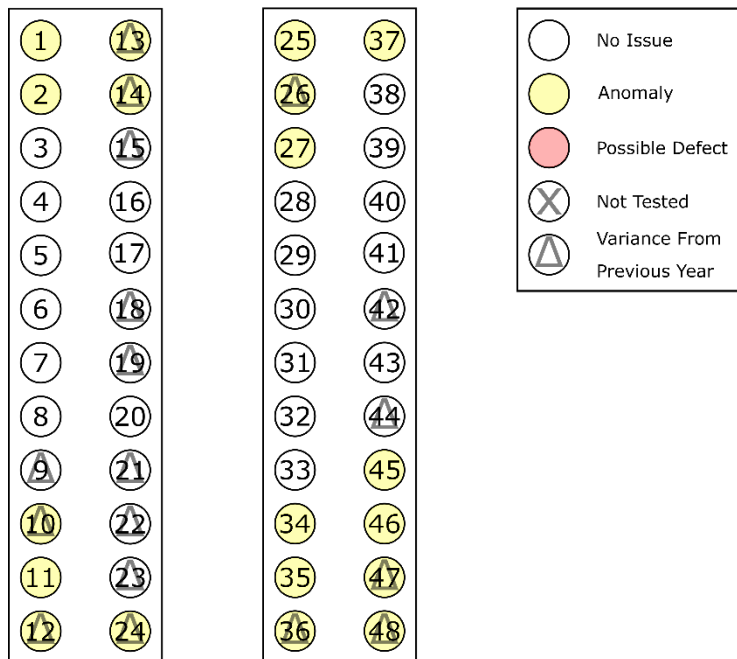
Figure 4. Gate 1—2021 results compared to 2020 results.

Figure 4 through Figure 11 provide an overview of the results on a rod-by-rod basis, giving a rating of No Issue, Anomaly, Possible Defect, or Not Tested. Rods given the Not Tested rating were not possible to test due to the cut of the rod being too short to attach the transducer. An additional category was added this year, Variance from Previous Year, which is explained following the figures.
