# Underwater Carbon Fiber–Reinforced Polymer (CFRP)–Retrofitted Steel Hydraulic Structures (SHS) Fatigue Cracks

*by Guillermo A. Riveros and Hussam Mahmoud*

**PURPOSE:** Recent advances in the use of fiber-reinforced polymers (FRP) to retrofit steel structures subjected to fatigue cracks have shown to be a viable solution for increasing fatigue life in steel hydraulic structures (SHS). Although several studies have been conducted to evaluate the use of FRP for retrofitting metal alloys and the promising potential of such has been well-demonstrated, the application has never been implemented in underwater steel structures. This Coastal and Hydraulics Engineering Technical Note presents the implementation of FRP patches to repair fatigue cracks at Old Hickory Lock and Dam miter gate.

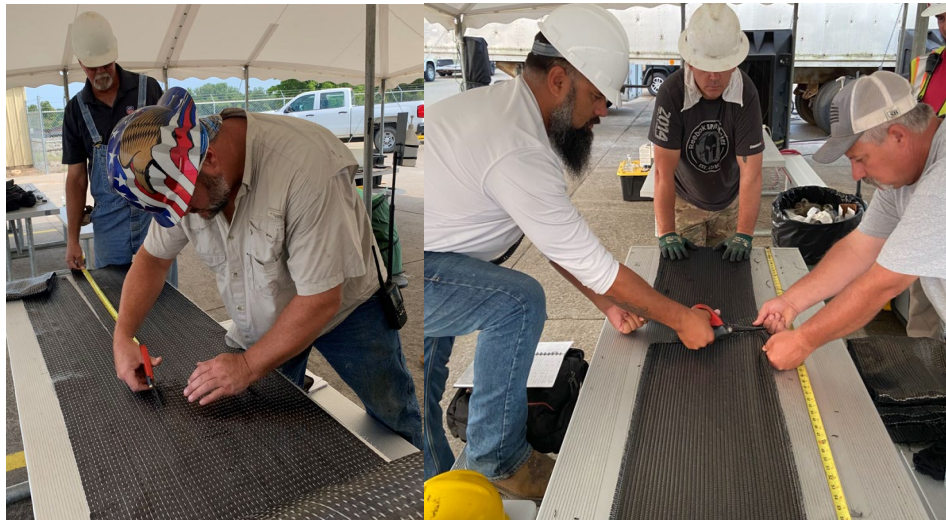
Figure 7. Cutting fibers to specific lengths. At left, CFRP. At right, basalt fibers.

- a. Fabric preparation. After inspection, precut all fabrics before mixing any epoxy. Cutting fiber 24 in to 36 in long (Figure 7) is preferred.
- b. Surface preparation. The required surface preparation is largely dependent on the type of element being repaired and strengthened. In general, the surface must be clean, dry, and free of protrusions or cavities, which may cause voids behind the Tyfo composite. Discontinuous wrapping surfaces (beams) typically require a sandblast, grinding, or other approved method to prepare for bonding. For SHS, the surface must be clear to the base metal. This can be accomplished either by grinding or sandblasting (preferable method) the surface and cleaning with acetone (Figure 8).

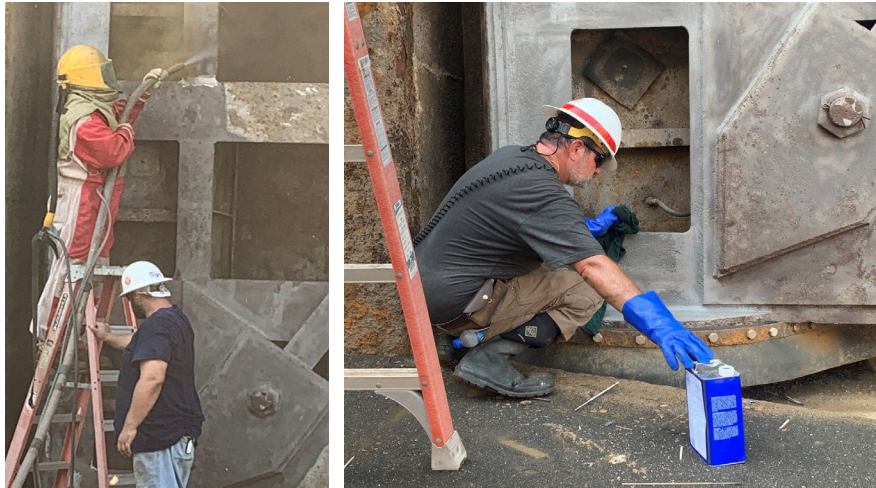
Figure 8. Sandblasting and cleaning the surface with acetone.

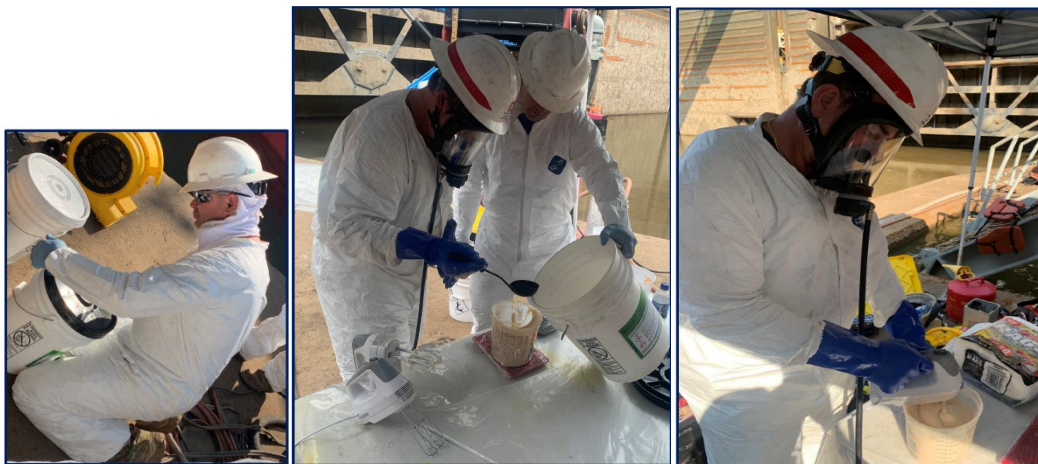
Figure 9. Mixing epoxy and adhesive.

- c. Mixing FYFE Tyfo S Epoxy. FYFE Tyfo S Epoxy is a two-component epoxy. The A component color is normally clear to amber with a thick consistency and slight resin smell. The B component is normally clear to yellow with a very thin consistency similar to water and has an ammonia-like smell. The FYFE Tyfo S Epoxy matrix material is combined with the FYFE Tyfo fabrics to provide a wet-layup composite system for strengthening structural members. Premix each component: 100 parts of component A to 34.5 parts of component B by weight. Mix thoroughly for 5 minutes with a low-speed mixer at 400 to 600 RPM until uniformly blended (Figure 9).

parts of component B by weight. Mix thoroughly for 5 minutes with a low-speed mixer at 400 to 600 RPM until components are thoroughly dispersed. Excessive mixing will shorten pot life (Figure 9).

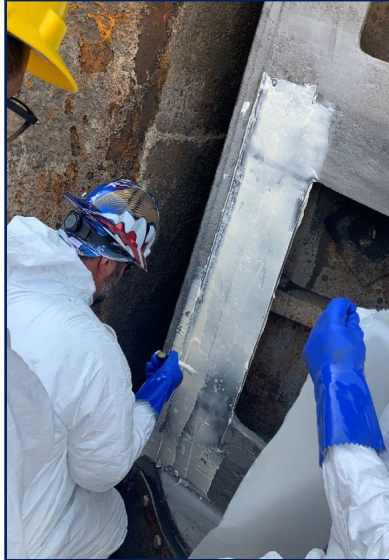
Figure 10. Adhesive application.

1. Apply adhesive to the clean surface (Figure 10).
  2. Install one layer of glass fiber (FYFE Tyfo WEB glass fabric) (Figure 11).
  3. Apply adhesive to the glass fiber.

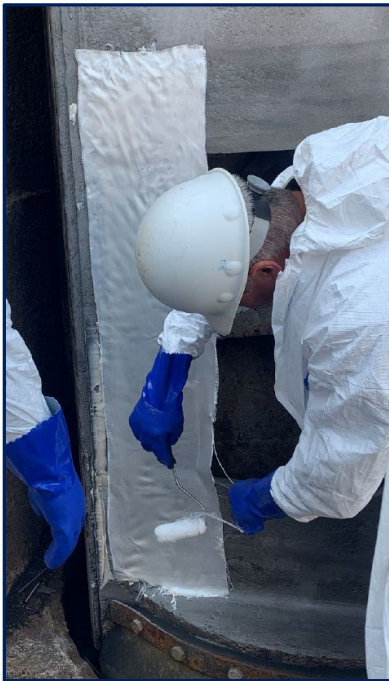
Figure 11. Glass fiber installation.

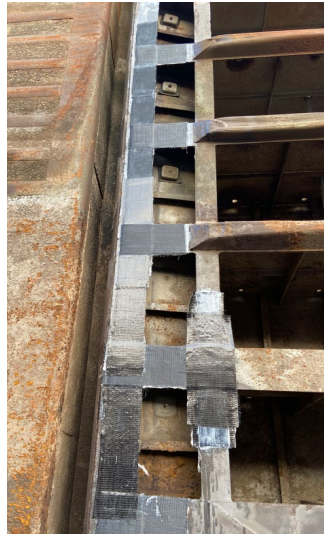
Figure 12. CFRP installation.

4. Carbon fiber saturation. It is recommended that Tyfo S is applied to one side of the carbon fiber with a roller. Then the semi-saturated layer of carbon fiber is applied to the glass fiber with adhesive. Once the carbon fiber is installed to the glass fiber, use a roller to complete saturation of the carbon fiber.

5. If a second layer of carbon fiber is needed, apply adhesive to the carbon fiber already installed, and apply Tyfo S to one side of the new carbon fiber layers with a roller. Once the carbon fiber is installed to the carbon fiber, use a roller to complete saturation of the carbon fiber (Figure 12).
