Stormwater Management Practices, Monitoring, and Maintenance Plan for US Army Garrison at West Point, NY

Darixa D. Hernandez-Abrams, Bruce Pruitt,
Samantha R. Wiest, and S. Kyle McKay

April 2023

Final report

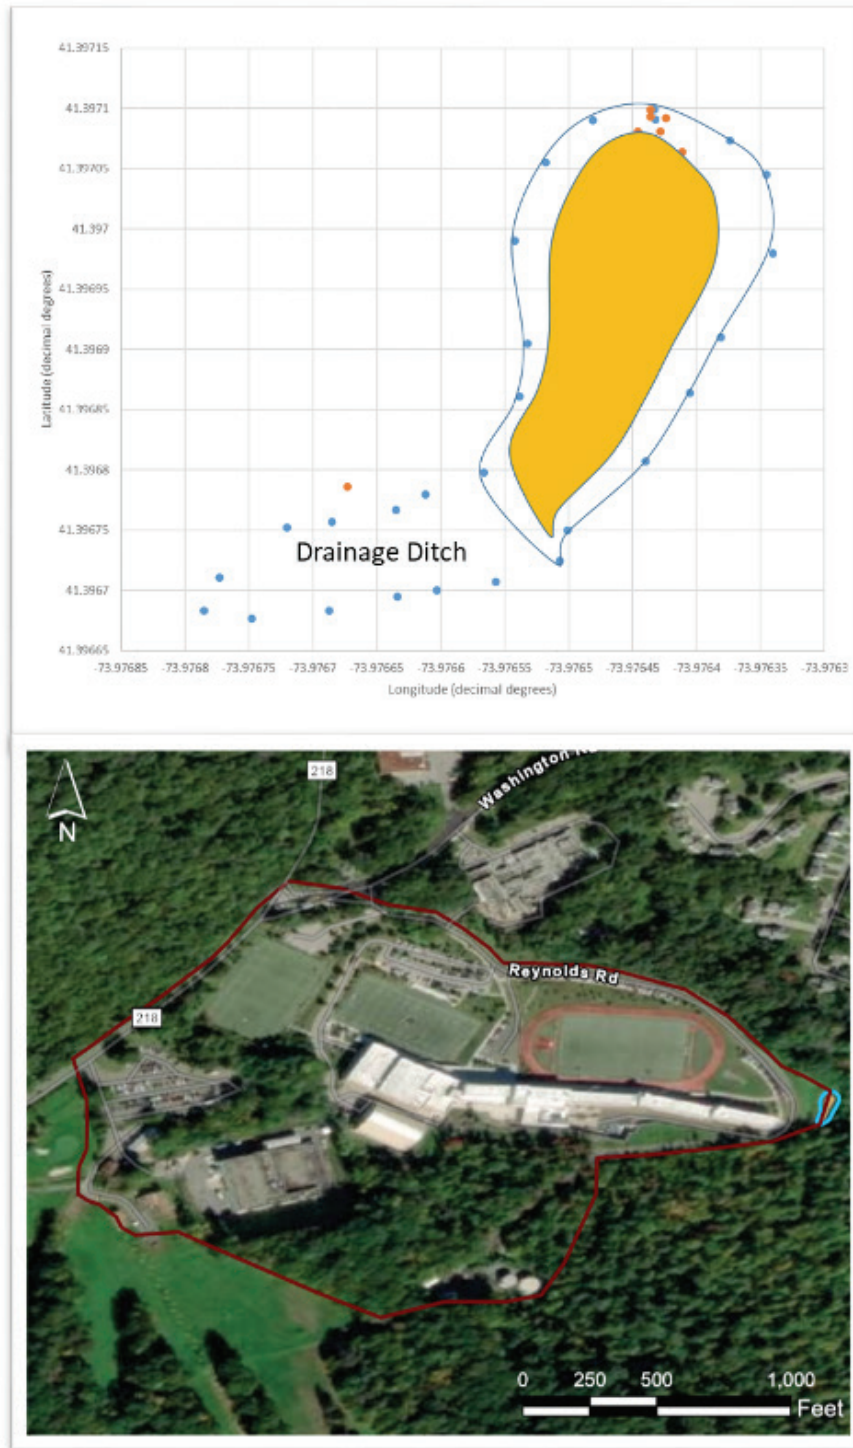
Figure D-3. USMAPS Detention Pond at Pipeline Trail off Reynolds Rd., US Military Academy, West Point, NY. GPS surface assessment (*top*), GIS-generated drainage area (*bottom*). Blue polygon on far right represents detention pond.

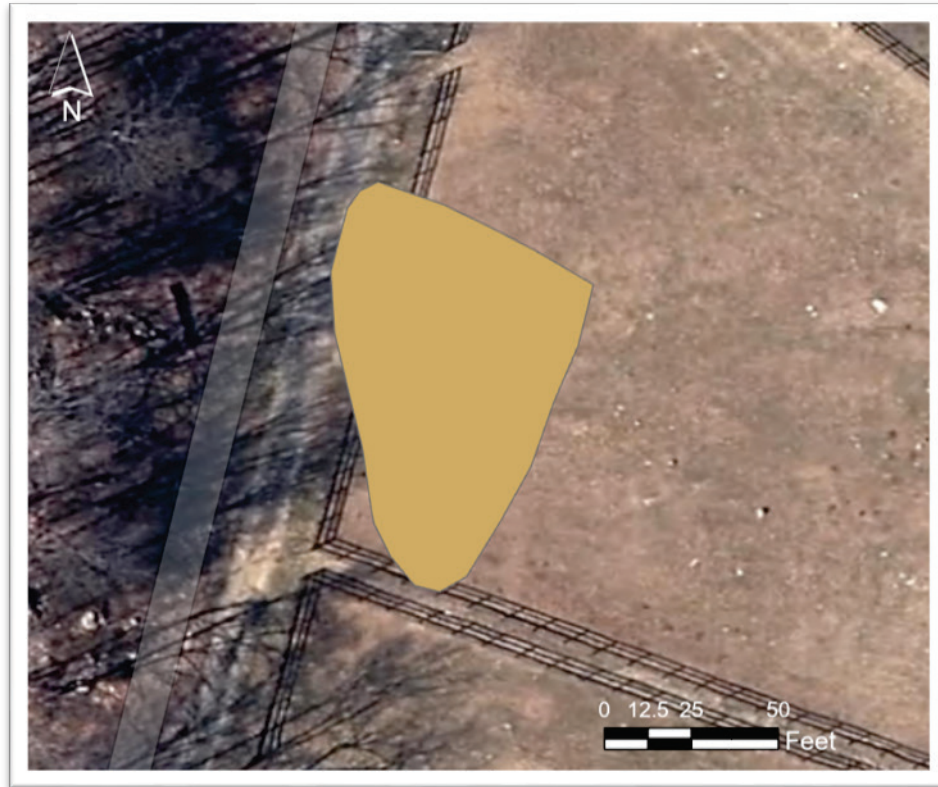
Figure D-6. Retention pond at West Point FMWR Morgan Farm Riding Stables and Kennel, US Military Academy, West Point, NY. Retention pond location and shape approximate due to recent GIS imagery not available.

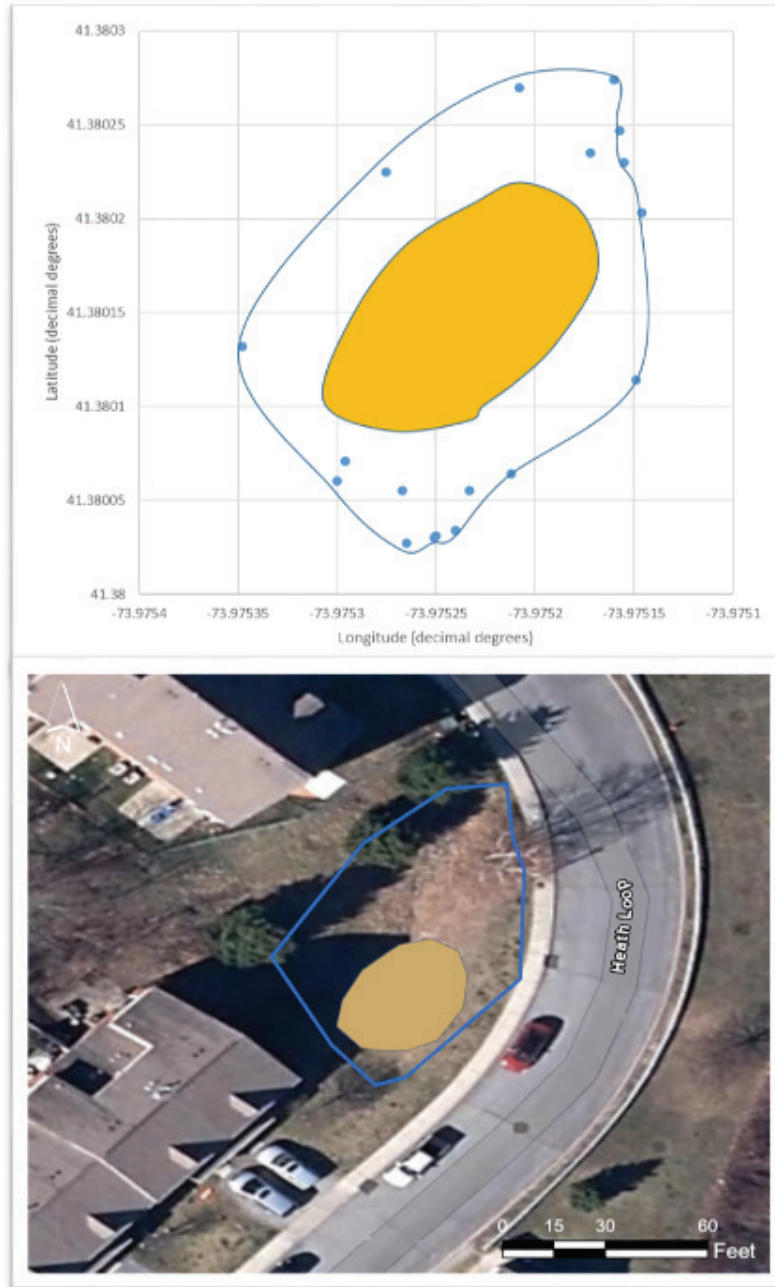
6.	DP_Heath_ OldRes_SE	41.380061, - 73.975291	Cantonment Heath Loop Old residential area south-east	(1) Pond with grass and shrubs bottom	Trash and debris Vegetation litter Overgrown veg Clogged inlets/outlet and riser Erosion around inlet Erosion on banks Maintenance access blocked Missing grate on outlet

Figure D-10. Southeast detention pond at Heath Loop residential area on Heath Loop Rd. off W. Continental Rd., US Army Garrisons, West Point, NY. GPS surface assessment (*top*), GIS assessment (*bottom*). Note detention pond depicted by blue and yellow polygon.

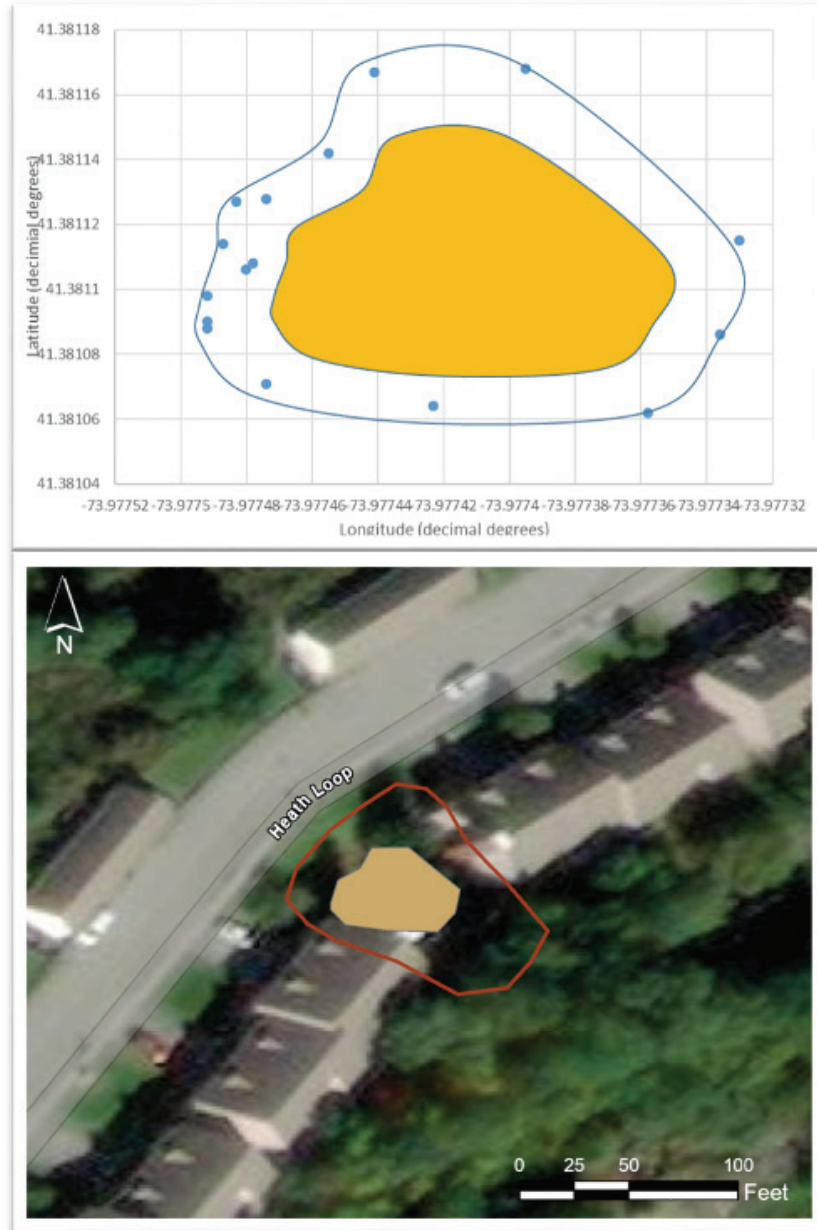
7.	DP_Heath_ OldRes_NW	41.381089, - 73.977434	Cantonment Heath Loop Old residential area north-west	(1) Pond with grass bottom	Missing grate on outlet
8.	DP_Heath_ OldRes_W	41.380311, - 73.977841	Cantonment Heath Loop Old residential area west	(1) Pond grass bottom with cobble for erosion control	Erosion around outlet Clogged inlets/outlets

Figure D-12. Northwest detention pond at Heath Loop residential area on Heath Loop Rd. off W. Continental Rd., US Army Garrisons, West Point, NY. GPS surface assessment (*top*), GIS assessment (*bottom*). Note detention pond depicted by blue and yellow polygon.

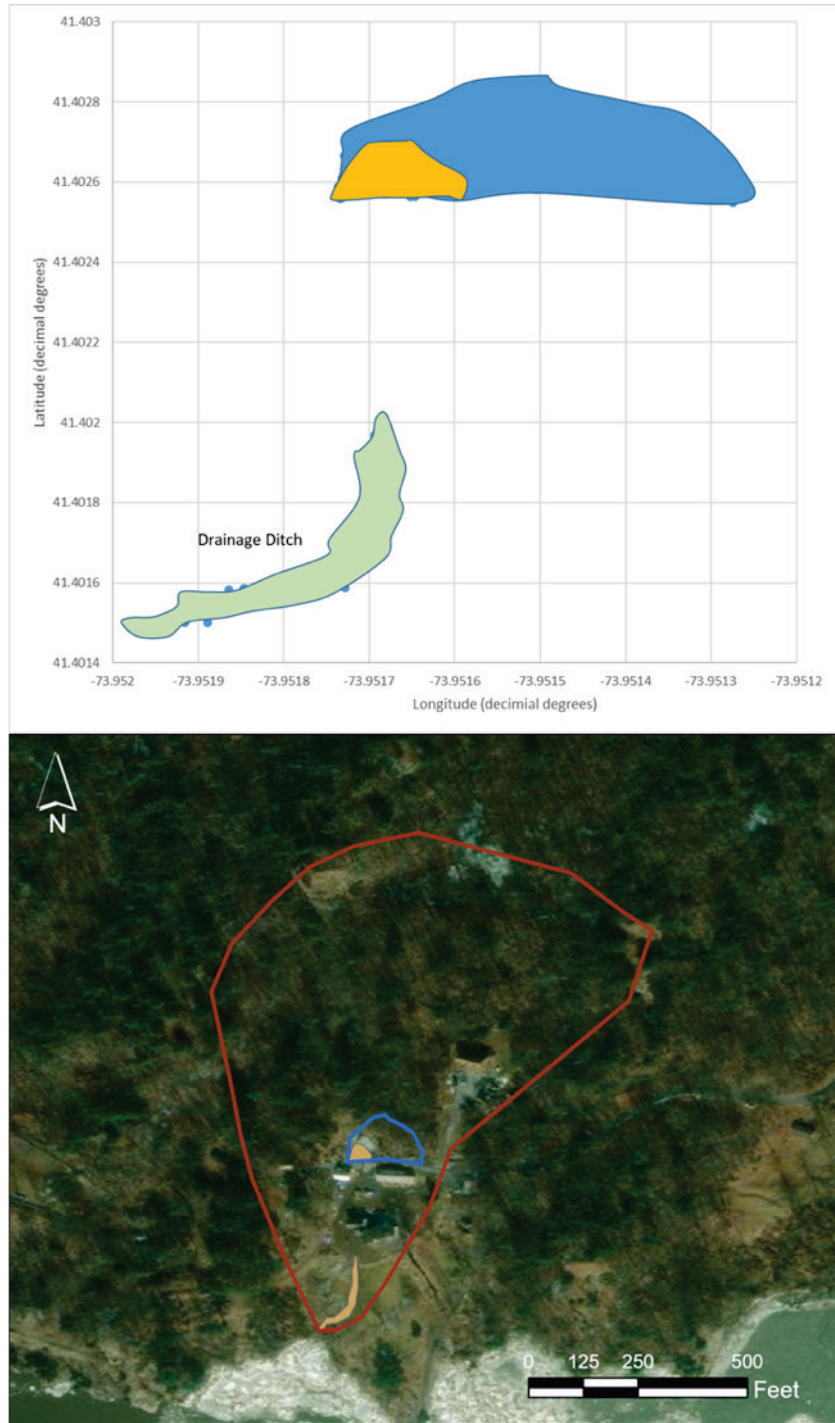
The wetland is approximately 0.31 acre-ft. The entire watershed is approximately 11.2 acres which includes the entire drainage to the Hudson River confluence (Table D-2). Hydric soils were observed in the wetland. The soils were 1 to 3 in. deep and characterized as a silt clay loam, angular to subangular blocky, firm, and color 10YR 4/1. The diversity of hydrophytes in the wetland exceeded all the other basins surveyed during this technical study (Table D-1). Even though the botanical survey was not comprehensive, ten plant species were observed not including plants outside of the permanently inundated area. Because of the uniqueness of this wetland area and the direct connection to the Hudson River, this area should be preserved. Introduced (invasive) species should be mechanically removed (e.g., *Ailanthus altissima*).

Figure D-13. Impounded wetland area on Constitution Island near Cold Spring, US Military Academy, West Point, NY. GPS surface assessment (*top*), GIS assessment (*bottom*). Note wetland and immediate catchment area depicted by yellow and blue polygons, respectively.

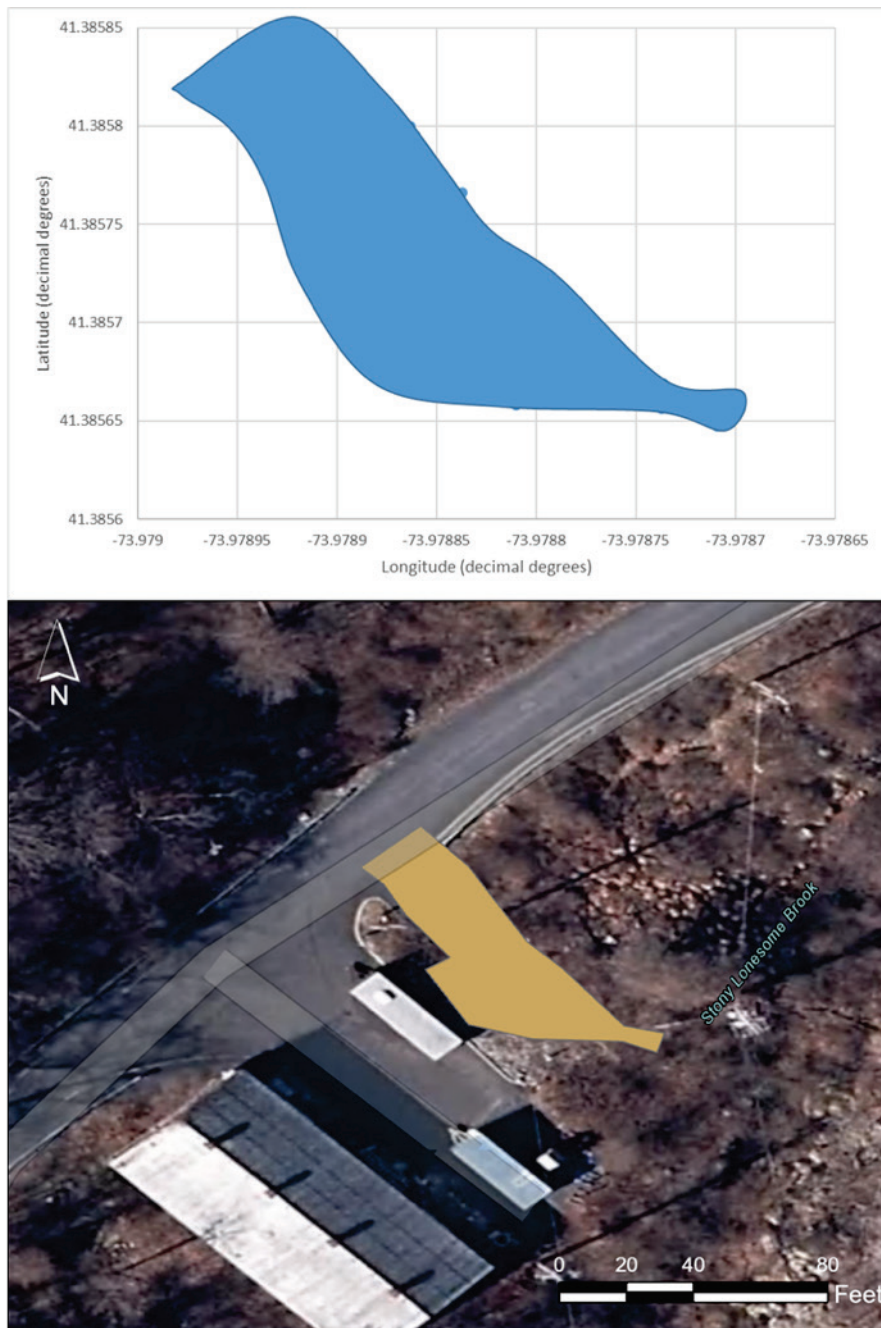
Figure D-14. West sand filter at Ordinance Road near fire station, US Military Academy, West Point, NY. GPS surface assessment (*top*), GIS generated (*bottom*).

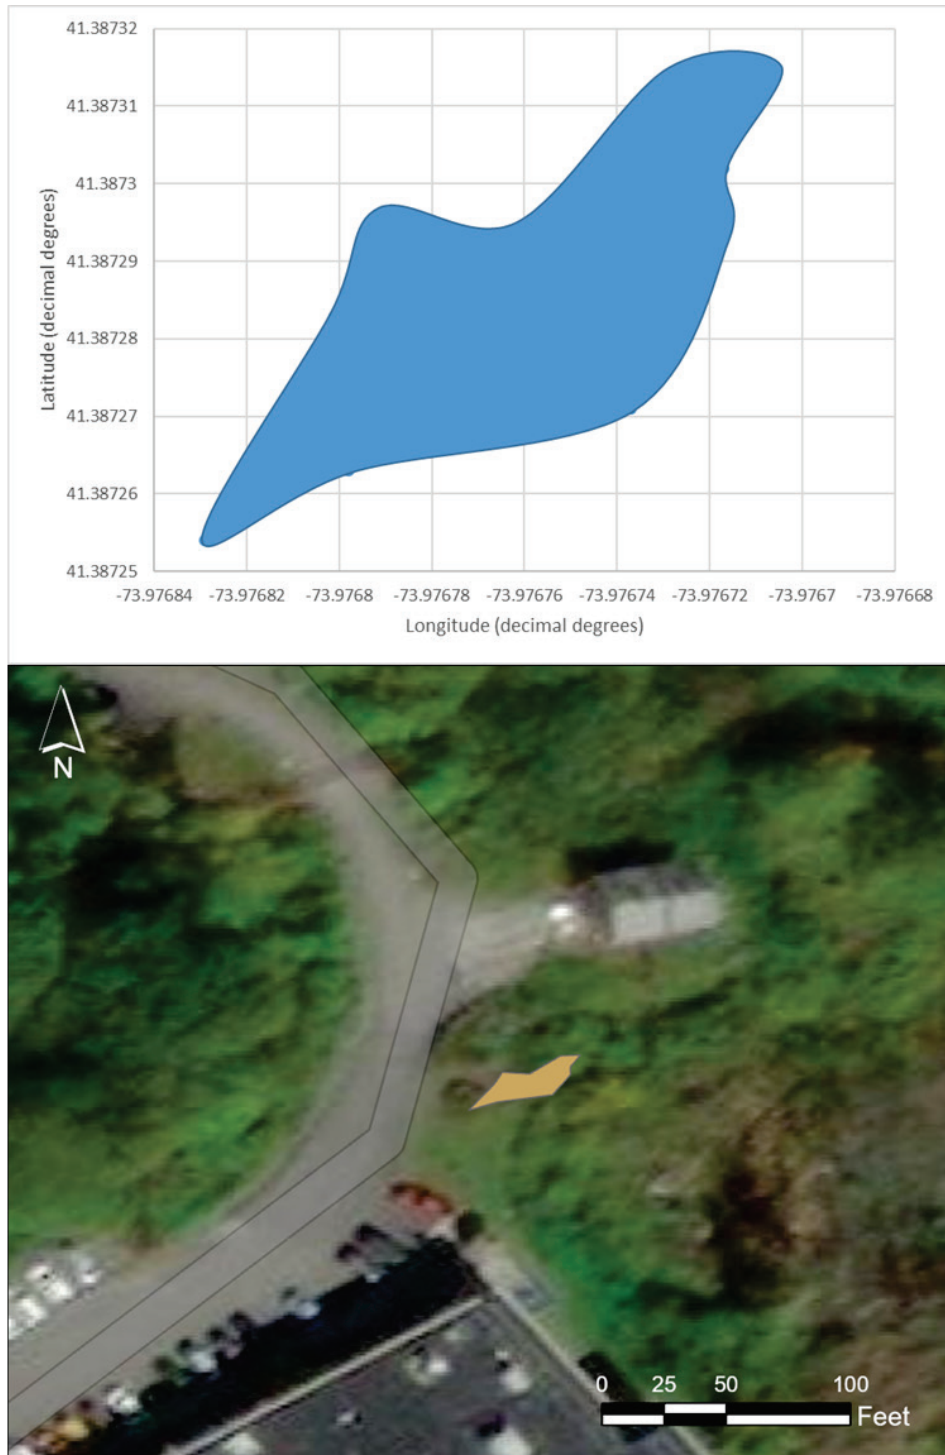
Figure D-15. Northeast sand filter at Ordinance Road near fire station, US Military Academy, West Point, NY. GPS surface assessment (*top*), GIS generated (*bottom*).

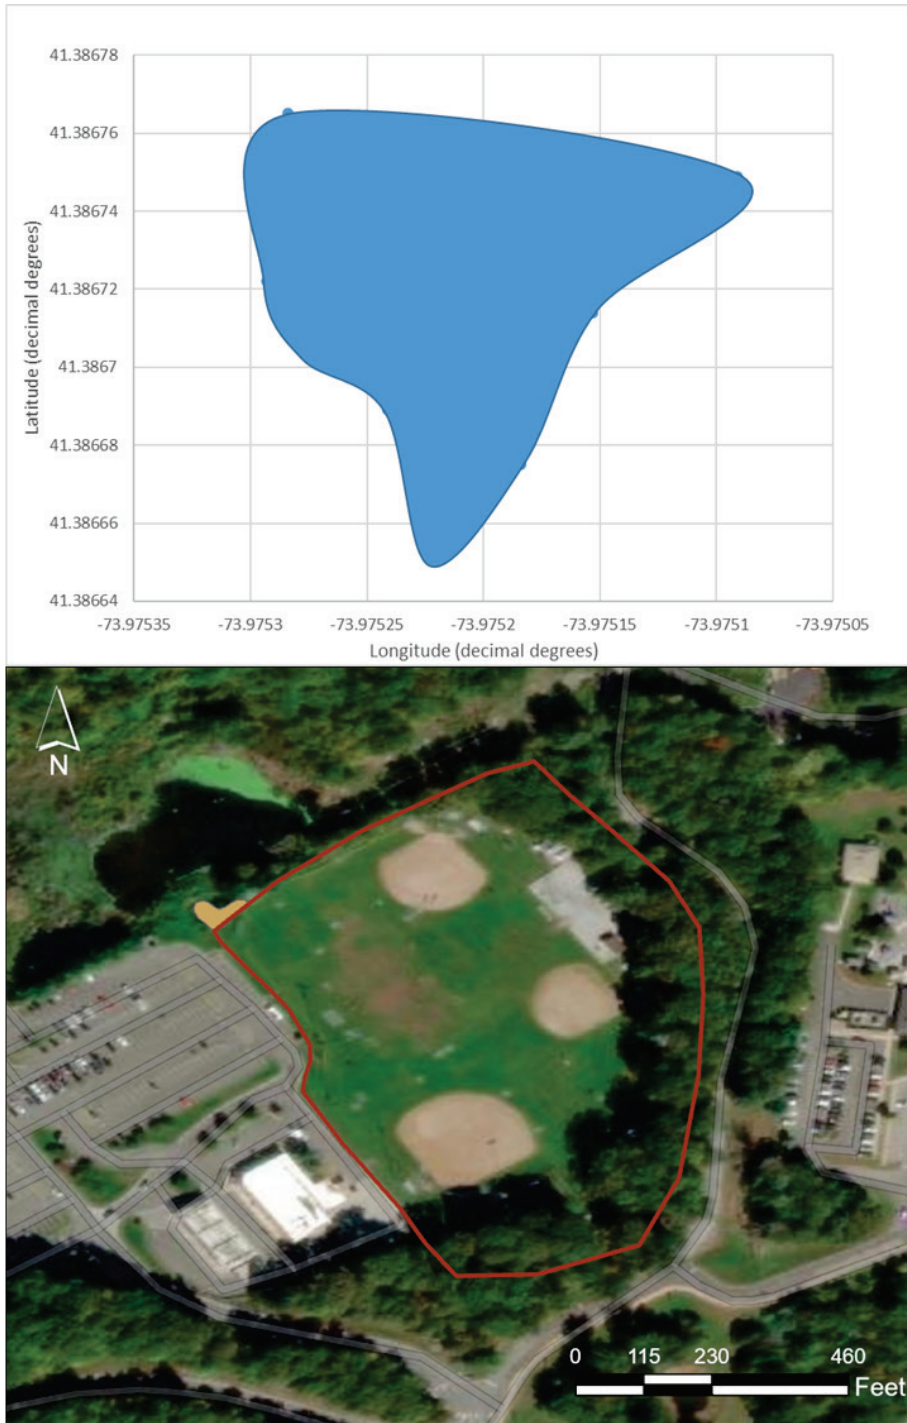
Figure D-16. East exchange sand filter near main exchange off Stony Lonesome Rd., US Military Academy, West Point, NY. GPS surface assessment (*top*), GIS generated (*bottom*).
