TESTS FOR INFORMATION ON
SHAFT REVOLUTION INDICATORS,
MAGNETO-VOLTMETER TYPE,
WESTINGHOUSE ELECTRIC CO. - MFR.

- Report B-2903 -

October 31, 1946

NRL Problem IC-1109

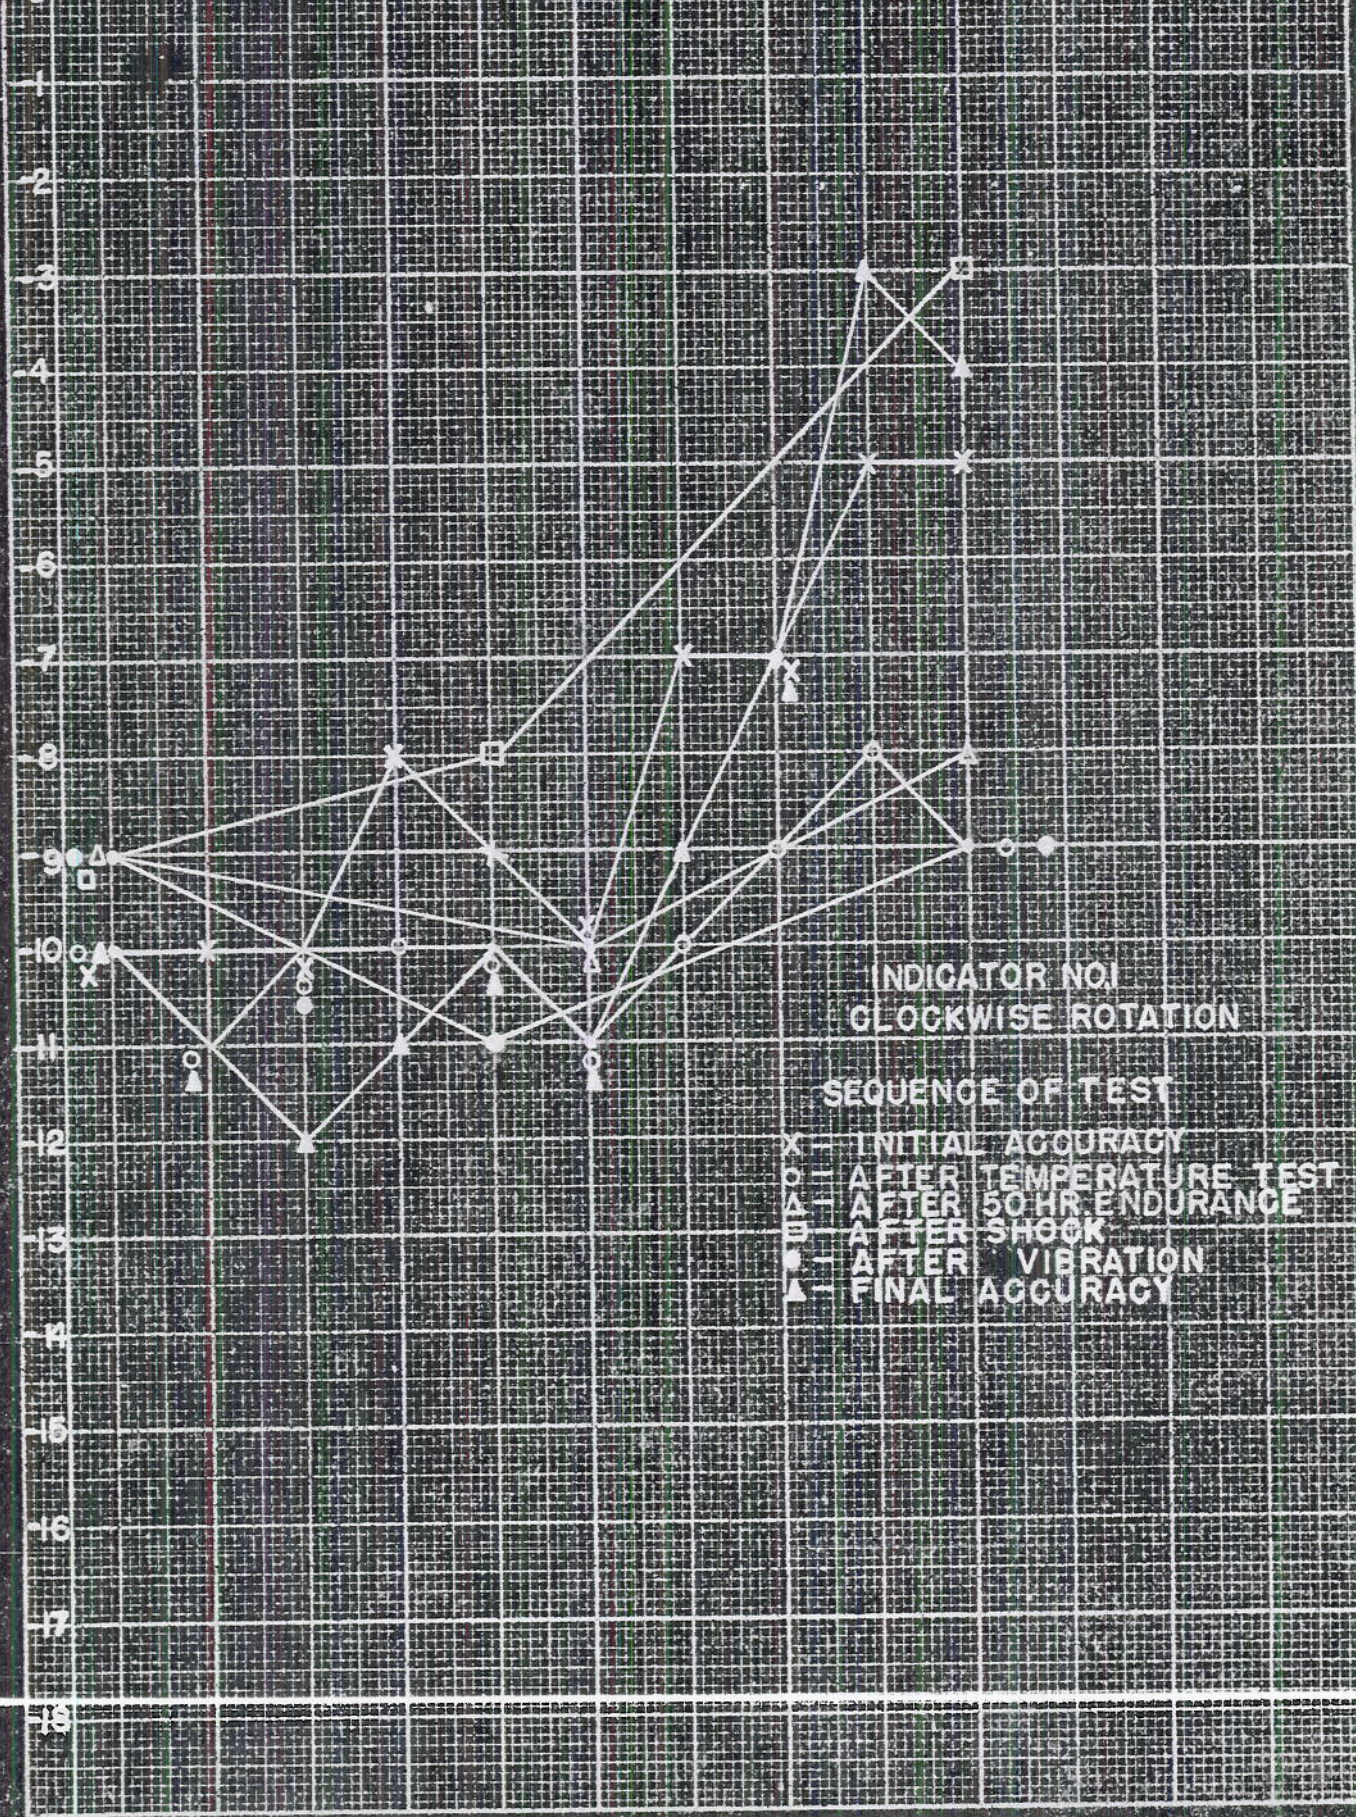
INDICATOR NO1
CLOCKWISE ROTATION

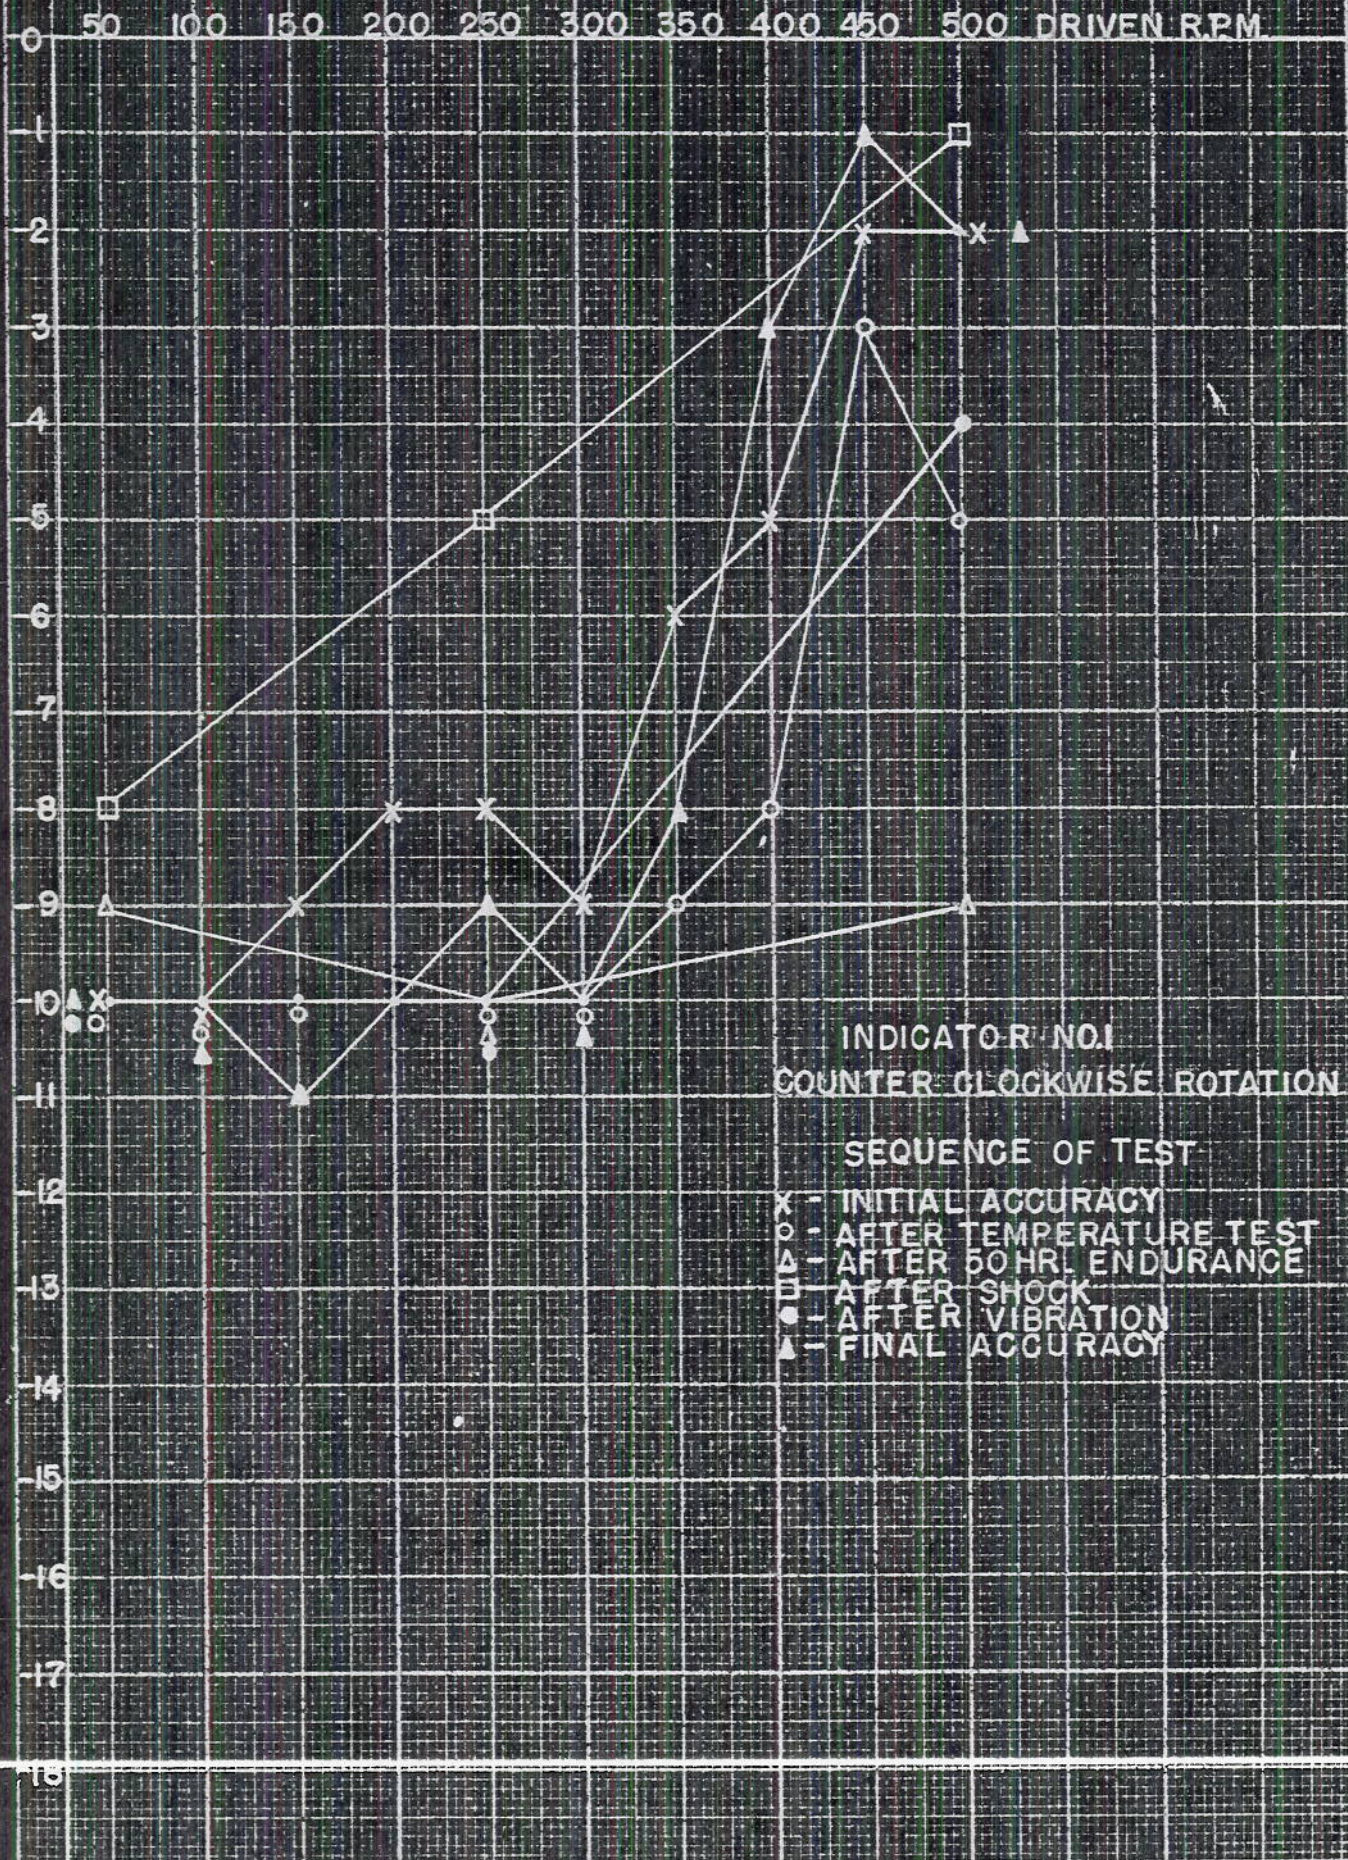
INDICATOR NO.1
 COUNTER CLOCKWISE ROTATION
 SEQUENCE OF TEST
 X - INITIAL ACCURACY
 O - AFTER TEMPERATURE TEST
 Δ - AFTER 50 HRS. ENDURANCE
 □ - AFTER SHOCK
 ● - AFTER VIBRATION
 ▲ - FINAL ACCURACY

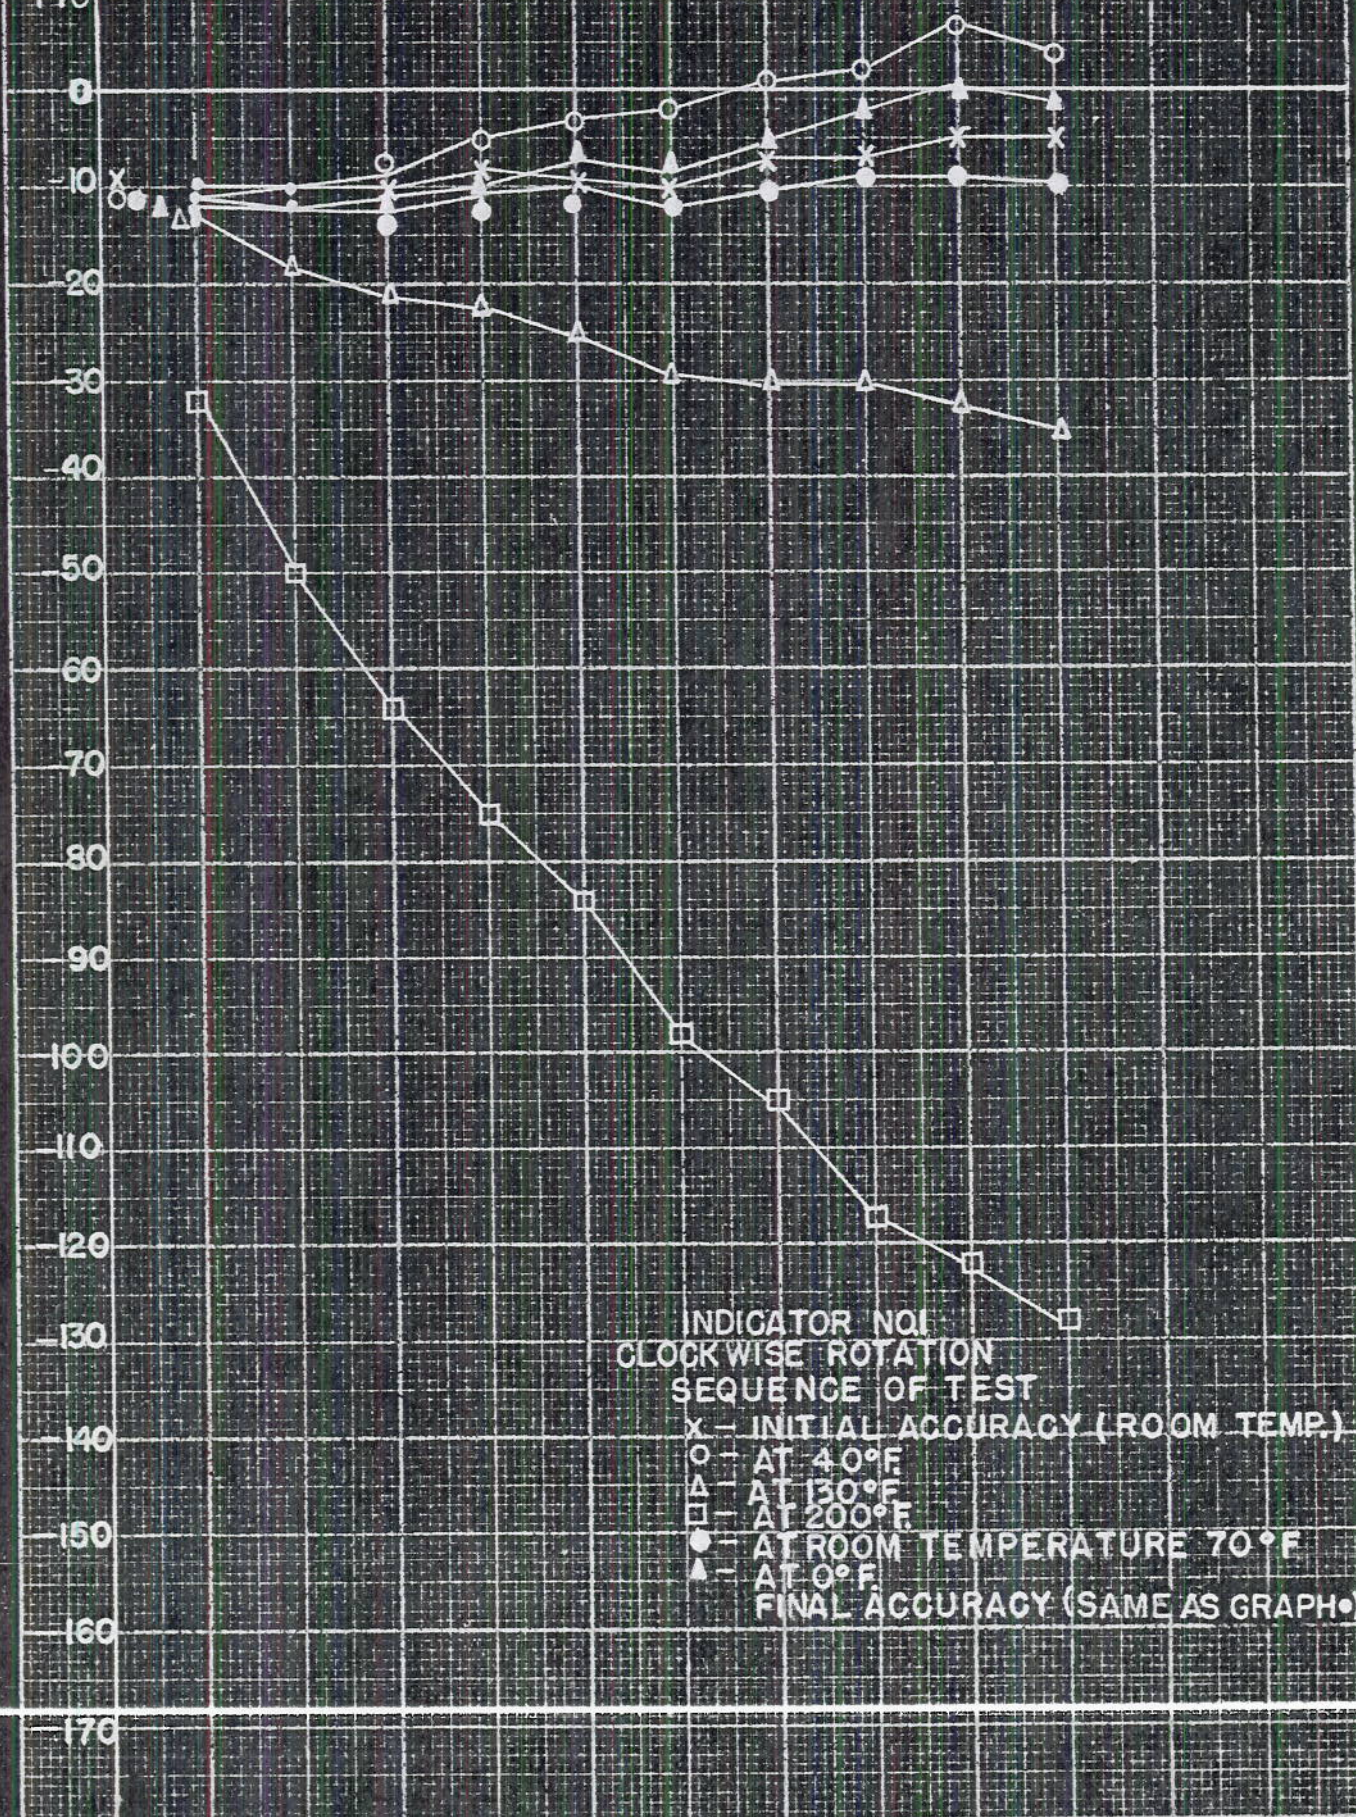
INDICATOR NO. 1
 CLOCK WISE ROTATION
 SEQUENCE OF TEST
 X - INITIAL ACCURACY (ROOM TEMP.)
 ○ - AT 40°F
 △ - AT 130°F
 □ - AT 200°F
 ● - AT ROOM TEMPERATURE 70°F
 ▲ - AT 0°F
 FINAL ACCURACY (SAME AS GRAPH)

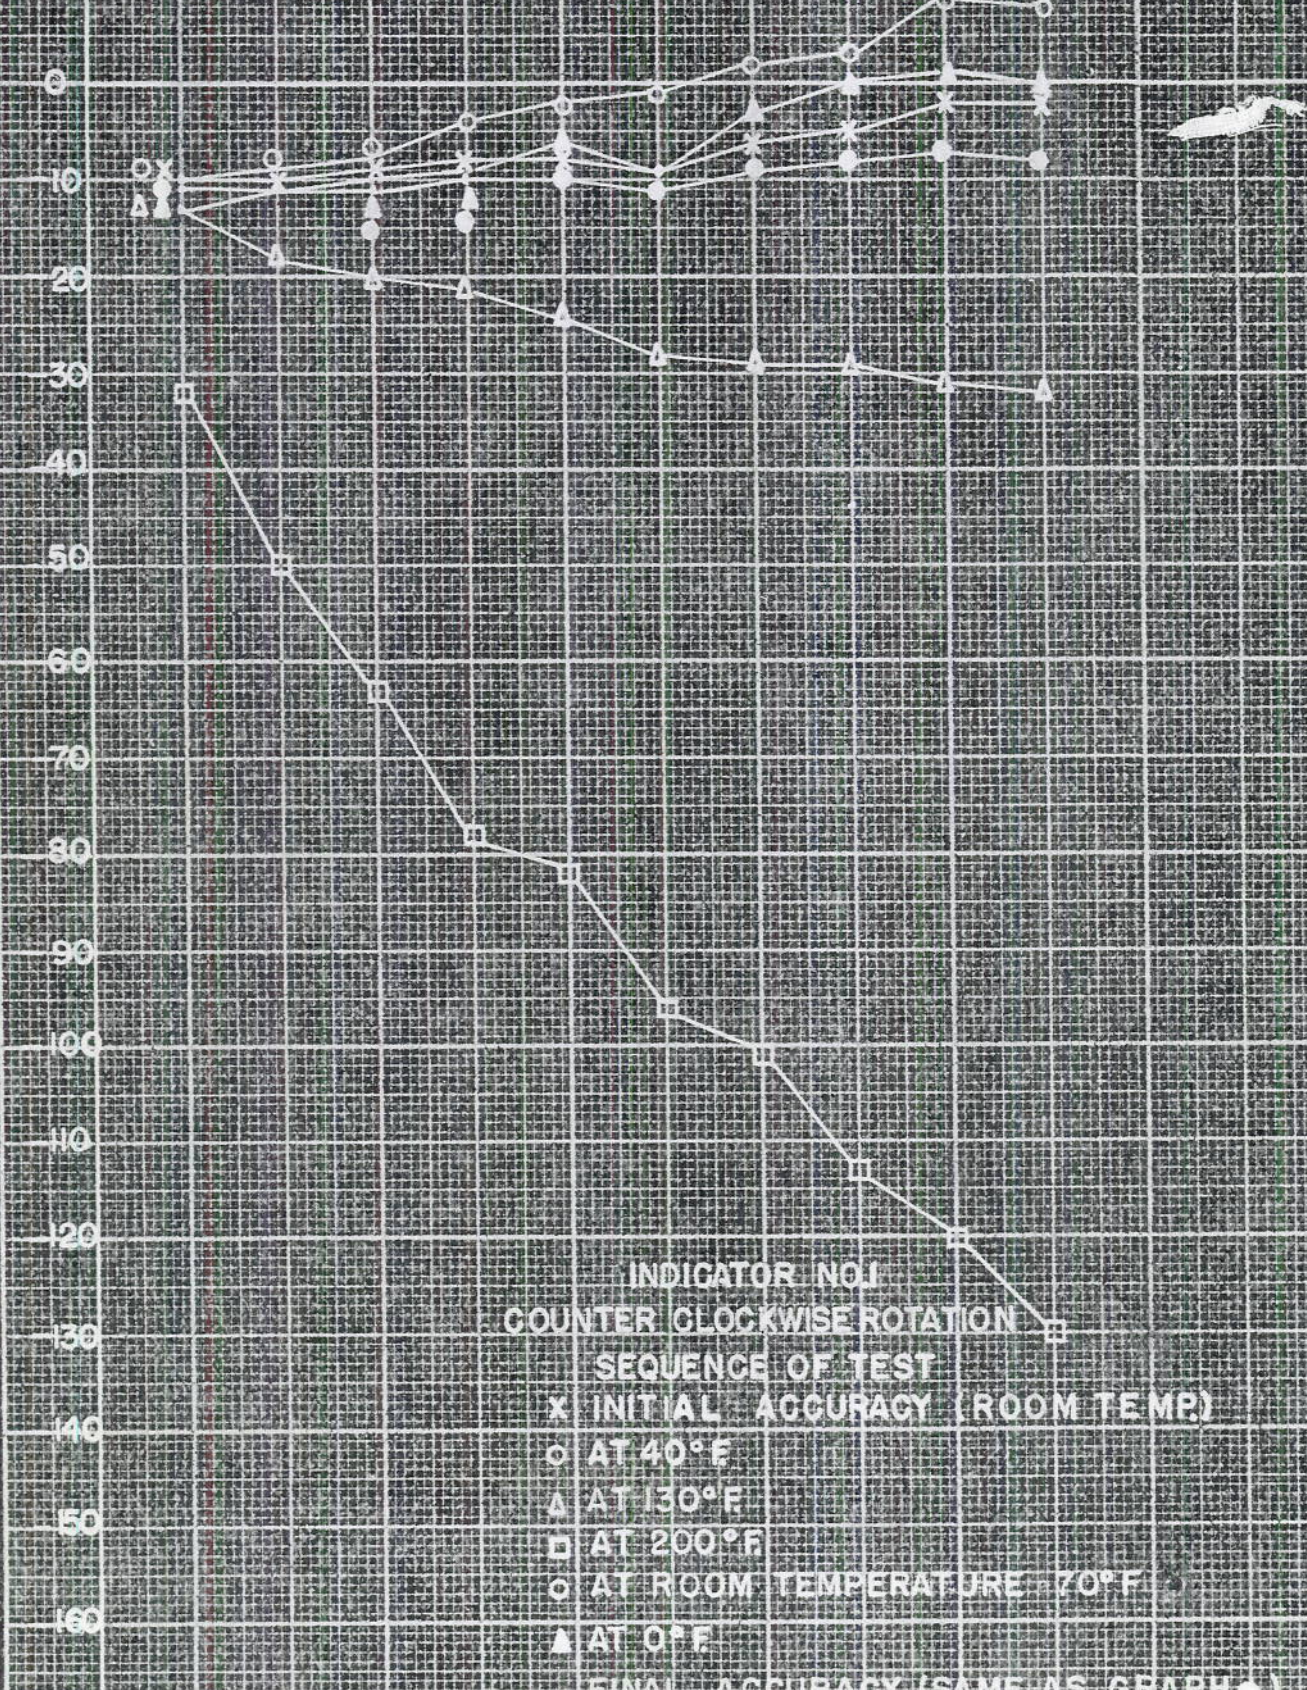
INDICATOR NO. 1
 COUNTER CLOCKWISE ROTATION
 SEQUENCE OF TEST
 X INITIAL ACCURACY (ROOM TEMP)
 O AT 40°F
 A AT 130°F
 B AT 200°F
 O AT ROOM TEMPERATURE 70°F
 A AT 0°F
 FINAL ACCURACY (SAME AS GRAPH)

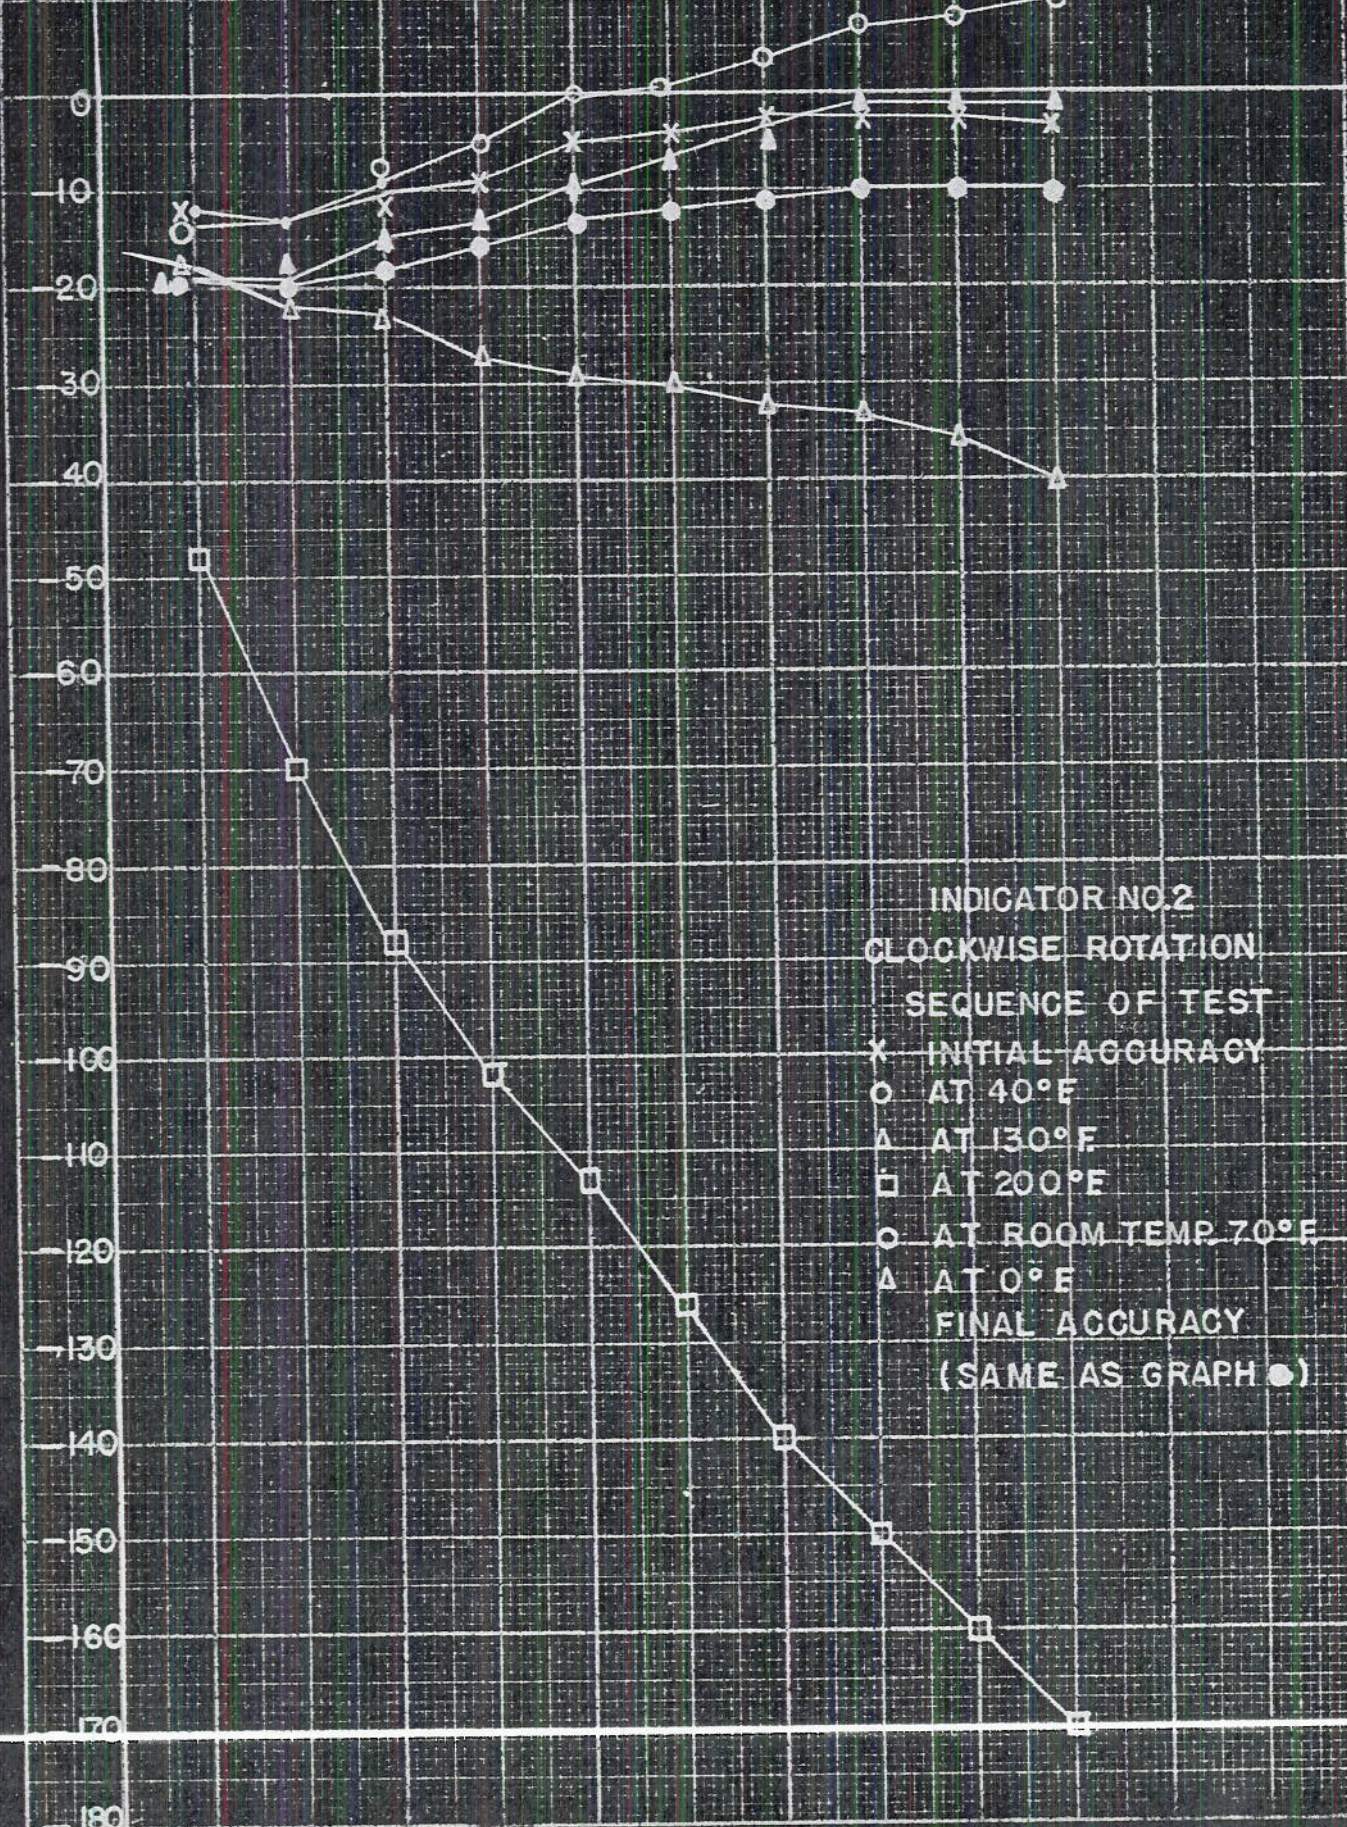
INDICATOR NO.2
 CLOCKWISE ROTATION
 SEQUENCE OF TEST
 X INITIAL ACCURACY
 O AT 40°F
 Δ AT 130°F
 □ AT 200°F
 ● AT ROOM TEMP. 70°F
 Δ AT 0°F
 FINAL ACCURACY
 (SAME AS GRAPH ●)

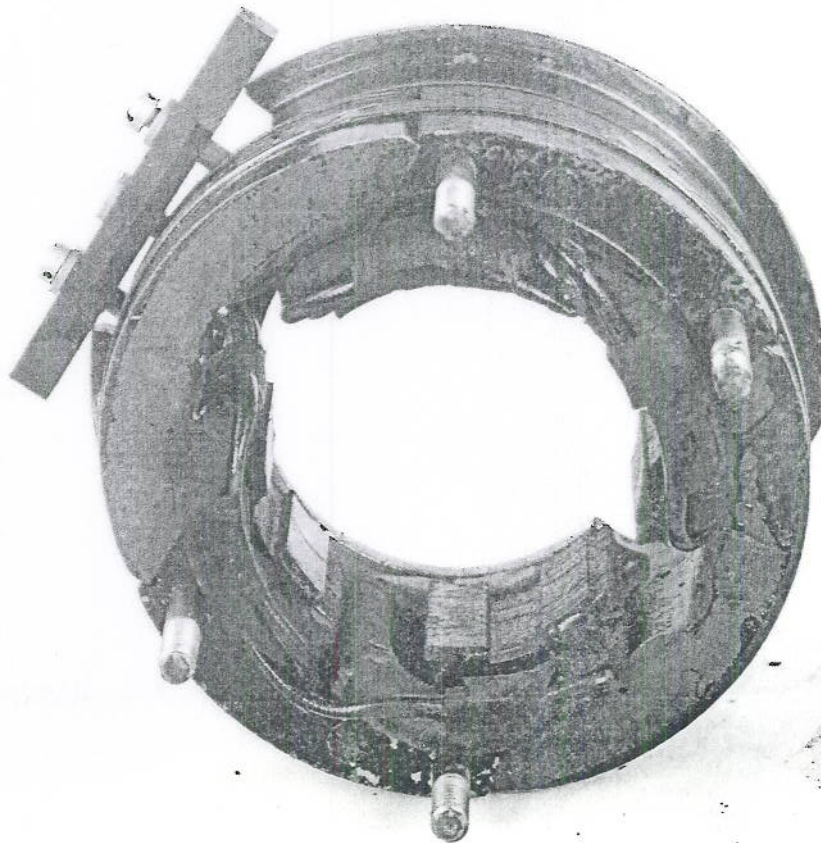
GENERATOR STATOR

13. A partial material inspection was made. The equipment was submitted to the specified dielectric test before and after the insulation test. At this point the generator was disassembled to determine if provisions were made to prevent entry of water. Due to the observed lack of shaft seals, the watertight test was omitted, however, both indicators were subjected to the specified splash-proof test and examined afterwards for leakage. Indicator No. 1 was then completely disassembled, reassembled, and rechecked for accuracy. There was some discrepancy in the indications noted before and after disassembly of the generator and indicator No. 1 so the magnetic shunt of the generator was adjusted to produce the previous generator voltage-output/speed values and the indications were found to be similar to those previously recorded, except in the case of the indicator No. 1. The rectifier unit of the latter was injured in disassembly.
